RESIDENTIAL BUILDING SURVEY

XXXXXXXXXXXX,
XXXXXXXXXXXX,
XXXXXXXXXXXX,
XXXXXXXXXXXX,
Essex,
CB10 xxx

INDEPENDENT CHARTERED SURVEYORS

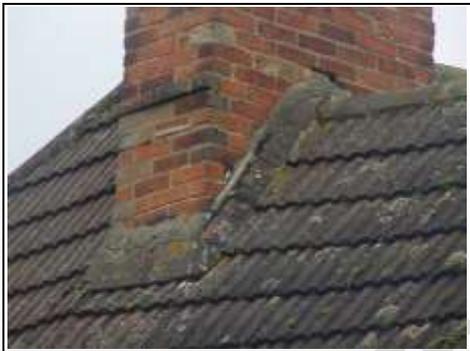
Both brick chimneys to the property have deteriorated over the years and unfortunately have been wrongly repaired with cement mortar which has caused further deterioration. In addition to this, the flashing is a tile on edge bedded into cement which opens up over time as you can see in the photograph.

Repairs with cement and tile on edge flashing

ACTION REQUIRED: General repair to the chimney recommend. Replace existing tile on edge flashing with lead flashing.

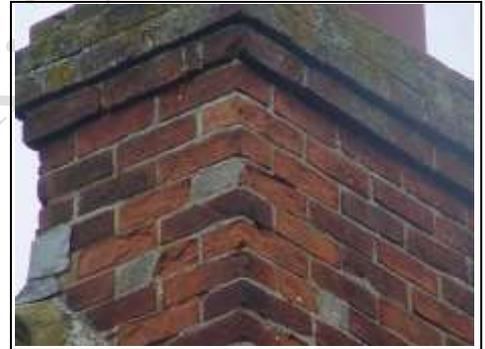
Cement repairs

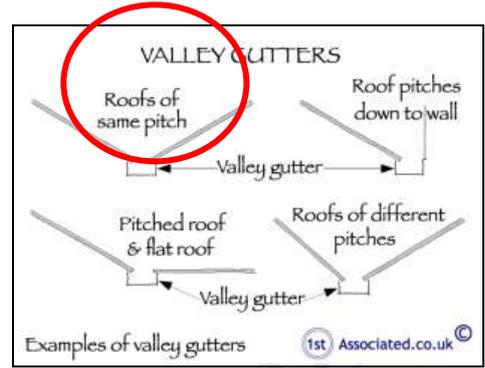
During our question and answer session with the owners they advised that there had been problems with the valley gutters and also parts of the roof leaking which had ultimately led to the replacement of the original concrete tile valley gutter with a lead valley gutter.

Valley gutter

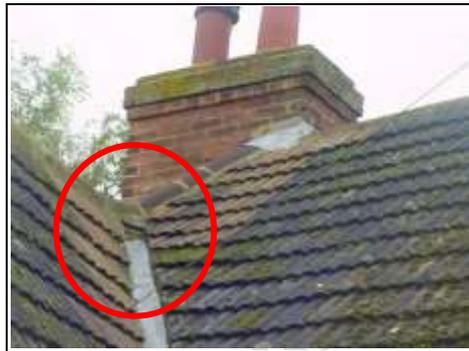
Original concrete tile valley gutter still present in some parts of the property

Lead valley gutter added. Note: Tiles have been repaired

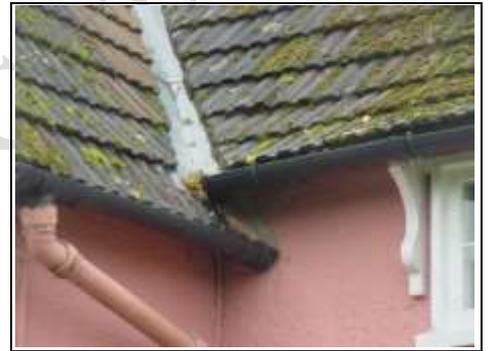
Lead valley gutter. Will it overflow the guttering?

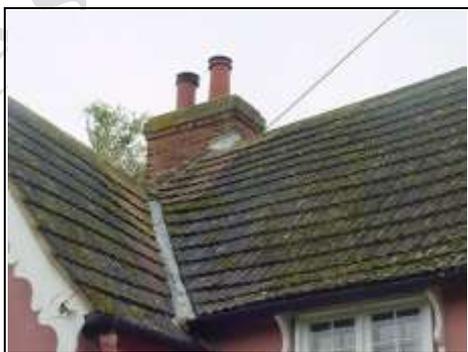
The property now has a concrete tile roof which is a much heavier roof. Typically roofs were replaced in the 1960's and 1970's with a heavier concrete tile roof. We believe this has caused stress and strain on the property as a whole and has had an impact on the roof and the walls causing roof spread.

Concrete tile roof

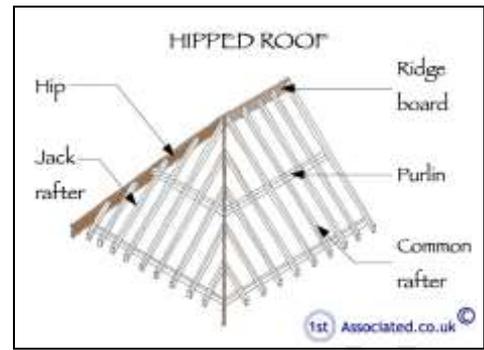
We would also add that this is a hipped roof so they are integrally unstable and we can see, probably one hundred years or so before the roof was re-roofed with a concrete tile, that it had been strengthened with metal brackets to the corners of the property.

Hipped roof

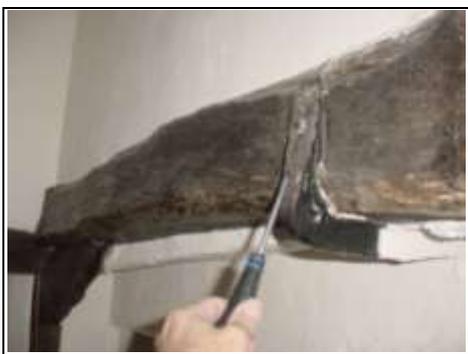
We can also see that replacement repairs and timbers have been added. Our concern is the general weakening of the structural frame particularly when you consider woodworm as well.

Bracing

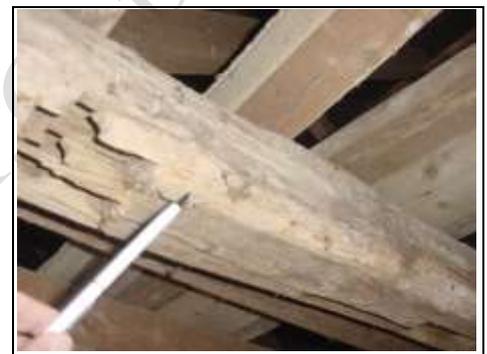
In the limited areas we could see it was affecting about thirty percent of the timbers. Whilst repairs can be carried out you do need to allow for these as part of your negotiation. We would expect costs to be incurred will be in the region of £15,000 - £30,000 as this is likely to be expensive as this is a listed building and you will have to do the work to a set way. An alternative that would be worth considering would be to lighten the load of the roof by having it thatched. We passed a local thatcher on our journey to the property:

Woodworm within garage/workshop

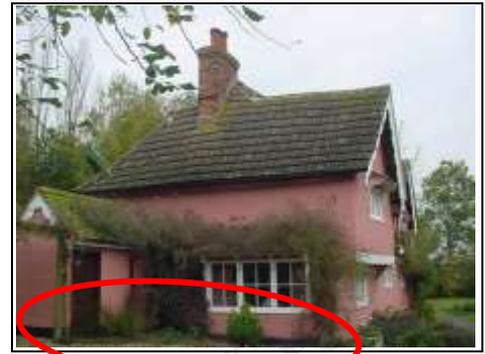
This property is held together with a timber frame structure very much like a skeleton of a human being. It works together as a whole, an essential element of it is the sole plate which is at the base of the property and forms part of the structure from which vertical wall timbers/posts are built from. It is particularly important in this instance that they are in good condition due to the roof issues mentioned.

Render meets ground

1) You need to check and confirm the sole plate to the entirety of the property by opening up and exposing it so you understand the full extent of the problem. This will mean removing render externally to the front left hand side, the left hand side and the rear of the property (old sections) and carry out any necessary repairs.

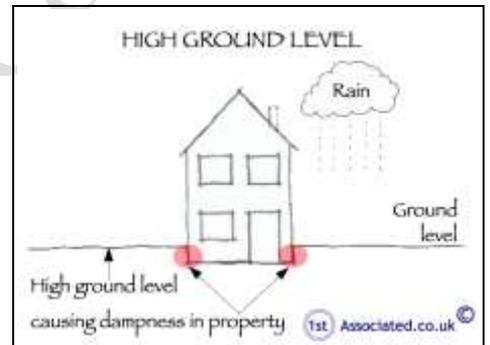
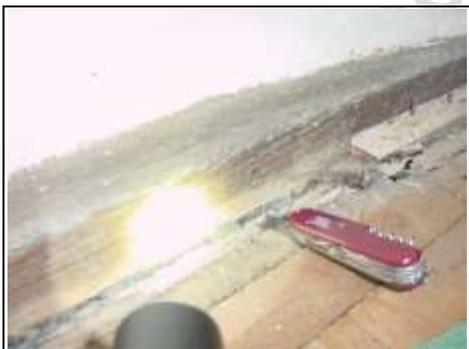
Sole plate

There are two key areas where there seems to be problems which is to the front left hand corner and to the left hand side. In addition to this the rear right hand gable and the right hand side we could not investigate this area (kitchen and office area). However where we have been able to investigate in the lounge, where we lifted part of the carpet, the wood parquet flooring underneath it, we were able to see what we believe to be the sole plate. Within the sole plate we found rot which we believe is partly due to the high ground level but also the concrete floor within the property that effectively acts like blotting paper.

2) Reducing the ground level around the property and adding French drains where necessary to get the water away from the property and giving any rainwater a definite path from the top of the hill to the bottom.

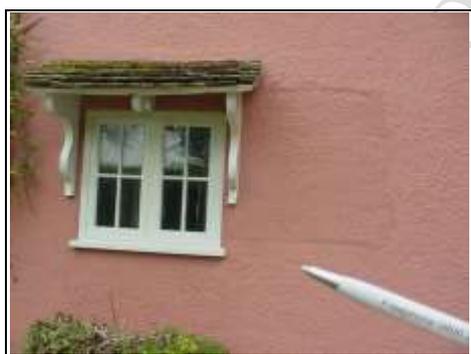
The outside of the property has cement render which effectively will be causing accelerated deterioration to the timber structure behind it. It is not that uncommon to have a cement render but you do need to consider the accelerated deterioration it causes to the structural frame together with the other issues in this report.

Render changes with alterations that have happened over the years

ACTION REQUIRED: Many people would be put off purchasing from this point alone. If you do decide to purchase then we would recommend you remove all the render to one gable end during the summer and warmer months of 2015 and examine the timber frame. We would be more than happy to help and advise further when the render has been removed.

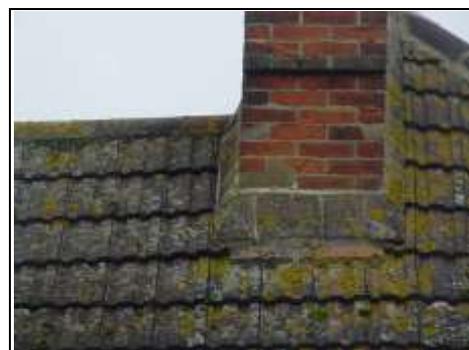
1) The concrete tile/cement flashings around the chimney – we would recommend these are replaced in lead.

Tile on edge flashing

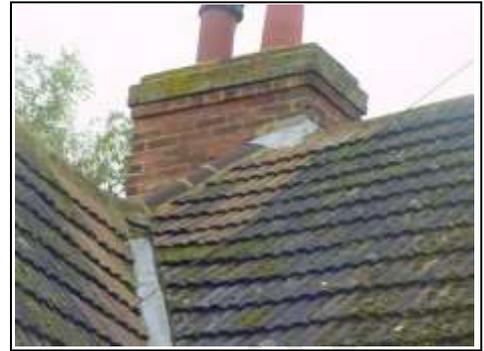
3) The valley gutters, some of which are formed in concrete – we would recommend these are replaced in lead.

Replacement valley gutter to front left side which current owner carried out

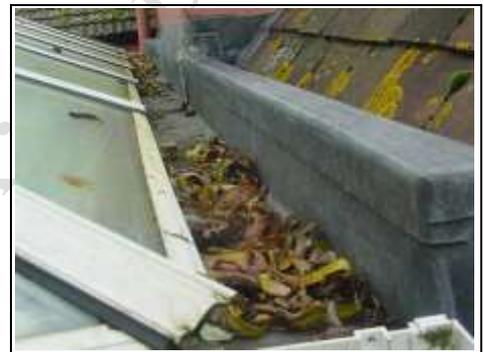
4) The awkward box gutter to the rear of the property which is catching a lot of leaves which will need constant cleaning.

Leaves in hidden valley gutter to rear

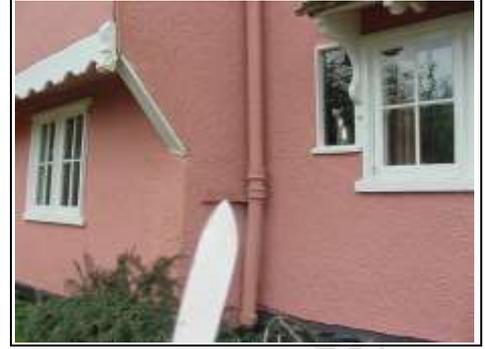
There looks to be some asbestos and cast iron gutters and downpipes – we suggest you need to replace the asbestos. Wherever possible we would suggest you keep the cast iron as it lasts far longer than plastic and it could be argued it is more appropriate for older buildings, although of course originally when this was a thatched roof it would not have had gutters.

Asbestos downpipe

ACTION REQUIRED: We would always recommend any asbestos is removed from a property as it can not only be dangerous, it can affect the value of the property. The only way to be a hundred per cent certain with regards to Asbestos in a property is to have an Asbestos report carried out.

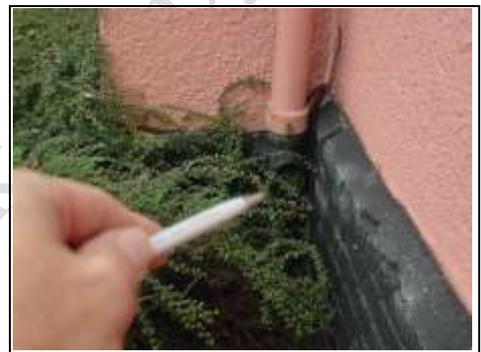
Downpipe discharging onto ground against building

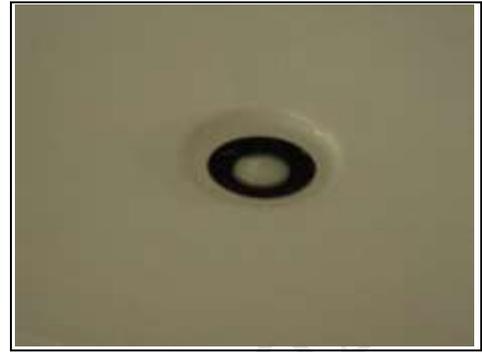
Extract in light within ground floor shower room

ACTION REQUIRED: We would recommend large humidity controlled extract fans be added to kitchens, bathrooms and drying areas.

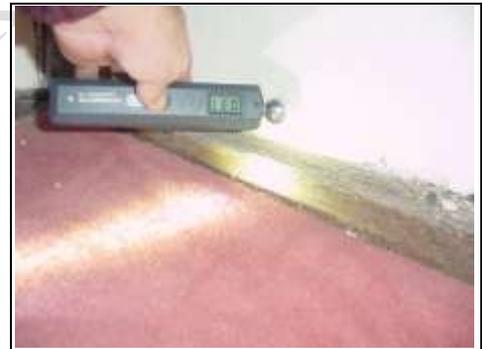
We generally found rising damp throughout the property. This partly relates to the relatively high ground water table in the area which is why you have a pond so close. Also, the lack of a defined path for the water which we have mentioned elsewhere within this report.

Rising damp

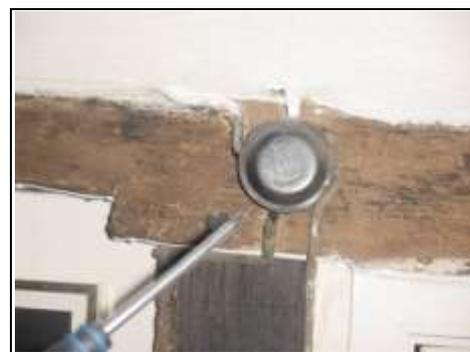
There is an old 1960's fuse board and several old fixings throughout the property. The owner did not have any wire fuse with them therefore we decided it was better not to carry out our basic electric test as it could have left them without lights or power.

Old electric fitting

ACTION REQUIRED: Institution of Engineering and Technology standards (IET) test and report and any recommendations to be carried out by an NICEIC registered and approved electrical contractor or equivalent.

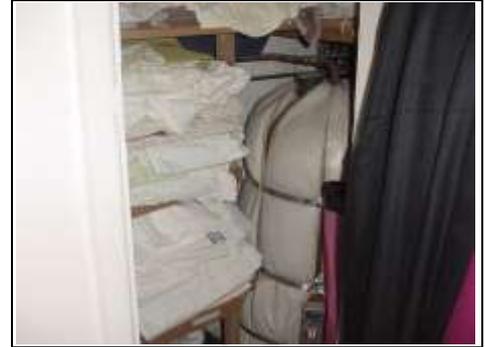
The hot water cylinder is located in the office on the first floor. It has an insulation jacket rather than factory lagged which indicates that it is relatively old. This cylinder will therefore not have the same thermal properties as a modern factory insulated cylinder. The problem with these is that they can leak at any time.

Older style hot water cylinder

ACTION REQUIRED: Replace.

ANTICIPATED COST: We have just had a replacement hot water cylinder carried out which cost £750; quotations required.

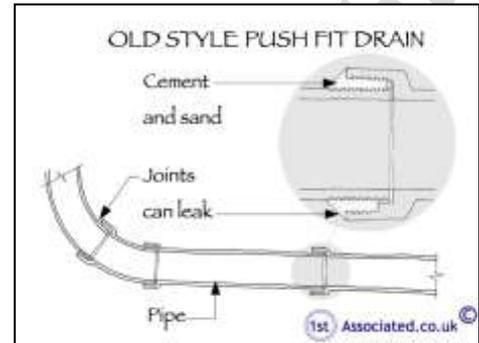
In older properties, such as this, drainage was often push fitted together rather than bonded together which means that they may leak over the years. Whilst we ran the tap for 15 minutes without any build up or blockages the only way to be 100% certain of the condition of the drains is to have a closed circuit TV camera report.

Push fit drain

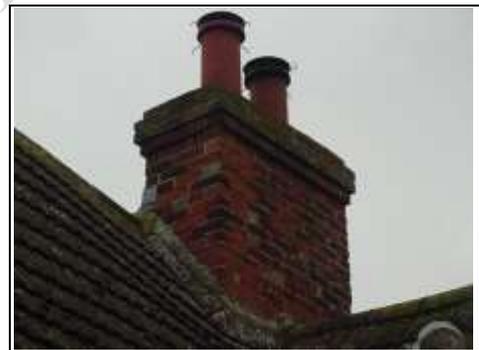
Left chimney

This chimney is brick finished with cement repairs and a tile on edge flashing which are not ideal and two chimney pots. From what we could see from ground level it looked in below average condition considering its age, type and style.

ACTION REQUIRED: We would recommend repair work is carried out to the chimneys before 2017. We also recommend replacing the tile on edge with a lead flashing. Please see our comments in the Executive Summary.

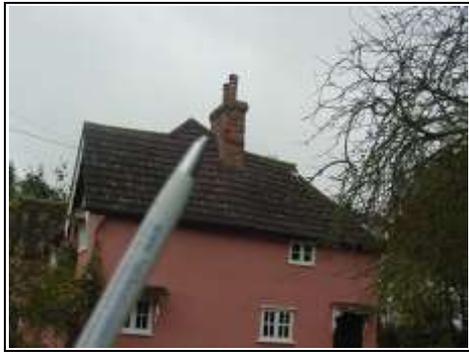
Chimney two

This chimney is also built in a similar manner to the first chimney, though we would comment that it is deteriorating and has had more repairs in cement and is weathered.

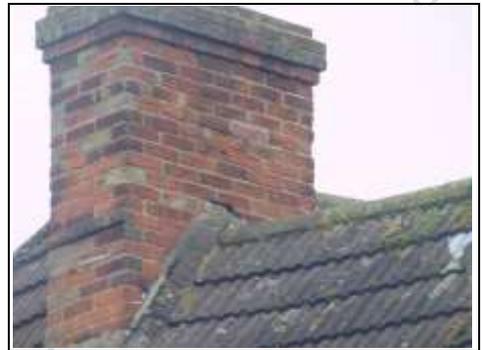
Repairs in cement and weathered

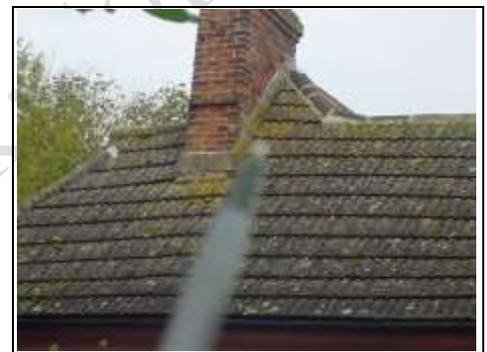
The roof is hipped and clad with a concrete tile and, from ground level, this looks in average condition considering the roofs age type and style. The roof has some moss.

ACTION REQUIRED: Please see our comments in the Executive Summary.

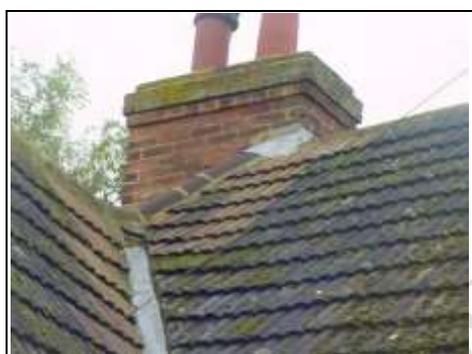
Replacement valley gutter to front left side which current owner carried out

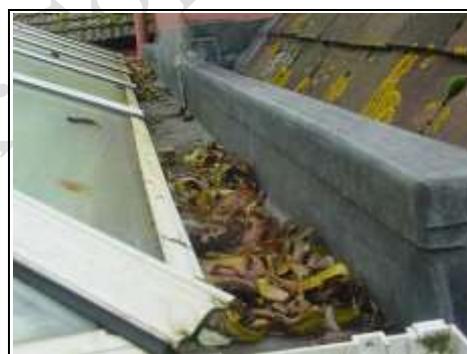
Leaves in hidden valley gutter to rear

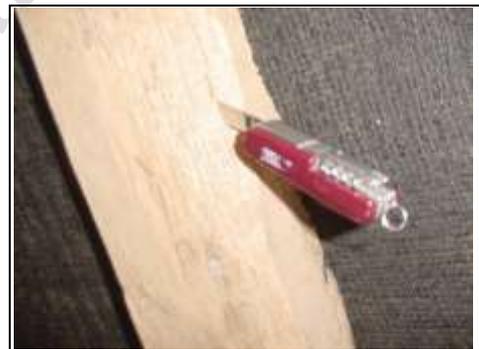
Woodworm with our knife going into the timber over an inch in depth

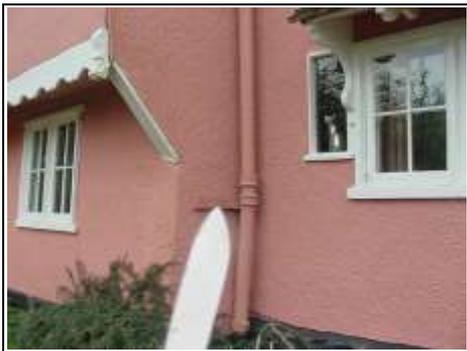
The property when thatched would not originally have had any gutters and downpipes. These have been added over the years and now look to be a mixture of asbestos and plastic. There may also be some old cast iron pipework remaining or it may have been replaced when the property was re-roofed in the 1960's/1970's. They are in below average condition for their age, type and style.

Asbestos downpipe

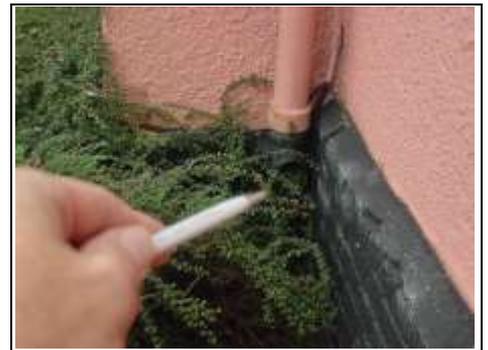
Downpipe discharging onto ground against building

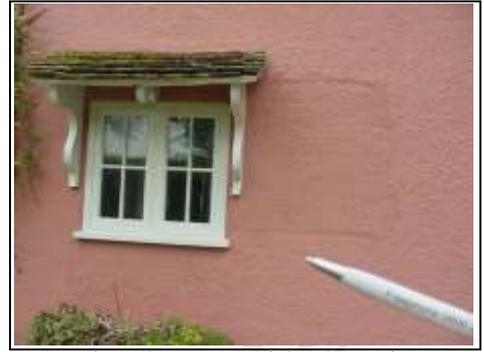
The external walls are finished in a cement roughcast render. Unfortunately cement rendering is one of the worst things you can do to a timber frame structure as it stops it from breathing.

ACTION REQUIRED: You need to open up a section to check its condition.

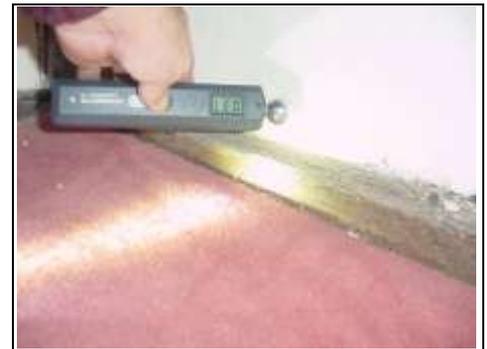
A visual inspection and tests with a moisture meter have been taken to the perimeter walls. In this particular case we have found what we would term as significant rising damp generally around the property with the exception of the newer extensions and conservatory.

Testing for rising damp

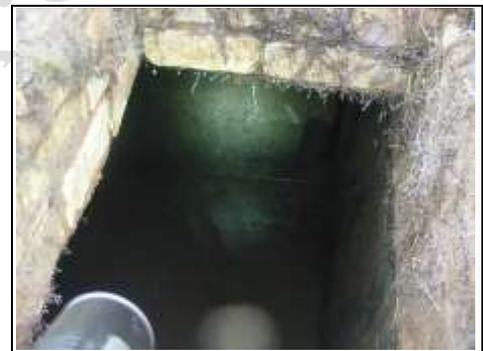
Minor roots visible in septic tank

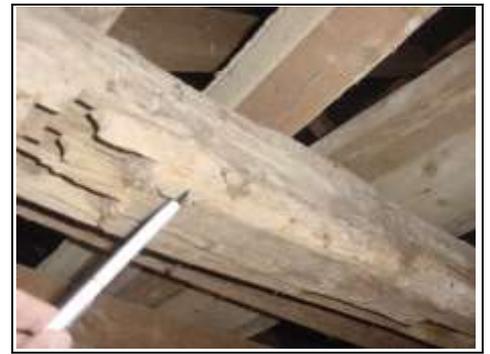
Woodworm within garage/workshop
