REFERENCE: xxxxxxxxxxxxxxxx

RESIDENTIAL BUILDING SURVEY

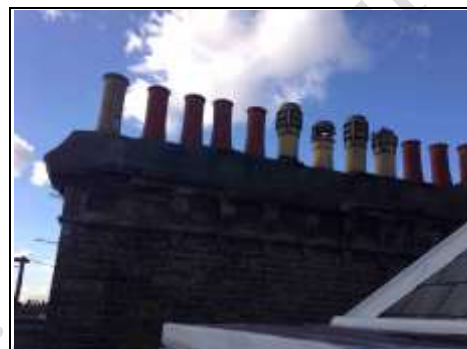
ACTION REQUIRED: Ad hoc repair work to chimneys.

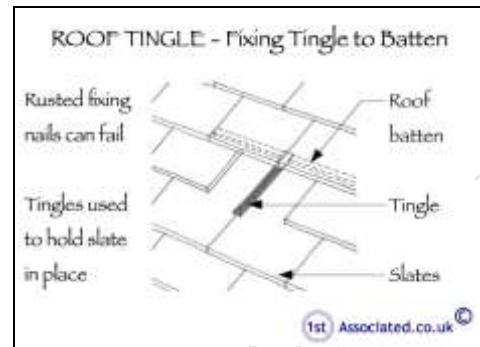
How the tingles fix on to the tiles

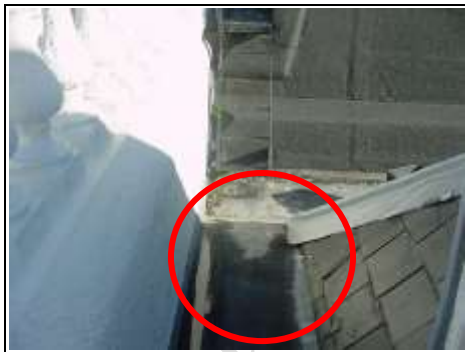
We also believe there are problems with the double pitched slate roof to the rear due to the staining we can see on the box gutter. This is the roof you are looking to extend upwards, so again it depends upon how quickly this work can be carried out as to whether repairs are necessary.

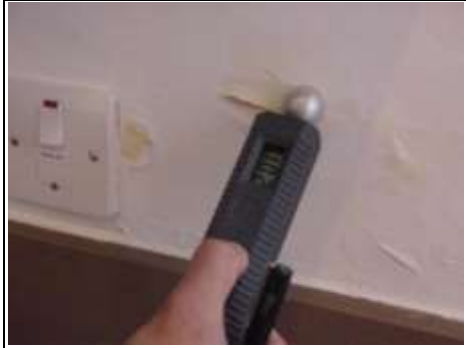
Damp meter readings indicate dampness is coming into the fourth floor via the front parapet wall

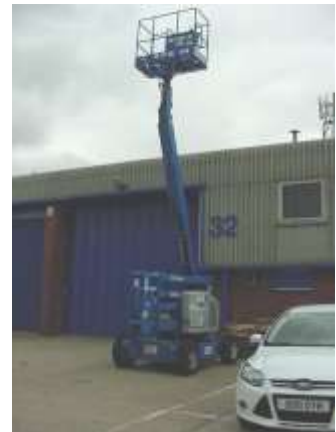
Example of a cherry picker

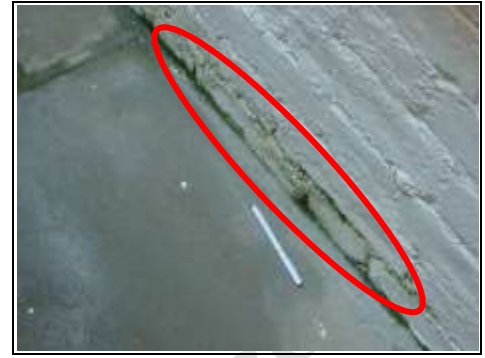
Mould around outside of walls in void area indicating

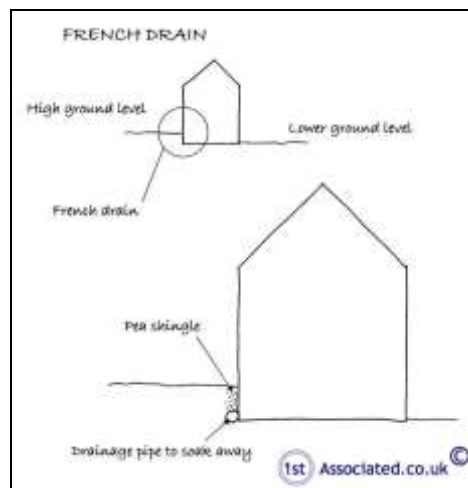
ANTICIPATED COST: Costs in the region of £15,000 to £30,000, particularly if the French drain leads into the drainage system. Please obtain quotations.

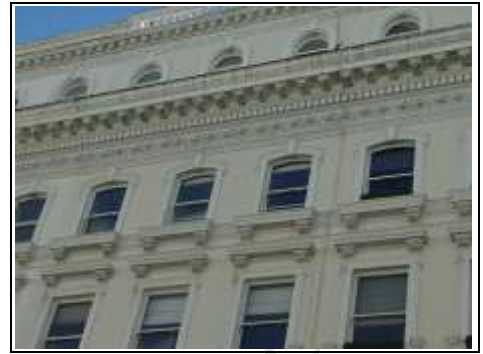
Render to front of property where hairline cracks can lead to dampness coming in

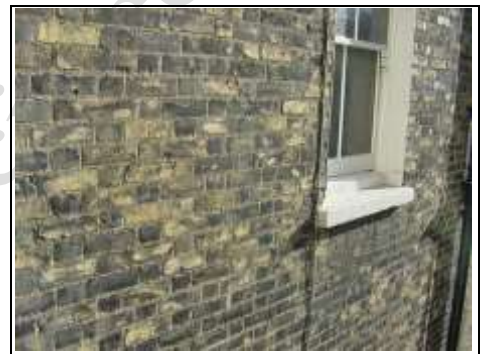
Flemish Bond brickwork at high level

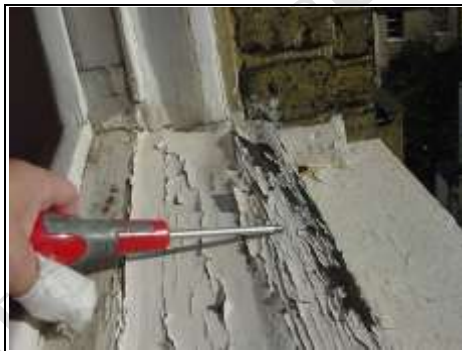
Timbers deteriorating

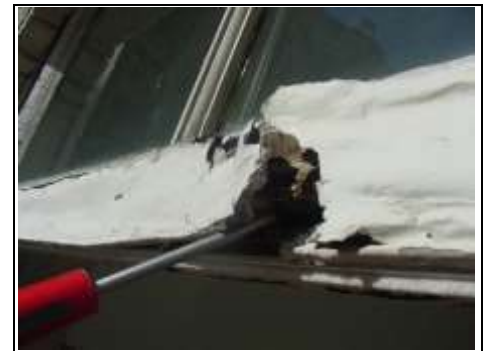
Window sills and ledges allow water to sit on them

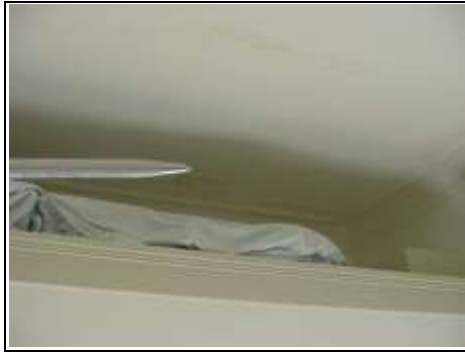
Staining in second floor bedroom
from bathroom above

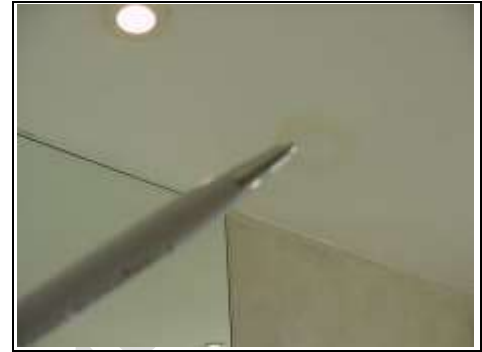
Staining in second floor
bathroom from apartment above

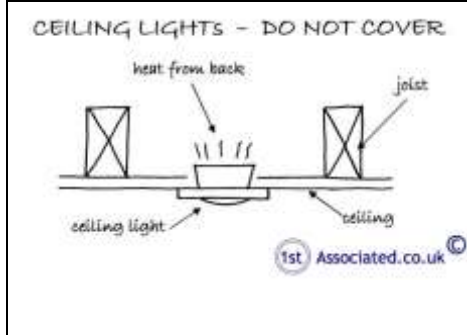
Ceiling lights sketch

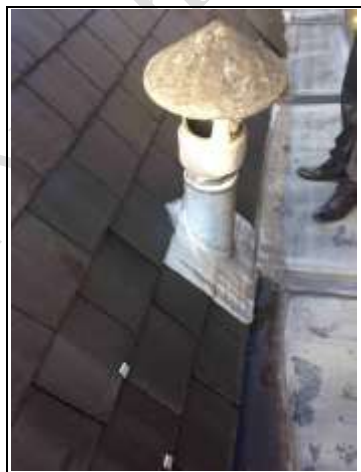
Asbestos flue to main/loft conversion roof on left hand side

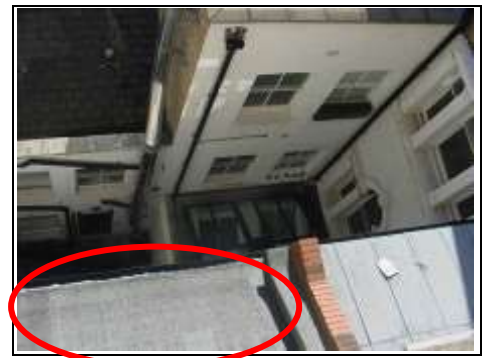
Your patched mineral felt roof to left hand side is in poor condition compared with next door's lead finished roof to the right

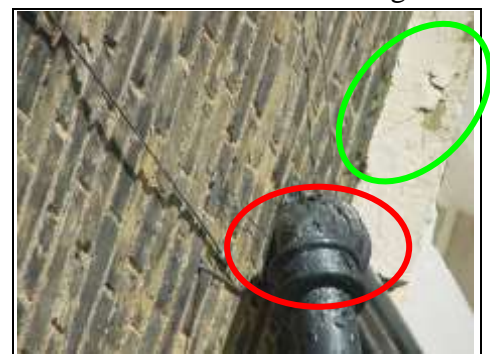
Cast iron pipe (red circle) and moulding (green circle) in need of redecoration

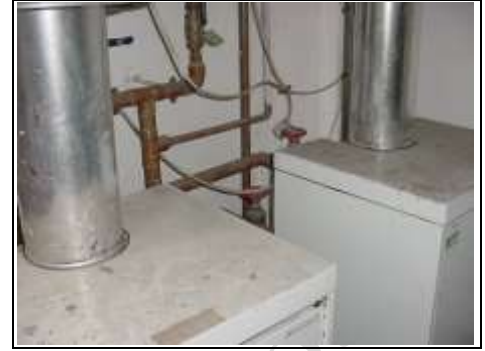
The individual systems could either be a gas supplied boiler and radiators, or if you wish to have high specifications you could add air conditioning throughout.

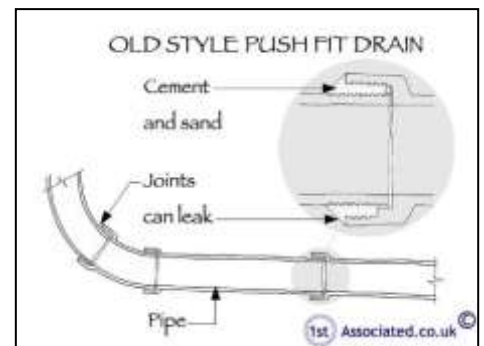
We would also advise that in older properties, such as this, drainage was often push fitted together rather than bonded together which means that they may leak over the years. Whilst we ran the tap for 15 minutes without any build up or blockages the only way to be 100% certain of the condition of the drains is to have a closed circuit TV camera report.

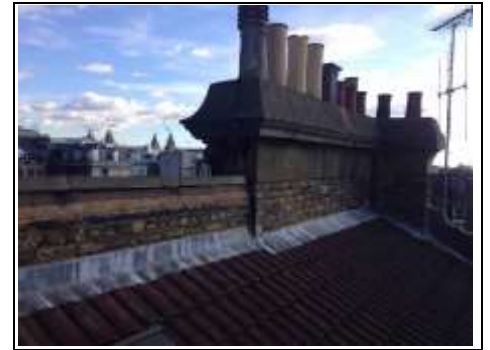
Chimney to rear left side

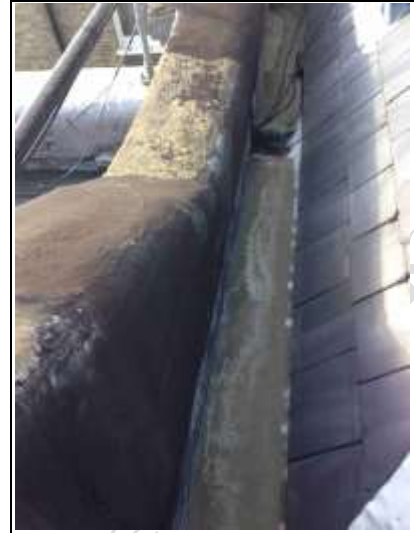
Bitumen covered parapet wall

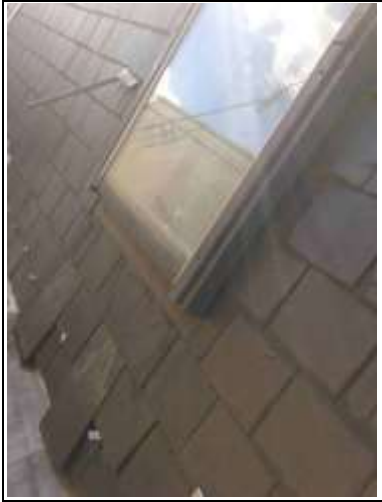
Roof window to front left hand side

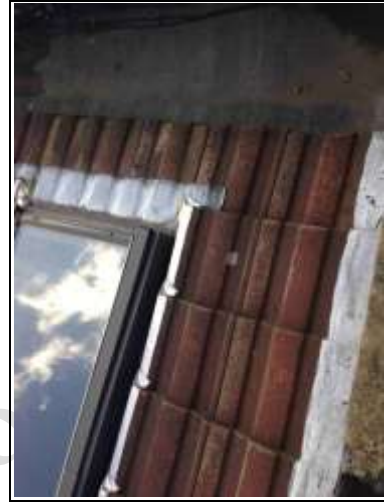
Roof window to rear left hand side with Flashband repair, which we always consider to be a temporary repair

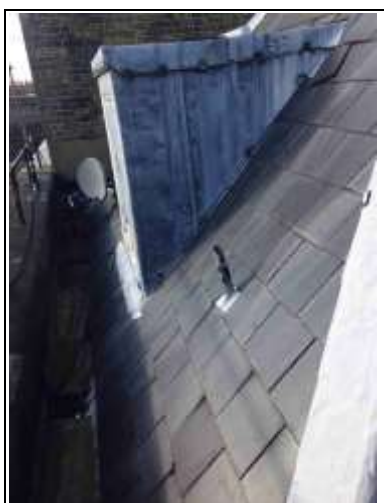
The property has a dormer window on the manmade slate roof. It is lead covered and looked in reasonable condition, with the exception of the timber window that needs repair and redecoration.

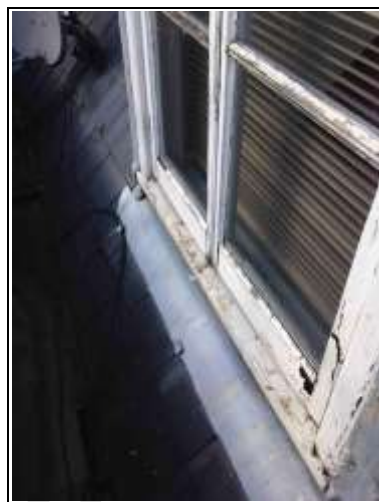
Timber window is deteriorating

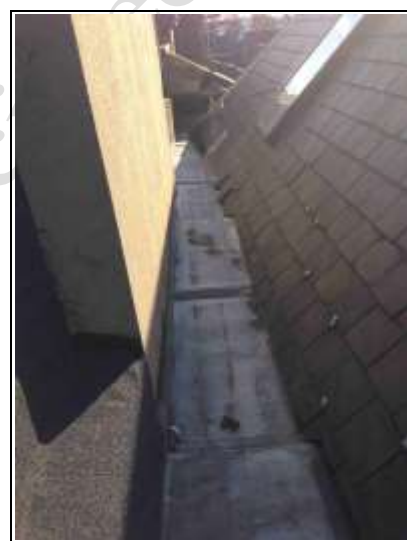
Main roof to left hand side

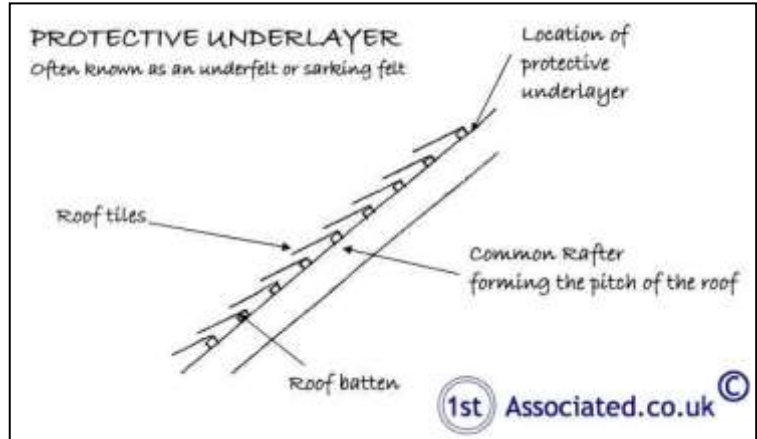
Protective Underlayer

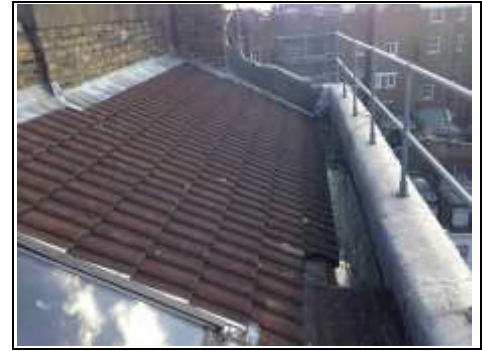
Single pitched concrete tiled roof

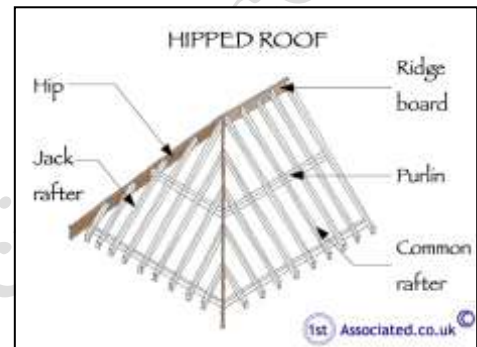
It is likely additional timbers have been added to the purlins or even possible steels, although we have not seen any.

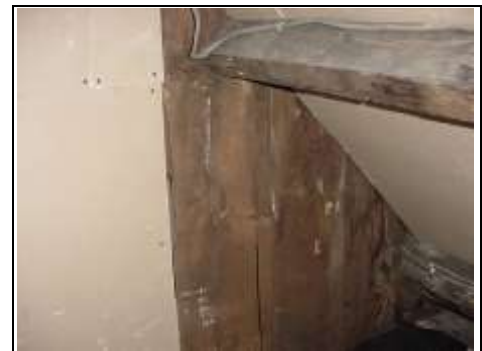
Small bit of roof we could see to the left hand side

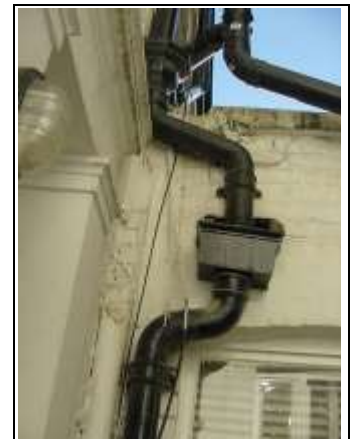
Cast iron hopper head

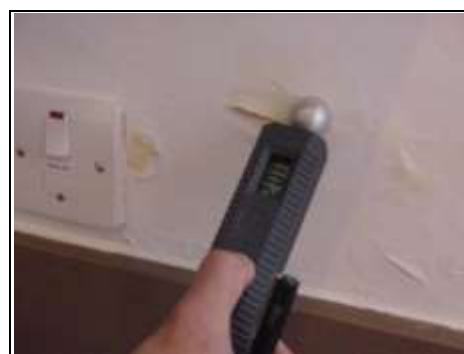
Dampness internally caused by box guttering to front wall

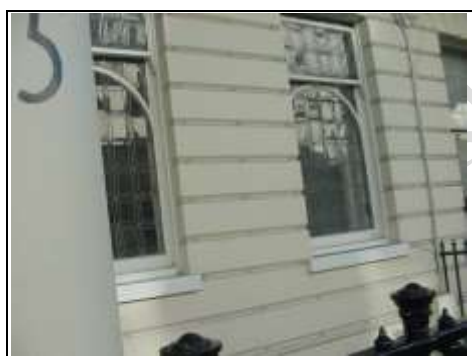
Stucco style render to
base of property

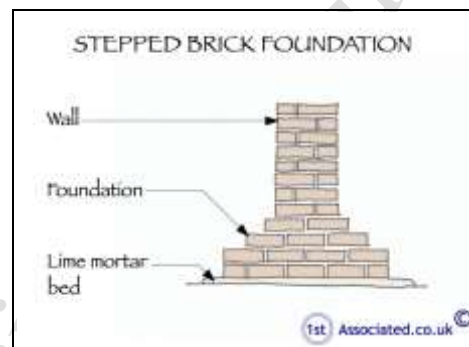
Stepped brick foundation

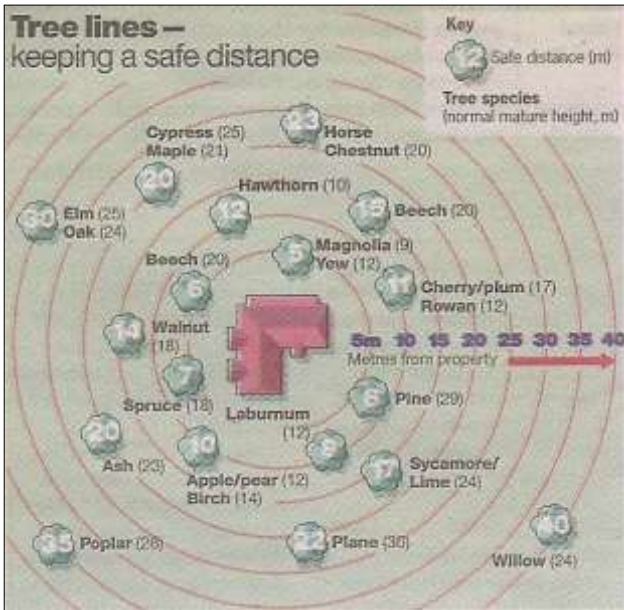
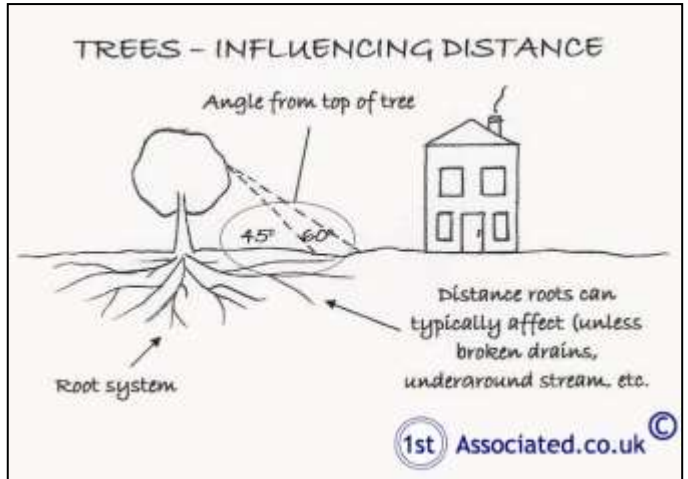
Influencing distance of trees to a property

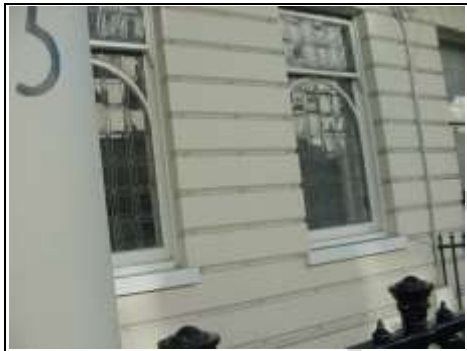
Single glazed windows

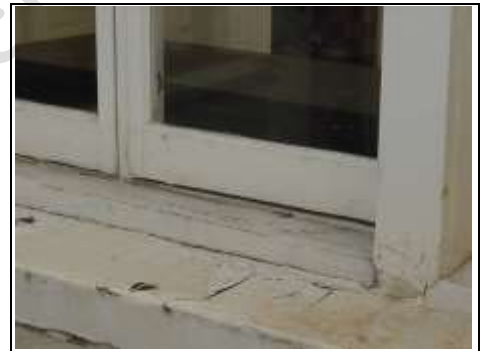
Windows generally need repair

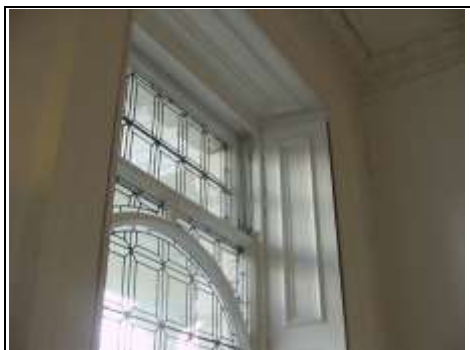
We noted some of the windows have leaded lights. As the building is Listed these will have to remain unless permission is obtained.

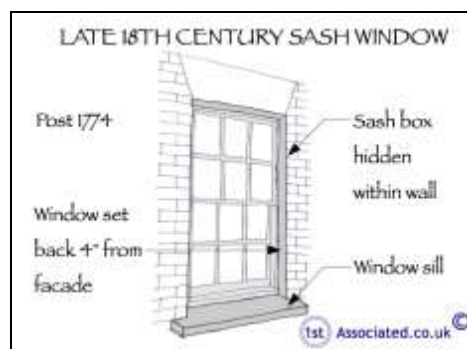
If you have not lived in a property with sliding sash windows previously, you should be aware that typically they are draughty and rattle. There is no easy way to eliminate this problem. In our experience, a general ease and adjustment of the windows and the addition of a plastic tube draught sealer (available from most DIY stores) and regular redecoration is the best option to minimise the draughtiness of the windows in this case. Horizontal Sliding Sash Windows (sometimes known as York Windows).

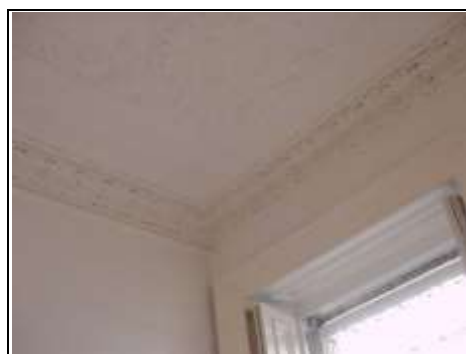
Over painted moulding on ground floor

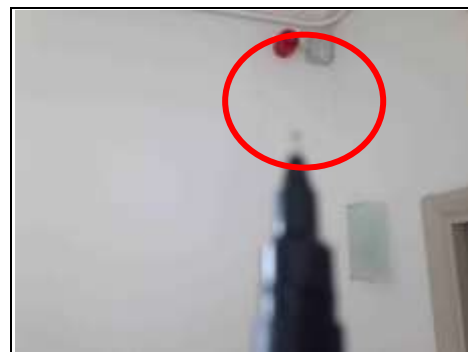
ACTION REQUIRED: Please see our comments in the Executive Summary.

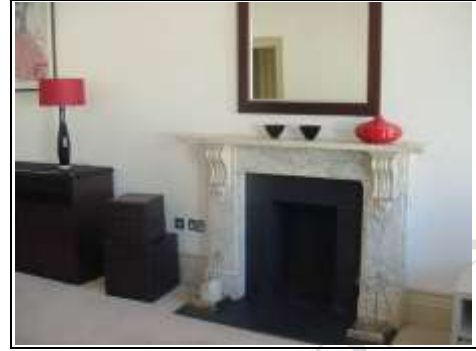
Marble fireplace on third floor

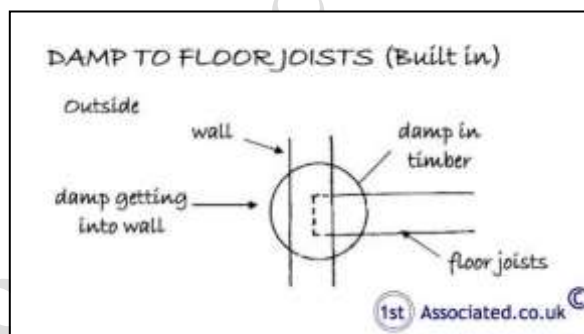
We have assumed that the ground floor through to fifth floor construction is joist and floorboards with embedded timbers, as this is typical in this age of property.

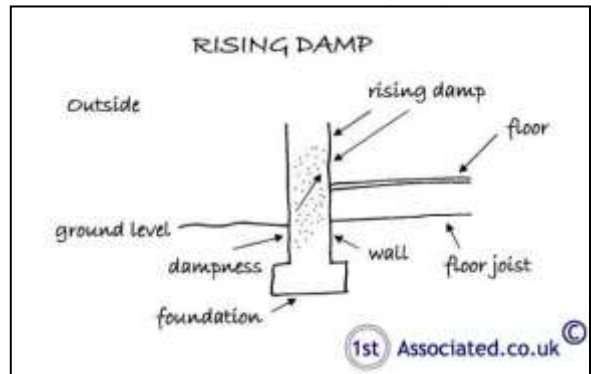
Rising damp depends upon various components including the porosity of the structure, the supply of water and the rate of evaporation of the material, amongst other things. Rising damp can come from the ground, drawn by capillary action, to varying degrees of intensity and height into the materials above. Much evidence points towards there being true rising damp in only very rare cases.

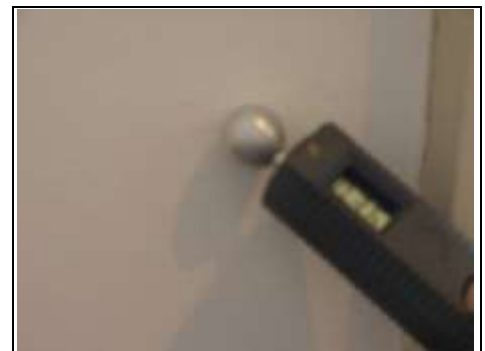
Testing for rising damp

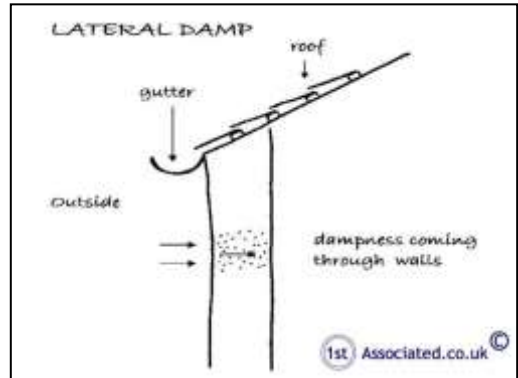
We used a damp meter on the external walls. We have found lateral dampness.

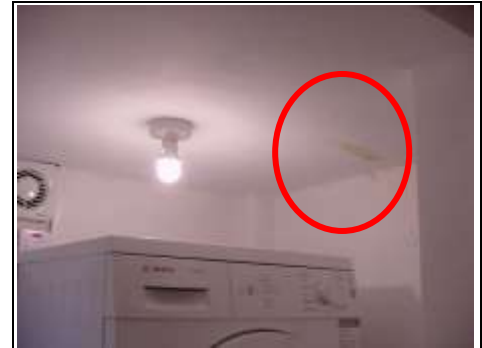
Staining on ceiling in utilities room on lower ground floor

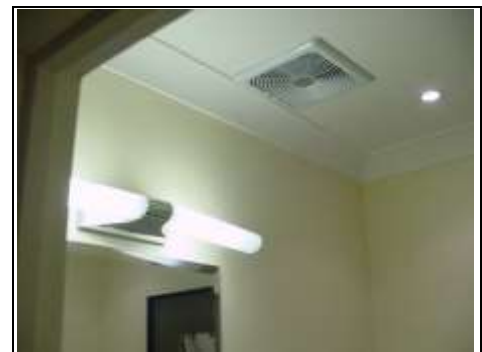
Extract fan on lower ground floor

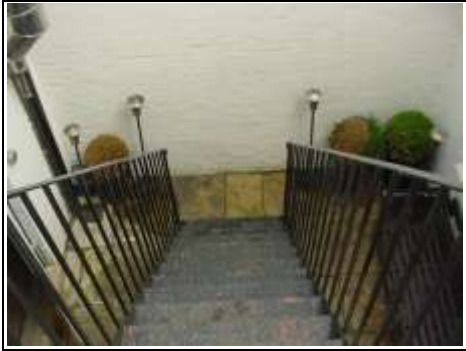
If this staircase remains with the new plans it will need redecorating and a rust stop agent used.

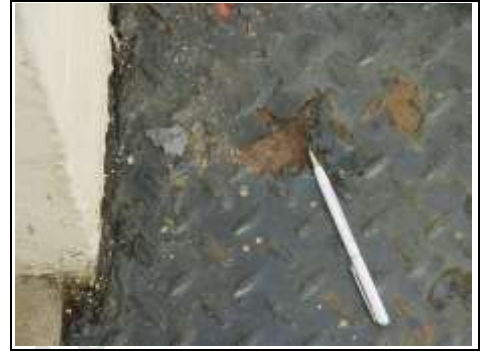
Close up of rusting stairs

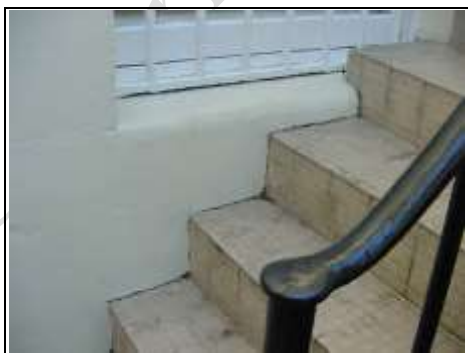
Tiled steps coming down to lower ground floor

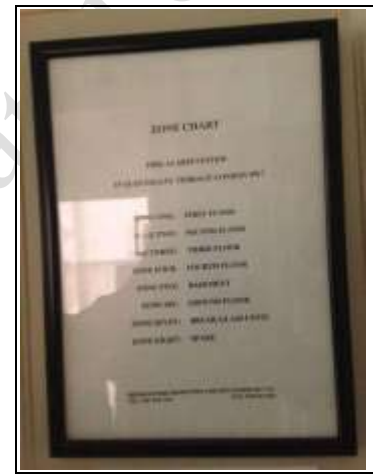
Zoning for fire alarm system which is what we always recommend

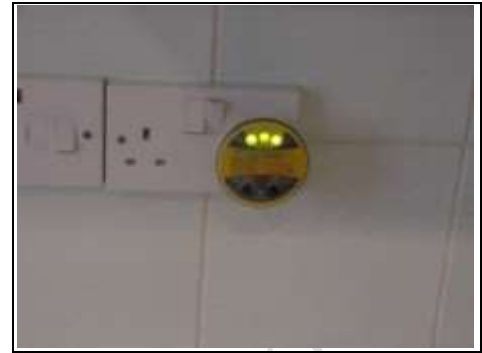
Earth test taken in ground floor kitchen

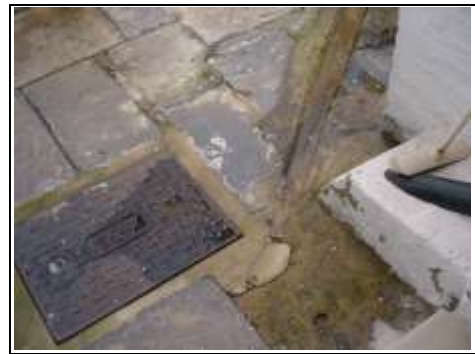
Manhole in middle void
