JOB REFERENCE: xxxxxxxxxxxxxxxxxxxxxxxxx

SCHEDULE OF CONDITION

We have been instructed to inspect and prepare a Schedule of Condition for The White Horse, xxxx, XXXXXXXXXXX, XXXXXXXX, XXXXXXXX.

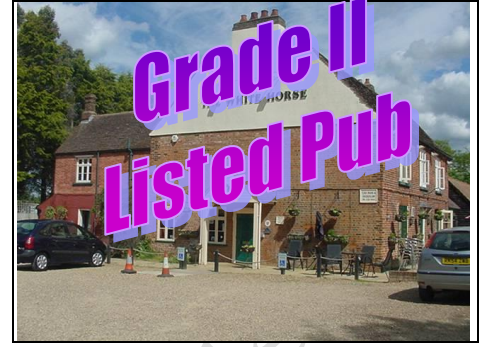
Front view

DESCRIPTION	CONDITION	ACTION REQUIRED
<p>Chimney: Brick build rendered chimney Paint finished</p>    	<p>Weathered and cracking to rear</p>    	<p>Repair and make watertight</p>

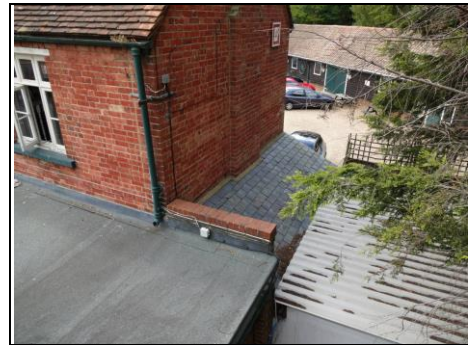
Left Aerial View - 360 Photo

DESCRIPTION	CONDITION	ACTION REQUIRED
Chimneys: Brick		See front elevation
Roofs: Low level slate roof	Slates displaced/slipped Build up of leaves

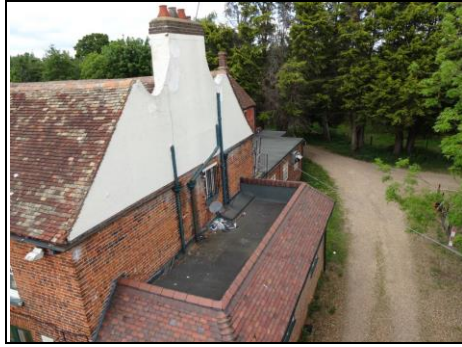
Rear Aerial View - 360 Photo

DESCRIPTION	CONDITION	ACTION REQUIRED
Chimneys: Right Side Chimney: Forms part of the rear Flemish Gable   Cracking   Dampness	Cracking and areas of dampness   Cracking

Dampness   Dampness at base	See front elevation Repair, repoint, re-render and redecorate and make watertight

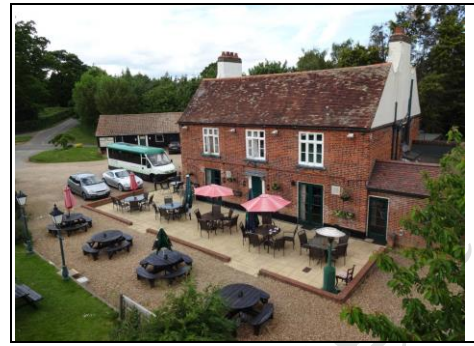
Right Aerial View - 360 Photo

DESCRIPTION	CONDITION	ACTION REQUIRED
Roofs: Tiles	Missing, spalling and deteriorating	See front elevation General overhaul of roof Exclude from lease
Gutters and Downpipes: Cast iron and plastic		See front elevation Clear
Walls: Flemish bond brickwork	Wrongly repointed in cement mortar	See front elevation Remove all cement mortar and repoint in lime mortar Exclude from lease
External Detailing: Windows: Casement	Two top windows particularly badly painted over rotten timber	Splice in new timber. It may be more economical to replace the windows subject to Listed Buildings Consent Repair, prepare and redecorate Exclude from lease

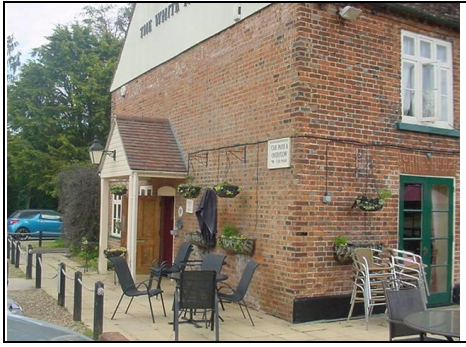
External entrance to lobby

DESCRIPTION	CONDITION	ACTION REQUIRED
Ceiling: Painted	Part painted

Repair, prepare and redecorate
Walls: Painted	Dated	Repair, prepare and redecorate.
Floors: Carpet	Worn	Clean/replace.
Detailing: Entrance Door: Timber Single width	Marked and worn to base Missing vision panel	Sand, prepare, repair and restrain.or replace

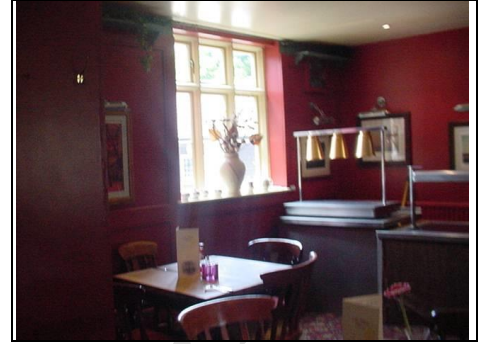
Right side

DESCRIPTION	CONDITION	ACTION REQUIRED
Ceiling: Painted Mock beams supported with columns

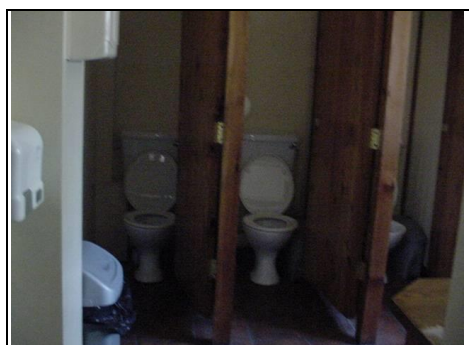
Ladies toilets

DESCRIPTION	CONDITION	ACTION REQUIRED
Ceiling: Painted	Dated	Repair, prepare and redecorate.
Walls: Painted Dry lining/False wall to Perimeter WC's divided by vertical boarding Splash back tiling around vanity units	Dated Hiding dampness

Dated Dated	Resolve dampness Repair, prepare and redecorate. Repair, prepare and redecorate. Deep clean
Floors: Tiles	Dated	Deep clean

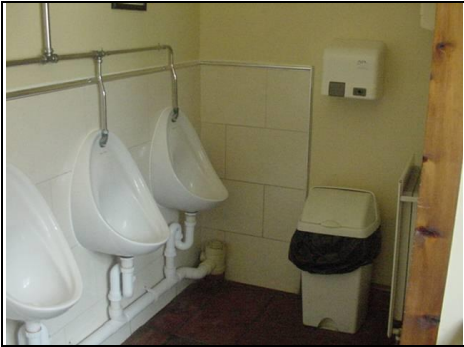
Urinals

DESCRIPTION	CONDITION	ACTION REQUIRED
Ceiling: Painted	Dated	
Walls: Splash back tiling around urinal	Dated Old fixing points	Fill holes. Repair, prepare and redecorate.
Floors: Tiles	Worn

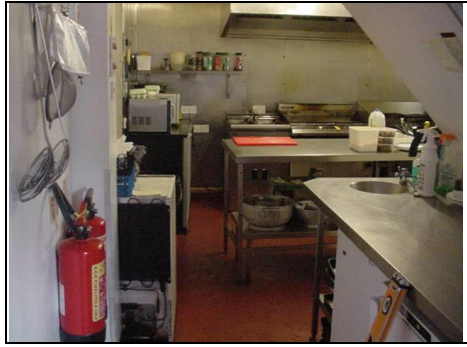
Kitchen prep area

DESCRIPTION	CONDITION	ACTION REQUIRED
Ceiling: Painted	Dated Joints proud	Rub back joints. Repair, prepare and redecorate.
Walls: Stainless steel	Dated	Clean
Floors: Vinyl style flooring	Joints splitting Marks where old style skirting Some areas need replacing	Replace
Detailing: Doors: Entrance door from main bar Door to function room and outside left side	Marked Marked	Repair, prepare and redecorate Repair, prepare and redecorate

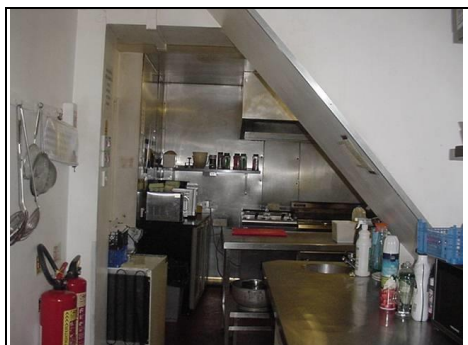
Looking from freezer units into the kitchen

DESCRIPTION	CONDITION	ACTION REQUIRED
Ceiling: Partly vaulted	Heavily stained underneath single pitched right side roof

Resolve dampness, repair, prepare and redecorate.
Walls: Painted	Heavily stained	Resolve dampness, repair, prepare and redecorate.
Floors: Vinyl style flooring	Slippery at the time of the inspection Marked	Deep clean and/or replace
Detailing: Door: Flush Fire door	Broken door closure Not applying with Fire Regulations	Replace
Services: Electrics		See Services Section

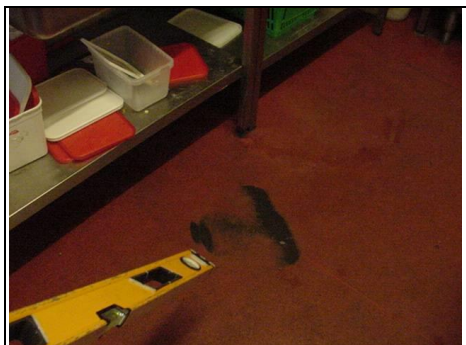
Burn marks to floor

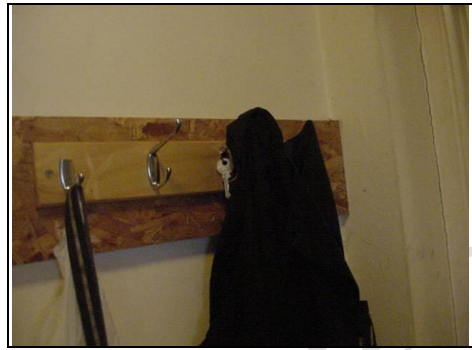
Lobby area (door width) with sterling board used for hangers

Dry lining has rotted away Dampness Hairline cracking between floor and ceiling Stirling board used for a coat hook

Resolve dampness. Re-line. Repair, prepare and redecorate.
Floors: Vinyl	Marked	Deep clean and/or replace

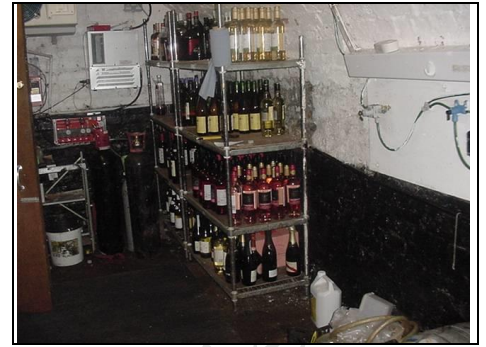
Cellar area

DESCRIPTION	CONDITION	ACTION REQUIRED
Ceilings and Walls: Vaulted Painted	Dampness and mould

Resolve dampness Repair, prepare and redecorate. Meeting with Environmental Health Officer recommended
Floors: Concrete Rubber mat covering large proportion of floor	Dampness Uneven Areas broken up at the bottom of the cellar drop

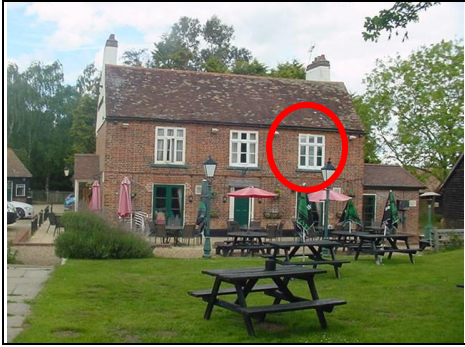
Bedroom one externally

DESCRIPTION	CONDITION	ACTION REQUIRED
Ceiling: Painted plasterboard	Undulating ceiling Leak Hole

Resolve dampness Resolve leak to peg tile roof. Repair, prepare and redecorate.
Walls: Wallpapered Chimney breast	Dampness Vented

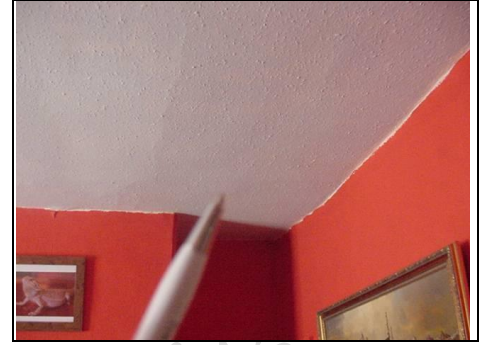
Ceiling undulations

DESCRIPTION	CONDITION	ACTION REQUIRED
Ceiling: Woodchip wallpaper	Dated Undulating ceiling Dampness	Resolve dampness Resolve leak to peg tile roof Repair, prepare and redecorate.
Walls: Red painted Chimney breast	Dated Dampness Blocked Unvented	Resolve dampness Resolve leak to peg tile roof Repair, prepare and redecorate.
Floors: Carpet	Worn	Clean/replace
Detailing: Windows: Casement Doors: Locked door	Black mould Rot noted externally Dated	Remove mould. Repair, prepare and redecorate Repair, prepare and redecorate

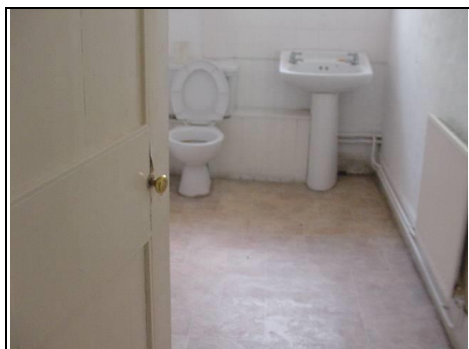
Bathroom

DESCRIPTION	CONDITION	ACTION REQUIRED
Ceiling: Painted	Leak from roof Undulating

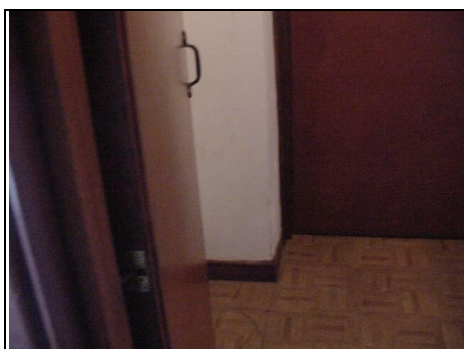
Ladies WC Lobby

DESCRIPTION	CONDITION	ACTION REQUIRED
Ceiling: Textured paint	Average	Repair, prepare and redecorate.
Walls: Painted	Dampness	Resolve dampness Repair, prepare and redecorate.
Floors: Vinyl	Dated	Replace
Door:	Impact damage	Replace

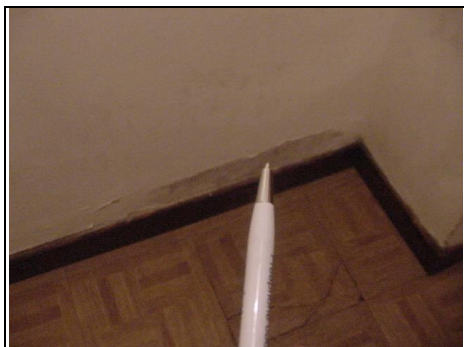
Dampness to gents lobby

DESCRIPTION	CONDITION	ACTION REQUIRED
Ceiling: Textured paint	Average	Repair, prepare and redecorate.
Walls: Painted	Dampness	Resolve dampness. Repair, prepare and redecorate.
Floors: Vinyl	Dated	Replace

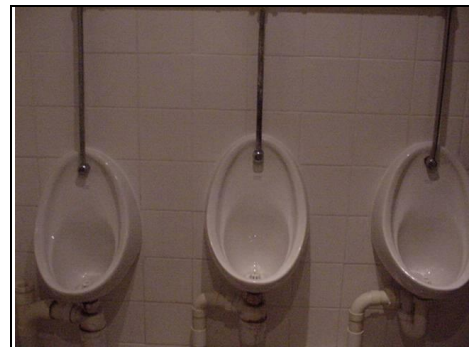
Urinals

DESCRIPTION	CONDITION	ACTION REQUIRED
Ceiling: Painted Access hatch into roof	Dated	Repair, prepare and redecorate
Walls: Painted Tiles Timber boarded partition for WC	Dampness Old fixing points	Resolve dampness. Repair, prepare and redecorate. Replace tiles and re-grout
Floors: Vinyl	Running water and dampness around urinals
