COMMERCIAL BUILDING SURVEY AND PROPERTY APPRAISAL

Large Building to be used for Commercial Use

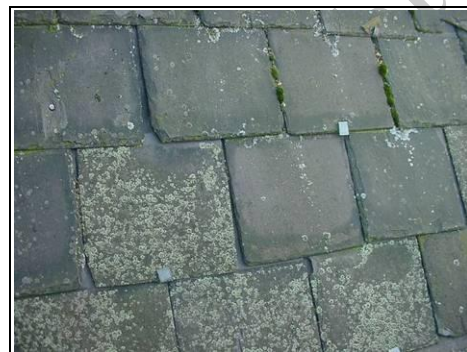
The main roof is clad with slates. We can see there have been various repairs using lead tingles. These indicate that the nail fixings are rusting, often known as nail sickness. We generally recommended where there are more than a dozen to two dozen tingles visible that re-roofing is likely in the near future, which is the case in this instance.

Close up of slates showing lead tingles to front of building

ACTION REQUIRED: Re-roof over next few years. There are no major visual signs internally (to the ceilings) that the roof is a problem. Having said that, we have not been in the actual roof space of these areas.

ANTICIPATED COST: In the region of £100,000 to £150,000 to re-roof or carry out major repairs. You need to obtain quotations, quotes will depend on whether you scaffold over the property to form a temporary roof or take the risk that there won't be adverse weather whilst you are carrying out the work.

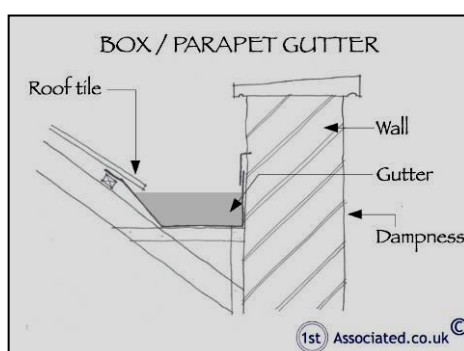
To the front of the property where we could inspect it, we found a box gutter. This we believe is allowing dampness into the walls.

ACTION REQUIRED: You will need to regularly clear this roof of leaves and debris. As you have trees surrounding the property this will be a constant requirement.

ANTICIPATED COST: Included in the main roof works.

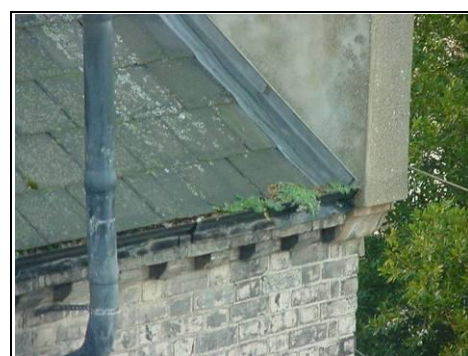
To the sides of the property we can see that the guttering sits partly over the walls. This means if/when leaks occur to the guttering dampness gets into the walls. This often takes a while to be visible and become more visible when a building is properly occupied as the warmth of the building draws the dampness through the walls.

Blocked gutters and vegetation growing

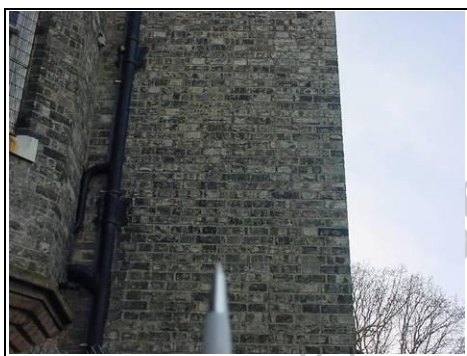
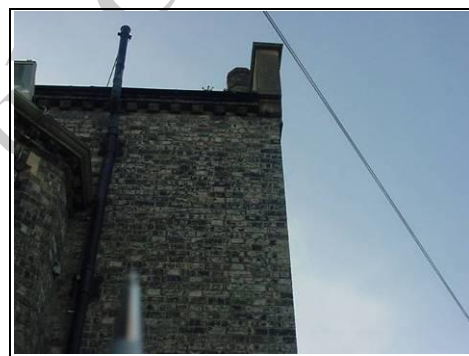
vertical crack running through the bricks to the length of the property.

Vertical cracking to right hand wing

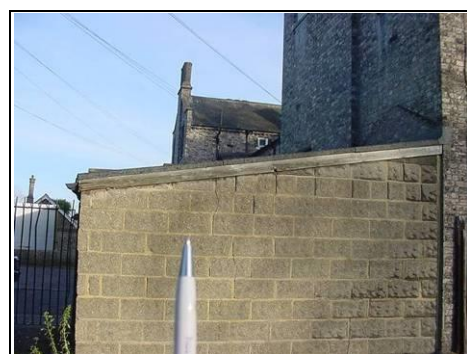
4.2 There is also cracking in the new single storey extension on the right hand side indicating that movement is still occurring. We can also see cracking internally in this section.

Cracking in single storey lean-to Right hand wing

ACTION REQUIRED: A buttress type structure may be needed to hold this wall in place together with tying in of the floor and roof structure.

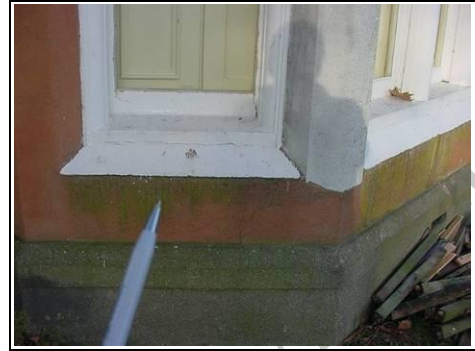
Movement in double bay to rear at low level

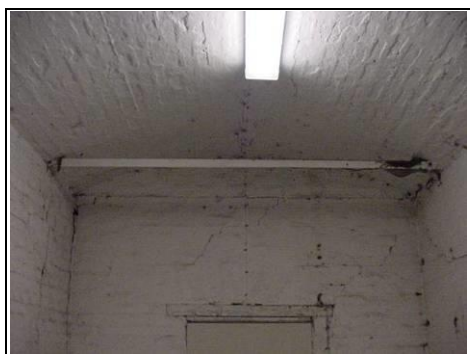
Lots of cracking in adjacent room to the clay store area

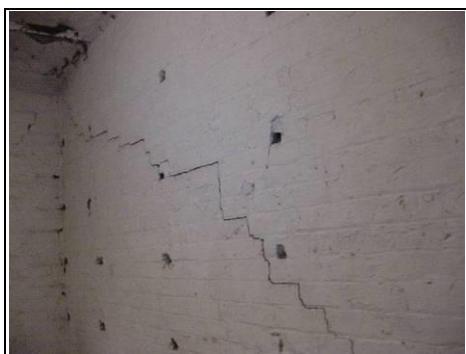
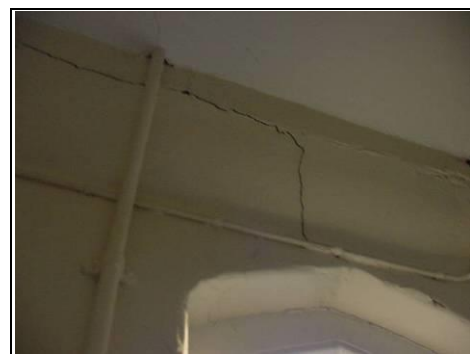
Cracking to lobby at top of spiral staircase

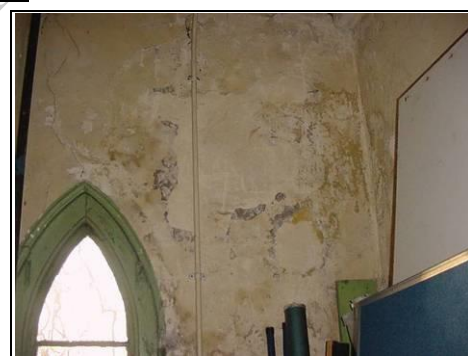
Dampness through walls, known as lateral dampness, visible particularly to pottery rooms and also the right hand elevation where the gothic window is visible. This may be due to the adjoining tree in that instance.

Dampness

ACTION REQUIRED: we believe that the repair work recommended to the gutters and downpipes and the repointing will reduce this to a manageable standard as a certain amount of damp is considered acceptable within older properties such as this.

ANTICIPATED COST: Already budgeted with regard to external repairs. We would additionally add £25,000 to £50,000 for internal repairs. We have kept this figure high as we feel that some of the work may be required to the Listed Building section of this property. Please obtain quotations.

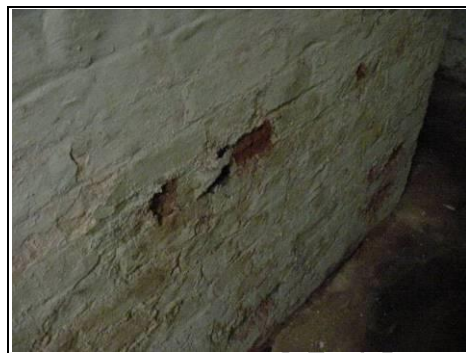
There is rising damp throughout the property. It was particularly noticeable in the basement/cellar area where we would expect there to be dampness. It is also visible in the left hand corridor at ground floor level. We feel it may also be present in other ground floor rooms, although there is timber panelling that may be hiding it. Spalling to brickwork from dampness

ACTION REQUIRED: We feel some form of French gully around the property would be the best way of reducing the dampness and managing the dampness but this only needs to be carried out once investigations have taken place. We recommend the property is monitored for at least a year.

ANTICIPATED COST: In the region of £30,000 to £50,000; please obtain quotations.

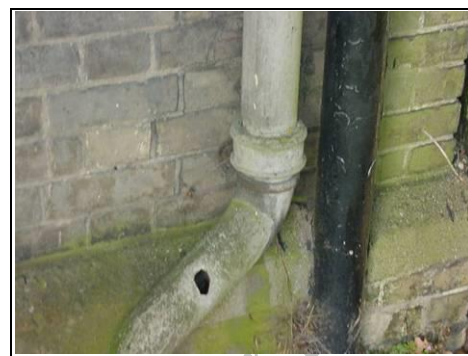
What we believe to be asbestos was found to the back left hand side of the property in the form of a pipe. In this age of property asbestos was commonly used during the refurbishments.

Asbestos pipe

ACTION REQUIRED: We would recommend an asbestos report is carried out on the property as a whole if one does not exist at the moment and that tests are carried out to establish what type of asbestos it is.

ANTICIPATED COST: Nominal sum of £10,000 - £20,000. Follow asbestos contractor's recommendations. Please note we are not asbestos surveyors.

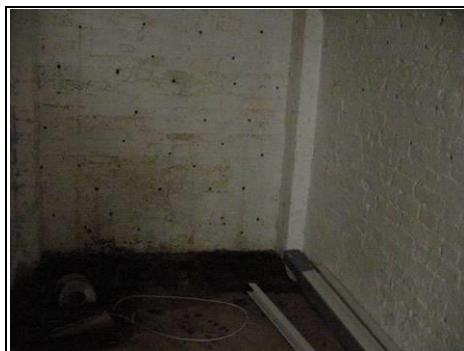
Within the basement we can see signs of dampness and past flooding. We can also see that various measures have been taken to try and reduce this. There are holes that have been drilled in most the external walls and some of the internal walls, which we believe could be acting as weep holes to allow water into the property and stop the pressure that is caused on the walls.

Holes drilled in the wall

ACTION REQUIRED: Either way you need to work out a suitable way to manage dampness and flooding to the cellar. Unfortunately we were unable to find a sump pump which we would expect to see to remove any water that gets into the cellar. This is the first thing that we would add.

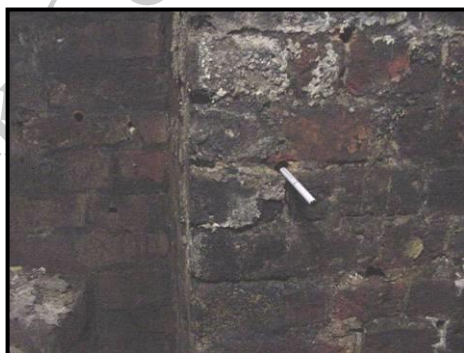
Pen indicates an example of one of many holes drilled in the wall in the basement

We would add that in the many years that we have been carrying out surveys we have never seen holes drilled in a cellar such as this and as such we would specifically recommend that your legal adviser writes requesting information with regard to any work that has been carried out to the basement area, particularly in relation to the holes.

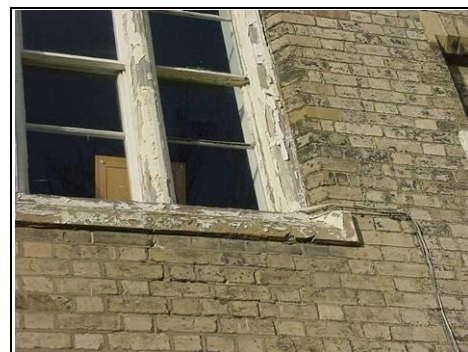
The property has a mixture of timber windows and sliding sash windows; all single glazed. We would specifically comment that bare timber is visible to many areas. We would recommend complete redecoration, although the timber is still in remarkably good condition all things considered.

Paint flaking off rear windows, bare timber visible

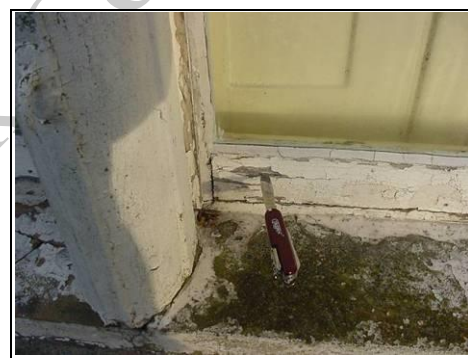
We have knife tested a sample of the windows at ground level and the quality of the original timber is still sound in most cases, although we can see that some new timber has been spliced in. We believe that these windows are saveable though this may not be the most economical way of proceeding it is the way that you most likely would have to proceed with a Listed building such as this as the Conservation Officer would have views on this matter.

Quality of windows on right hand gable

ACTION REQUIRED: Prepare, repair and redecorate.

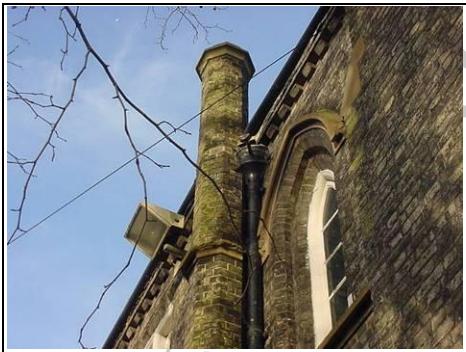
Chimney on right hand gable, overflowing hopper head causing deterioration to brickwork

ACTION REQUIRED: The majority of the chimneys will required some repointing. We noticed some work had been carried out in a hard cement mortar which may cause spalling to the brickwork.

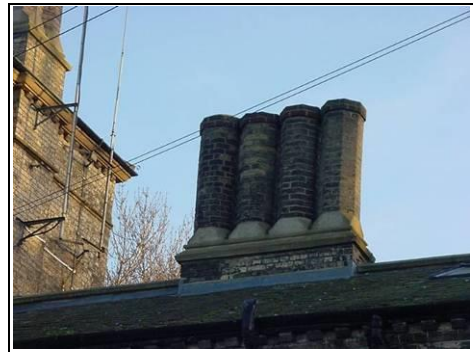
Minor spalling brickwork

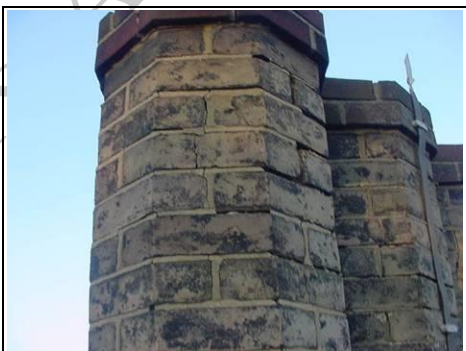
Close up showing cracking to brickwork and repointing required

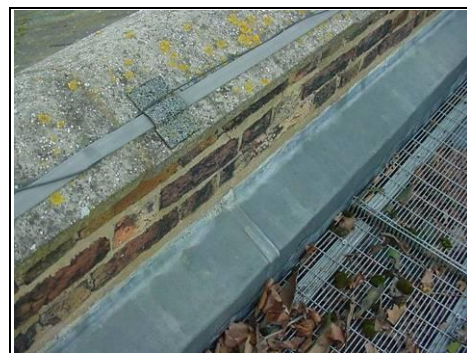
Parapet wall has been wrongly repointed in cement mortar

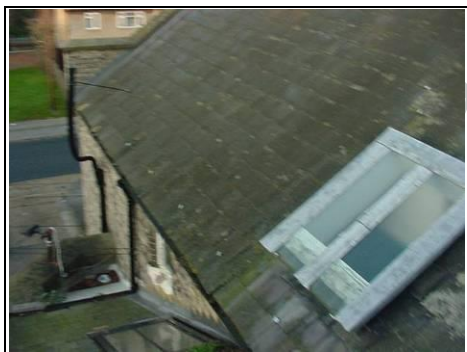
Roof light four – left hand side
Older style wood made roof window which has then been covered with lead of equivalent and tends to be more problematic than the purpose made windows

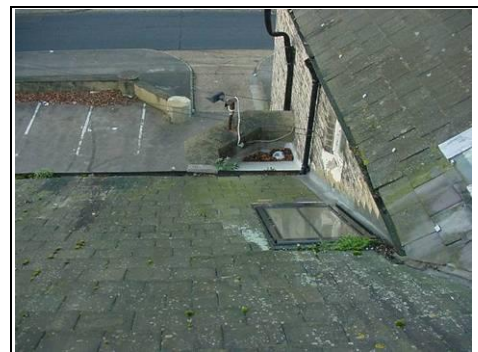
Roof light five – left hand side
This is an awkward detail with vegetation growing at the top that needs to be removed as part of your annual maintenance programme

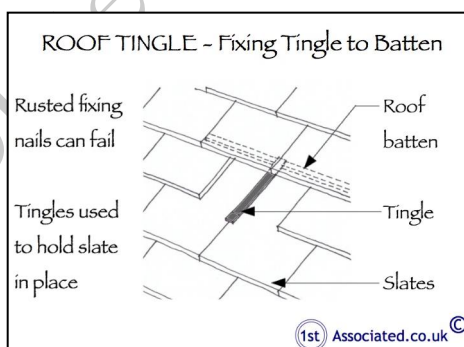
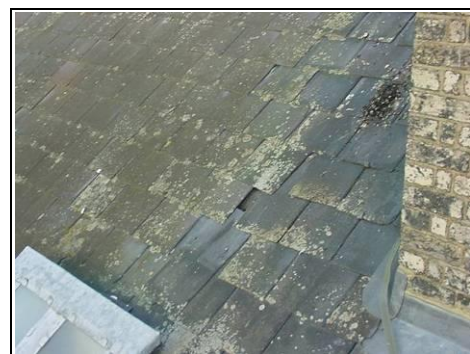
We were able to access the front roof and inspect this more closely where we could see lead tingles were present, as well as there being some cracked and slipped slates.

Missing slate to front left hand roof

ACTION REQUIRED: We feel that the roof may have nail sickness, which is the rusting of the nail fixings. Please see our comments in the Executive Summary.

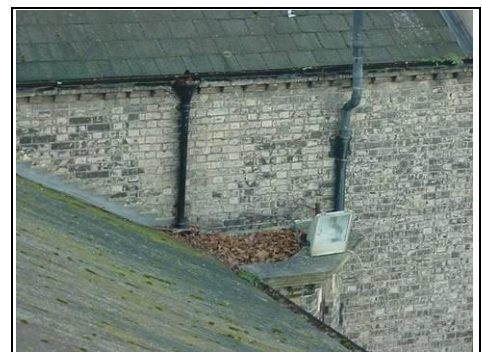
Oriel flat roof right hand side which is leaking

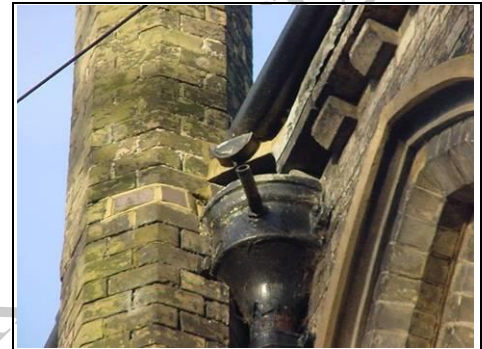
Hopper head overflowing, chimney needs repointing

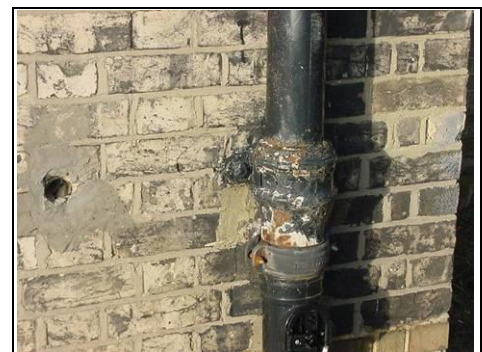
Cast iron downpipe being linked to a plastic downpipe, we assume the original cast iron has rusted away

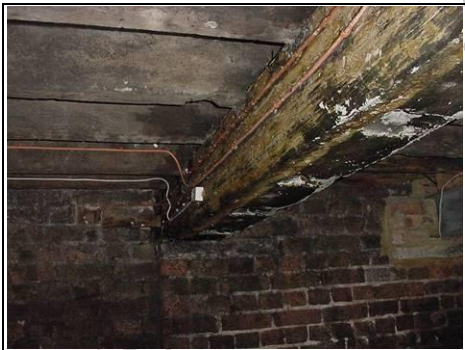
Spine beam

We can also see a spine beam within the basement to the front left hand side and can also see that many of the timbers have rotted away and been replaced which is partly why there is cracking in it.

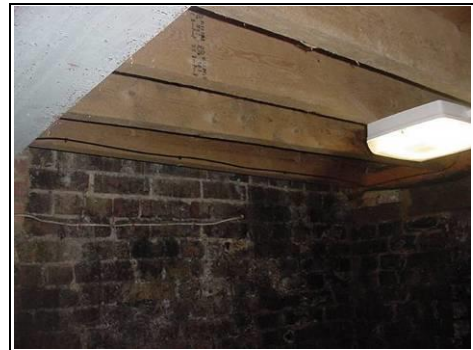
Replacement timbers

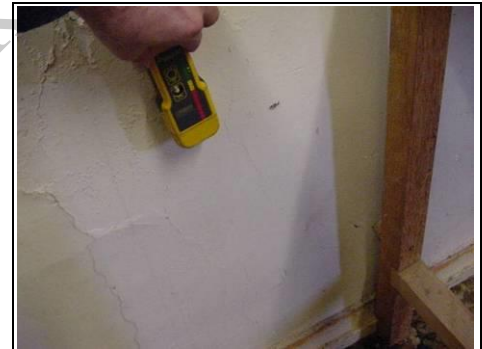
A random visual inspection and tests with a moisture meter have been taken to the perimeter walls. In this particular case we have found rising damp throughout the property.

Finding rising damp

ACTION REQUIRED: Please see the Executive Summary.

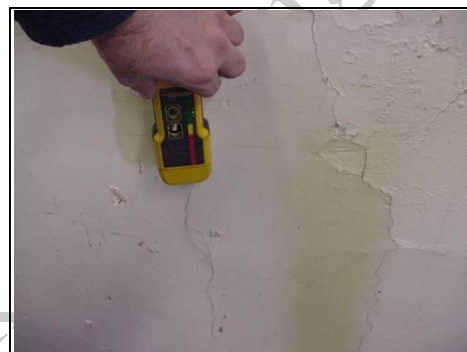
We used a damp meter on the external walls. We have found dampness, particularly to the front and right hand side of the property but we believe it is present throughout it is just hidden in some areas by such things as the wall panelling.

Dampness to front of property
