# RESIDENTIAL BUILDING SURVEY

XXXXXXXXXXXXX,  
XXXXXXXXXXXXX,  
xxxxx Somerset  
BA5 xxx

INDEPENDENT CHARTERED SURVEYORS

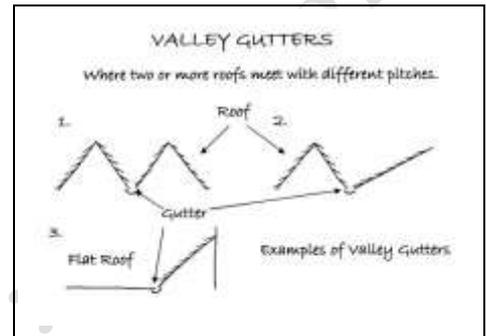
Generally we would comment that the roof is in better condition than we were expecting for this age, type and style and height of property particularly due to the many valley gutters which can often be problematic and the flat roof area which can also be a problem. However, this type of roof does need constant maintenance.

Flashband is a sticky backed felt which is best used for temporary repairs only.

**ACTION REQUIRED:** We would recommend that lead repairs are carried out to the roof and valley gutters, where currently Flashband has been used, which we consider a temporary repair product.

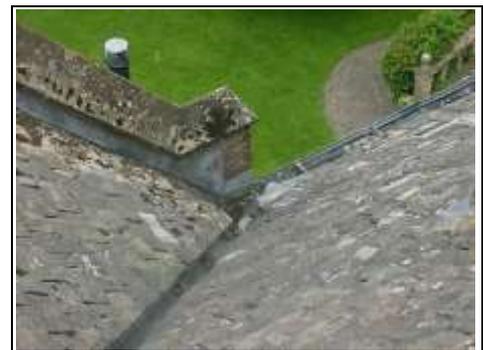
Valley gutter that is becoming blocked next to a lead guttering

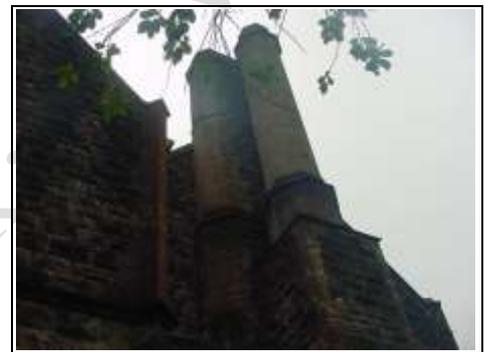
Rear right hand chimney which is starting to deteriorate

We would also recommend cutting back the trees particularly to the right hand side to enable better sunlight and also some repointing work to the stonework. We would specifically draw your attention to the chimneys on the left and right side which look to be in need of some work although they will be difficult to access other than by scaffold. Scaffold costs on this height of property alone can run into many thousands of pounds due to its height which is why no doubt one of the reasons in the past this work has not been carried out and work has only been carried out on a limited nature to the areas that are easy to reach.

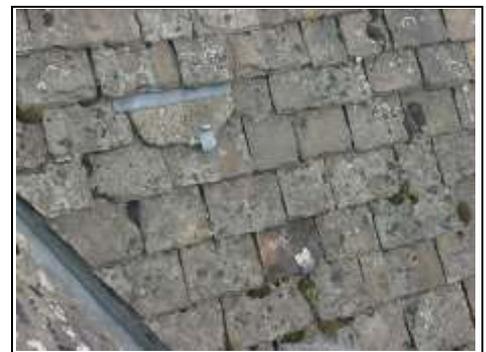
We note that some of the roof stone slates have deteriorated and have been fixed with a lead tingle, which indicates the nails are rusting. Ideally these should be replaced properly. There is also an outside chance the roof has nail sickness, which is where the fixing nails have rusted away and as such then sections of the roof will need to be replaced. This can only really be ascertained by removing sections of the roof and having a close look. It is this risk that we are concerned about with the high level work areas.

Lead tingles

The weakening of the fixing nails to slates or tiles due to the nails which fix them to the battens rusting. This is normally attributed to problems with slate roofs.

**ANTICIPATED COST:** We would set aside the sum of £20,000 to £40,000 for high level work as you are likely to need a scaffold access in some areas and also there may be problems with the nail fixings deteriorating to the slates. Having said that good maintenance will keep this roof going for many years to come and you may wish to wait until there are major roof leaks before commencing work. Quotations required.

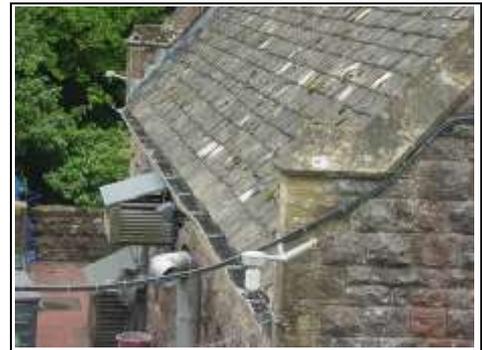
With this type of property and these surroundings, which is surrounded with trees, you will have a constant battle against leaves filing the gutters, you need to have a good maintenance regime which from what we can see has been put in place by Sid Hodges the maintenance man. Sid is working to a budget and has come up with some practical ways of maintaining the property. He uses a weed killer to kill the weeds in the gutters (via a water pistol!) and then clears these using long ladders. This is not ideal and we would recommend that you buy a tower scaffold and make the maintenance easier and safer (see adjacent photo).

Guttering left hand side of property

**ACTION REQUIRED:** You will need to constantly clean the gutters and hopper heads and downpipes. We recommend you buy a tower scaffold as blocked gutters, valley gutter or hopper head would very quickly cause major problems.

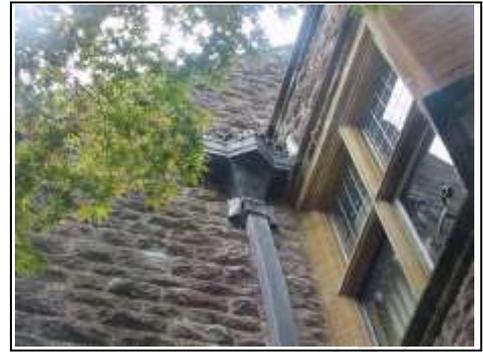
Looking up at a lead hopper head and downpipe and surrounding trees

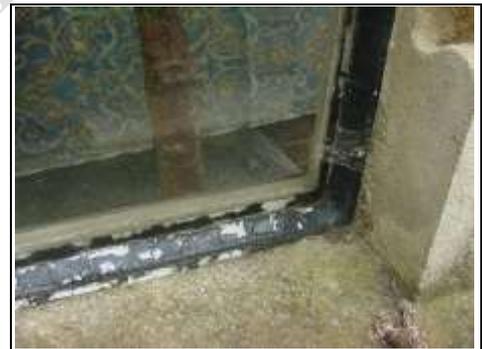
Metal windows require regular maintenance to ensure that you can open and close them fairly easily. We noticed that some of them were unopenable during the course of our survey.

Windows need regular maintenance

**ACTION REQUIRED:** We would recommend a programme of maintenance where you work on each elevation and improve the windows year by year together with removing the moss from any stonework such as the stone window sills and ad hoc repointing, removing any cement mortar and replacing with a lime mortar

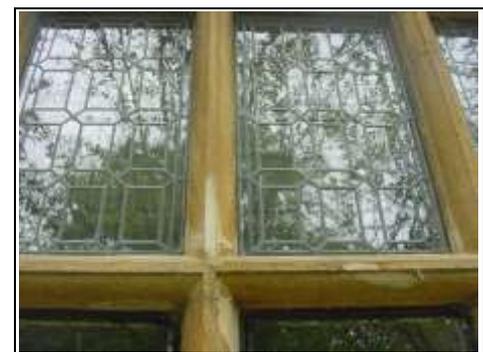
In this window you can see previous repairs

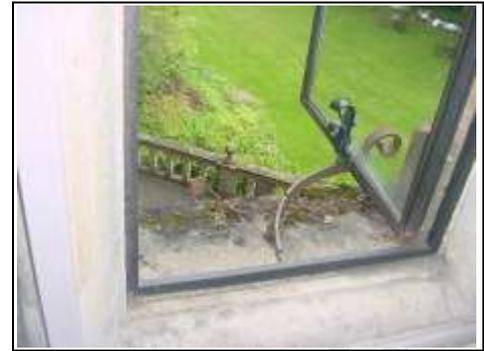
Moss on the window sill – this will need clearing

**ANTICIPATED COST:** We would consider this work as part of the general maintenance package. If you want to carry out one off repairs to the windows and cleaning the stonework we would expect costs in the region of £10,000 to £15,000. This will be changed considerably depending upon the access available; quotations required.

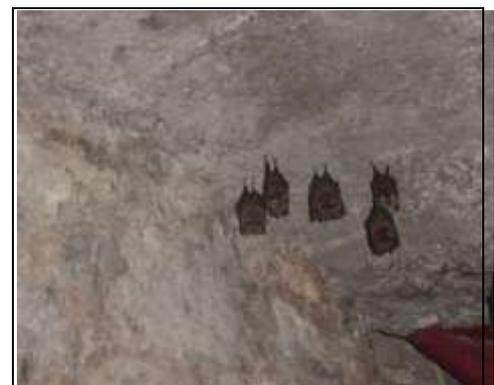
We have carried out a visual inspection of the foundations and viewed the vaulted basement with the bats! We cannot see any unexpected cracks within the external walls. Our view within the vault was very limited. We believe there may be metal (likely to be cast iron), used as part of a reinforcement of the structure, as this was something used in this era, although we have not specifically seen it in the property and more investigation will be required.

Bats in the basement

**ACTION REQUIRED:** We would recommend a detailed inspection of the basement focusing on the condition of any structural steel members and associated repair.

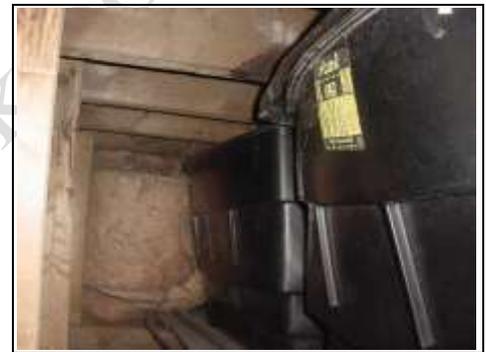
From what we can see water tanks in the flat roof are causing condensation and in turn wet rot to the timber roof above, which has the lead flat roof over this.

We believe that the condensation needs to be stopped otherwise severe damage will be caused to the flat roof above. You can do this by adding vents which will be relatively cheap as well as putting lids on the tanks and reducing the insulation, but we would say there are too many tanks in too small a space which becomes a warm area and causes condensation.

**ACTION REQUIRED:** We recommend lids for the water tanks and venting of the area, although we would add that it is very constricted in these areas and you may wish to look at relocating the water tanks.

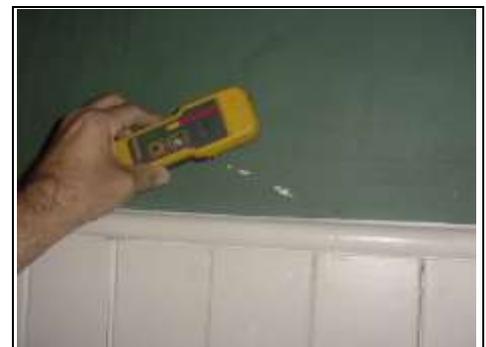
As we would expect in a property of this age, type and style and in this location, we found dampness, both in the form of rising damp and in the form of lateral damp. We would comment that we feel that dampness has been blown out of all proportion by damp proof companies, however in some areas plaster is deteriorating from the dampness coming through. If the property was left unheated we feel this would deteriorate rapidly.

Finding lateral dampness

We would recommend a constant background heat is maintained in the property. You may wish to look towards some sort of green energy solution such as solar panels to reduce/off-set your bill, however this is a long term commitment in our experience.

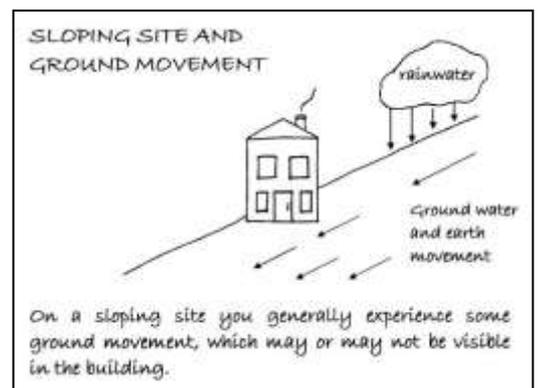
The property is on a sloping site; the adjacent road is considerably higher (approximately two to three metres) than the car park area. As such we feel that you will have problems with rainwater and surface water when it rains heavily and whilst this property is being sold in the summer we feel it will be a very different place in the winter and therefore we would look at managing how the rain travels around the building.

Currently you have one main drain in the centre of the car park and a running gully.

**ACTION REQUIRED:** We recommend increasing this to take the rainwater away and around the property and therefore minimise the unseen damage that can occur to the timber floors that are adjacent to the front and side walls.

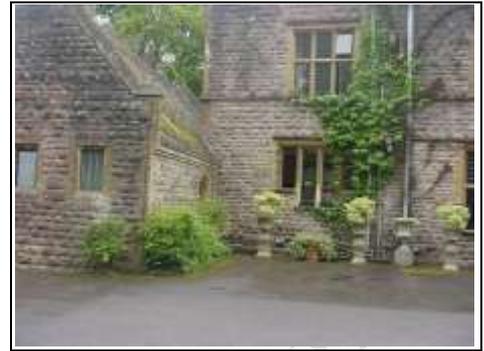
Tarmac passing surface water towards the property

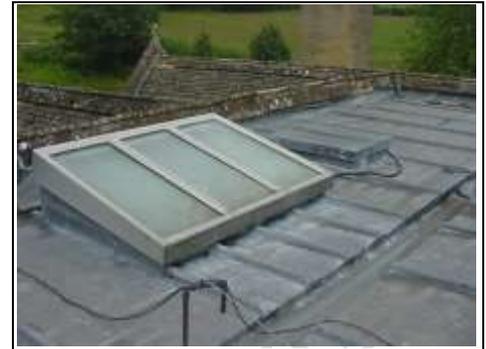
There is a plastic roof window on top of the main roof. It would be worth replacing with a more appropriate roof light that can also give access to the main roof from the corridor below. Consideration should also be given to putting some water tanks actually on the roof.

Roof light

It seems inevitable with roof windows that they will sooner or later leak. If this doesn't occur then they seem prone to condensation. Keep a cloth handy!

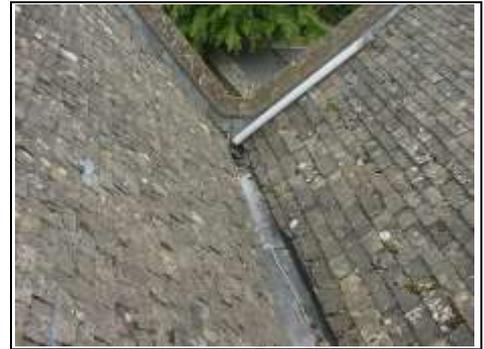
There are numerous lead valleys to the property. First of all, we were pleased to see that they were lead, although we can see that some of them have had Flashband repairs (sticky backed lead) which we consider a temporary repair. It really was in a far better condition than we would expect.

Valley gutter

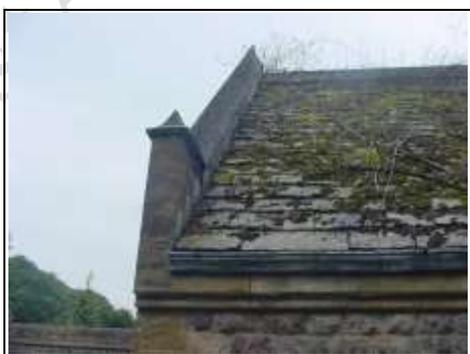
The worst area of roof that we can see is at low level to the left hand side where the kitchen and store area is. There is no obvious reason for its poor condition. It may have been covered with a tree or bush for some time and had water sitting on it.

Low level left hand side of roof

**ACTION REQUIRED:** We would clear this roof of moss and of vegetation and then check the condition. In addition at the same time there is a hidden valley gutter, investigation should be carried out here to check for excessive dampness.

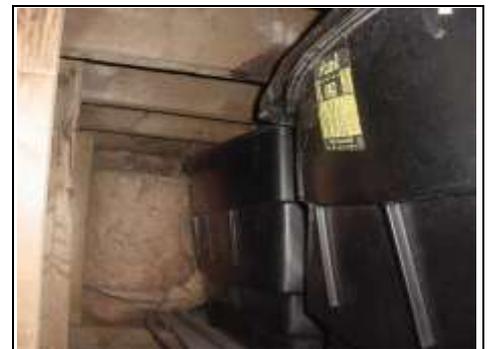
We have spoken about problems with condensation occurring over the water tank areas which has the lead flat roof above it and we have spoken of areas of the valley gutters where dampness is getting in.

Dampness directly above the water tank

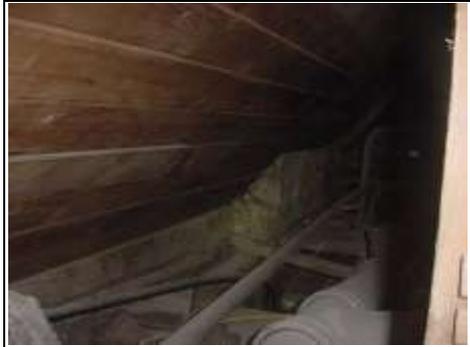
Far left hand side – here you can see a timber decking has been used to support the valley gutter which looks in reasonable condition

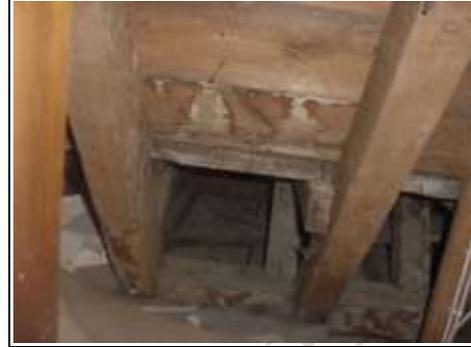
Far right hand side – we could see some water staining indicating that dampness was getting through

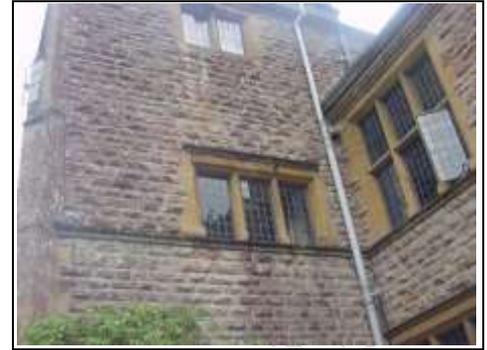
The property has had plastic soil and vent pipes added over the years as requirements to have wash hand basins, showers and bathrooms in the property has increased. Whilst we do not feel the plastic soil and vent pipes are appropriate for this age, type and style of building, they serve a practical purpose.

Plastic soil and vent pipe

**ACTION REQUIRED:** You may wish to look at replacing these. In some areas plants have grown over the soil and vent pipes and drain pipes, which is not ideal as it can in time damage the stonework. Please see our comments in the Executive Summary.

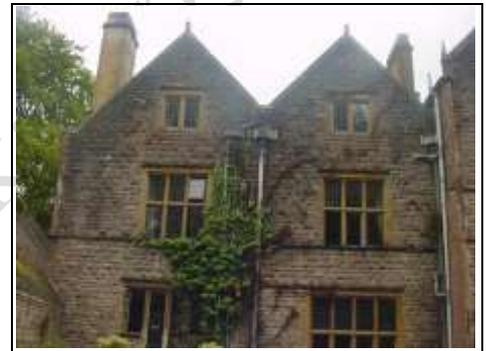
Plants growing over soil and vent pipes and also the downpipes

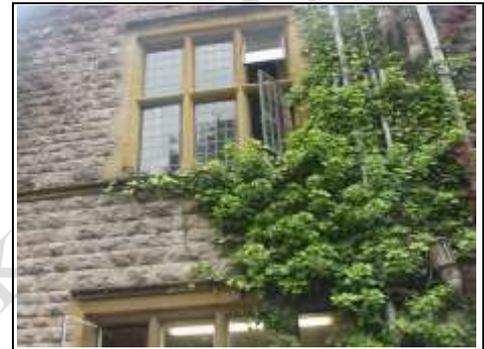
The walls are finished in a squared coursed stone. This is in average condition for its age, type and style. It has had some repair work carried out to the mortar using cement rather than the original lime mortar. This is what we generally come across. There will always be maintenance work to be carried out on stonework such as ad hoc repointing and also in this case general clearing of the moss.

Trees need cutting back

**ACTION REQUIRED:** Initially we recommend cutting back of trees around the property to allow sunlight and air circulation. We also recommend the purchase of a good quality tower scaffold (see earlier photo) to first of all aid investigation and then maintenance of the property with a safe access.

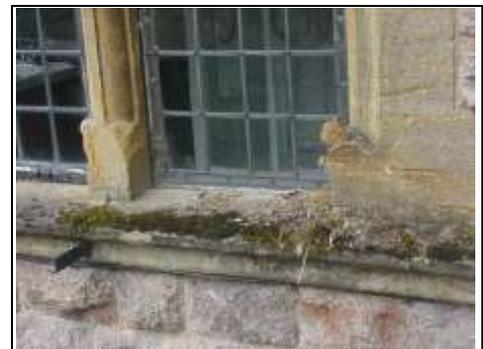
We can see the stone mullion windows have been repaired many times over the years and some would benefit from repair. Some of the stone is suffering from moss sitting on the ledges particularly the window sills.

Moss on ledges of window sills

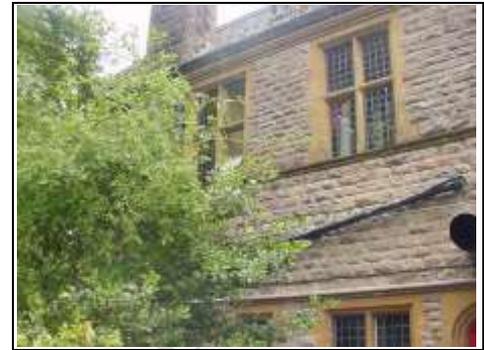
Part of the feature of this property are the surrounding trees. However we do feel that you need to seek professional advice as the trees are relatively close in what we would term as influencing distance of the property, which means that they can affect the foundations and underground services. We would add that properties with trees nearby will always be susceptible to movement.

Trees growing close to left hand elevation

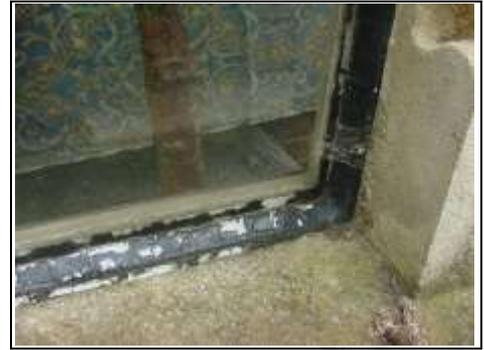
Windows deteriorating

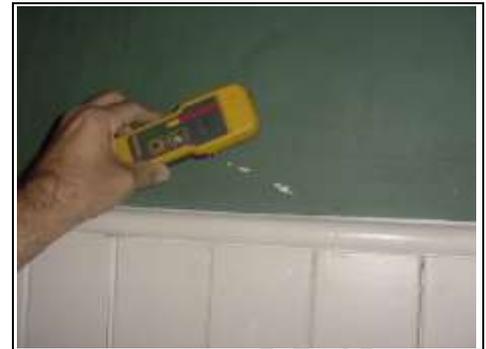
A random visual inspection and tests with a moisture meter have been taken to the perimeter walls and some internal walls. The readings we obtained indicated that there is dampness in the property which we were not surprised at, particularly the front wall which from what we can see has all the rainwater discharging on it from the adjoining car park. We will not be at all surprised if there is damage and deterioration to the timbers to this elevation.

Testing for and finding lateral dampness!

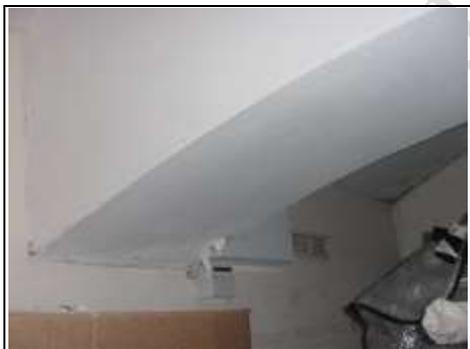
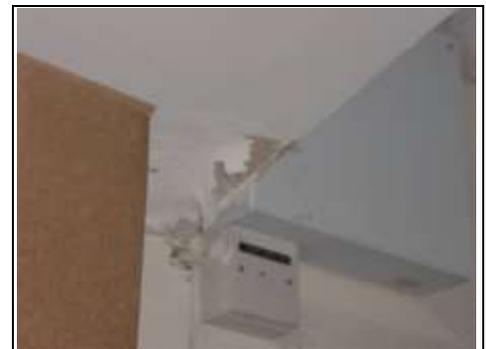
We also noted dampness coming in from the car park into the basement area through to the Prep Room.

Dampness in Prep Room coming from car park area

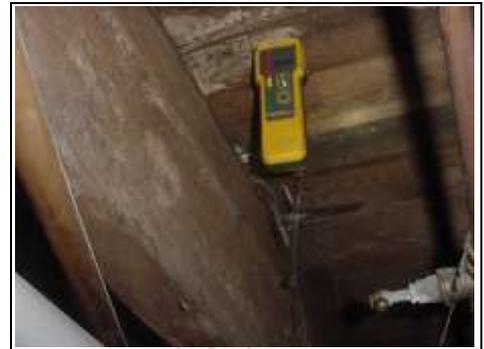
Dampness coming in through the flat roof

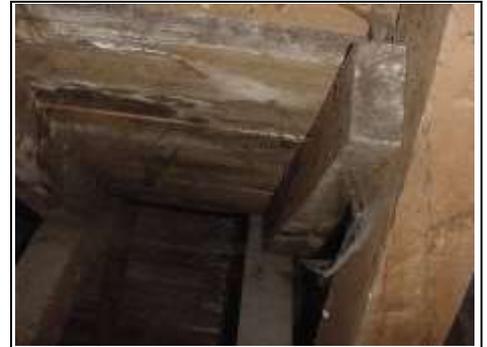
Dampness in timbers to valley gutters

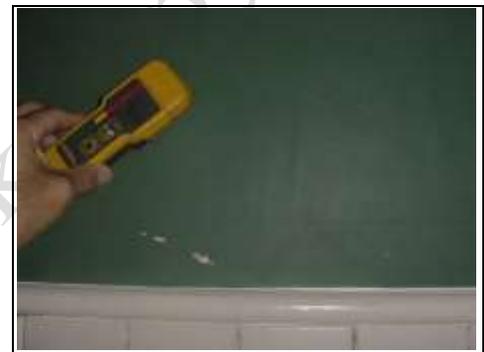
Lateral dampness coming through the walls
