# SCHEDULE OF CONDITION

**Maidstone,  
Kent,  
ME16 xxx**

**GEM Associates Limited**

The Schedule of Condition offers a detailed description of the condition of the property at the time of our inspection on xxxxxxxx

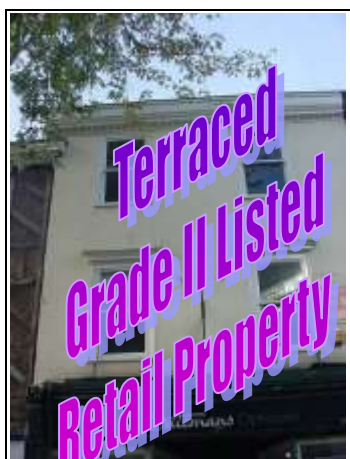
Top of building

DESCRIPTION	CONDITION	ACTION REQUIRED
<p><b>Roofs:</b></p> <p>We had a very limited view of the roof. Hipped clay tiles hidden from view</p>	<p>Based upon the condition of the timbers seen within the roof dampness is coming in</p>

<p>Roof hidden from view</p>	<p>Make watertight</p>
<p><b>Parapet wall and box gutter:</b></p>

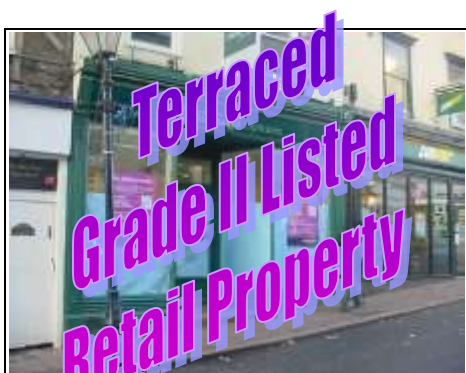
Shop front

<p>Canopy</p> <p>Signage</p>	<p>Dated</p> <p>Glass has been pushed out of position.</p> <p>Bare wood visible in areas and damage to the top</p>

<p>Damaged canopy</p> <p>Previous owners signage remains</p>	<p>Repair, prepare and redecorate</p> <p>Re-bed glass and make secure. Repair, prepare and redecorate</p> <p>Repair, prepare and redecorate</p> <p>Remove signage</p>

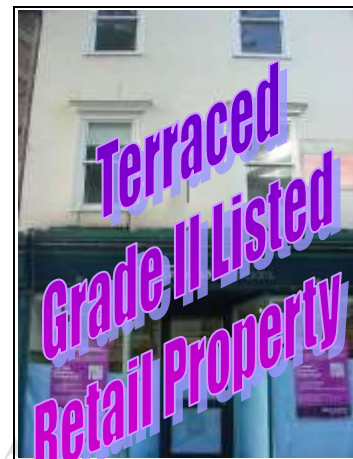
Whole of building

<p><b>Walls:</b></p> <p>Modern cement render</p> <p>Structural frame – timber frame assumed</p>	<p>A cement render can accelerate deterioration to a timber frame (assuming there is a timber frame beneath)</p>	<p>Take samples of the render to determine its composition.</p> <p>Should be re-decorated as part of the yield up clause within the lease and due consideration given.</p> <p>Open up to check condition of the structure below the render before taking on lease</p>
<p><b>External Detailing:</b></p> <p>Windows: Timber single glazed sliding sash windows</p>

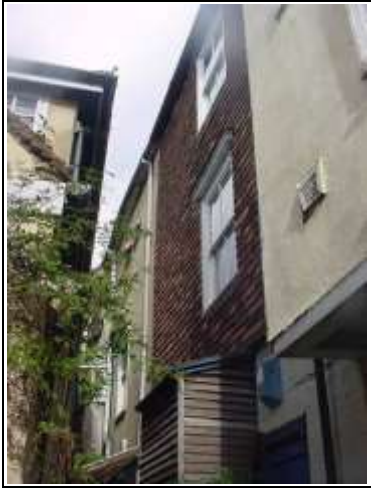
Vertical tiling to top

<p><b>Walls:</b></p> <p>Vertical tiling : high level Painted brickwork : low level</p> <p>Wooden ship lapped boxed area</p> <p>Structural Frame Timber frame assumed</p>

<p>Wooden ship lapped boxed area</p>	<p>Repair, prepare and redecorate</p> <p>Repair, prepare and redecorate</p> <p>Open up and check condition prior to legally committing to lease.</p>
<p><b>External Detailing:</b></p> <p>Windows: Single glazed sliding sash windows</p> <p>Painted timber door</p>	<p>Dated</p> <p>Dated</p>	<p>Repair, prepare and redecorate</p> <p>Repair, prepare and redecorate</p>

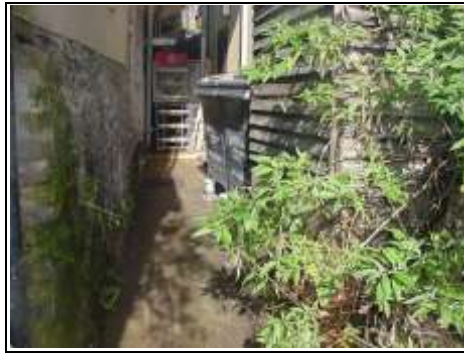
Rear of property

DESCRIPTION	CONDITION	ACTION REQUIRED
<b>Roofs:</b>  Not visible		See comments in front elevation with regards to roof leaking and deterioration to roof structure
<b>Gutters and Downpipes:</b>  Plastic	Average – re-routing recommended	Ensure all gutters are watertight and falling towards the downpipe. Repair and secure as necessary, ensure downpipes are clear.

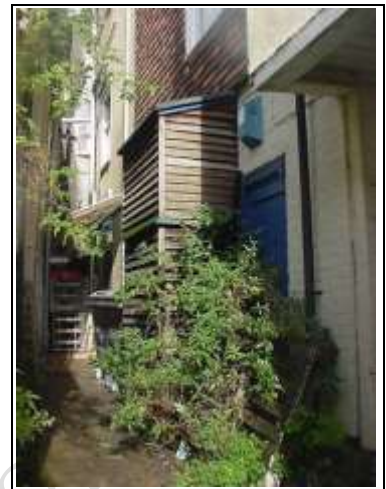
Rear view- shiplap boarding needs re-staining

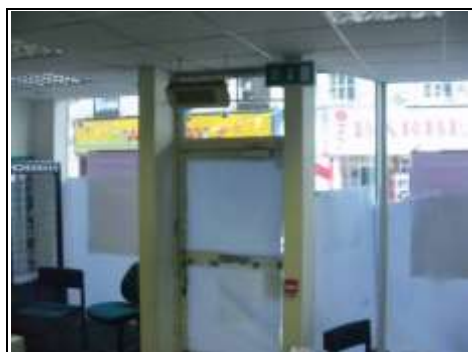
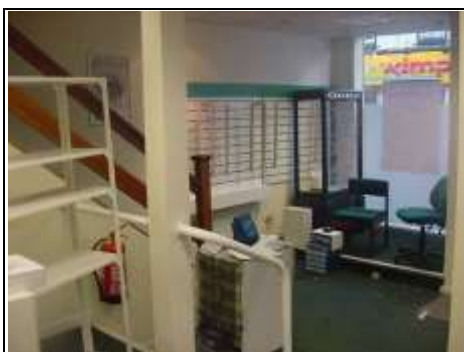
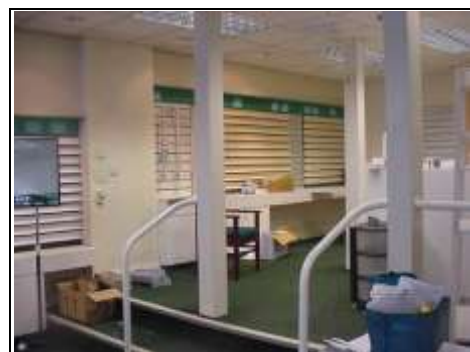
## Shop Trading Area

Suspended ceiling tiles	Water staining to ceiling tiles

Water staining

Above ceiling tiles	Replace. Unlikely to be able to find matching tiles therefore allow for replacing the entirety of the suspended ceiling system

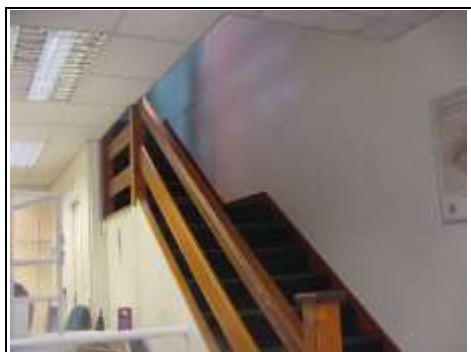
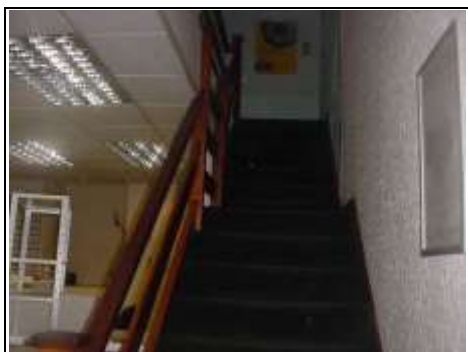
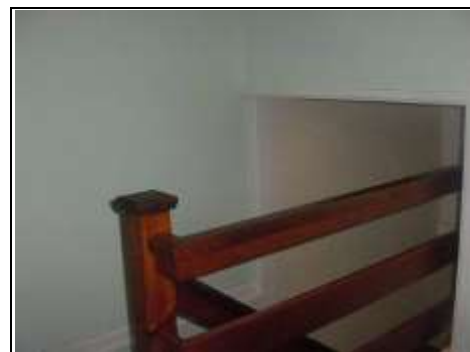
## Staircase

DESCRIPTION	CONDITION	ACTION REQUIRED
<b>Ceilings:</b>  Painted plaster (which is the underside of the staircase from the first to second floor)	Marked	Repair, prepare and redecorate
<b>Walls:</b>  Textured wallpaper	Dated	Repair, prepare and redecorate
<b>Handrail:</b>  Wooden	Dated	Clean handrail and balustrade and re-varnish
<b>Floors:</b>  Carpet	Used	Clean/ or replace

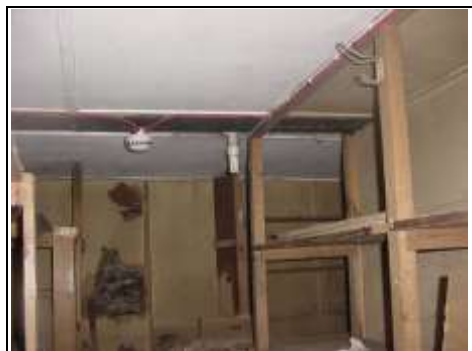
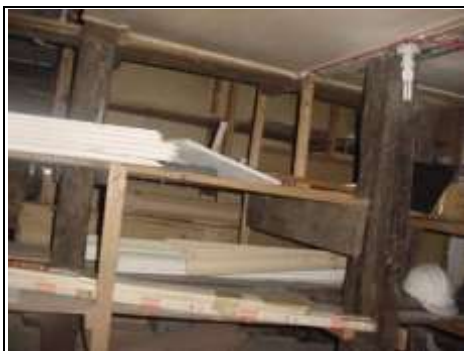
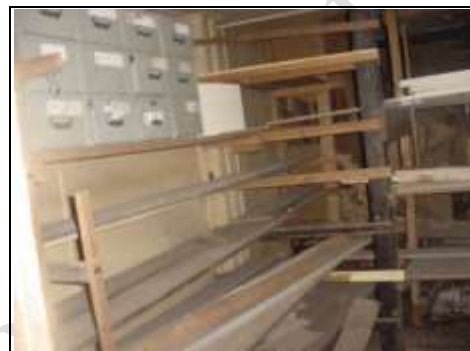
## Basement Area

DESCRIPTION	CONDITION	ACTION REQUIRED
<b>Ceilings:</b>  Boarded with timber trims on the joints  Joists are horizontal	Damp deterioration and woodworm

Woodworm

<p><b>Walls:</b></p> <p>Brickwork with a render with lime wash</p> <p>Studwork – one sided- it divides the basement</p> <p>Metal frame to the front of the basement</p>	<p>Signs of woodworm and wet rot</p>

<p>Wet rot in timbers</p>

<p>Dampness coming through to cellar</p>

Floorboards with joists	Repairs and additional work required for strengthening of floors

<p>Metal frame given support to the entrance door area</p>	<p>Repair and replace timbers</p> <p>Landlord to confirm this has Listed Building approval</p>
<p><b>Floors:</b></p> <p>Concrete and timber</p> <p>One step three quarters of way in</p> <p>Two steps to rear section</p>	<p>Trip hazard</p>

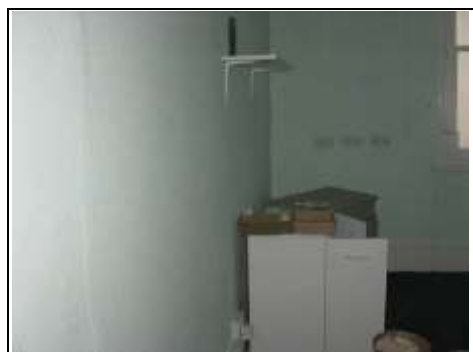
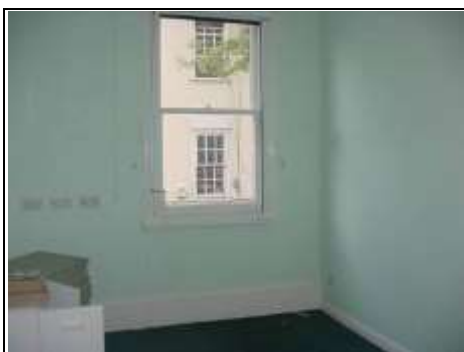
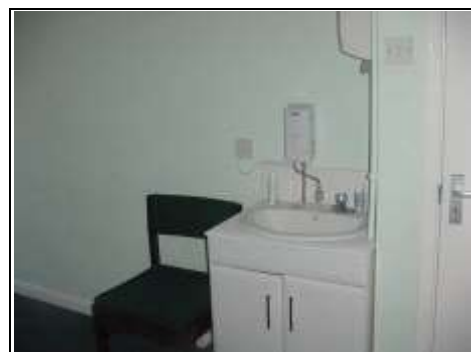
Front right hand office

DESCRIPTION	CONDITION	ACTION REQUIRED
<b>Ceilings:</b>  Textured painted	Dated	Repair, prepare and redecorate
<b>Walls:</b>  Woodchip paper	Crack to middle of right hand wall  Undulation to front right hand corner  Old fixing holes	Repair, prepare and redecorate
<b>Floors:</b>  Carpet	Used	Clean/or replace
<b>Sanitary Ware:</b>  Sink

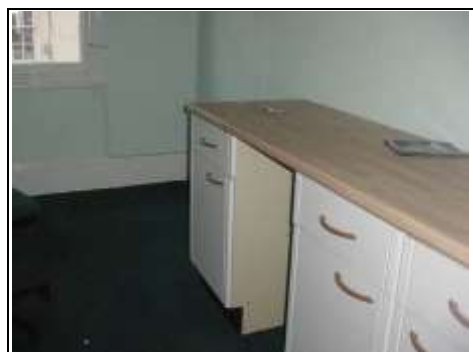
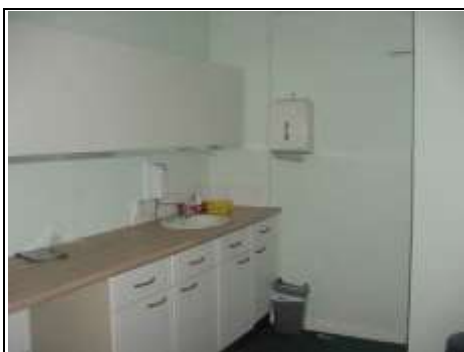
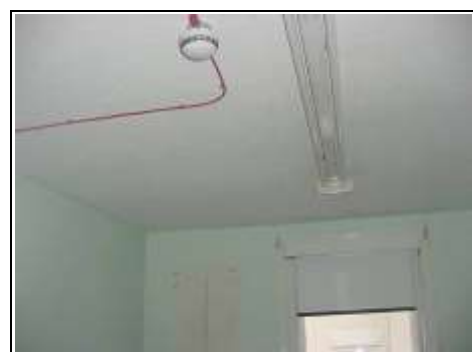
Front left hand office

DESCRIPTION	CONDITION	ACTION REQUIRED
<b>Ceilings:</b> Textured painted	Dated	Repair, prepare and redecorate
<b>Walls:</b> Woodchip paper	Dated	Repair, prepare and redecorate
<b>Floors:</b> Carpet	Used	Clean/or replace
<b>Sanitary Ware:</b> Sink is part of the unit on left hand side		Deep clean
<b>Detailing:</b> Windows:  Painted timber door	Modern timber sliding sash window with roller shutters  Marked	Repair, prepare and redecorate  Repair, prepare and redecorate
<b>Services:</b> Florescent Lights	No diffuser on lights	Provide diffuser and clean

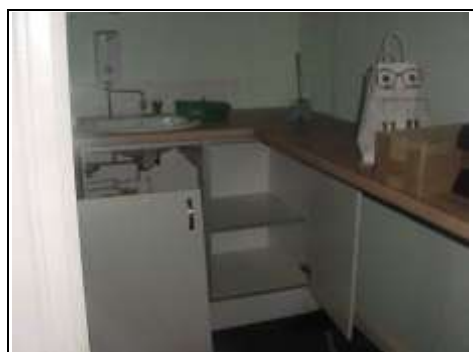
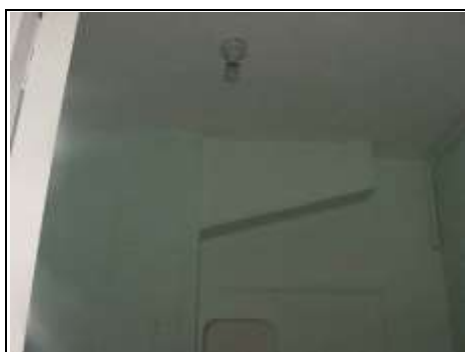
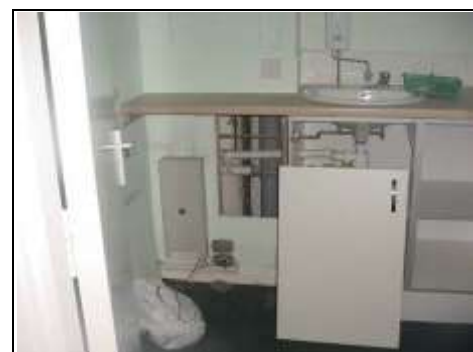
## Internal Kitchenette

DESCRIPTION	CONDITION	ACTION REQUIRED
<b>Ceilings:</b>  Painted with one light bulb	Dated	Repair, prepare and redecorate
<b>Walls:</b>  Woodchip paper	Dated	Repair, prepare and redecorate
<b>Floors:</b>  Carpet	Used	Clean / or replace
<b>Sanitary Ware:</b>  Sink with splash back		Deep clean
<b>Detailing:</b>  Painted timber door	Marked	Repair, prepare and redecorate
<b>Services:</b>  Soil and vent pipe -plastic

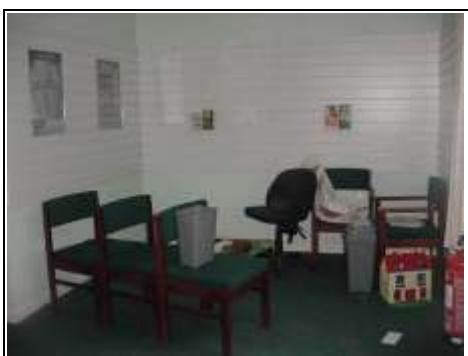
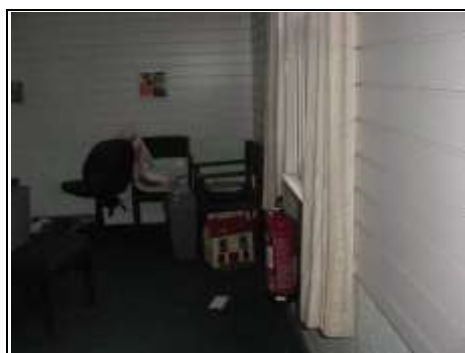
## Rear Open Plan Room to left hand side

DESCRIPTION	CONDITION	ACTION REQUIRED
<b>Ceilings:</b>  Painted	Dated	Repair, prepare and redecorate
<b>Walls:</b>  Painted Display units		Remove display units and make good Repair, prepare and redecorate
<b>Floors:</b>  Carpet	Used	Clean/ or replace
<b>Detailing:</b>  Windows:  Painted timber door	Dated	Repair, prepare and redecorate  Repair, prepare and redecorate

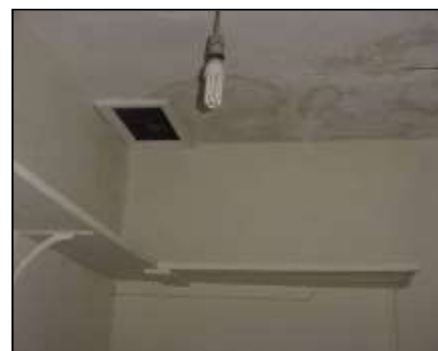
Dampness above staircase area

DESCRIPTION	CONDITION	ACTION REQUIRED
<b>Ceilings:</b>  Painted	Marked with undulations, indicating lath and plaster ceiling  Ladder access	Make roof watertight before carrying out work  Repair, prepare and redecorate
<b>Walls:</b>  Woodchip paper	Heavily marked

Dampness visible	Repair, prepare and redecorate
<b>Floors:</b>  Carpet	Used	Clean / or replace

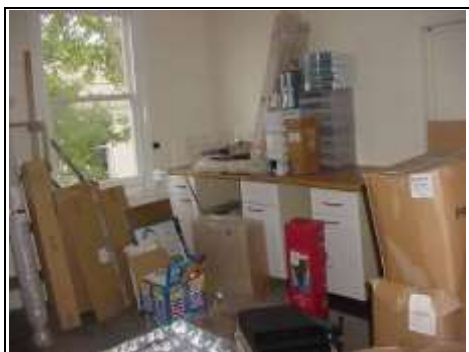
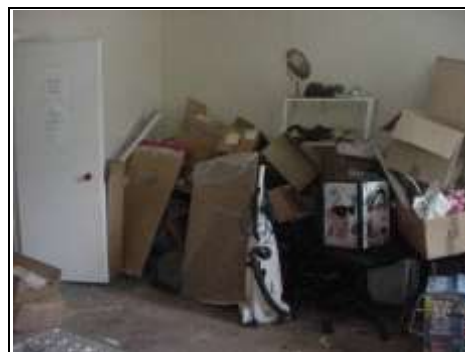
## Front Store Area

DESCRIPTION	CONDITION	ACTION REQUIRED
<b>Ceilings:</b>  Painted	Dampness coming in to front of right hand window

Dampness next to window	Make roof, parapet wall and box gutter watertight prior to carrying out work  Repair ceiling Prepare and redecorate
<b>Walls:</b>  Painted	Dampness to rear right hand side dividing wall	Repair walls Prepare and redecorate
<b>Floors:</b>  Floorboard	Deflection This may relate to embedded timbers or woodworm and wet rot	Strengthen floors

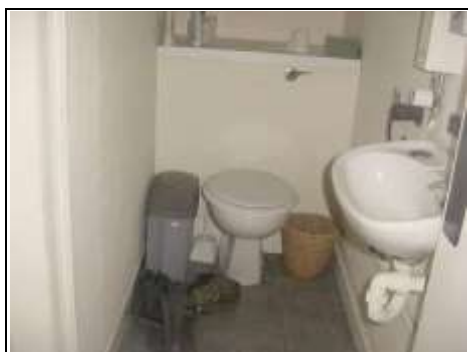
Gent WC

DESCRIPTION	CONDITION	ACTION REQUIRED
<b>Ceilings:</b> Woodchip wallpaper Vent	Dated	Repair, prepare and redecorate
<b>Walls:</b> Painted woodchip wallpaper	Dated	Repair, prepare and redecorate
<b>Floors:</b> Poly vinyl	Marked	Clean /or replace
<b>Sanitary Ware:</b> One WC, one wash hand basin	WC encased Dated wash hand basin	Deep clean
<b>Detailing:</b> Painted timber door	Marked	Repair, prepare and redecorate

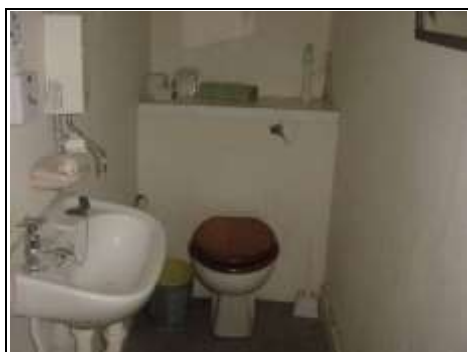
Ladies WC

DESCRIPTION	CONDITION	ACTION REQUIRED
<b>Ceilings:</b>  Woodchip wallpaper  Vent	Dated	Repair, prepare and redecorate
<b>Walls:</b>  Painted woodchip wallpaper	Dated	Repair, prepare and redecorate
<b>Floors:</b>  Poly vinyl	Dated and deteriorating	Clean /or replace
<b>Sanitary Ware:</b>  One WC, one wash hand basin	WC is within a shelf Dated wash hand basin with a water heater	Deep clean
<b>Detailing:</b>  Borrowed light to rear room  Painted timber door	Marked	Redecorate  Repair, prepare and redecorate

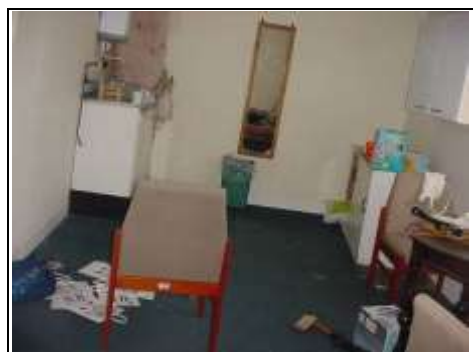
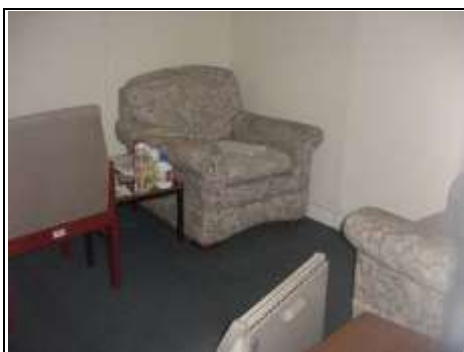
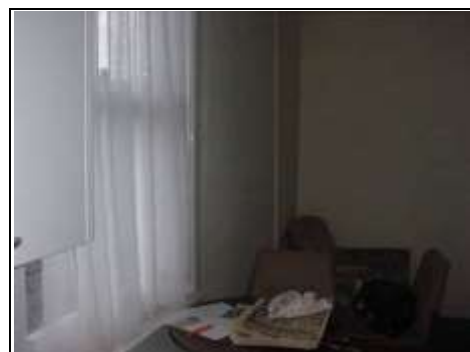
## Staff Room to Rear

DESCRIPTION	CONDITION	ACTION REQUIRED
<b>Ceilings:</b>  Painted woodchip wallpaper  Smoke alarm	Dated	Repair, prepare and redecorate  Needs test and report
<b>Walls:</b>  Painted	Dampness to left hand side

Damp coming through on left hand side from the roof and the wall	Repair, prepare and redecorate
<b>Floors:</b>  Carpet	Used	Clean
<b>Sanitary Ware:</b>  Sink and drainer to left hand side and a Saniton Aquarius water heater		Deep clean

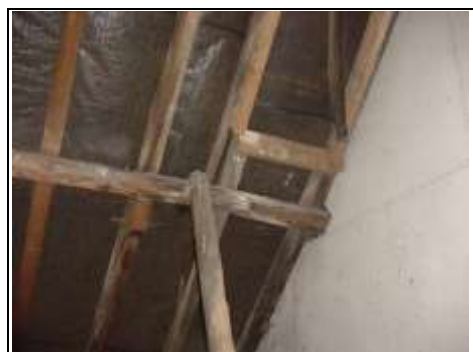
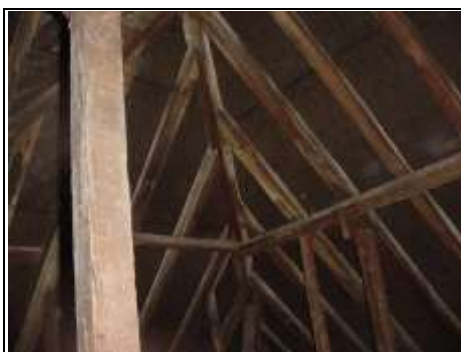
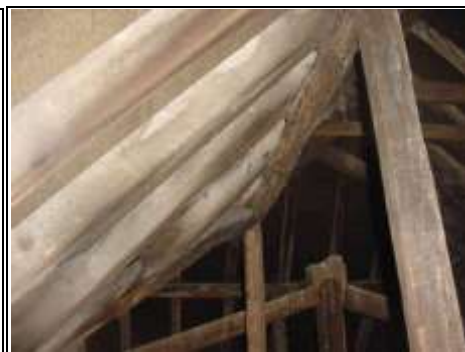
## ROOF - INTERNAL

DESCRIPTION	CONDITION	ACTION REQUIRED
<p><b>Roof Covering:</b></p> <p>Note we could not see the roof properly.</p>	<p>Pigeons are in the roof indicating that there are holes in the roof covering which will allow rain water in</p>

<p>Damp and pigeons coming in Pigeon droppings throughout</p>	<p>Repair and make watertight</p>
<p><b>Roof Structure:</b></p> <p>Roof timbers: There are a combination of styles of ages and timber roofing</p>	<p>The roof timbers showed signs of dampness and were relatively thin profile compared with what we typically see.</p>

<p>King post has been cut</p>	<p>We would expect extra strengthening to be required in the roof or replacement of timbers</p>
