A review of a Victorian Flat with black mould

How one of our Surveys can help you

We have recently carried out a survey for the owner of a flat in a converted three storey Victorian property.

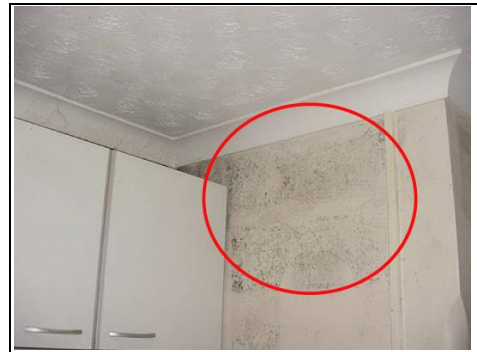
As is often the case with this age, type and style of property there were a combination of reasons for the black mould and condensation. These included:-

1. Original construction and modern renovation
2. Poor design details
3. Lack of maintenance
4. Occupier lifestyle
5. Lack of ventilation

Black mould

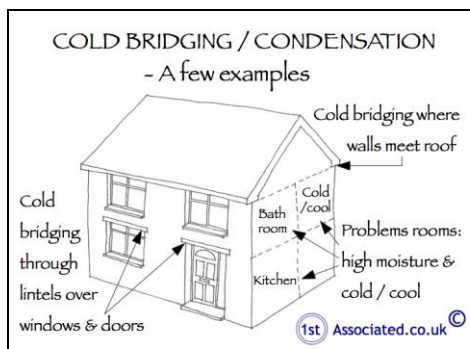
Condensation

We advised our client that solving the issues with this flat may take some time and a lot of money. We firstly recommended that large humidity controlled extract fans were added to the property to remove moisture in the bathroom and kitchen and that a full air conditioning system, again with humidity control, should be installed. We also felt that the rear of the property should be dry lined and the detail to the render should be improved by adding a bell mouth to the base and a drip detail over windows to prevent dampness entering the building.

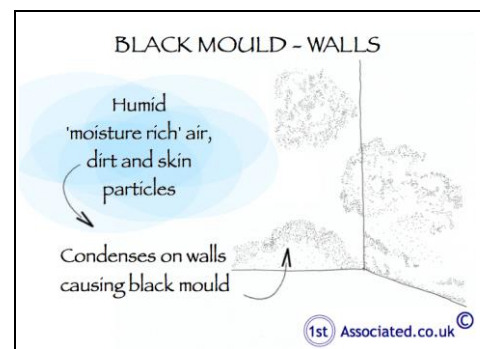
Black mould

High levels of modern insulation had been added to the newer extensions without any thought given as to how it would affect the original building. The added insulation to the newer areas meant that humidity was being drawn to the older, colder, original areas to the rear of the building which was resulting in black mould occurring.

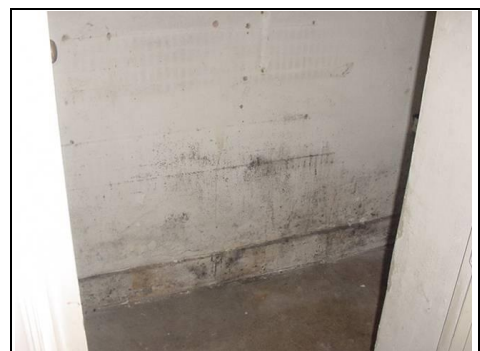
Black mould

We advised our client that the insulation levels would ideally need to be balanced but that this could be expensive as it would mean alterations to the roof and around the windows. The alternative would be to dryline the rooms that were affected

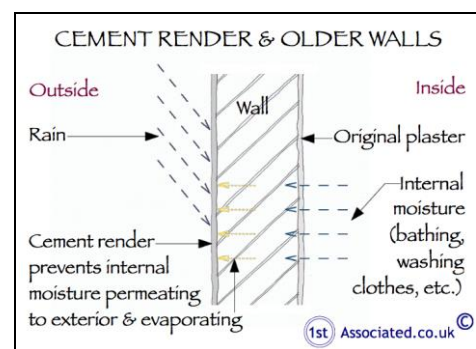
We also noted that the exterior of the property had been rendered with a cement based render which was too hard and was cracking. We also believed that plastic based paints may have been used which will prevent the building from breathing as it is supposed to.

Cement render

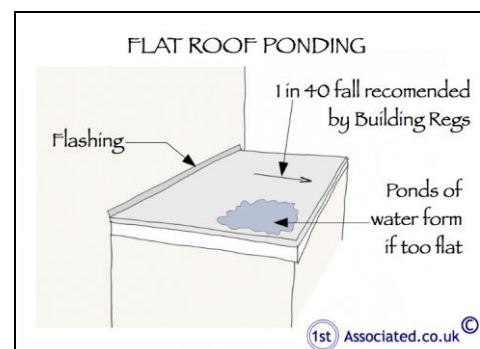
The property had a flat roof to the rear; this is a roof with no pitch or fall. Water is unable to run off this type of roof and we could see ponding which adds weight to that section of the roof and causes deterioration.

Ponding

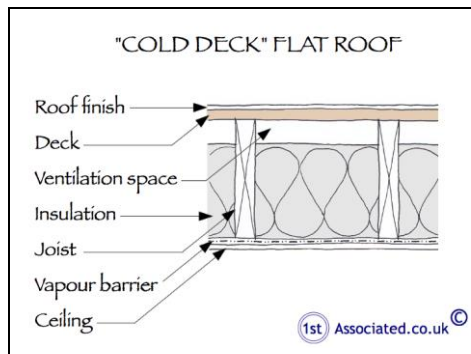
We also believed this to be a cold flat roof with no insulation and would have preferred it to be a warm flat roof with insulation.

Cold flat roof
