Church Conversion Example Commercial Building Survey

Call us for a Quote on Freephone 0800 298 5424

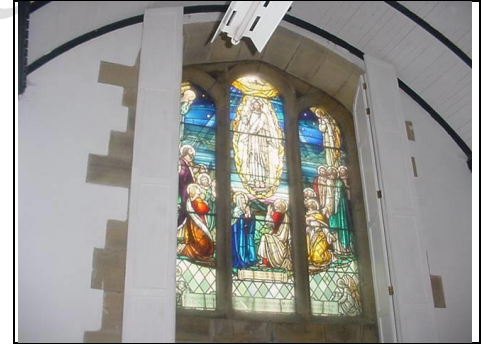
Large stained glass window

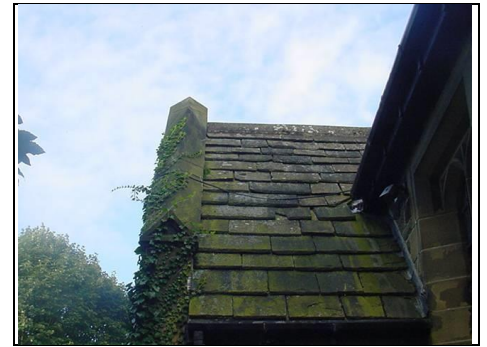
Damaged stone slabs to roof

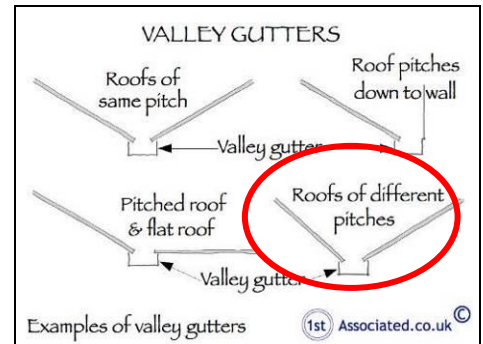
Two main parapet walls with Flashband repairs (red ovals) and valley gutter (green oval)

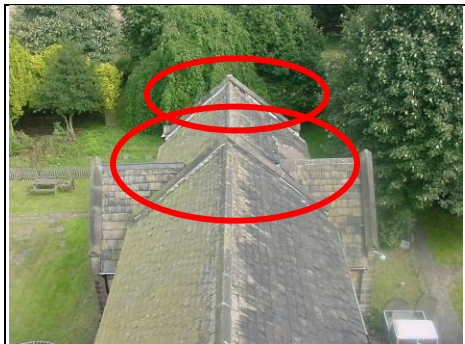
Parapets to nave and chancel

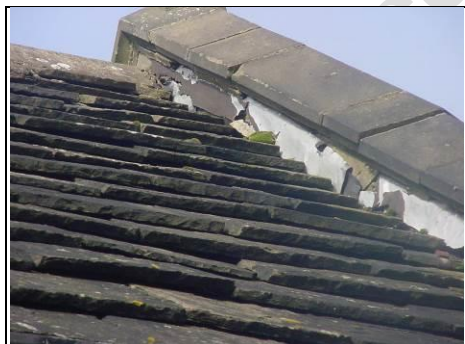
Flashband flashing deteriorating on chancel roof

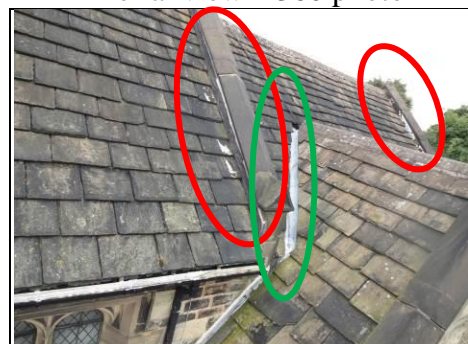
Two main parapet walls with Flashband repairs (red ovals) and valley gutter (green oval)

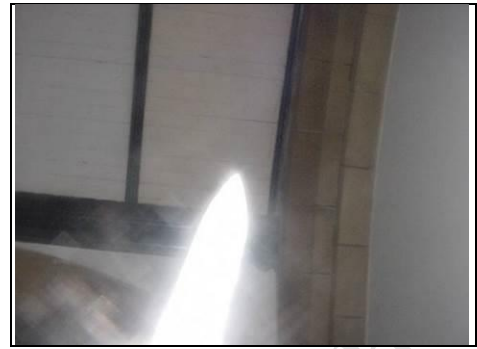
Dampness visible within chancel apartment area

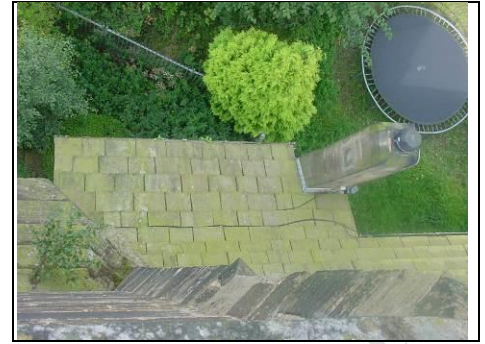
Please see the Roof Section of this Report.

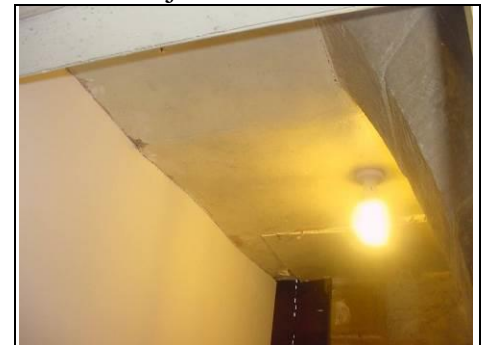
Staining to store room roof

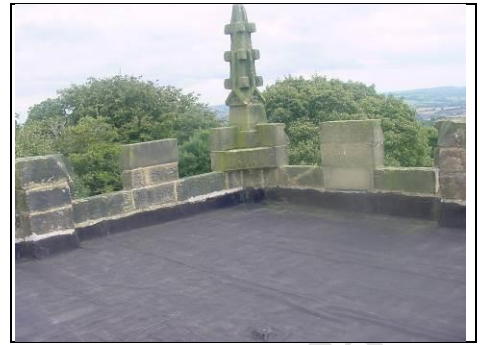
Repairs have taken place to the Tower parapets

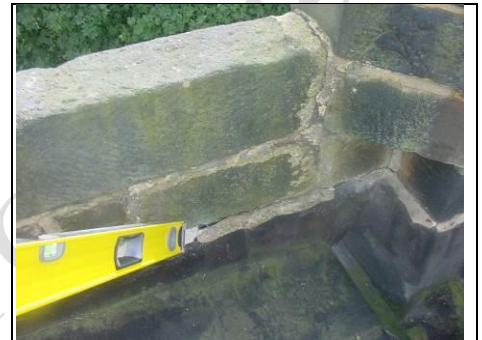
Pointing coming away from the flashing

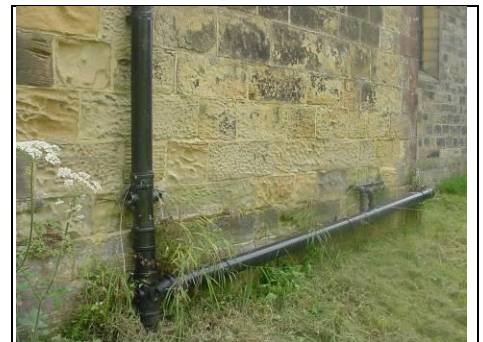
The deterioration tends to affect the areas that do not get sunlight as much, such as the north face/rear of the church. In this case there is also some deterioration generally, particularly at high level.

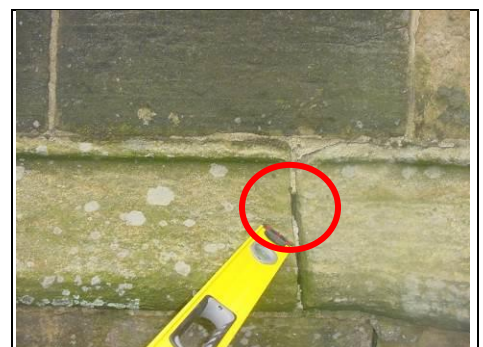
Weathering to pointing

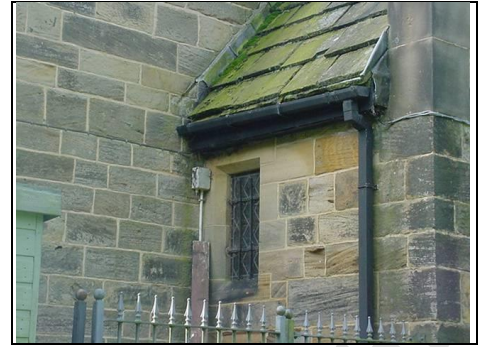
Damaged stonework to north side

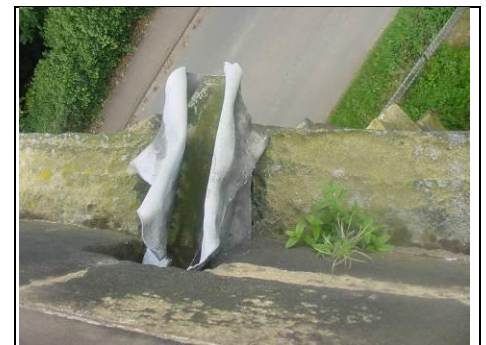
Tower rainwater head that discharges rainwater down the building

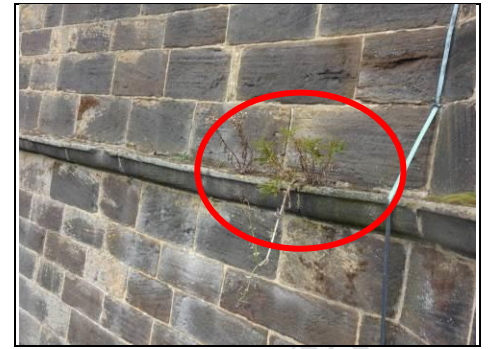
Plants growing out of the ledge
Aerial view – 360 photo

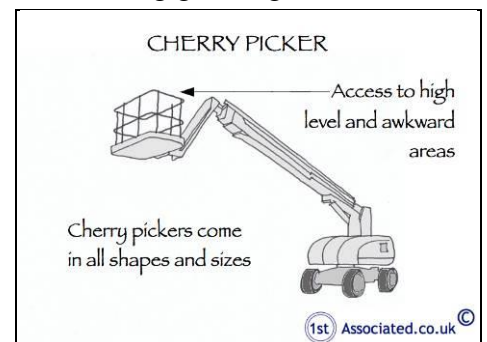
Please see the Walls Section of this Report.

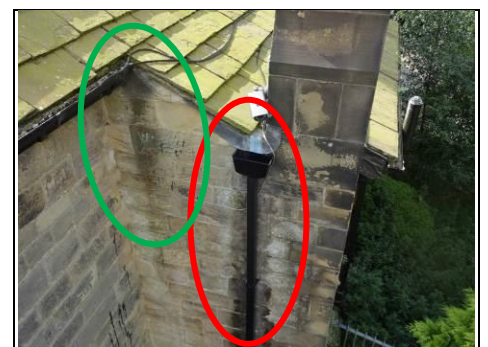
Leaking hopper head– staining down wall (red oval) and overflowing gutter (green oval)

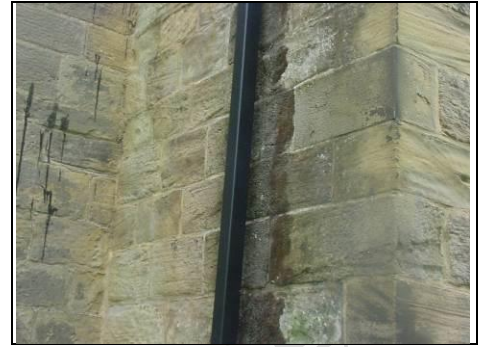
Water discharging down rear left wall next to chimney

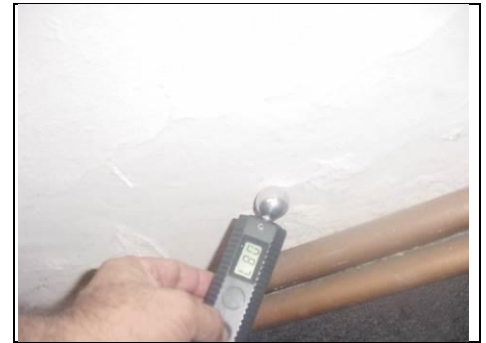
Testing for rising damp

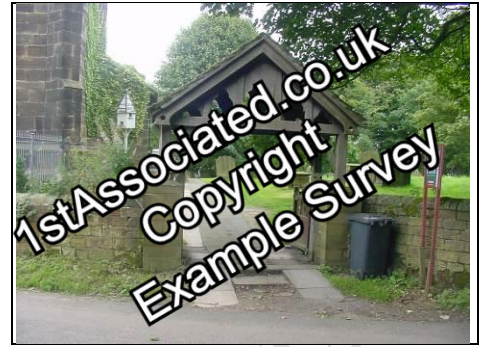
Entrance to church land

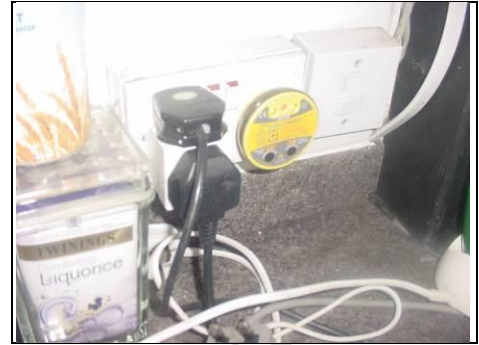
The electrics are dated and failed our earth test in the kitchen. We think the electrics are complex and have been built up over the years. The existing owners have built up a knowledge of these and you need to have a tour specifically noting down what light points refer to and the fuseboard refers to what if you do decide to purchase the property.

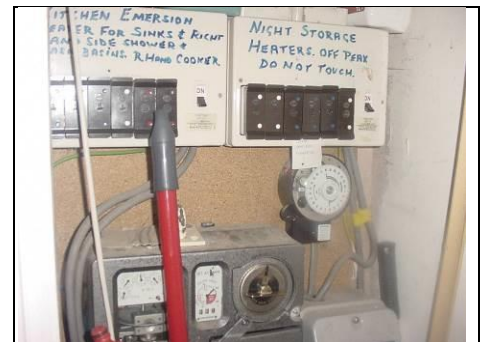
We recommend an Institution of Engineering and Technology (IET) test and report to be carried out by an NICEIC registered and approved electrical contractor or equivalent.

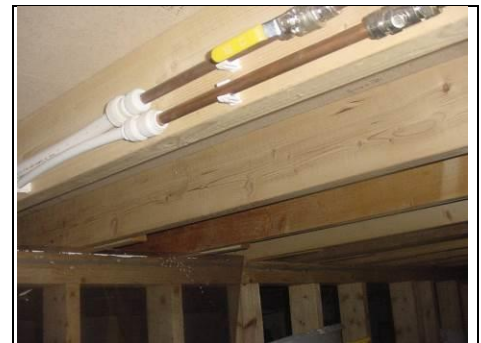
Mix of plastic and copper pipes under the lounge

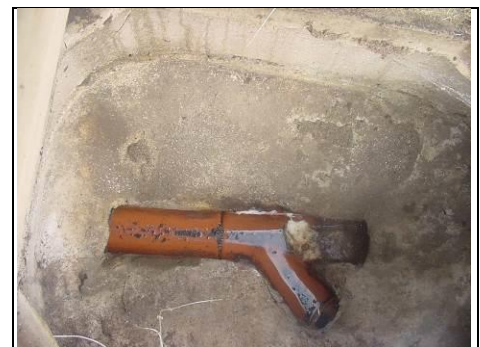
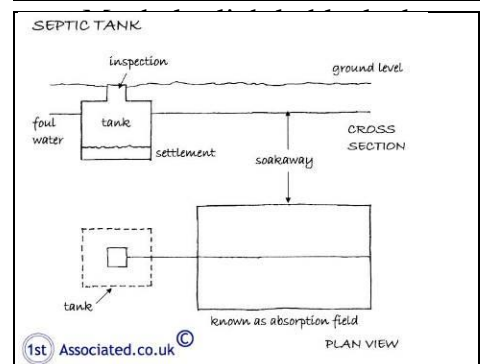
As we have not opened up the septic tank you can take the current owner's word for this or you can ask for whoever emptied it last to comment further.

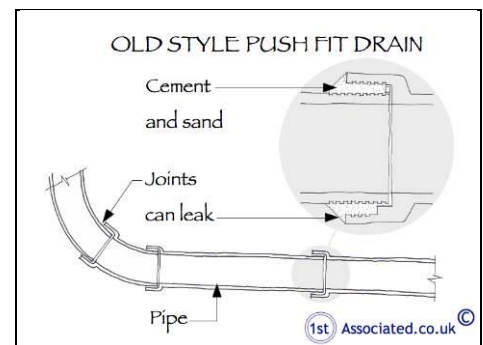
In older properties, such as this, drainage was often push fitted together rather than bonded together which means that they may leak over the years. Whilst we ran the tap for 15 minutes without any build up or blockages the only way to be 100% certain of the condition of the drains is to have a closed circuit TV camera report.

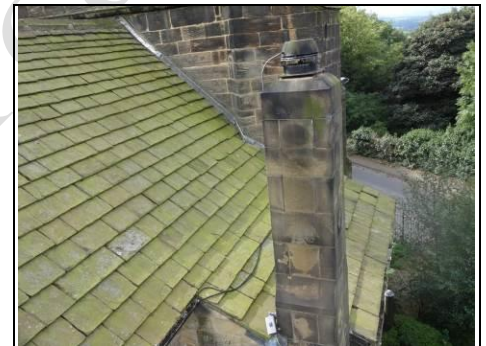
This chimney is stone built with a lead flashing and one chimney pot. From what we could see from ground level it looked in average condition considering its age, type and style.

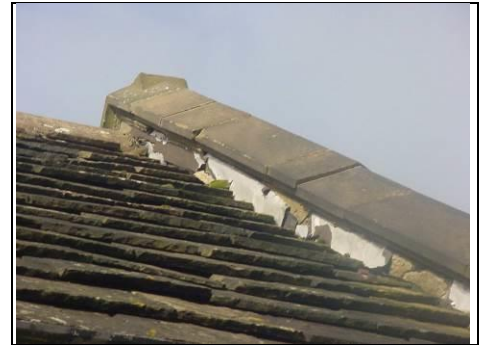
Deteriorating flashing on parapet

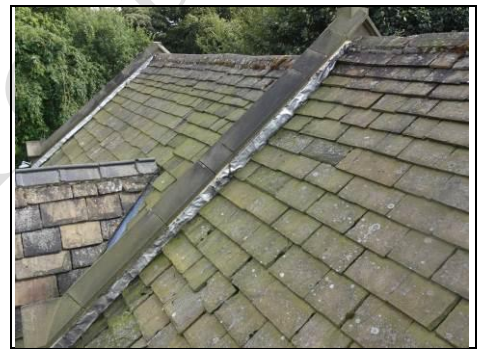
Flashband repairs on parapet

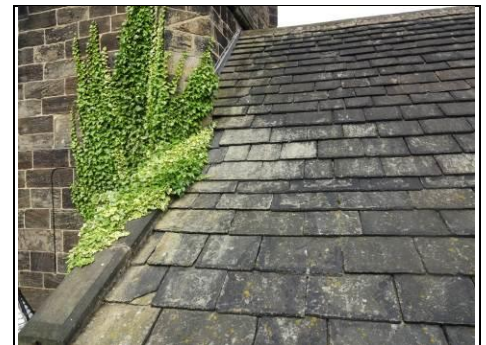
However, we have been misled with this type of roof before and when taking off the roof covering have found there to be rotten timber beneath. Unfortunately as we have not been able to access the roof space we cannot comment further but we would be more than happy to return to inspect the roof space if it is opened up.

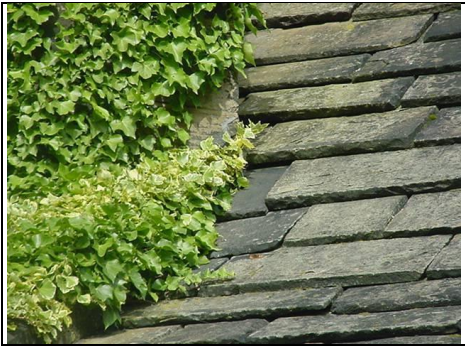
Damaged slabs have been replaced over entrance porch with a thinner slab

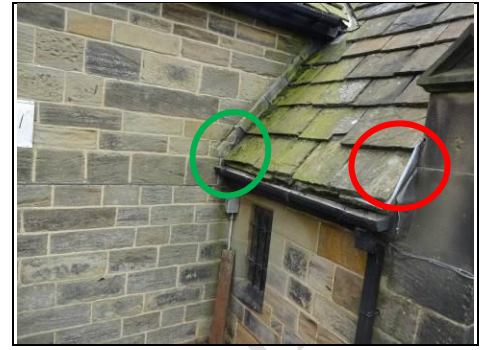
Extra lead added (red oval) and missing lead (green oval).
Leadwork needed
Aerial view – 360 photo

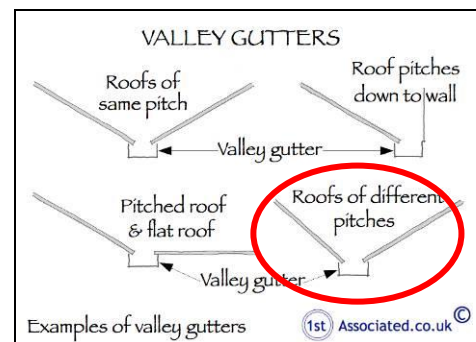
Where the roofs meet there are valley gutters which would have originally all been lead but some of them look to have been replaced with other materials. We think, from ground level, that it may be a GRP (glass reinforced plastic) valley gutter or a plastic valley gutter.

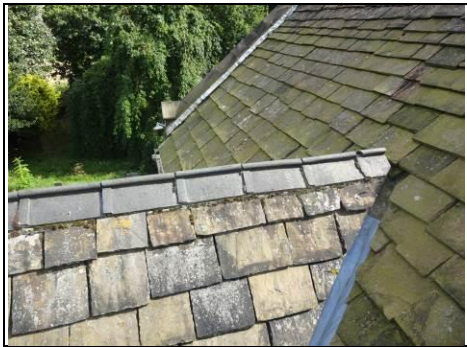
Repairs to valley gutters
Aerial view – 360 photo

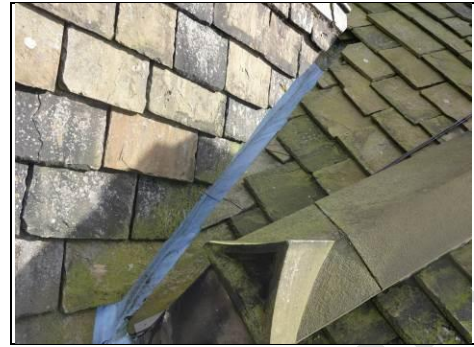
Repairs to valley gutters
Aerial view – 360 photo

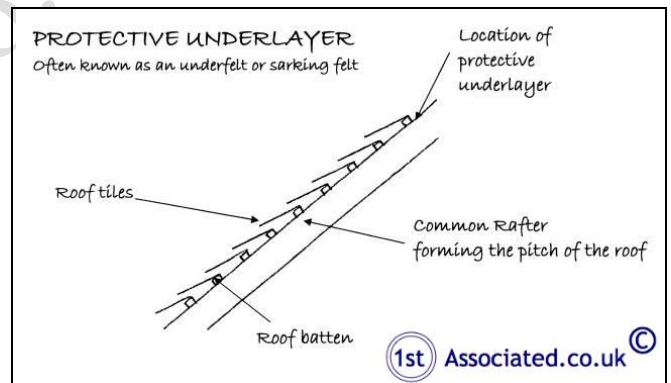
Protective underlayer

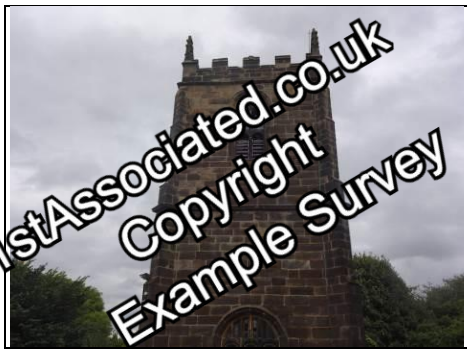
Lightning rod runs down to the ground

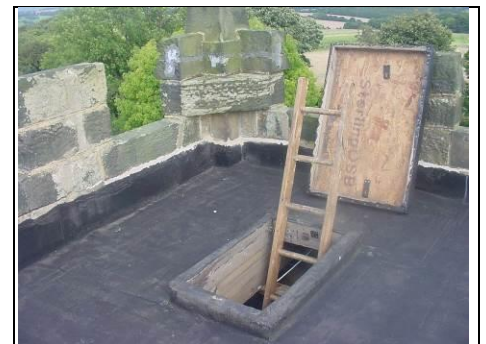
The black felt roof with wooden ladder access

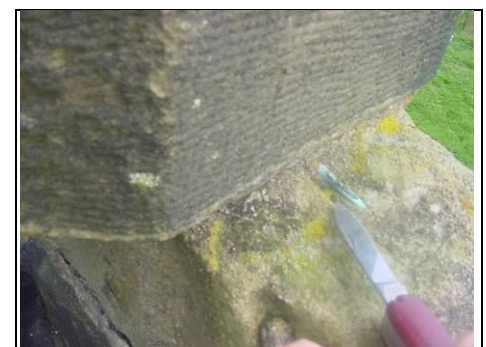
Metal bars tying stonework of battlements/castellations

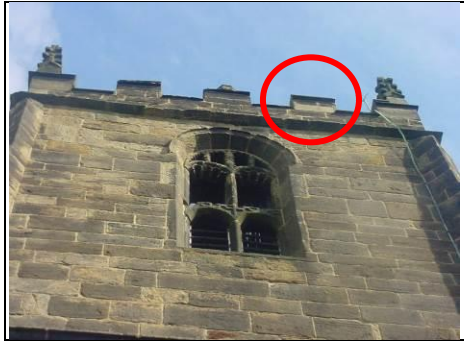
Old repairs to parapet visible

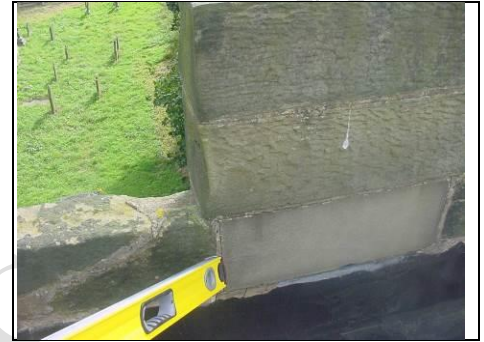
Old repairs to parapet visible

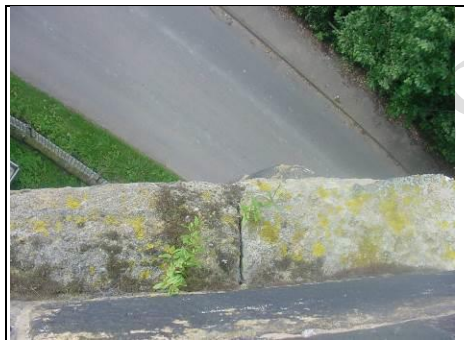
Ledge joints need repointing and growth of vegetation

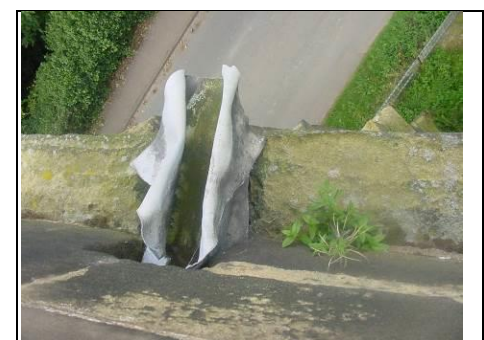
Rainwater gully discharges rainwater down wall

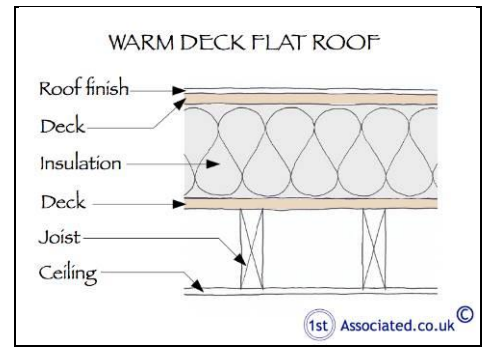
In theory modern flat roofs should now be what is known as a warm roof, or insulated roof, but there may be exemption on this on Listed buildings.

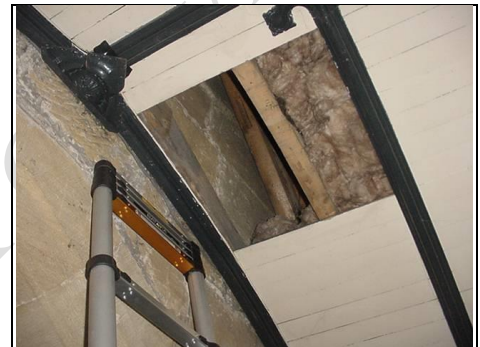
Small access into roof space

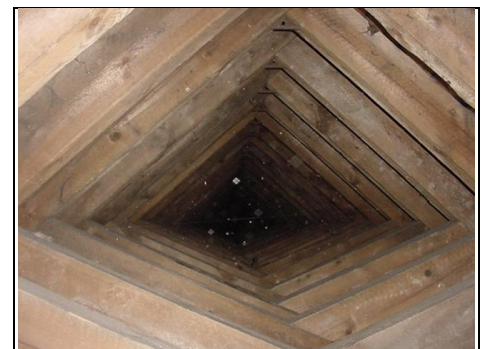
Looking down scissor roof over Nave

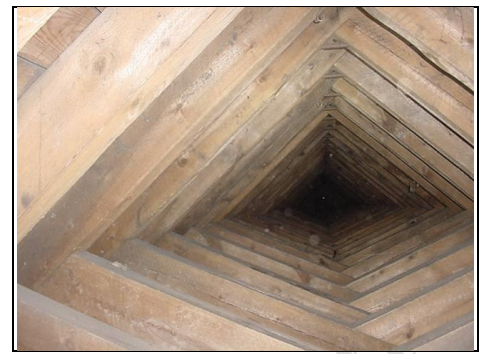
Timbers are in relatively good condition

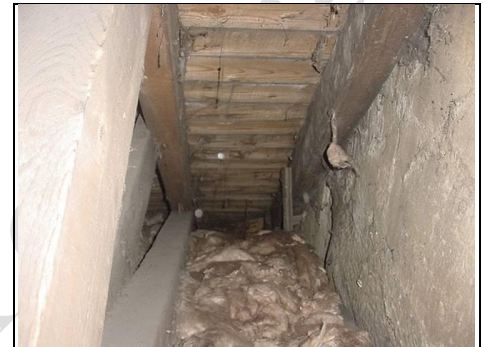
Close boarding and insulation

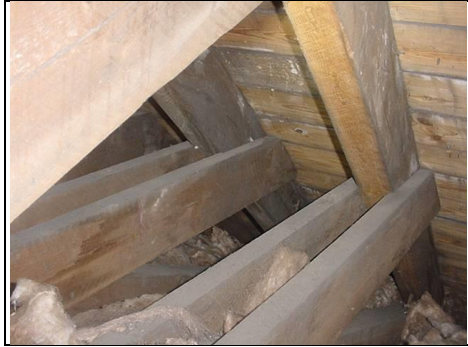
Substantial timber trusses,
spaced approx. 350mm apart
(not measured)

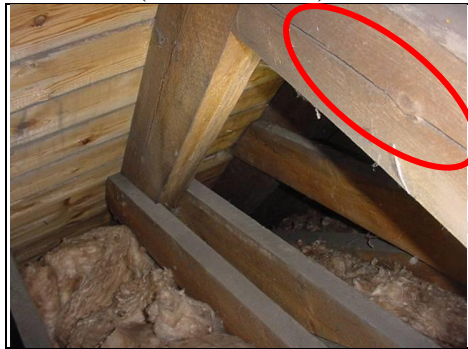
Collars and close boarding

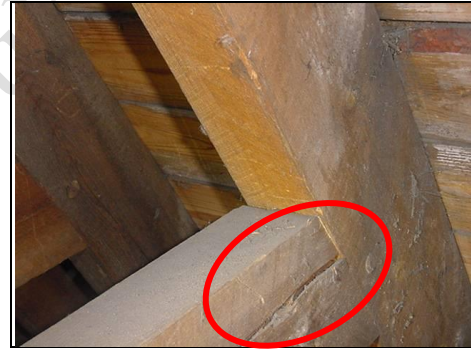
However we think that the sheer weight of the timber is likely to be more of a problem than timber deterioration. From what we could see this was minimal/to non-existent in the areas that were visible.

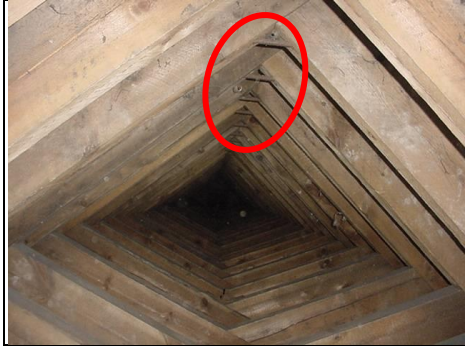
Metal tie bars to ridge

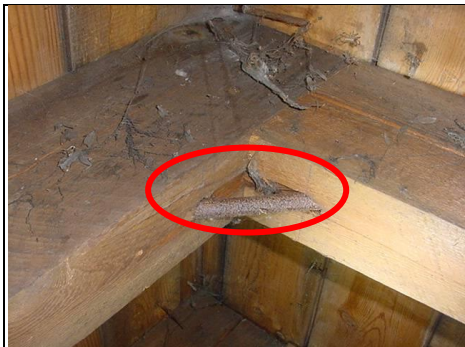
Rusting metal tie bar

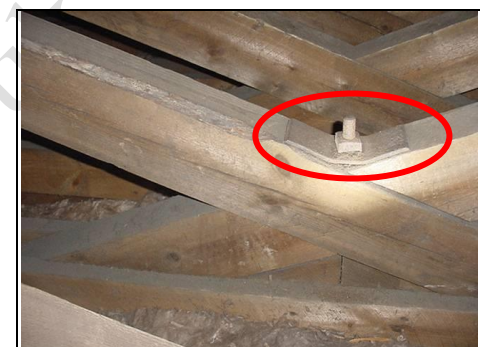
Bolt at top of horizontal tie bar

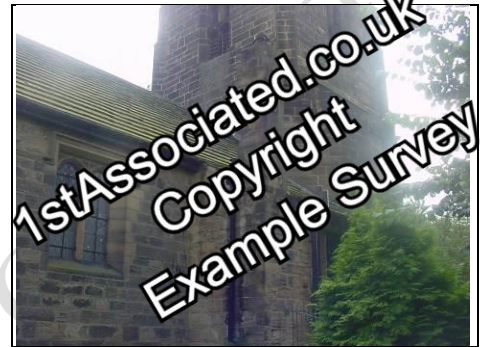
Hopper head and gutters discharge down wall

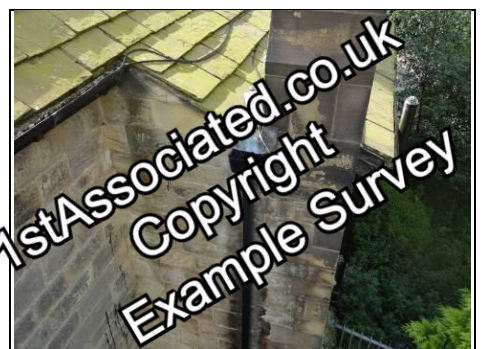
Close up leaking hopper head and gutters, discharging down the wall
Aerial view – 360 photo

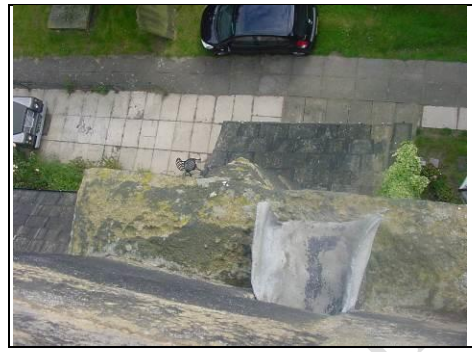
Rainwater discharging from tower flat roof via lead gully

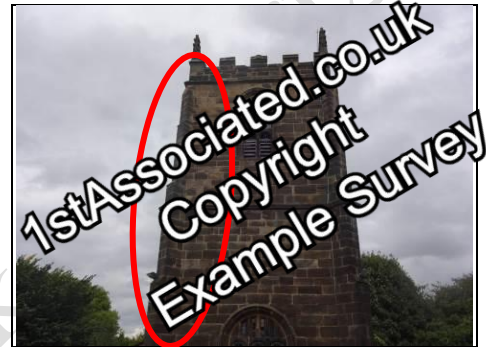
Water discharges down Tower

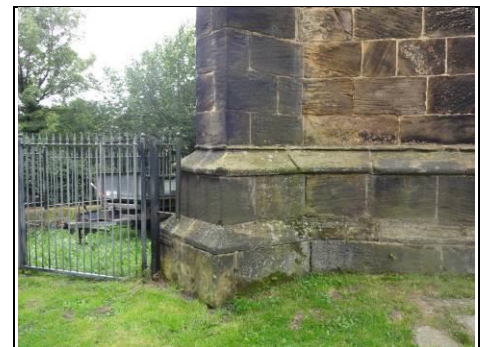
Water runs to the base where there is worn out pointing and deterioration to stonework

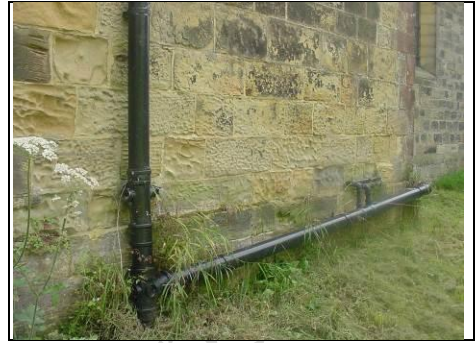
Rear right soil and vent pipe

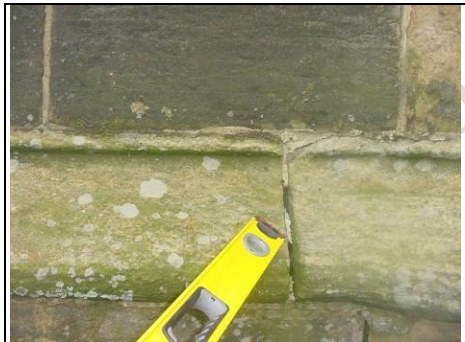
Weathering to stonework and deteriorating pointing

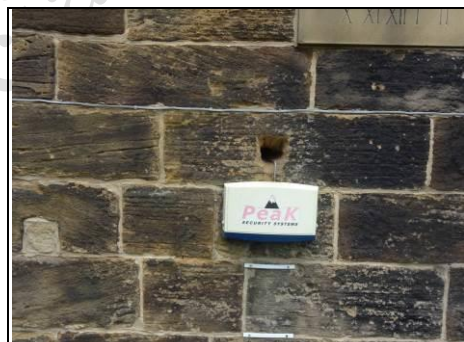
Repairs to stonework generally to south face
(and access hole for wasps!)
Aerial view – 360 photo

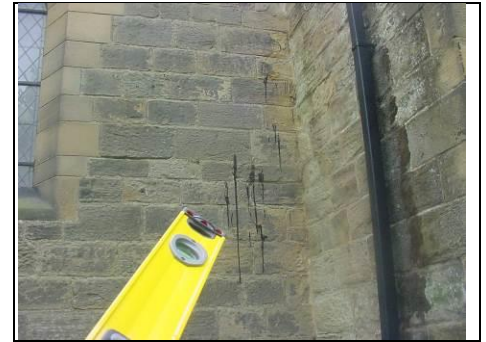
Tar on stonework to rear and downpipe leaking down wall

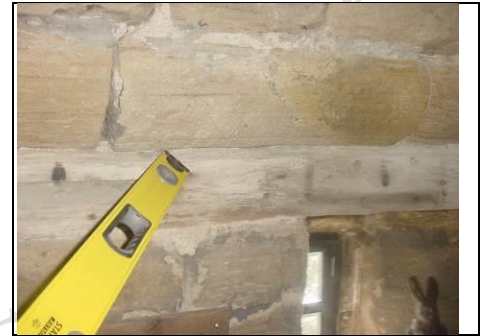
Timber Wooden lintel

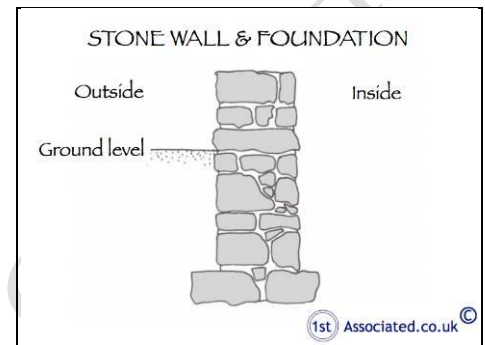
Given the age of the property you may find different depths of foundations. We would expect to find a shallow or stepped stone foundation.

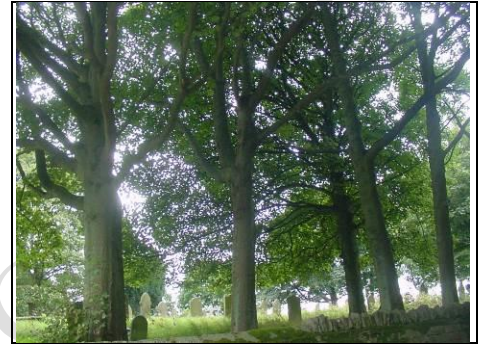
Trees in churchyard. Check they are regularly maintained otherwise they will cause problems to the boundary wall

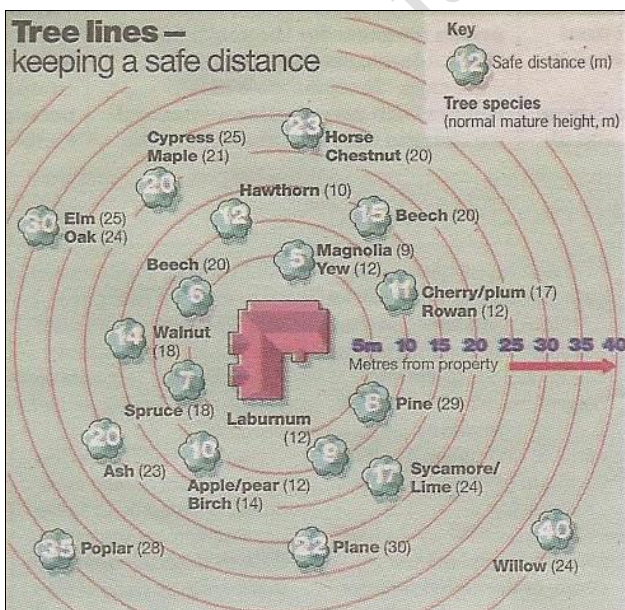
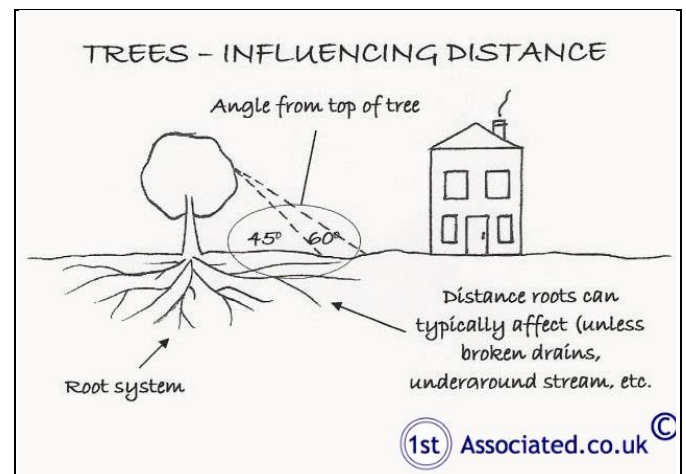
Influencing distance of trees to a property

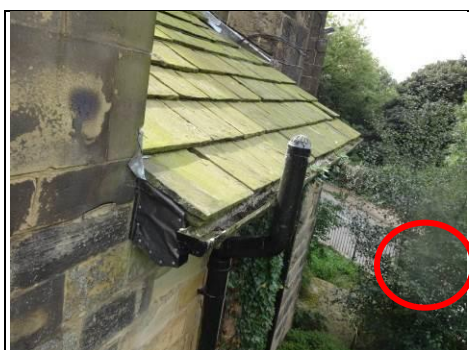
DIY plastic repair to fascia board

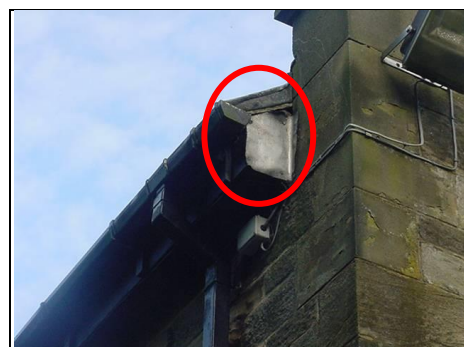
Flashband repair front right side

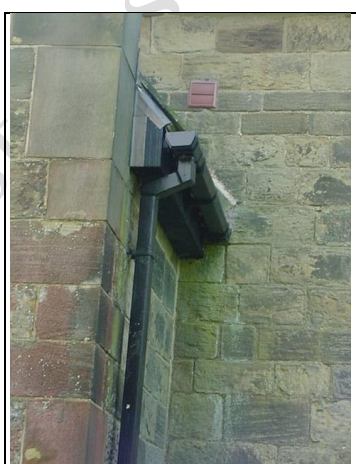
Flashband repair to fascia on north side

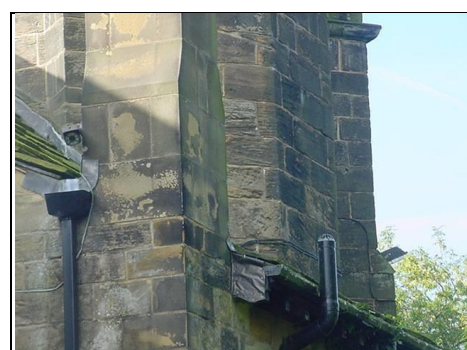
More Flashband repairs

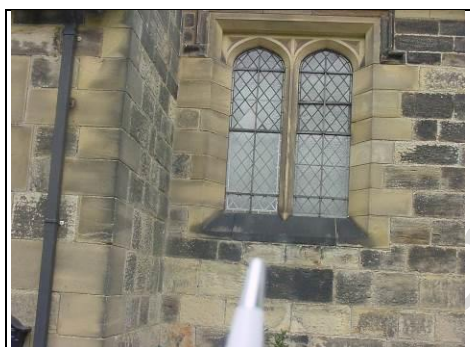
Perpendicular windows to front/south side have been repaired

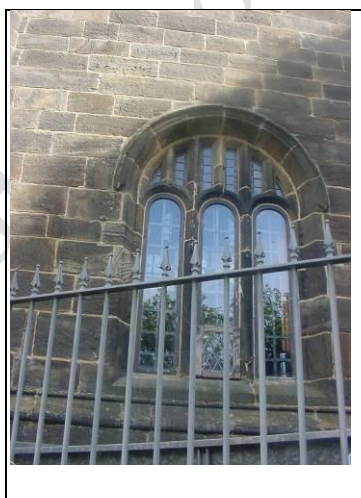
Perpendicular window in tower

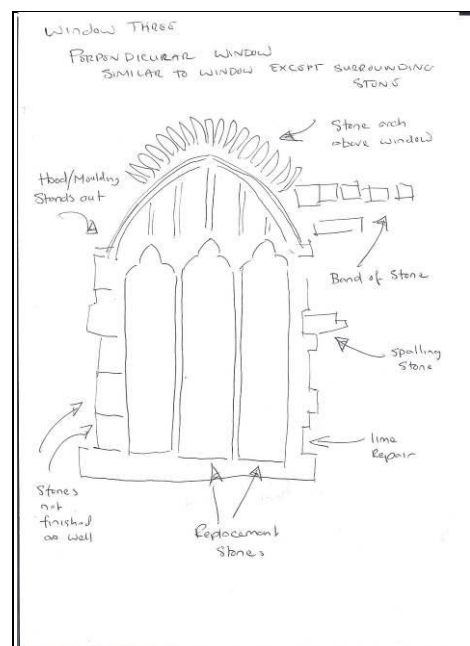
Perpendicular windows
1350-1660

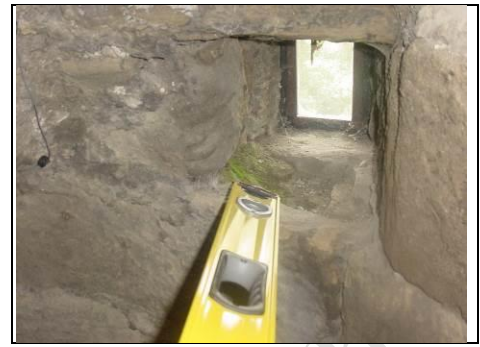
Dampness and moss coming through window

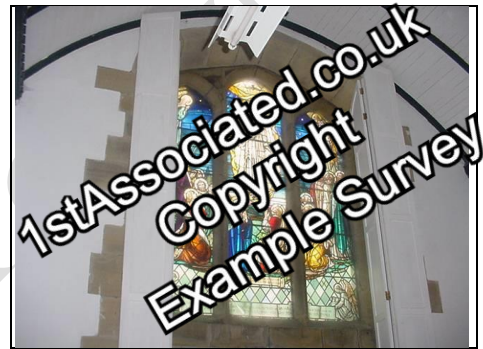
Stained glass window

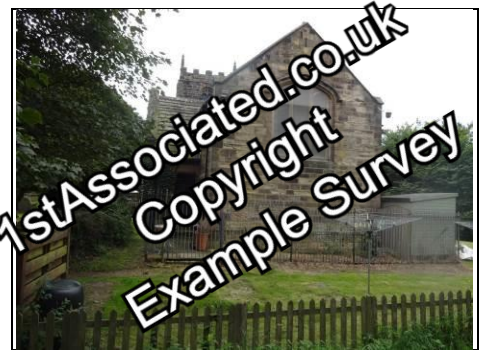
Perpendicular stained glass window externally covered with plastic

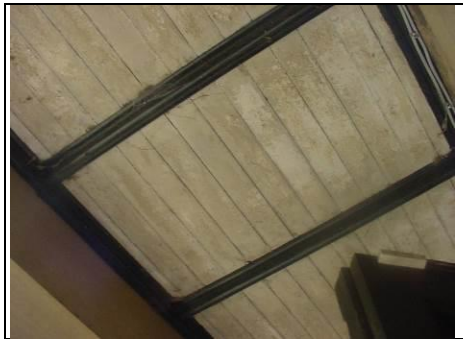
Some of the barrel ceilings / waggon roof are in poor condition

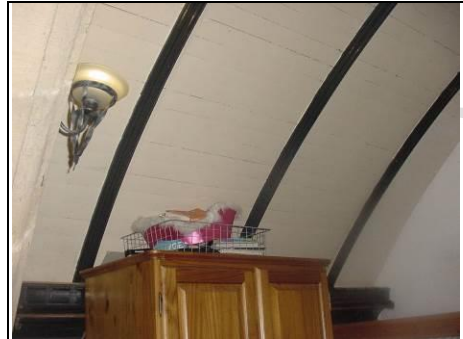
Barrel ceiling / waggon roof

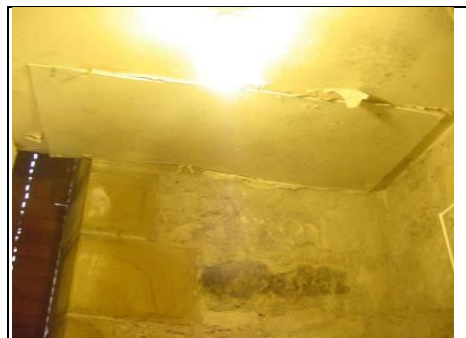
Damp in ceiling to store room off kitchen

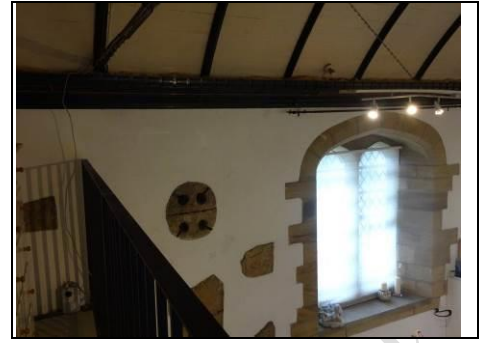
Interesting carvings in the church walls

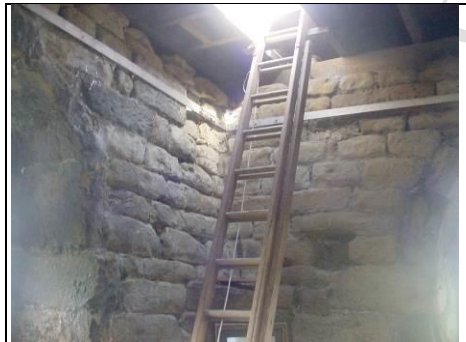
Bracing running around the top of the Tower

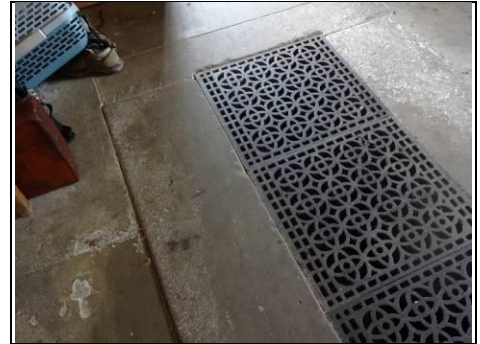
Grill in floor in reception area adjacent to kitchen

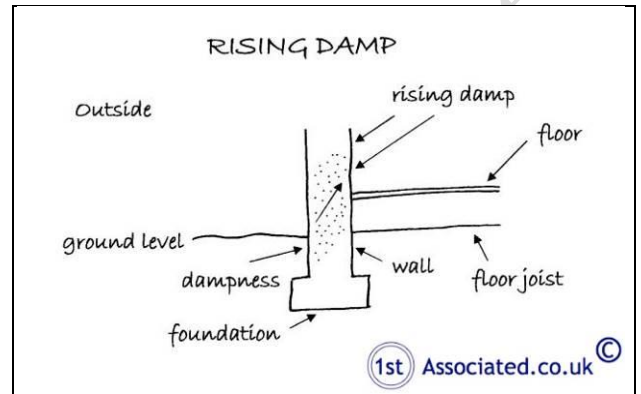
Rising damp depends upon various components including the porosity of the structure, the supply of water and the rate of evaporation of the material, amongst other things. Rising damp can come from the ground, drawn by capillary action, to varying degrees of intensity and height into the materials above. Much evidence points towards there being true rising damp in only very rare cases.

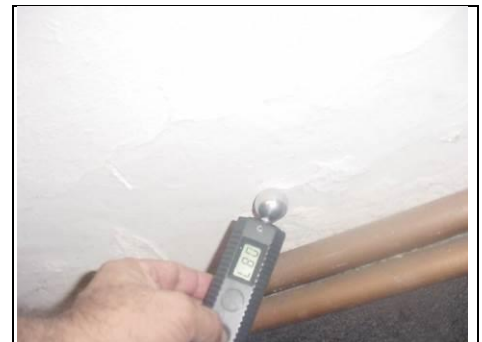
Testing for rising damp

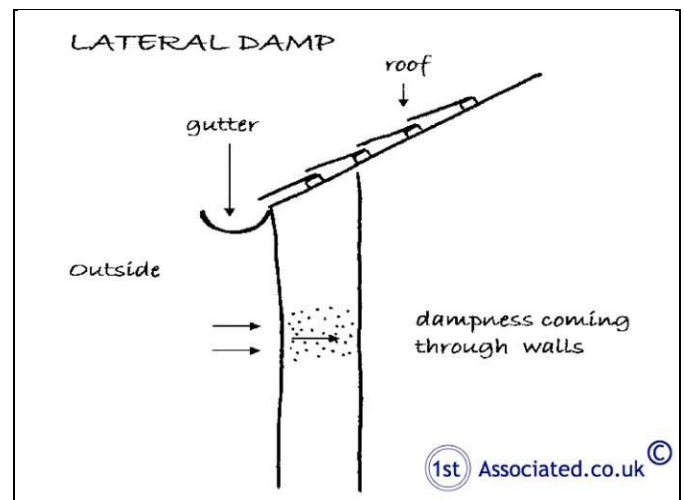
This is where water ingress occurs through the walls. This can be for various reasons such as poor pointing or wall materials or inadequate gutters and downpipes, such as poorly jointed gutters.

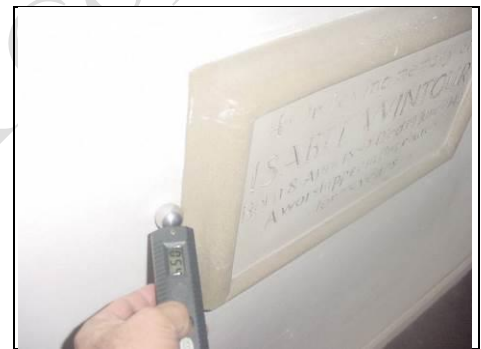
Testing for lateral dampness

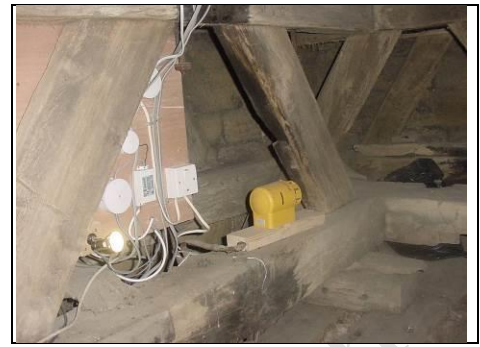
Timber in the Belfry

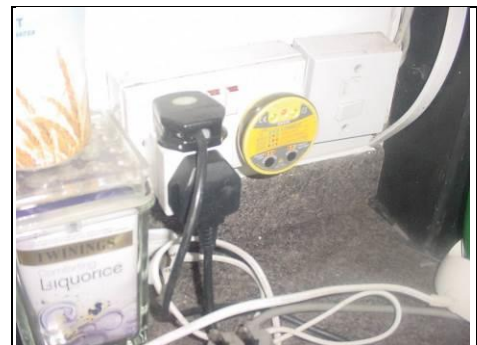
ACTION REQUIRED: Please see our comments in the Executive Summary.

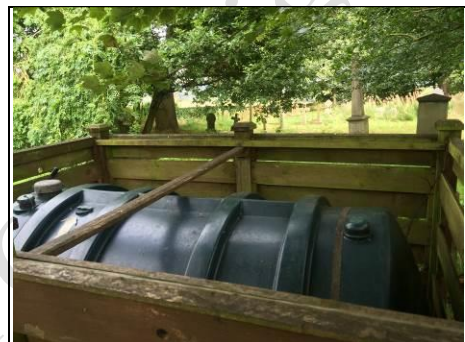
The oil tank is located to the front right. We were pleased to see it is plastic. These usually replace the older metal tanks that can rust and they typically have a double lining, meaning that if they leak they leak into the outer lining.

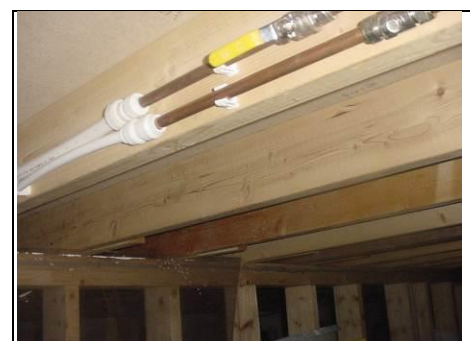
Mixture of plastic and copper piping

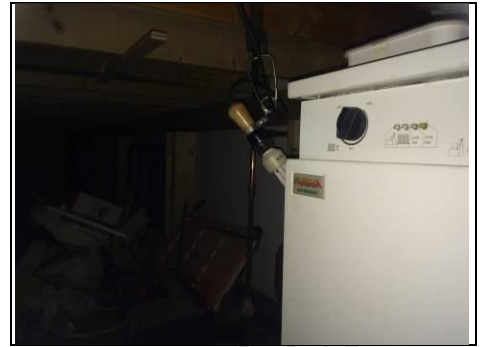
It is an Enviromax Firebird combi oil boiler. Possibly because of its original commercial background the property is on both single and three phase which is more typical of a commercial business, such a hotel or large pub, which is similar what this building once was as we understand it was used as a youth hostel. The present owner advised that the Brownies and Guides, etc used to come and stay over at the property.

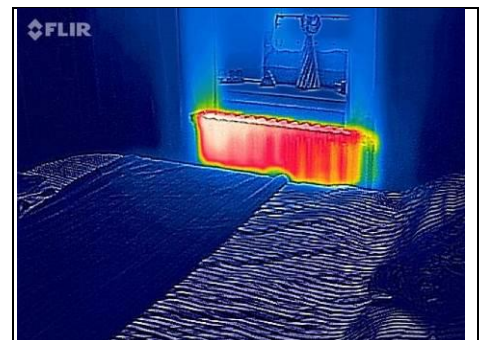
Thermal image of radiator

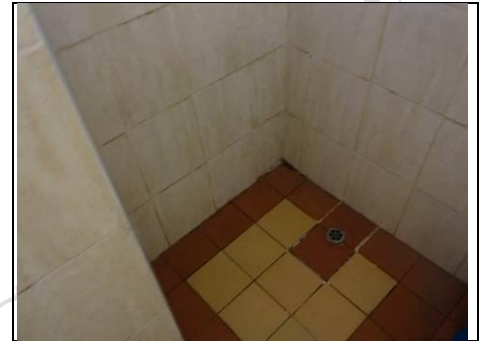
Black mould to tiles in shower room

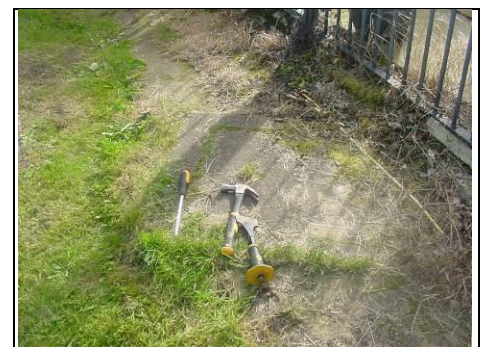
Manhole one, located to east/south side

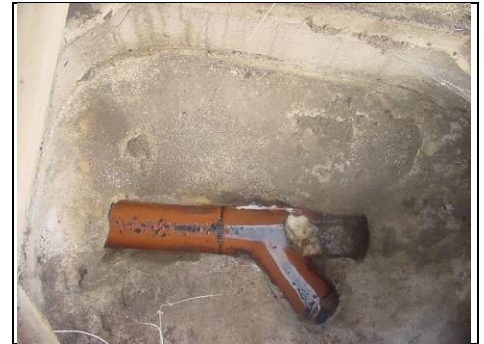
Manhole two located to north side/
east end

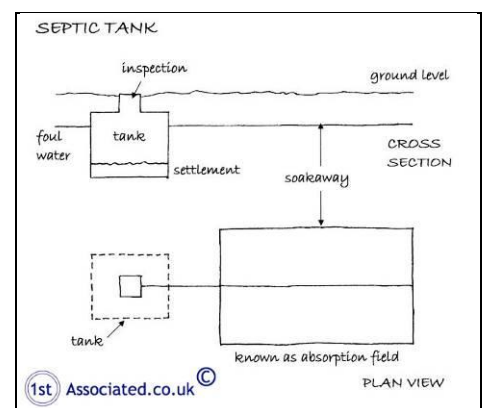
The property is served by a traditional septic tank installation, a private drainage arrangement that is entirely the responsibility of the building owner. Septic tanks can be of brick, concrete or modern GRP construction but should all operate on the principle of solids being broken down by bacteria, the partly treated foul water then being disposed of by discharge into adjacent ground by a system of soakaways, land drains or perforated pipes: we have been unable to determine the adequacy of treatment or the effectiveness of the disposal arrangements.
