# Georgian/Regency Example Residential Building Survey

Call us for a Quote on Freephone 0800 298 5424

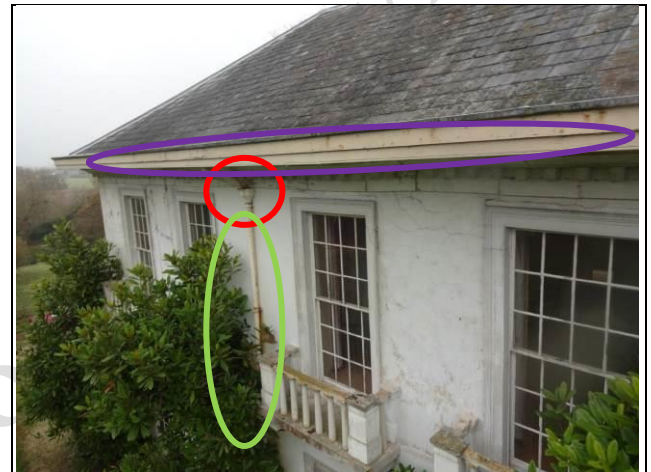
Hopper heads (red), downpipes (green) and wide eave fascias and soffits (purple)

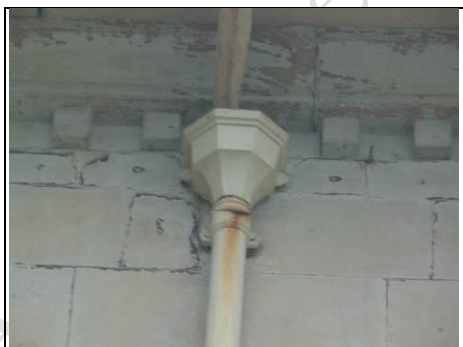
Cracked collar to hopper head and rusting downpipes

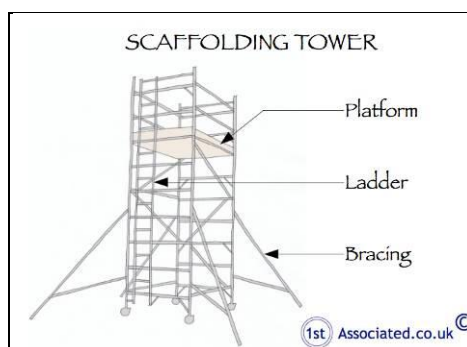
Much of the hopper heads, downpipes and gutters and repair work to the walls is high level meaning it may need full scaffolding, tower scaffolding or cherry pickers.

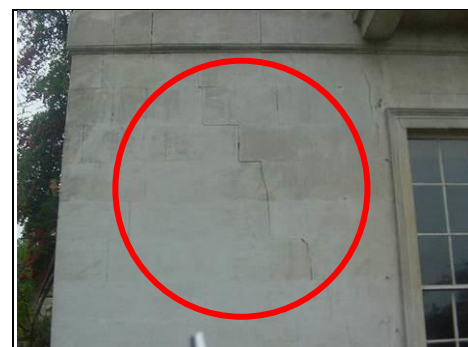
Cracking in stonework

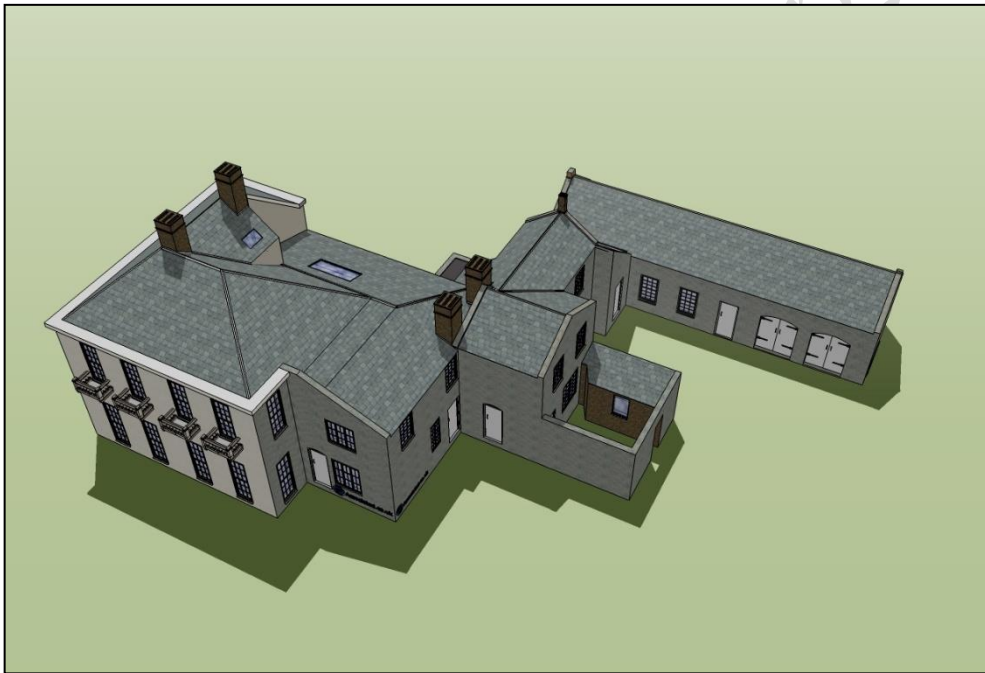
3D ISO view of chimneys and roofs

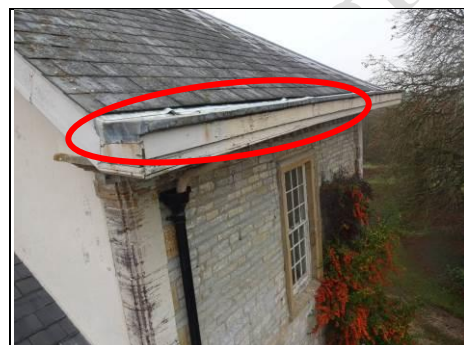
Lead detailing / box gutter on the wide eave fascias and soffits to rear left side  
Aerial view – 360 photo

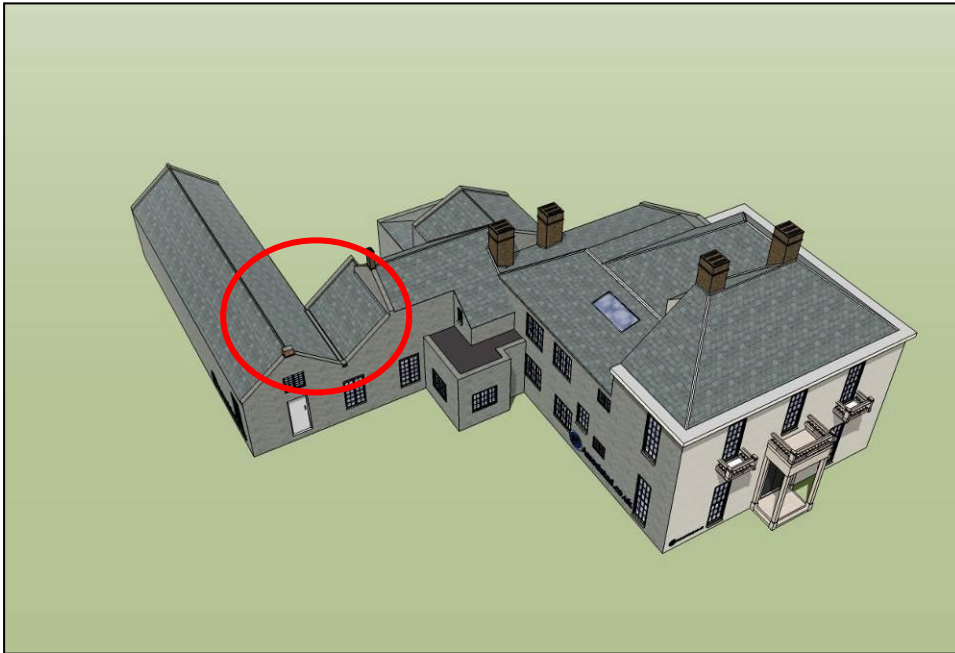
3D ISO of Butterfly roof

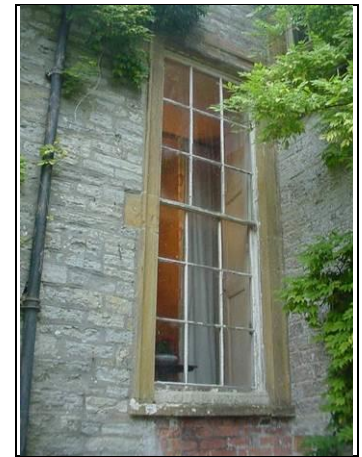
Prop on casement window where there is movement above

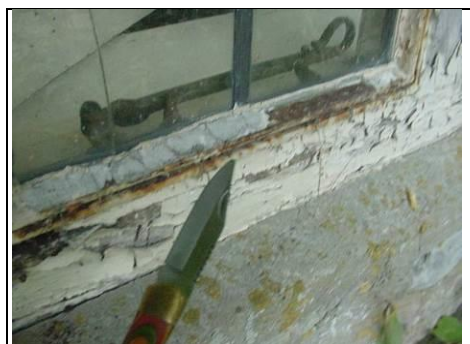
Rusting metal casement window

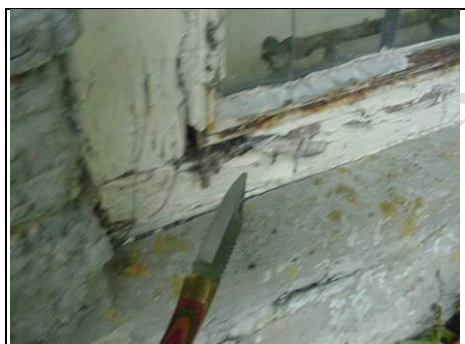
Deterioration to timber

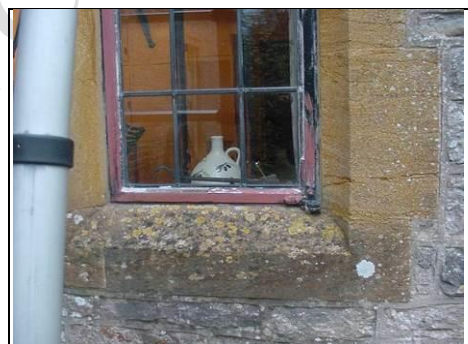
Mullion window with metal  
casement frame

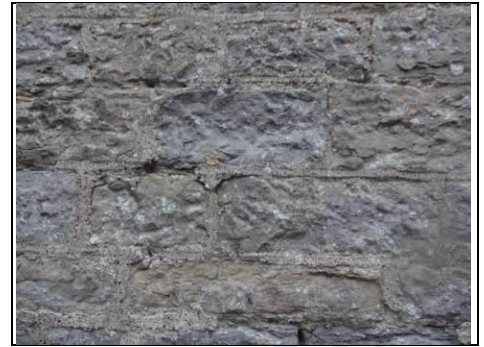
There is coursed stonework visible to the right and rear of the property. Listed building references Hamstone, from Ham Hill, Somerset and was a limestone which one source says was abandoned in 1930's. However we have also seen other sources saying that there are quarries still open; please see the companies and the comments we have made in the Appendices of this report.

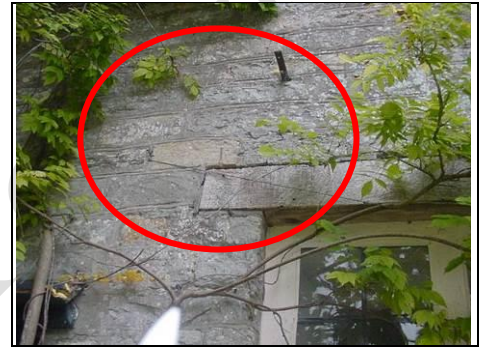
Stonework looks to have been wrongly repointed in cement mortar

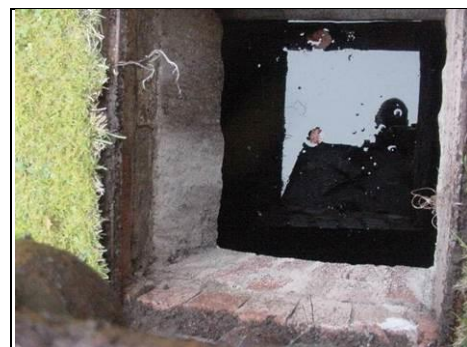
Looking into the well to the rear of the property near the kitchen

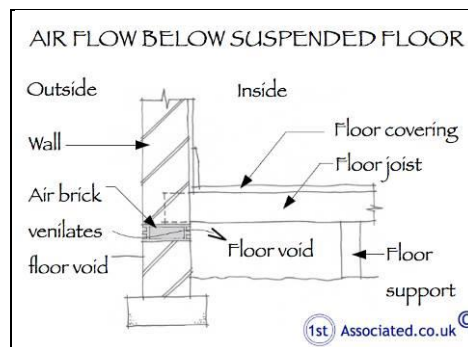
Suspended timber floor

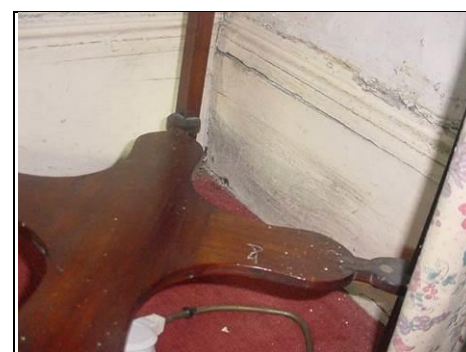
Area where the floor is softer and had a duller thud

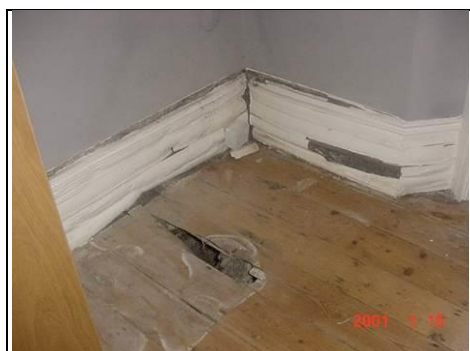
Dry rot example (not this property)

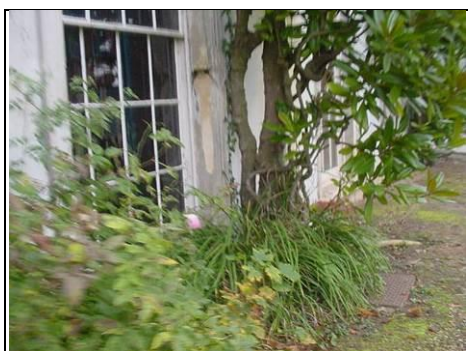
Trees and vegetation close to front of property

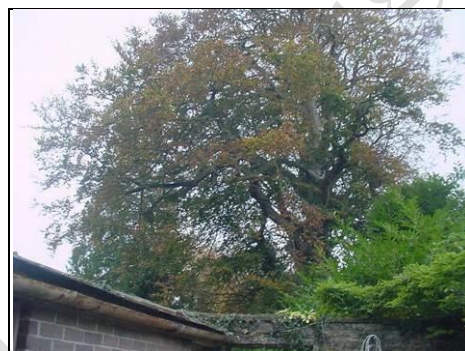
Large tree to rear right

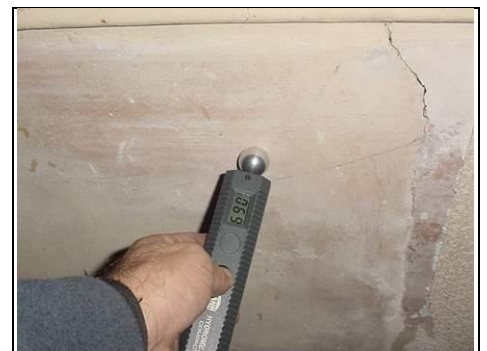
Checking for lateral dampness

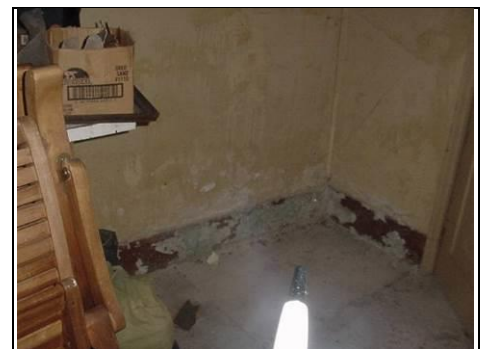
Dampness in the workshop/ old kitchen

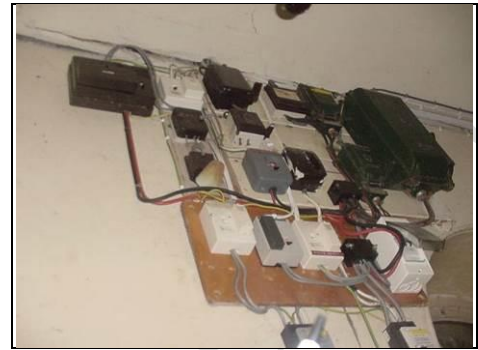
The electrics near to the Right Room

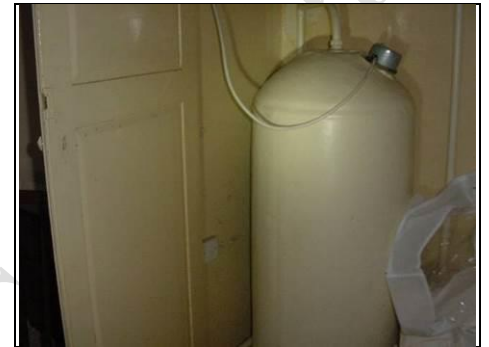
Water tank in left middle room

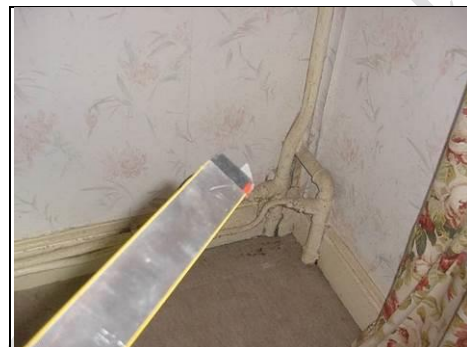
We found five manholes (we think there may be more), one of which was the well, two were dry and the one to the rear near the kitchen was clear and one we could not lift. We feel further investigation is required particularly with regard to the well and sewerage system which the owner did not know much about. Drains that work in a property like this with one person/a few people are completely different to when the property is fully occupied.

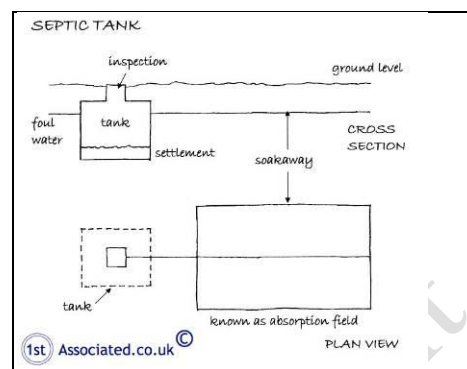
**ACTION REQUIRED:** We recommend a closed circuit TV camera report of all the drains before you commit to purchase the property. We would particularly like to investigate the well and the sewerage tanks if there are any. It could be the basic hole with rubble in it or it could be more of a septic tank, similar to the adjacent sketch, with drainage points for liquids around the property.

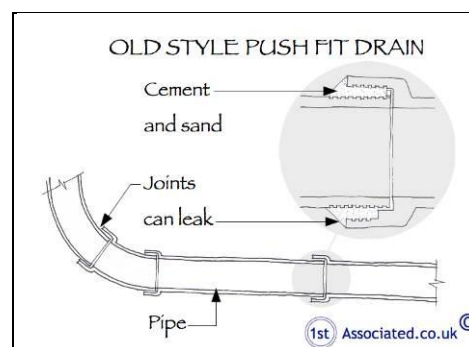
There is danger in older properties of having a lead water supply; we would recommend that you speak to the water company to ask them if they have carried out such replacement, as you will be re-piping much of the water used in the building it gives an ideal opportunity to also check for any remaining lead pipes.

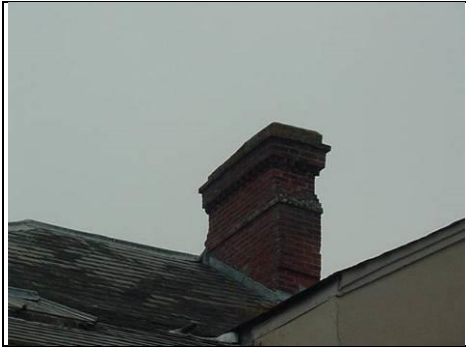
This chimney is brick finished with a lead flashings. From what we could see from ground level it looked in slightly below average condition considering its age, type and style. We noted dampness internally. The lead flashings do not look to have been cut into the joints which is our preferred method for this type of flashing.

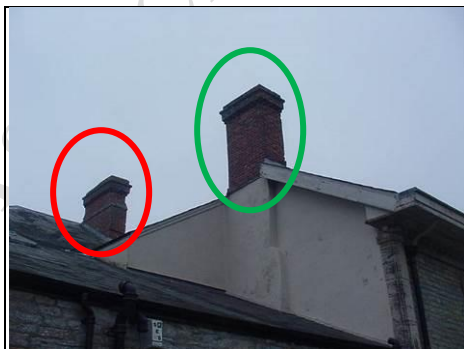
Chimneys one (red oval) and two (green oval)

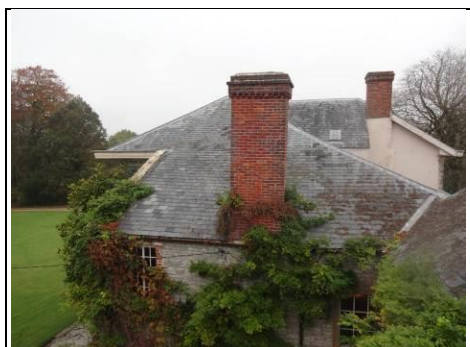
Chimney three  
Aerial view – 360 photo

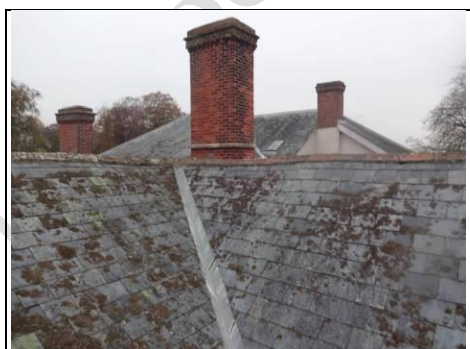
Chimney four deteriorating  
Aerial view – 360 photo

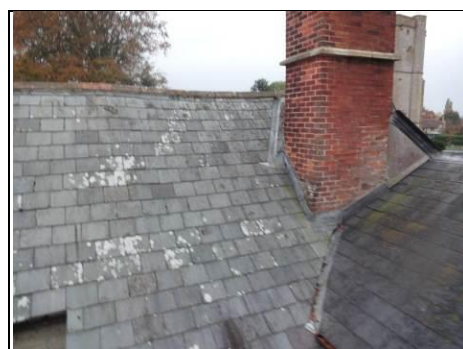
Spalling brickwork  
Aerial view – 360 photo

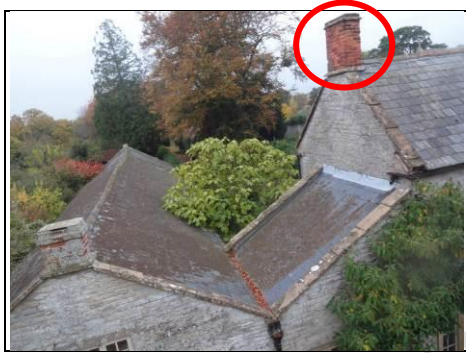
This chimney is brick built and is the smallest of the chimneys. It has a concrete cement flashing and is in below average condition for its age, type and style with spalling brickwork.

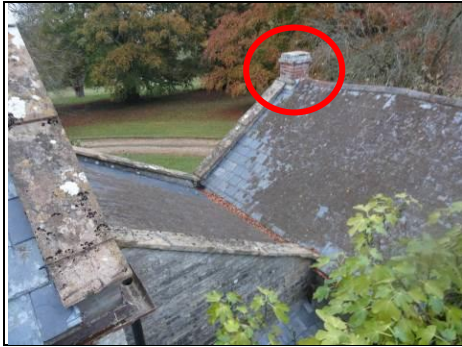
This is a small brick built chimney with cement flashing and look in below average condition considering its age, type and style.

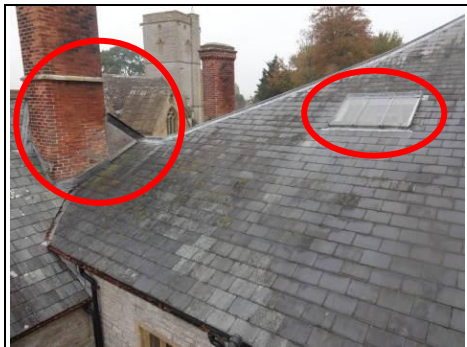
Roof window  
Aerial view – 360 photo

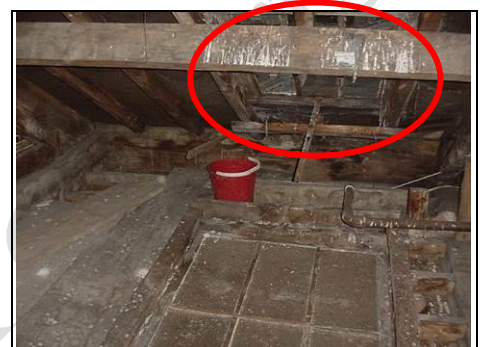
Roof window is leaking. A bucket is never a good thing!

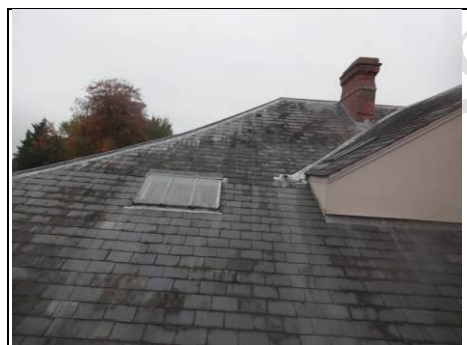
Roof window close to Linen Room  
Aerial view – 360 photo

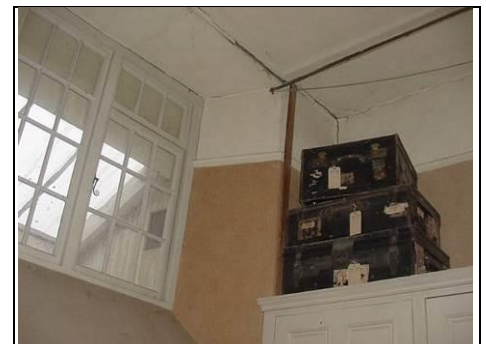
Roof window seen internally  
within Linen Room

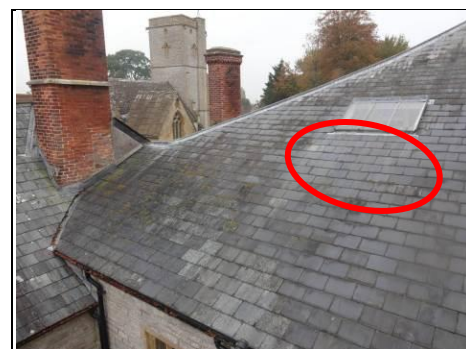
Repairs to slates below roof window  
Aerial view – 360 photo

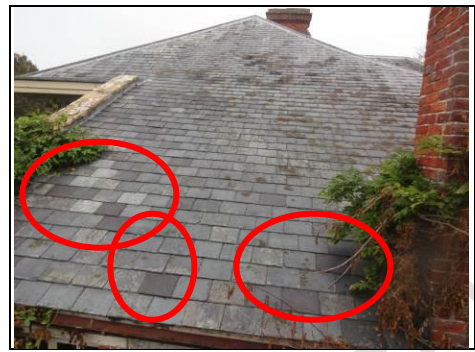
Right side roof  
Aerial view – 360 photo

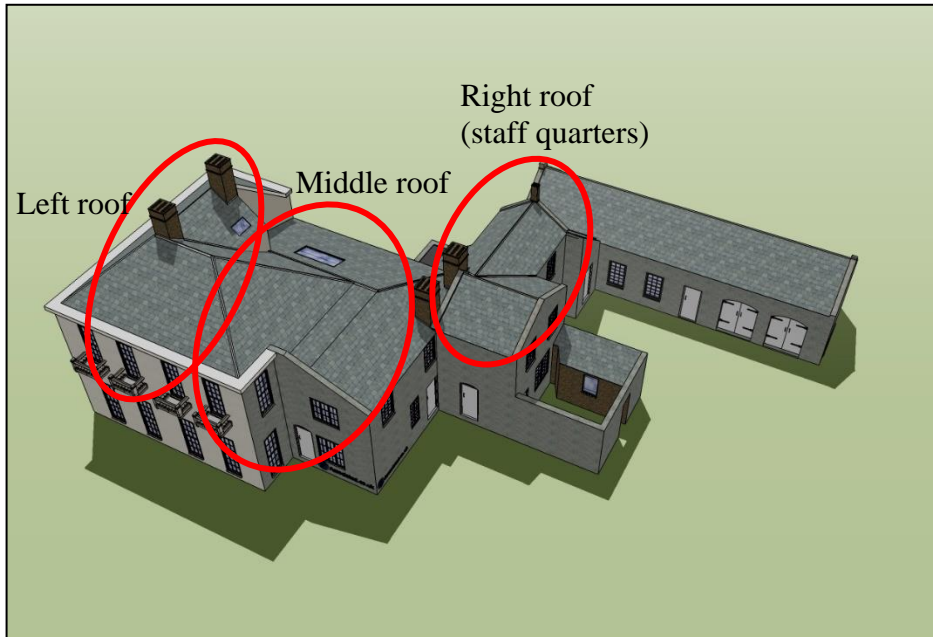
**Protective Underlayer (Often known as the sarking felt or underfelt)**

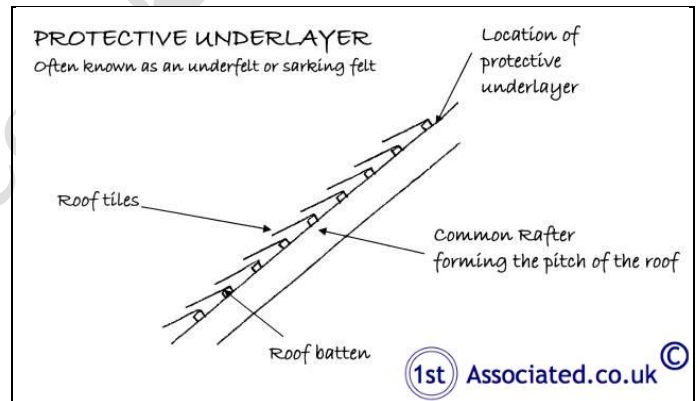
Protective underlayer

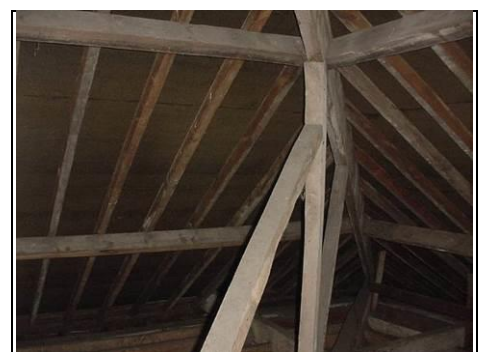
This photo shows the common rafters (the ones that form the pitch of the roof) and the dark area between is the underlayer.

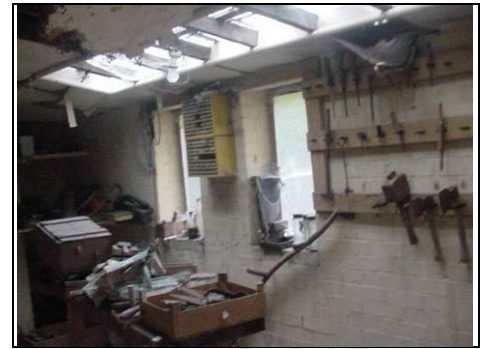
This is a mono-pitched roof over the tool store, clad with slates, some of which are glazed. We would comment we found some movement in this building and also to the adjacent rear wall which may have made the area not watertight. It was being used as a tool shed at the time of our inspection. If this space is useful to you then you need to make it watertight.

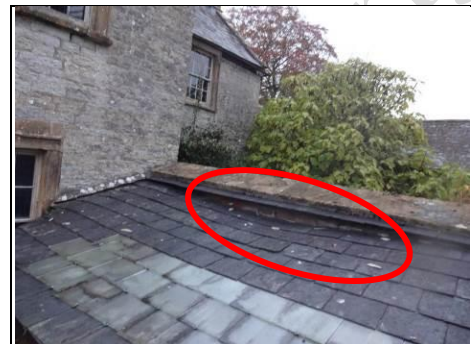
Roof dipping and flashing coming  
away  
Aerial view – 360 photo

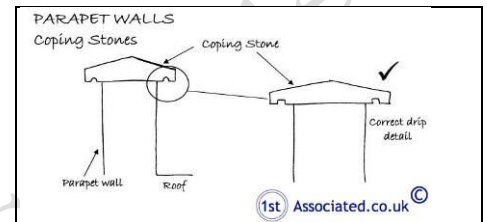
The flat roof is covered with asphalt with a stone parapet surrounding it and a lead flashing which looks in average condition for its age, type and style. We would comment that there may be some dampness getting in around the parapet walls as there looks to have been repairs to these over the years.

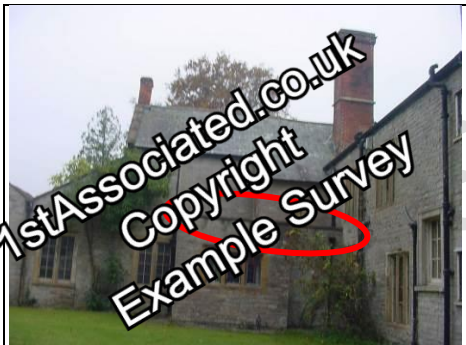
Small flat roof over rear kitchen

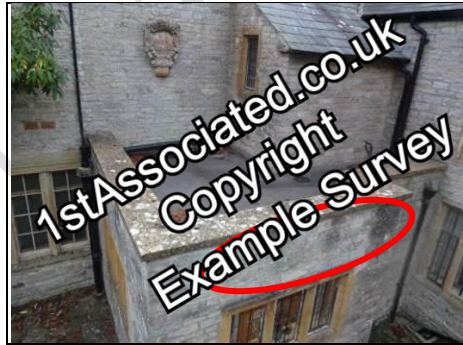
Small flat roof over rear kitchen  
with pattern staining beneath  
Aerial view – 360 photo

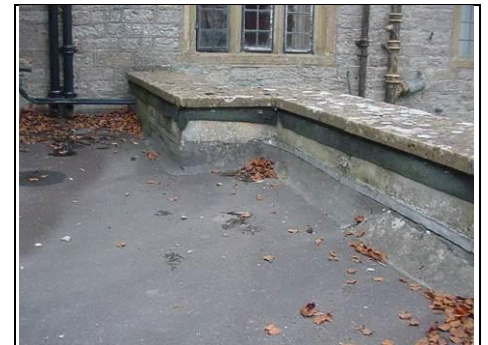
Close up of flat roof  
and stone parapets

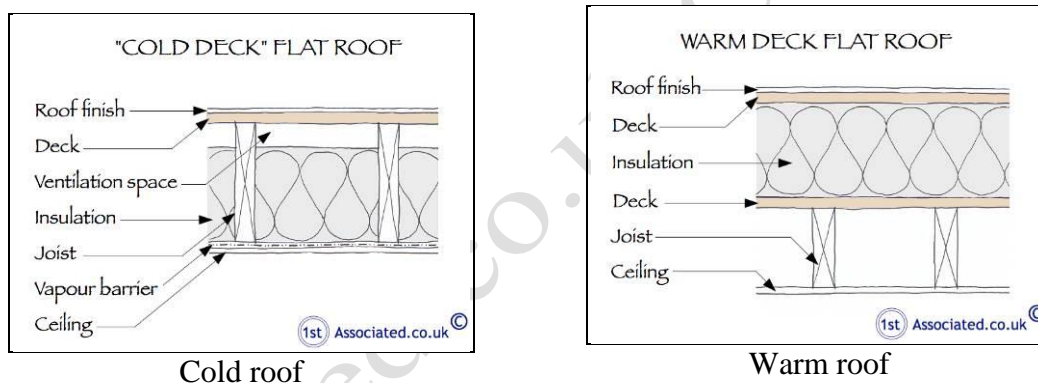
All the roofs were inspected from ground level with the aid of a x16 zoom lens on a digital camera and/or aerial photographs. Flat roofs have been inspected from a ladder adjacent to the flat roof.

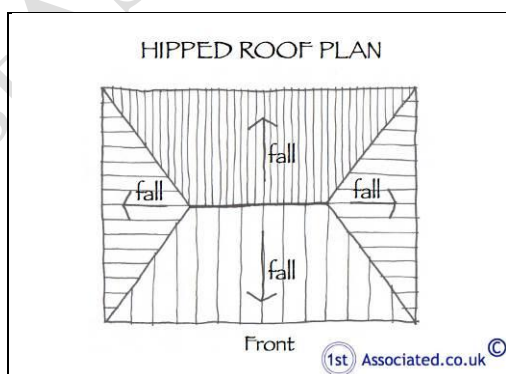
We will consider each part of the roof in turn relating to the three areas listed above. This is a hipped Kingpost cut timber roof, which are generally the roof structure is purpose made and hand built on site. Without the original design details we cannot categorically confirm that there are no defects. We cannot confirm there are no defects however it is feasible that there are problems in the roof that are hidden.

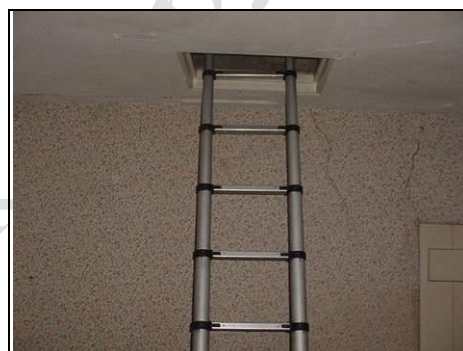
Loft access from staff quarters in the rear roof. Note the cracking to the wall behind the ladder

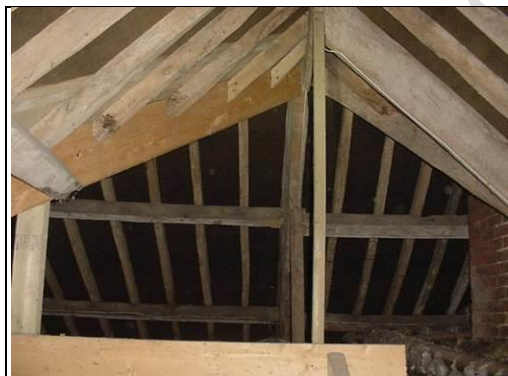
The horizontal timber at the bottom has been added as has the timber directly above (on a slight slant).

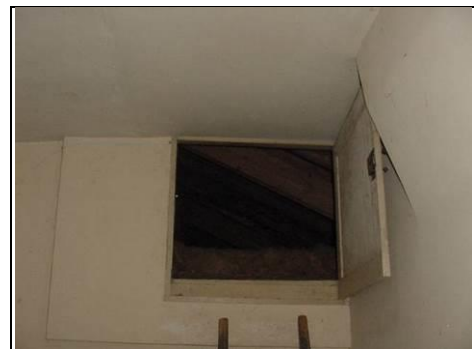
Loft access via half landing

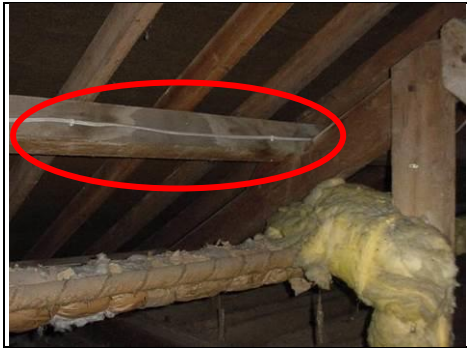
Staining on purlin and possible asbestos

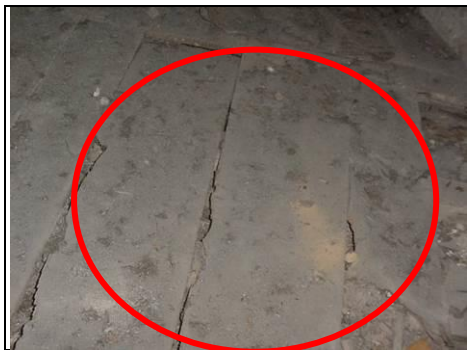
Frass in floor boarding

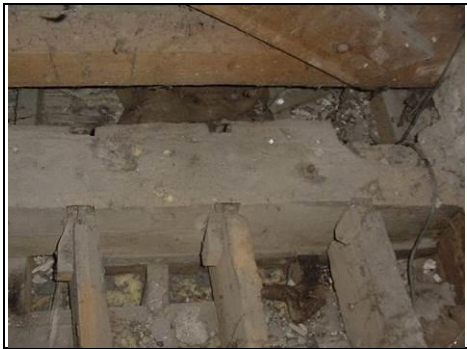
Joint looks to be opening up and repaired, unless this is a style of joint we have not seen before

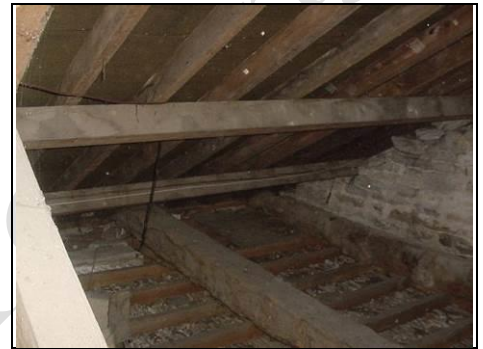
Older ceiling timbers with newer purlin and common timbers

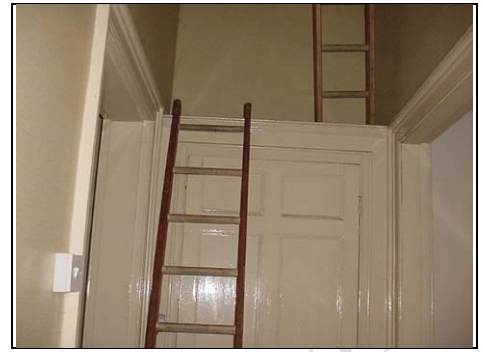
Ladder to roof space on left

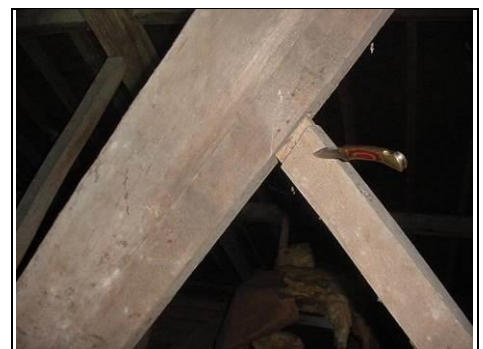
Tenant joint is coming away from the rafter

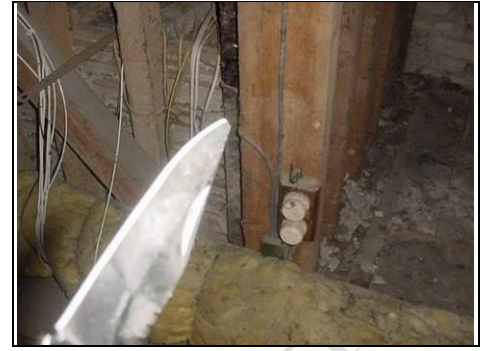
We can often identify the age of an electrical installation by the age of wiring found in the roof. In this case we did find old electric cables which is another reason we recommend you re-wire the property.

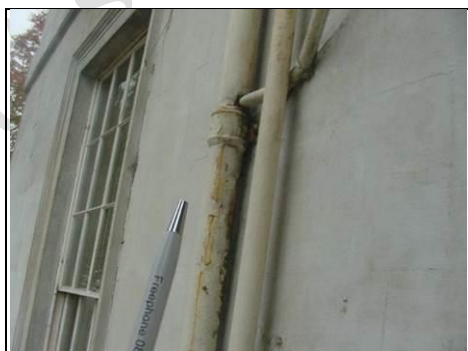
Rusting downpipe on left hand side

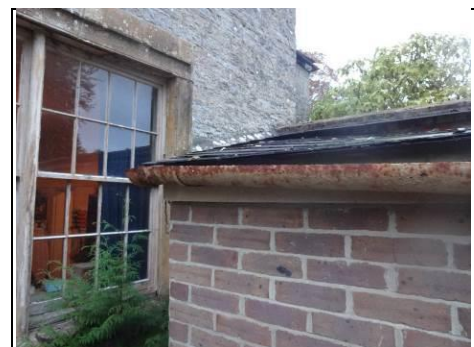
Rusting guttering  
Aerial view – 360 photo

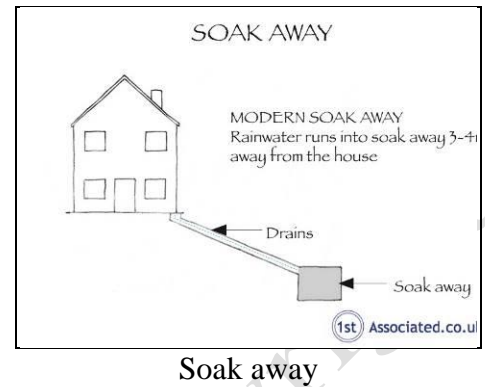
**ACTION REQUIRED:** Please see our comments in the Executive Summary.

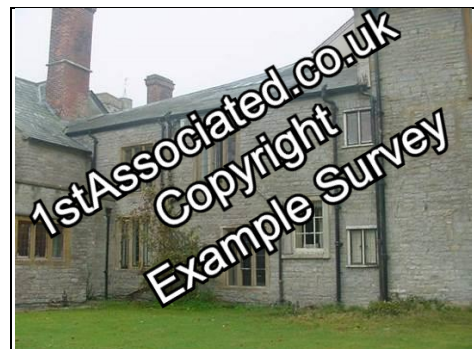
Soil and vent pipe to rear

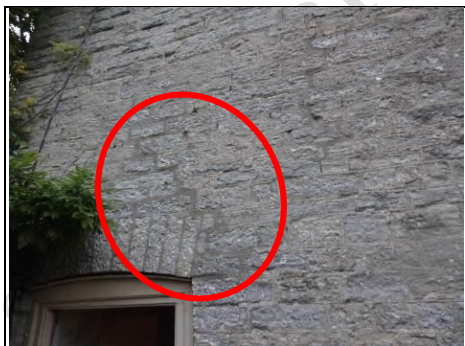
Stepped crack above door  
Aerial view – 360 photo

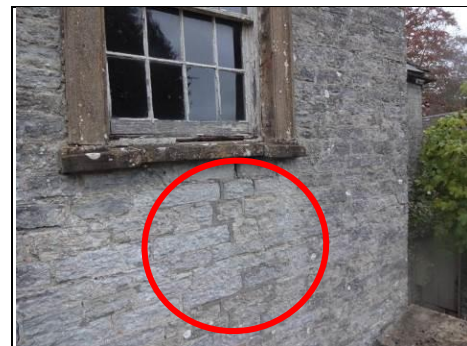
Crack under window on right side  
Aerial view – 360 photo

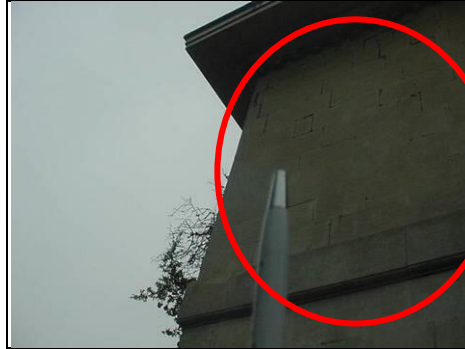
Crack to rear left side at high level

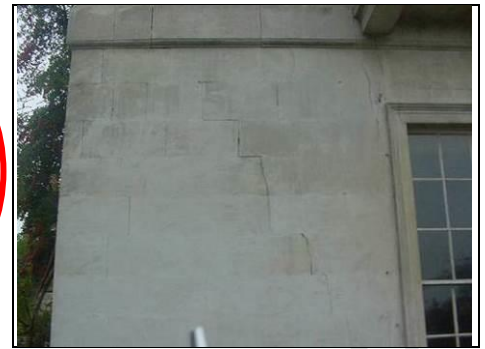
Stepped crack to rear left side at low level

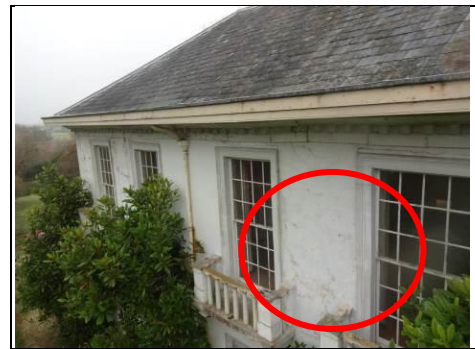
This is good quality Ashlar finely cut/dressed stone. It has a thin joint, as in this case, and a very high quality finish. It then had, either originally or at a later day, had what looks to be a lime wash applied to it. Many coats of this can almost look render like and restoration of this is a key factor in making the building watertight, as well as bringing to life the appearance of the property. It does need to be appropriate for its age, type and style and you will need to consult the Conservation Officer with regard to this.

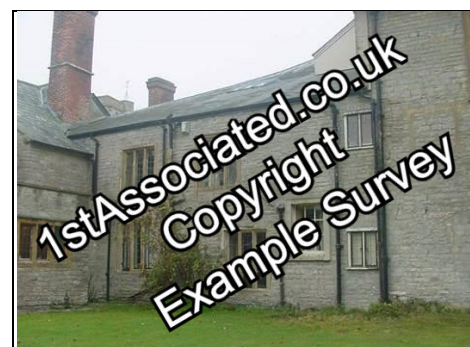
Older part of property

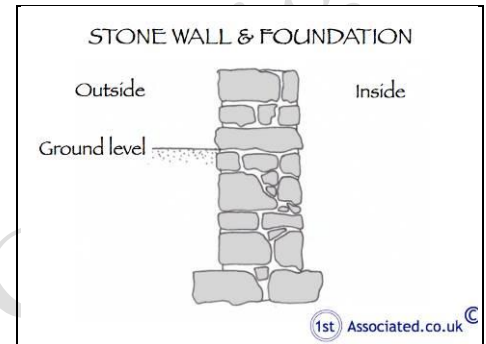
Finally, we have not excavated the foundations but we have drawn conclusions from our inspection and our general knowledge of this type, age and style of property. We would always recommend that you remain with the existing insurance company of the property. As no excavation has been carried out we cannot be 100 percent certain as to how the foundation has been constructed and we can only offer our best assumptions and an educated guess, which we have duly done.

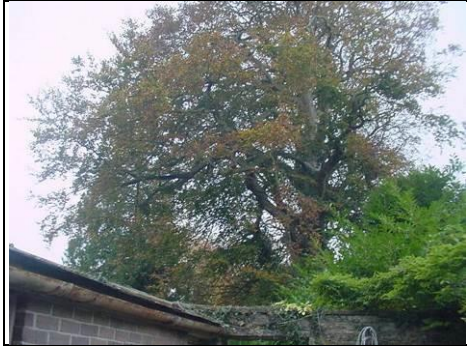
There are trees within what we would term as influencing distance but you do need to speak to your insurance company as they may have a different interpretation for insurance reasons.

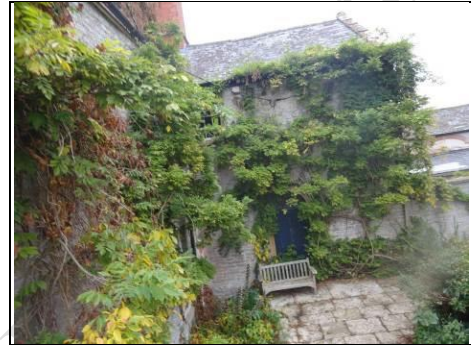
Close up of right side where the wisteria needs cutting back

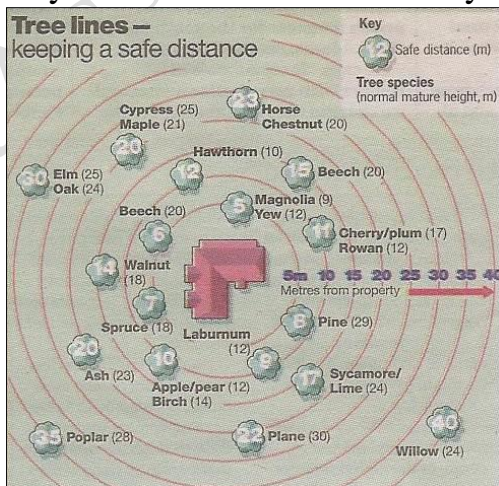
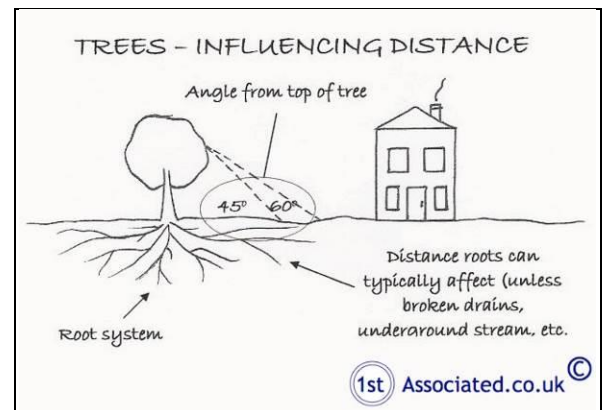
Influencing distance of trees to a property

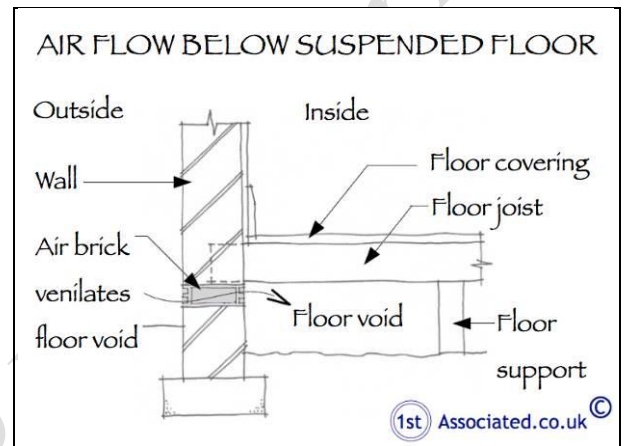
Suspended timber floor

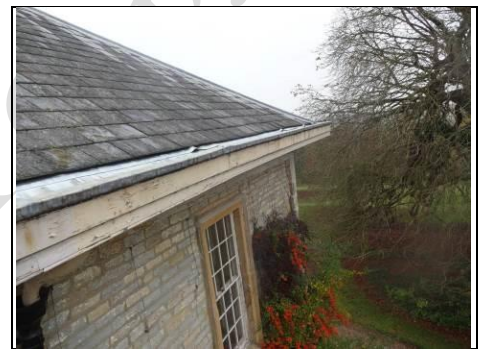
Fascias and soffits and lead detail

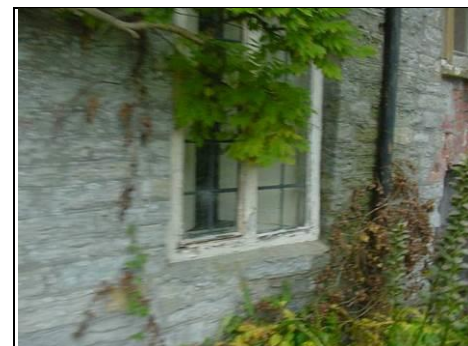
This window on right side of property is in terrible condition

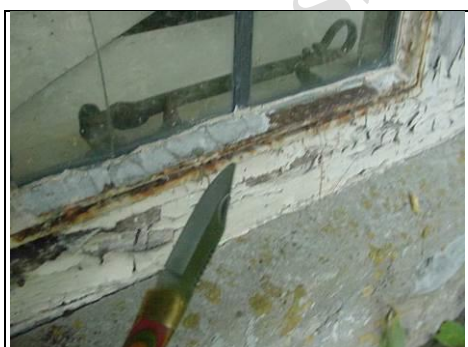
Deteriorating timber window with metal frame

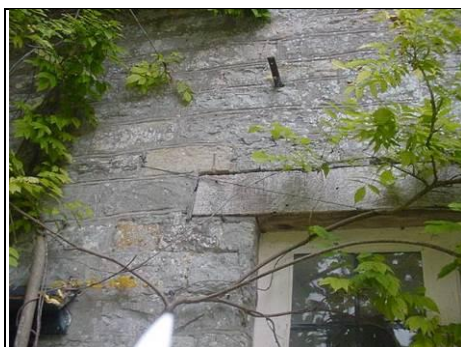
Timber lintel over window, Visible on right side. There will be hidden timber lintels within the building.

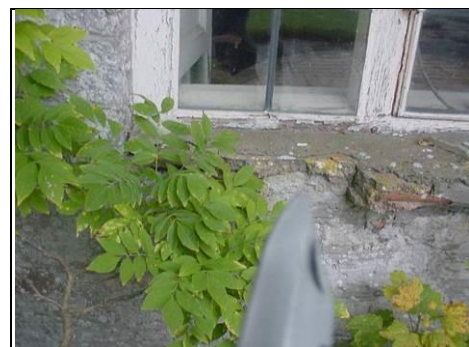
Window sill repaired in cement on right side of property

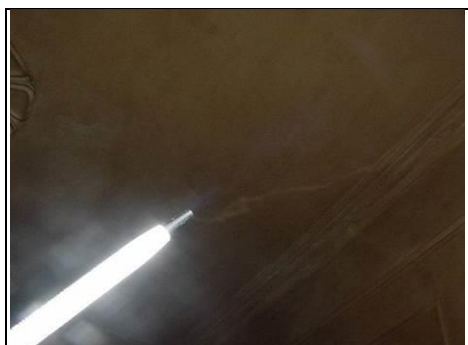
Crack to ceiling in rear left dining room

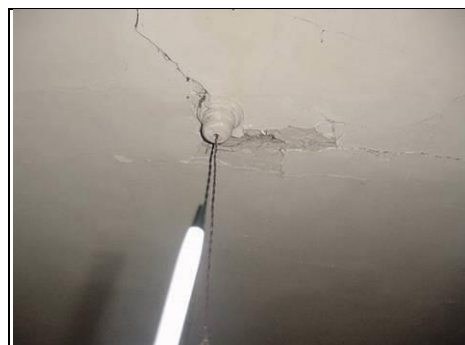
Cracking in ceiling of bathroom

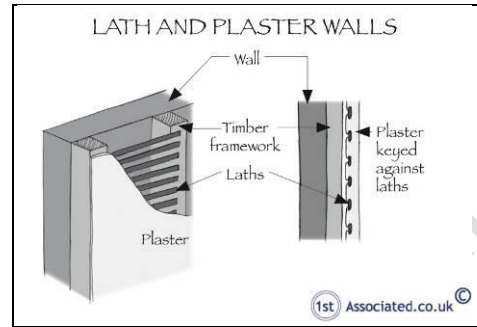
Lath and plaster walls

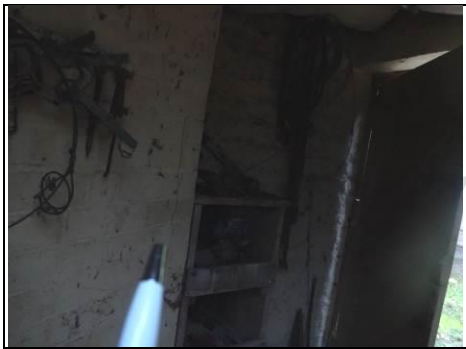
Cracking in tool shed

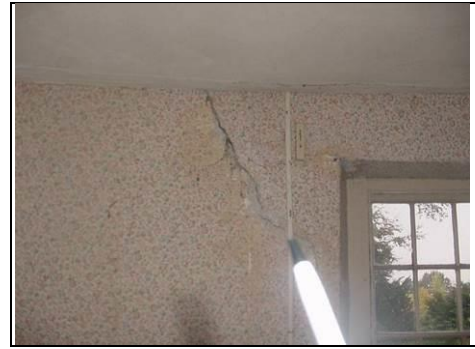
Cracking in staff quarters bedroom

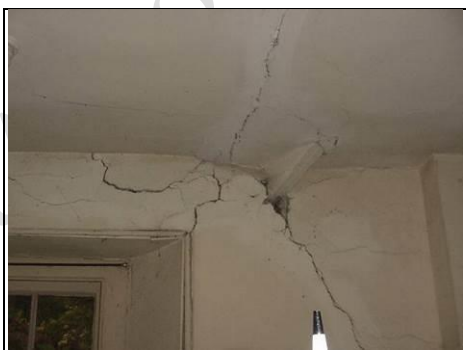
High level cracking to walls and ceiling around window on staircase to staff accommodation

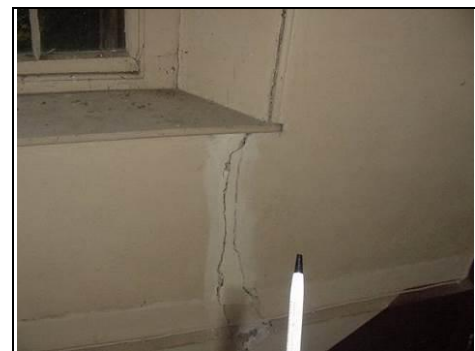
Low level cracking in rear bedroom in staff accommodation

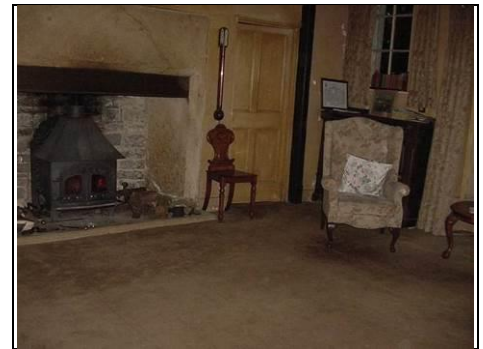
Hall/rear room,  
only fire currently in use

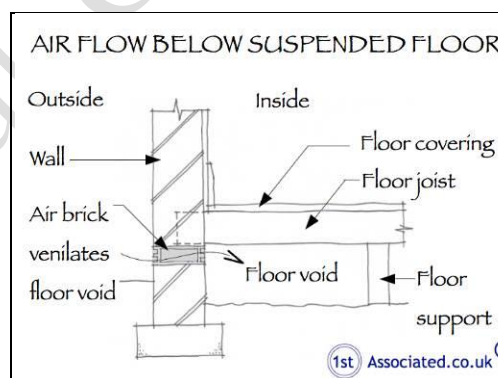
Suspended timber floor

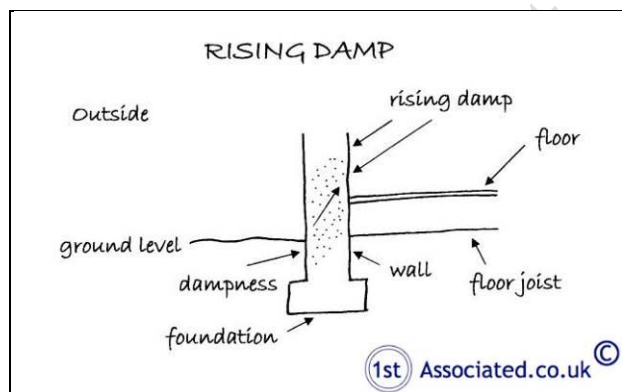
*Rising damp depends upon various components including the porosity of the structure, the supply of water and the rate of evaporation of the material, amongst other things. Rising damp can come from the ground, drawn by capillary action, to varying degrees of intensity and height into the materials above. Much evidence points towards there being true rising damp in only very rare cases.*

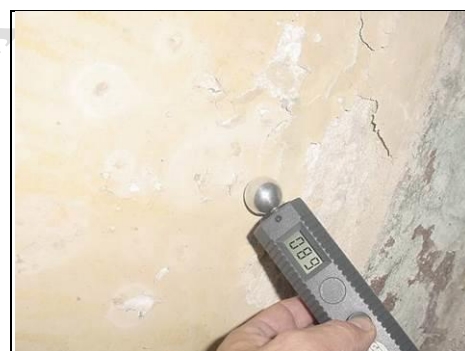
Testing for rising damp

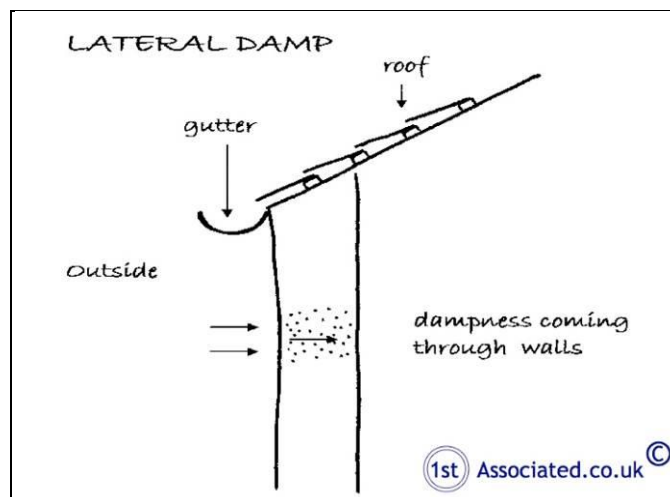
*This is where water ingress occurs through the walls. This can be for various reasons such as poor pointing or wall materials or inadequate gutters and downpipes, such as poorly jointed gutters.*

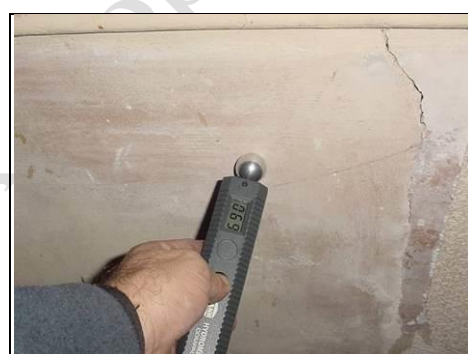
Testing for lateral dampness

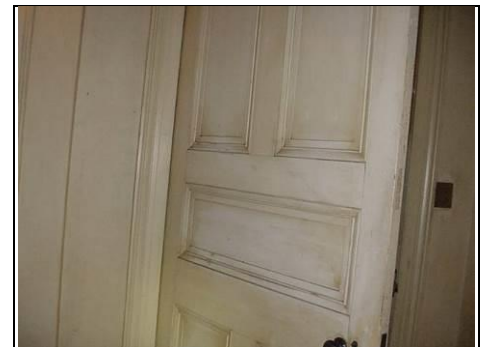
We were unable to examine the underside of the stair timbers so we cannot comment further upon the stair structure.

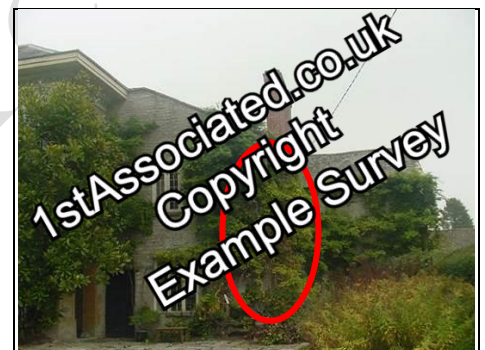
Staircase externally

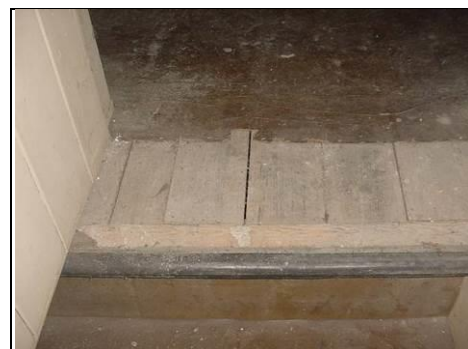
Half landing embedded timbers

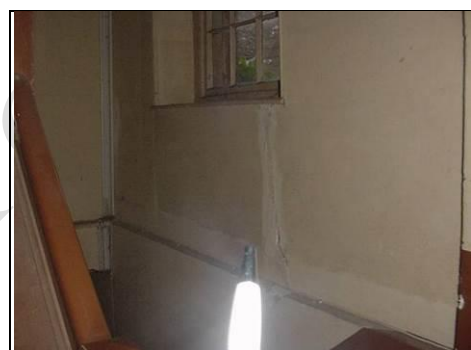
Crack in the wall next to the staff accommodation stairs

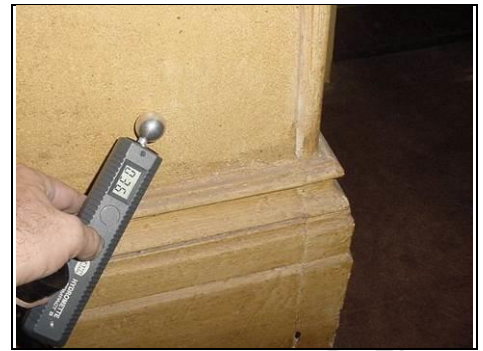
Detailing skirting on to a lath and plaster / false wall

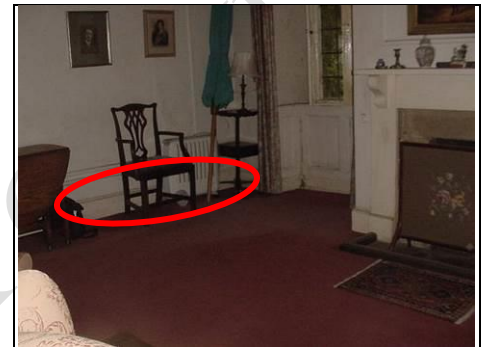
Signs of dry rot in the skirting boards

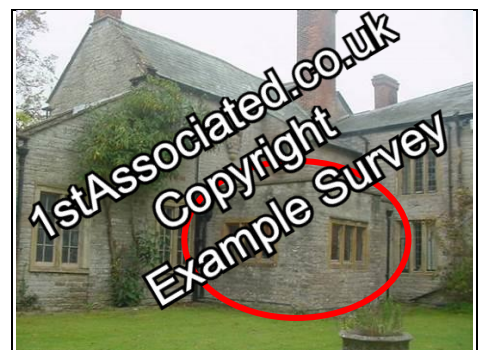
We have not tested any of the kitchen appliances.

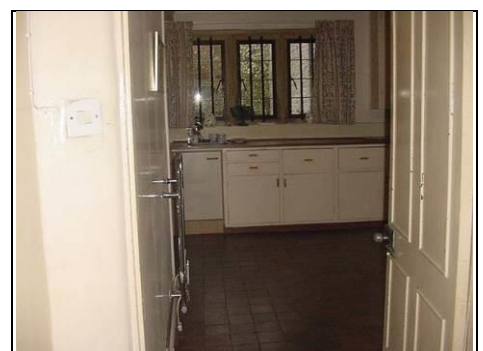
Finally, it should be noted that not all joinery has been inspected. We have viewed a random sample and visually inspected these to give a general overview of the condition. Please also see the External Joinery/Detailing section.

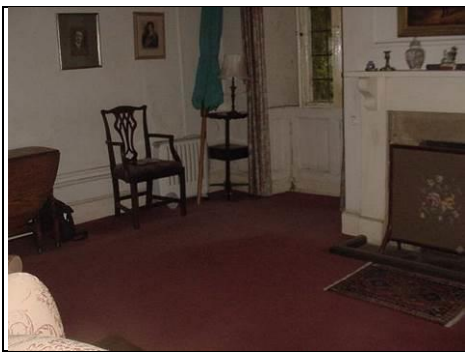
The School Room to the front right is where we believe dry rot is most likely to be

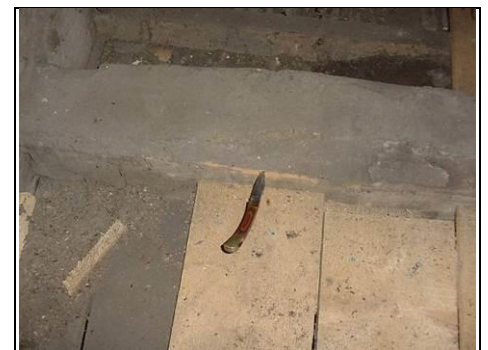
In many properties there is an element of woodworm that is no longer active. Here we believe you also still have active woodworm.

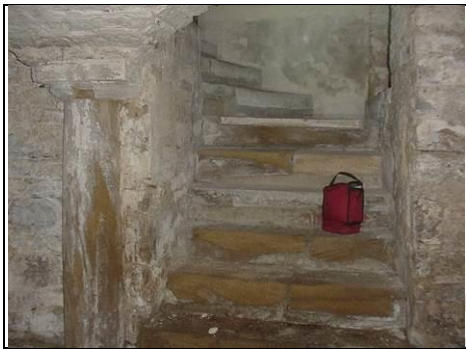
The property has an underground cellar, divided into two areas, with a vaulted ceiling and stone floors. We accessed the cellar via the internal entrance and the stone steps. There looks to also be an external entrance.

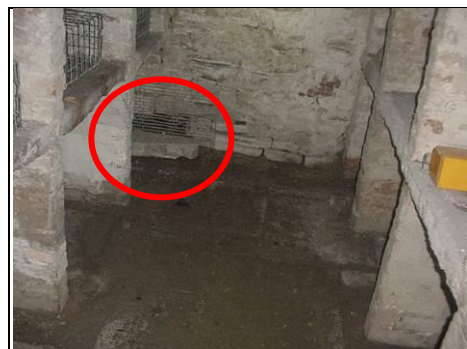
Drain in the storage area which we think may be linked to the well as it is approximately in line with it

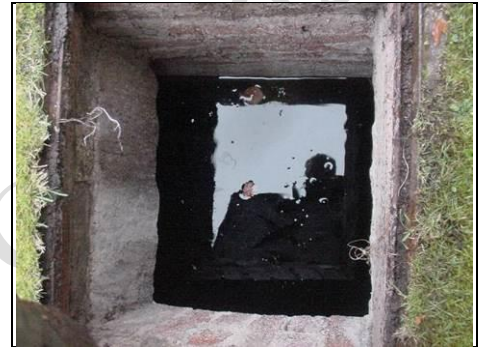
Looking down the well
