# Georgian/Regency Example Residential Building Survey

Call us for a Quote on Freephone 0800 298 5424

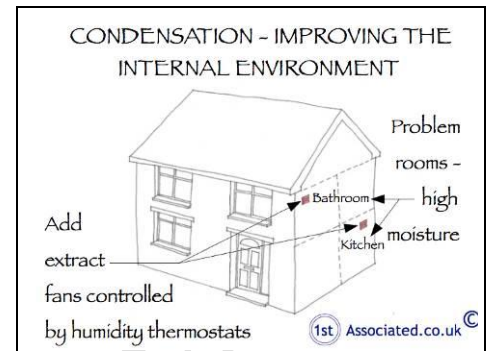
Cold bridging is caused by a colder element in the structure allowing coldness to pass through the structure much quicker when warm moist air is present in the property. Cold bridging is often caused by things like having a shower or a bath, cooking or washing, particularly if you are drying washing on the radiators. This is also caused by the general climate which results in condensation on the element.

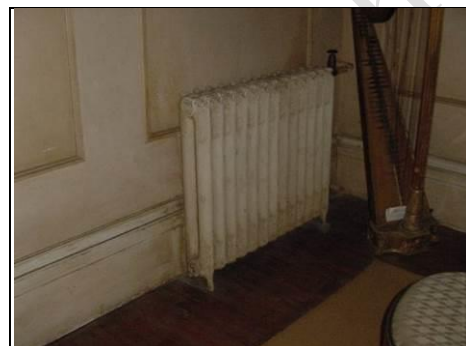
Old school style radiator

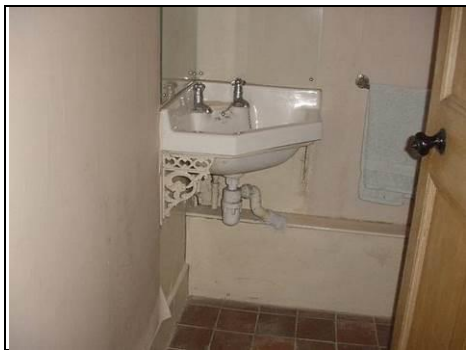
There looks to be water damage indicating that there has been a leak in this area.

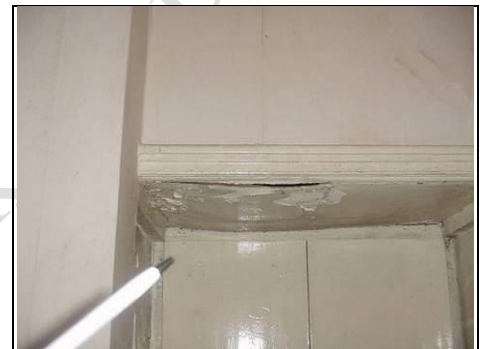
Water damage in cloakroom

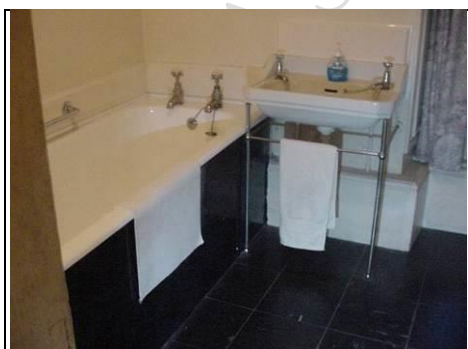
The two bathrooms consist of a three piece worn bathroom suite, consisting of a bath, wash hand basin and WC, which looks in average condition. Unusually one of the bathrooms had three taps.

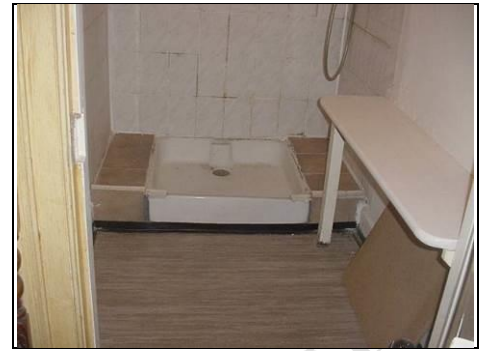
The wet room consists of a shower which is in average condition for its age, type and style. The estate agent commented that it was possibly the first wet room in the country and we would comment that it needs upgrading.

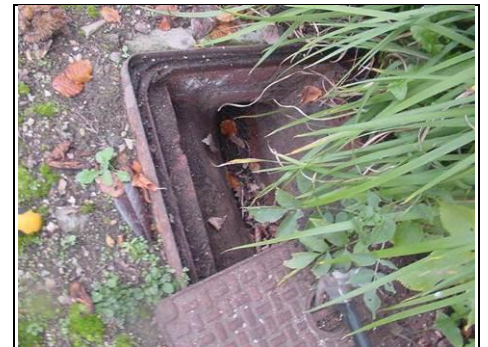
Manhole to front of property

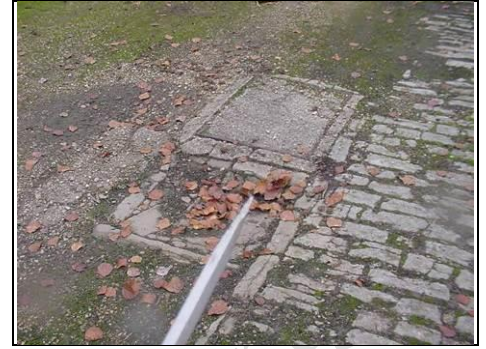
Manhole to right side, we were unable to lift the cover

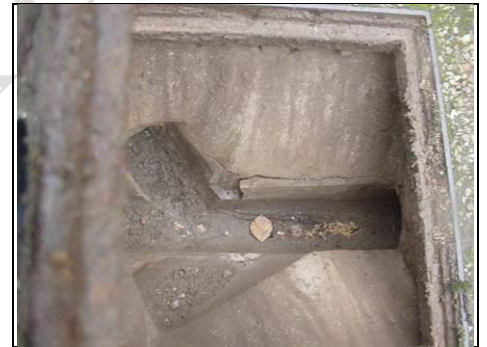
Dry manhole located to the rear near to the kitchen

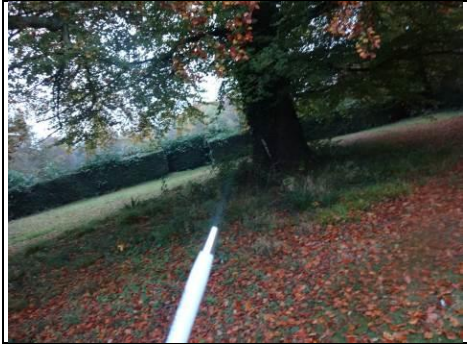
Basic septic tank by tree

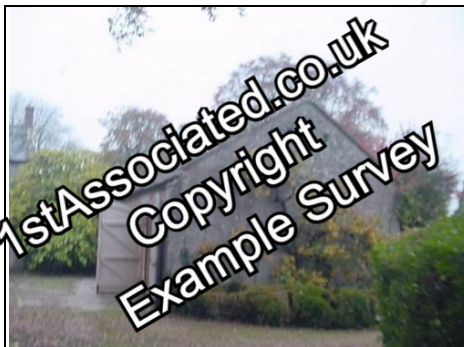
Gable end of stables/garage

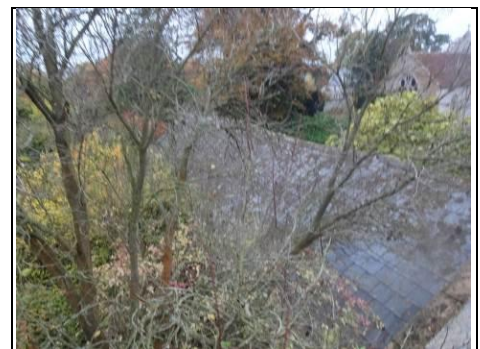
Trees hiding deteriorating rear of stables

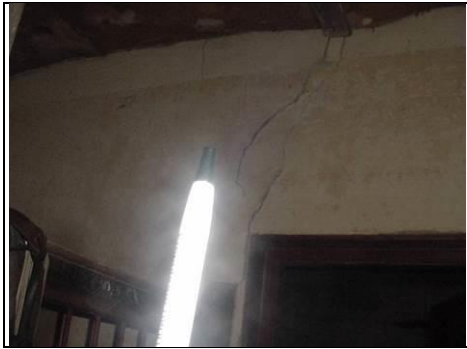
Cracking internally in stables

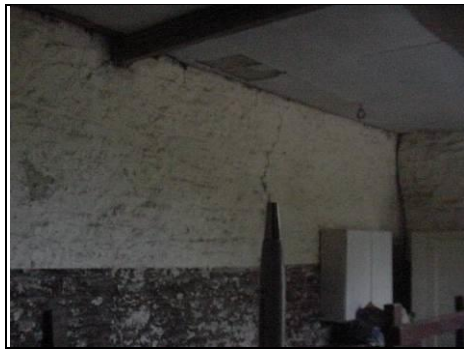
More cracks in garage area

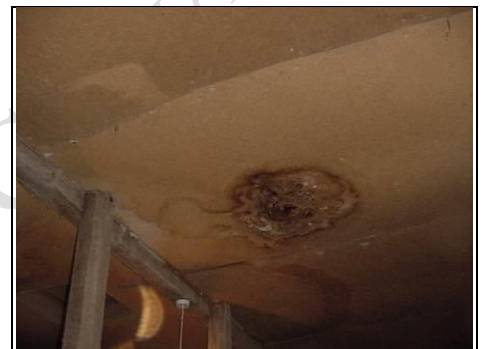
Roof of stable area leaking

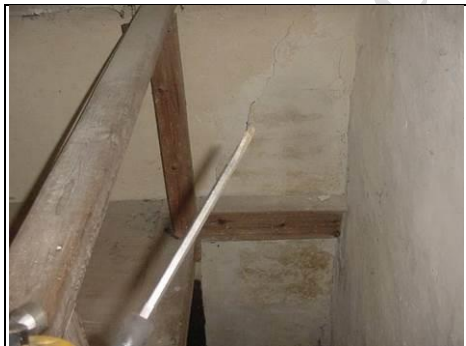
Cracking and dampness coming through walls by rickety staircase to the first floor

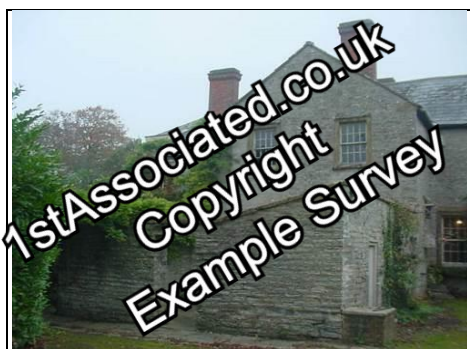
Tool shed externally

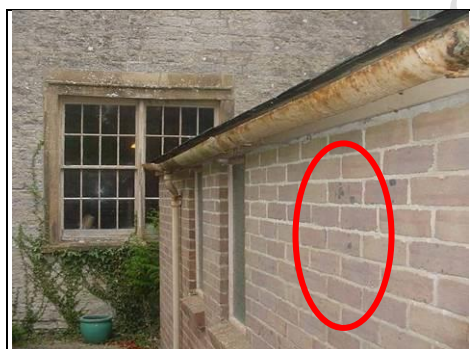
Aerial view – 360 photo

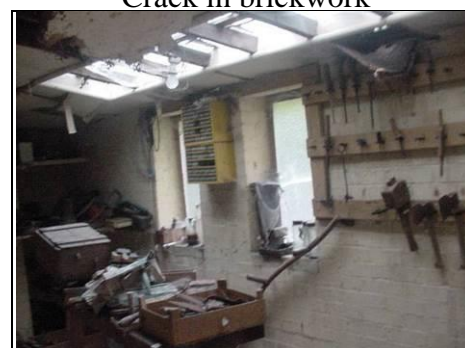
Tool shed internally

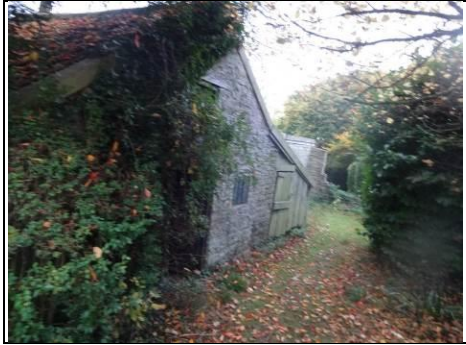
There are other outbuildings. We noted cracking to the walls due to, we believe, the large amount of pressure on the right side of the property.

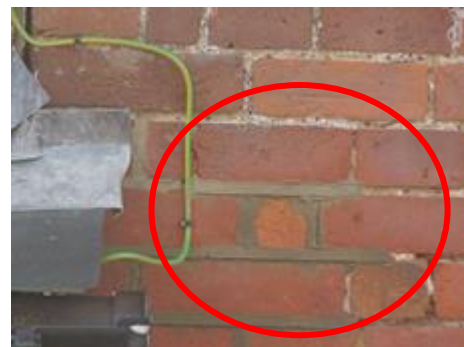
Inappropriate cement mortar will cause damage to soft red bricks
