# Stone Built Example Residential Building Survey

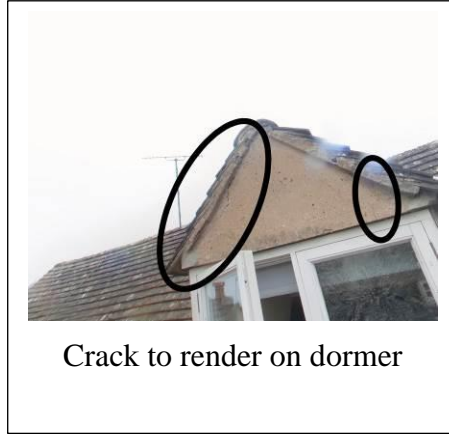
There is a dormer window to the front of the main roof. We noted a crack in the render, which has been partially repaired, therefore this is a known about problem.

Front main roof  
with dormer window

**ACTION REQUIRED:** Repair the render on the dormer and make watertight.

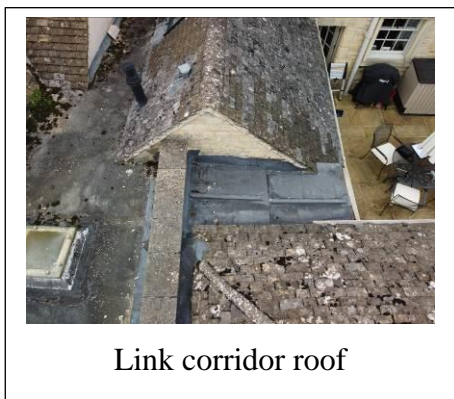
We have referred to the lead flat roof covered area as the link corridor roof, however that corridor also carries under the pitched kitchen roof which we have spoken about earlier. Some of the lead detailing, particularly the flashing, looks like it could be leaking, although there are no obvious signs internally.

Link corridor roof

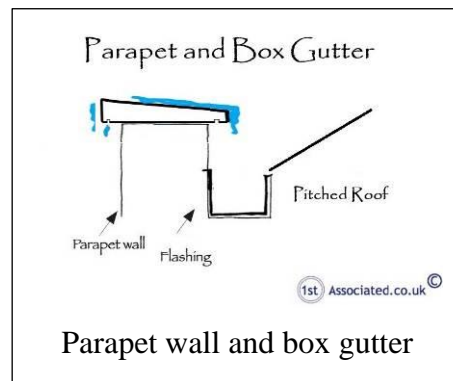
This is a pyramid roof, clad with limestone slate. We noted cracking to some of the slates. There is a parapet wall/box gutter where it meets next door. The leadwork runs all the way along a parapet wall detail, which needs checking.

Parapet wall and box gutter

**ACTION REQUIRED:** Generally overhaul roof, replacing damaged tiles/slates and repair flashing details;

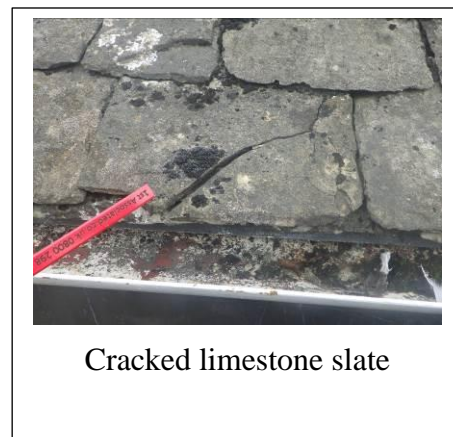
Cracked limestone slate

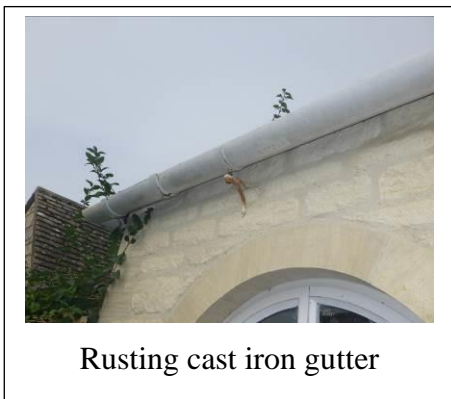
The property has cast iron gutters and downpipes. It does look like they have been painted over in the past and the rust is coming through in a number of places.

Rusting cast iron gutter

**ACTION REQUIRED:** Repair, prepare and redecorate or replace cast iron and, as previously mentioned, clear the moss from the box gutter.

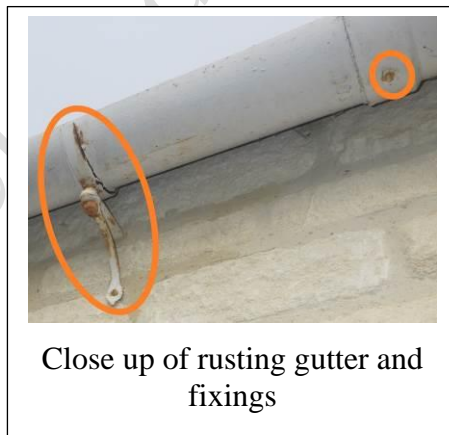
Close up of rusting gutter and fixings

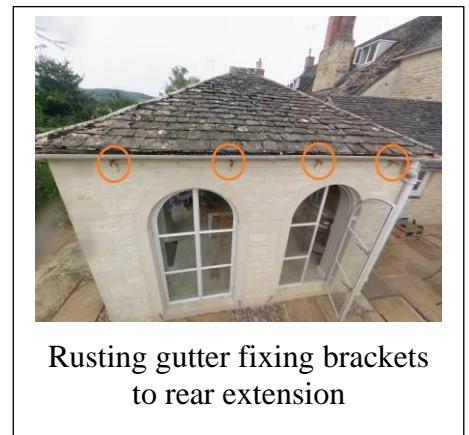
Rusting gutter fixing brackets to rear extension

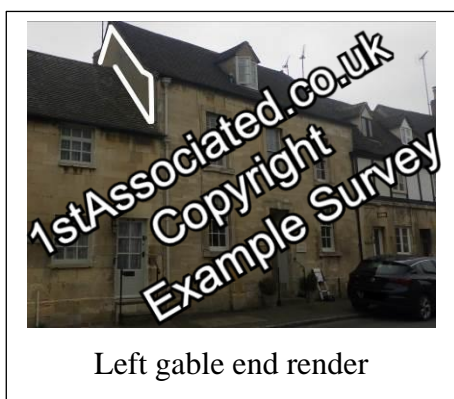
The render to the left gable (all directions given as you face the property) is deteriorating (coming away) near the chimney (see blue oval and blue arrow below). Gaps can still be seen and water damage is occurring in this area. We can also see there may be bulging/movement in this area (white oval), indicating there may be problems with the structure beneath, which could be a timber frame or deteriorating stonework.

Left gable end render

**ACTION REQUIRED:** Remove all the render and check the condition of the gable end and carry out repairs, and see if it is a timber frame, although it may also be a rubble stone wall.

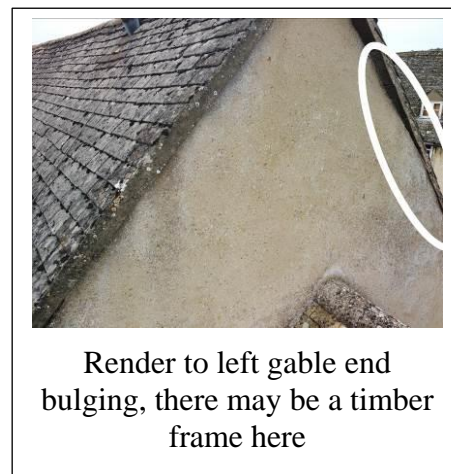
Render to left gable end bulging, there may be a timber frame here

We think the render moving is probably the effect of deterioration to the structure below; although it is difficult to be certain without opening up the structure.

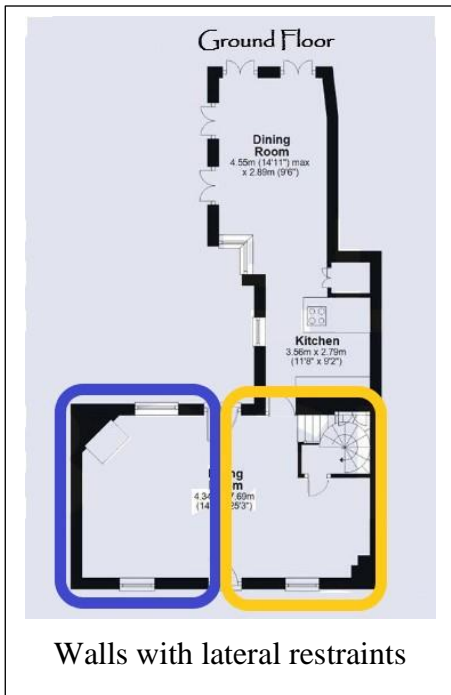
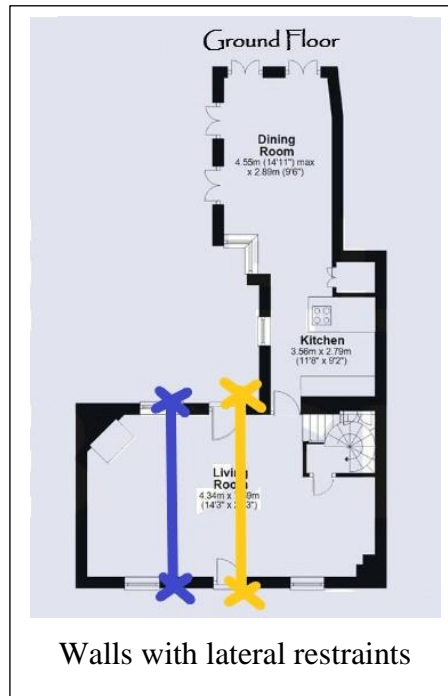
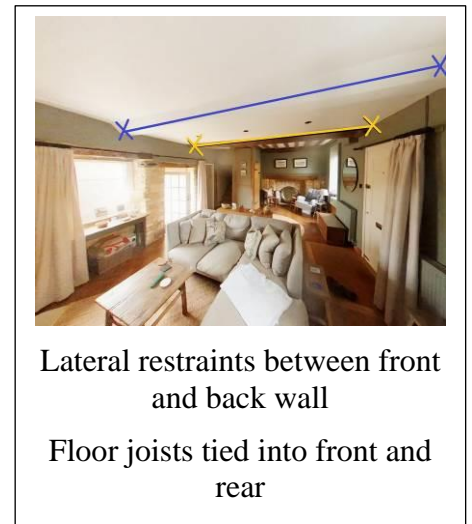
We have already mentioned earlier that the left hand gable appears to be deteriorating and that we have found a crack in the left bedroom at first floor level, indicating to us there could be movement in this area.

**ACTION REQUIRED:** Further investigation is needed. We recommend the structure is opened up to the ceilings and also to the left gable end (see Section 5.0 of this report) to understand the construction and make suitable repairs.

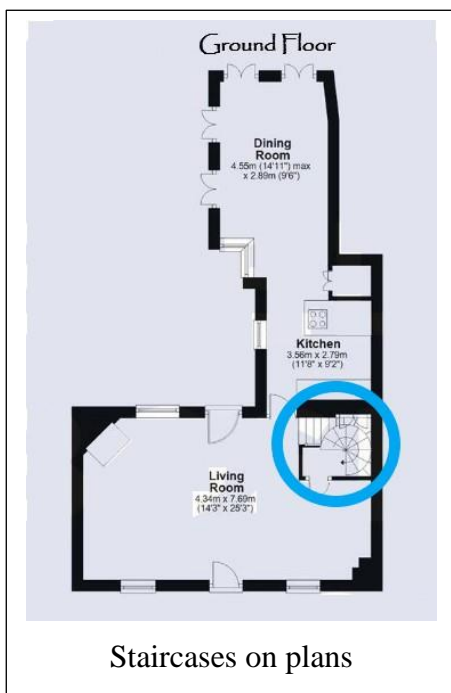
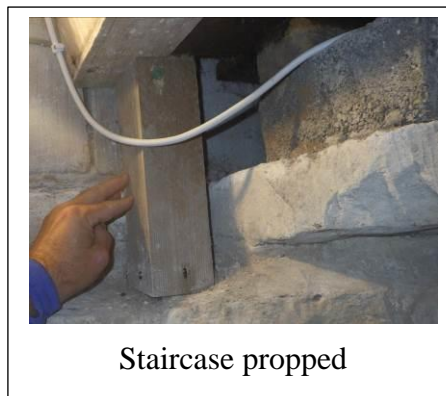
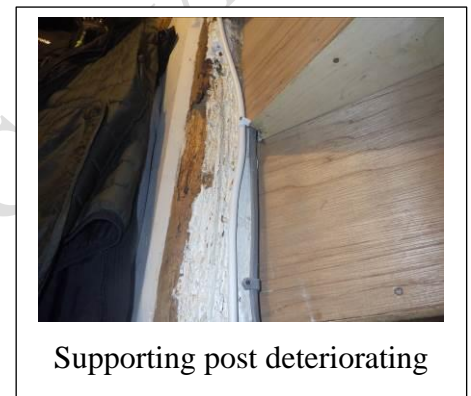
As you are no doubt aware, the cellar is very damp. We think over the years this has affected the stairs and it has been partially rebuilt. We could see to the back of the timber stairs, visible from the cellar stone steps that there was some timber propping up the stairs and also timber that was deteriorating and had signs of wet rot and wood destroying insects.

**ACTION REQUIRED:** We recommend a Carpenter opens up the staircase and checks how it is supported and replace any deteriorating timbers.

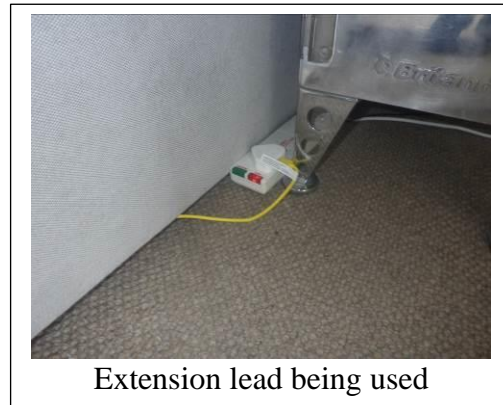
We also believe there is a lack of double socket points, as we noted the use of extension leads.

Extension lead being used

**ACTION REQUIRED:** We recommend a new fuse board with a metal casing; modern standards require half hour to one hour fire resistant casing around a fuse board.

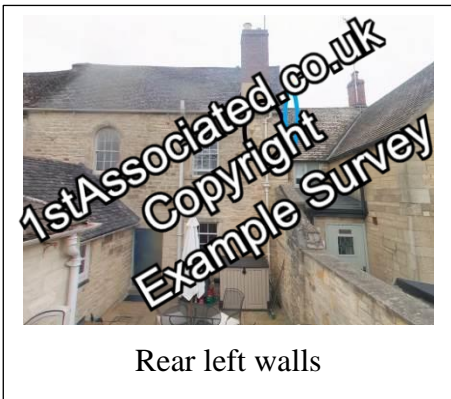
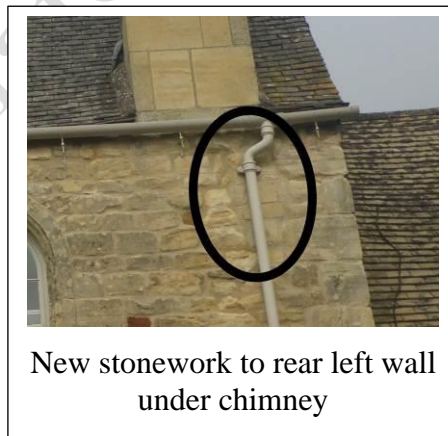
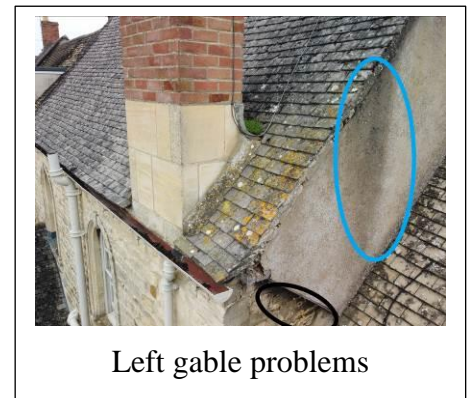
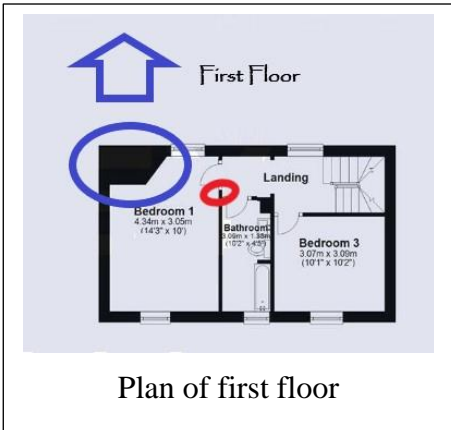
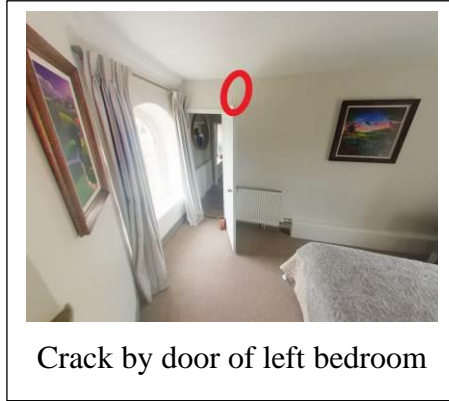
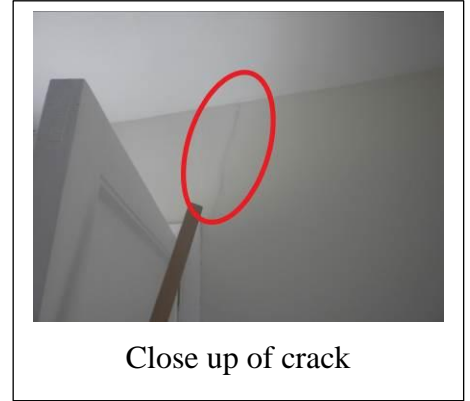
Key for above photos	Example of problems
Black	Rear left walls and rainwater goods
Blue	Left gable problems
Red	Crack
Purple	Chimney

We believe this to be an historic defect, which has come about due to the amendments, alterations and changes to the property. For some reason the left side of the building does not seem as stable as the right side. We can make some guesses in relation to this:

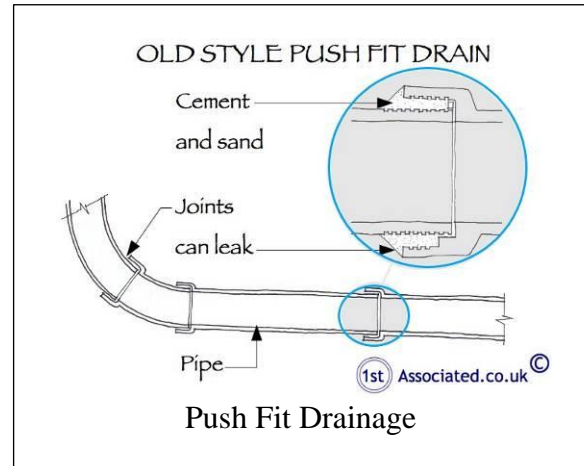
There is an unusual drainage system with three manholes to the rear. We did not manage to lift any. We suggest that dampness to the cellar could be coming from this area via leaking drains, and as such would recommend a close circuit TV camera inspection of the drains.

**ACTION REQUIRED:** Whilst we ran the tap for fifteen minutes without any build up or blockages the only way to be one hundred percent certain of the condition of the drains is to have a closed circuit TV camera report.

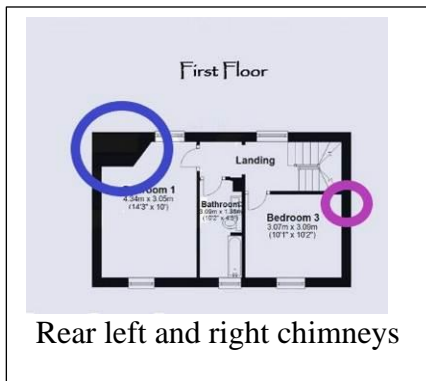
Chimney Two has been lowered and capped and it sits on the Party Wall. This type of chimney can get damp.

Rear left and right chimneys

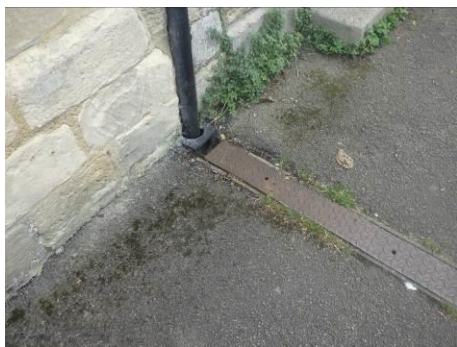
We were pleased to see the downpipe to the front of the property is channelled underneath the path. To the rear there is a sort of gully; we would recommend a better gully is put in place to minimise water getting into the base of the property.

Downpipe going into drain to front

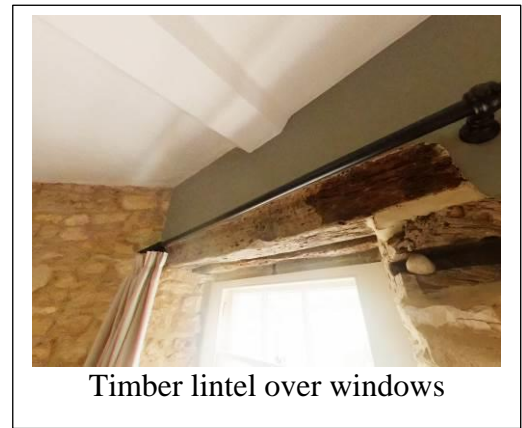
As the walls are damp (please see our comments in the Executive Summary) this can lead to deterioration in the lintels.

We noticed that the lintels over the windows go from front to back, which is not ideal.

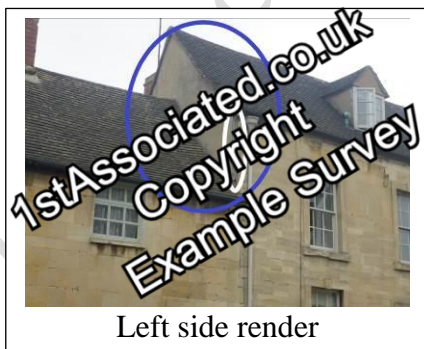
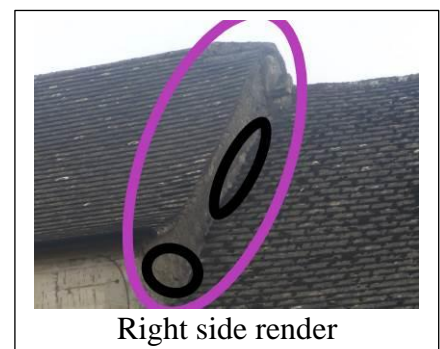
There is smoothish render to the left and right gable ends at high level. The render to the left side gable end is deteriorating, with some water getting behind it. To the right side we can see a rougher plaster, which look to have been repaired several times and it looks like there may be a hole in it as well.

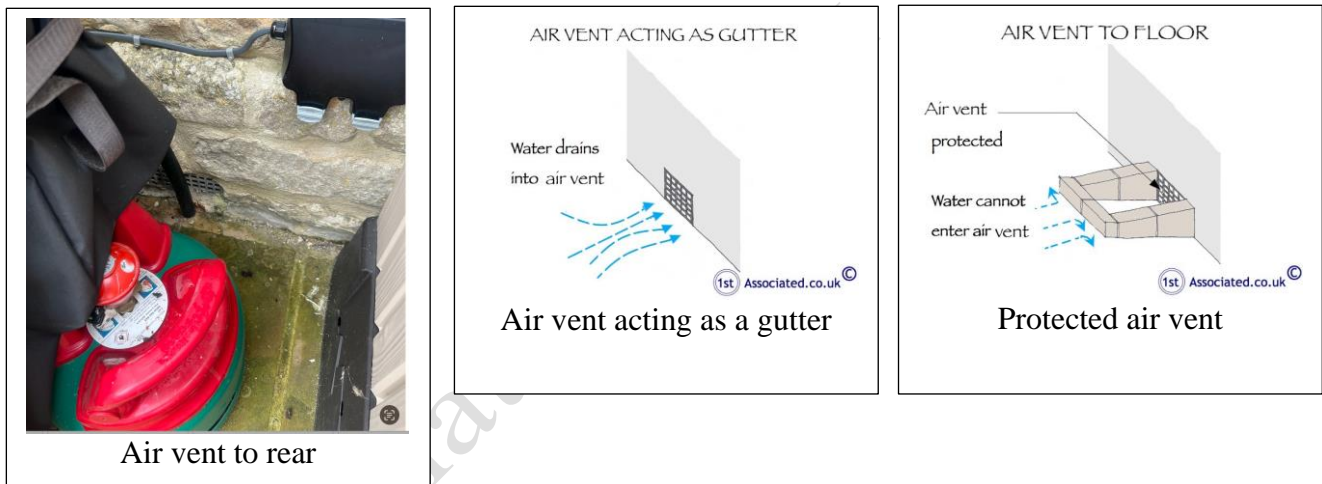
In this case the only air vent we noted was to the rear of the property. It is low to the ground and could be acting as a gutter, allowing dampness in.

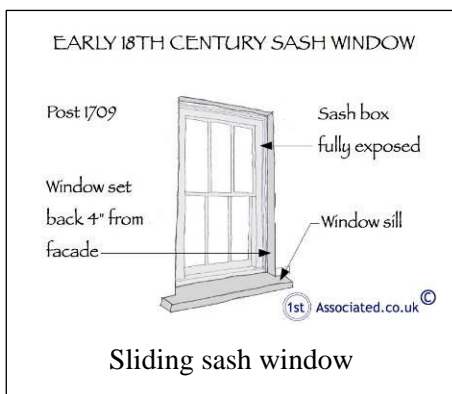
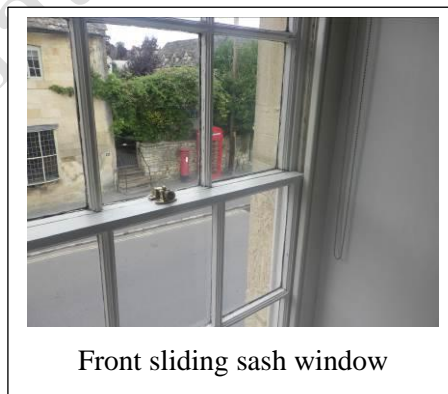
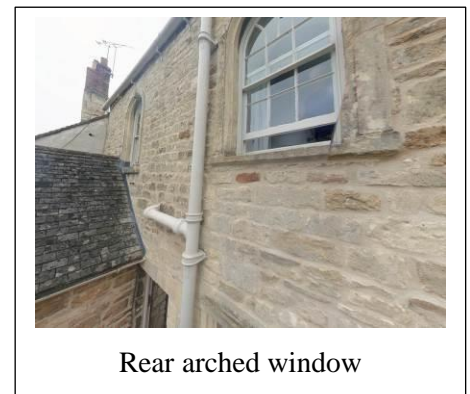
Generally, we would comment they are average quality for their age, type and style, with some weathering. They will need seasonal easing and adjusting and the sooner they are redecorated the better.

**ACTION REQUIRED:** Ease and adjust, repair, prepare and redecorate, the sooner the better.

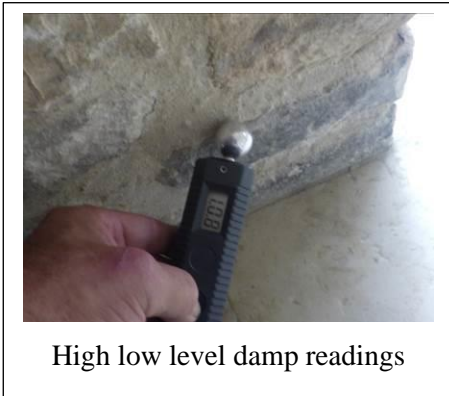
High low level damp readings

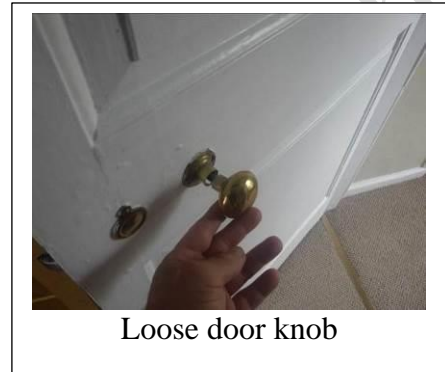
**ACTION REQUIRED:** The door ironmongery needs a little attention in some areas.

Loose door knob

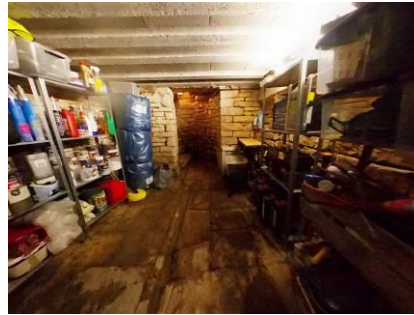
Cellar, no sump pump noted

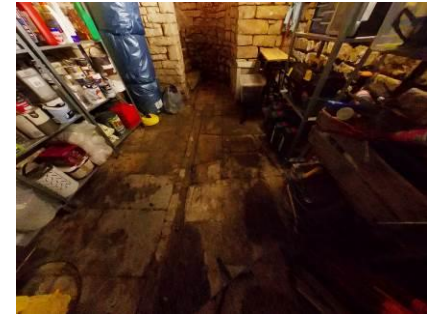
The property has a below ground cellar. This is in below average condition for its age, type and style and was very wet at the time of the survey, which could be due to a spring in the area. We would normally expect to find a cellar relatively dry at this time of year.

Very wet floor on a dry day

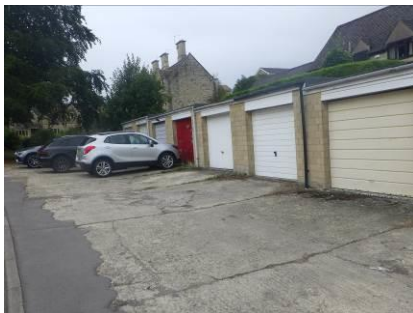
The property has a single garage in a block of garages a short walk away. It looks to be stone built, with a timber roof structure with a mineral felt covering. It did look like there had been a roof leak of some kind over the years.

Garage, short walk away from house

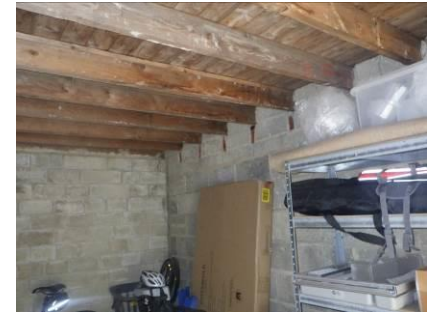
Stonework and timber roof
