# Timber Frame Example Residential Building Survey

# INTRODUCTION

Firstly, may we thank you for your instructions of xxx; we have now undertaken an independent Building Survey (formerly known as a Structural Survey) of the aforementioned property. This Survey was carried out on xxx.

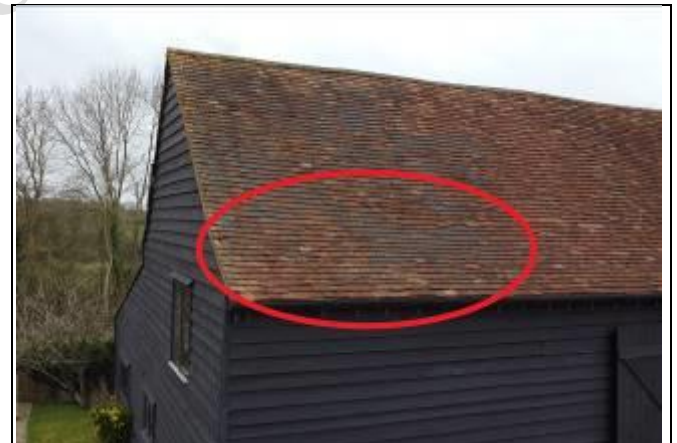
Queen post frame missing to the left side of the property

Front left problem area  
~ Aerial View - 360 Photo ~

**ACTION REQUIRED:** Initially we would recommend monitoring however we feel it is likely that work will be required to the area above the left side bedroom. Often strengthening can take place with timber or metal. Further investigation is required.

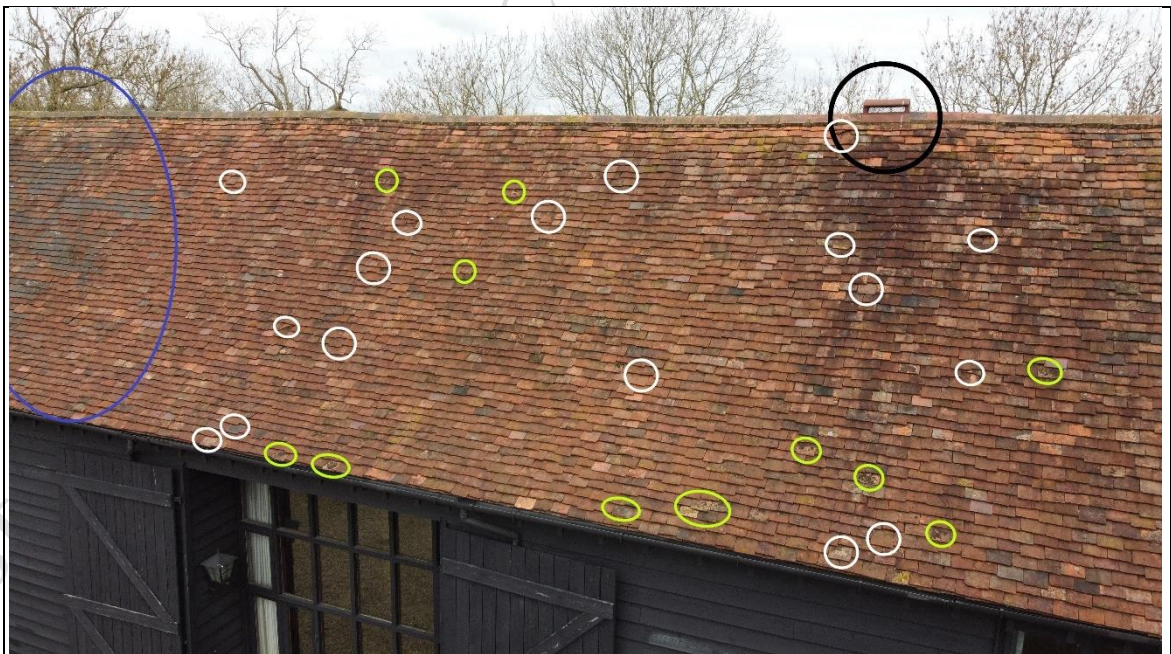
On our photograph below we have highlighted a sample of problems to the roof. The problem with this type of roof is sometimes repairing it can cause more damage than it resolves particularly if the roofing company are not used to carrying out work on listed buildings. We would recommend you are always present when work is carried out on the roof and ask for photographs to be taken of any work.

Front roof – chimney vent (black circle)  
Spalling (yellow), broken, slipped or missing tiles (white)  
~ Aerial View - 360 Photo ~

We would add with this age of roof there is usually some missing or displaced tiles. This is nothing unusual however we do believe this is above average in this instance.

**ACTION REQUIRED:** You can either carry out work as and when you are aware of problems or what we would recommend is for you to have the roof overhauled/checked and repaired before the winter.

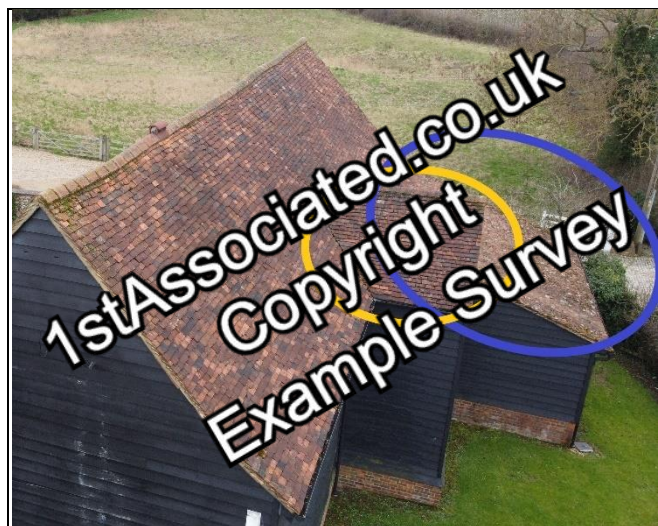
Rear left shallow pitched roof (blue)  
Stair area (yellow)  
~ Aerial View - 360 Photo ~

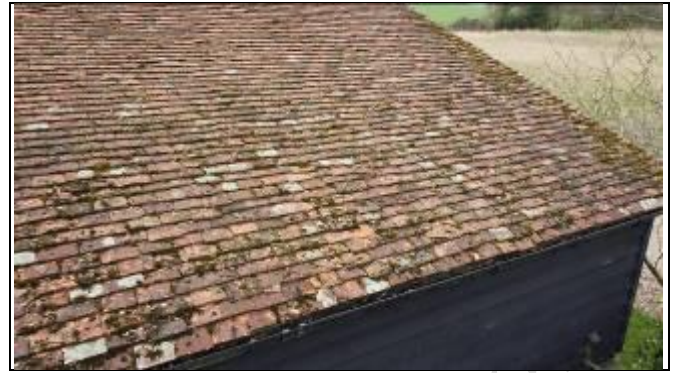
Moss to roof indicating surface starting to deteriorate  
~ Aerial View - 360 Photo ~

The other alternative is to leave the roof as is and patch repair as problem areas are found. You need to be fairly stringent on having this roof area regularly checked.

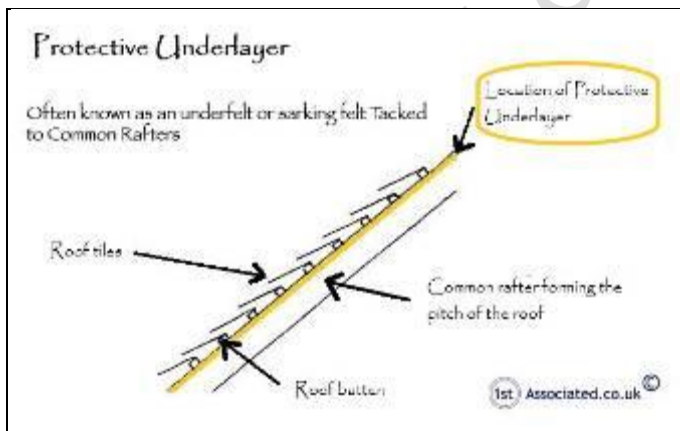
Protective underlayer

We can see in this area a boarded finish, we would normally expect to see a protective underlayer such as a sarking felt which were carried out from the War era to the 2000's and a breathable protective underlayer if carried out later than this. We believe this roof is susceptible to dampness getting in. Whilst we have come across in the past effectively flat roofs that are then covered over by tiles, with a traditional tile we are generally not comfortable with a roof below twenty degrees although we are aware that some have been made for lower pitches than this.

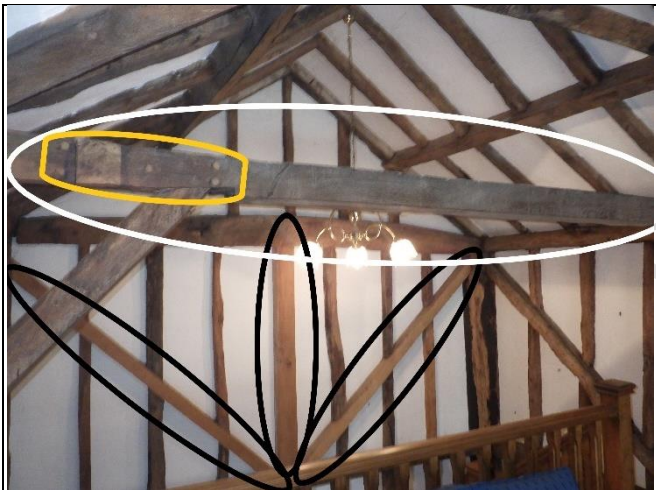
We can see quite a lot of alterations internally with the replacement timbers. We believe this roof once had a shallow pitched or even flat roof which has been altered at some time.

New pegs (yellow)  
Re-used timber (white)  
New structural timbers (black)

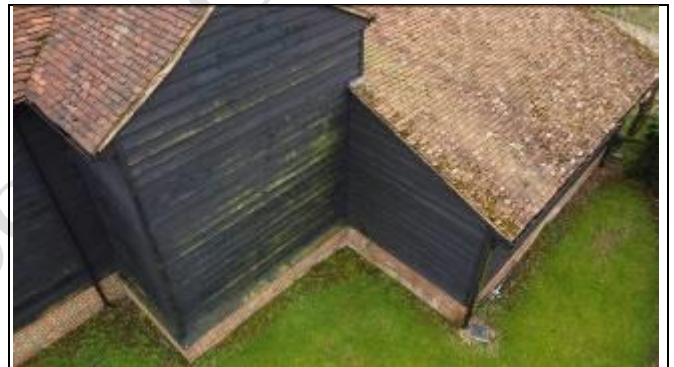
Moss to middle rear weatherboarding externally  
~ Aerial View - 360 Photo ~

There have been quite a number of major structural timbers changed internally so we believe at some point this area suffered quite badly from rot. At present there is a general moss to the area.

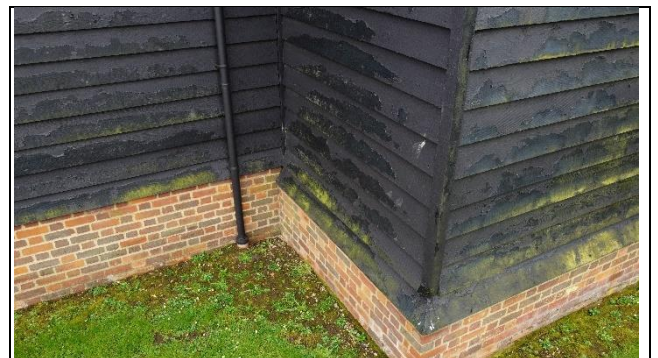
Dampness/moss at low level

At low level there is moss to the weatherboarding and wet and damp areas of grass to the rear over and above what we would expect although we do appreciate this is on a sloping site; we think that perhaps the water is not being taken away properly and there is a leak on the drainage system.

We would recommend this is investigated and possibly add a soakaway if one doesn't exist; see our further comments on this later on within the report. The detail where the brickwork and the timber meet with the timber boarding we often see formed in lead and whilst this may change the look of the building and will need Conservation Officer approval we think it would be a better detail even if lead was used and then timber placed over the top of it and then you accept from time to time that the timber will need replacement.

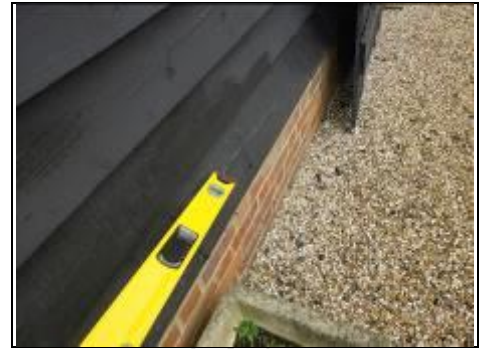
Angle timber over brickwork would this be better in lead this would need conservation officer's approval

We would reiterate our earlier comments with regard to the detail where the weatherboarding meets the brickwork at the base of the property which we feel is likely to be an area where you get accelerated deterioration. We would recommend a lead detail in this area which you need to discuss with the Conservation Officer; even if it is a lead detailing underneath the weatherboarding.

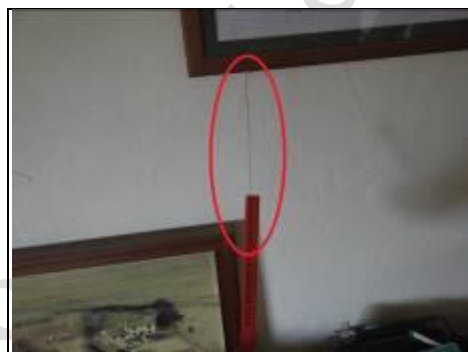
We noted vertical cracks internally within the rear left bedroom area and en-suite which is dry lined and false walled. We cannot be certain what this is hiding, it may relate to dampness or may relate to deterioration in the structure.

Second vertical crack found on rear wall of ground floor left bedroom

Ideally, we would recommend the existing owners take out an insurance claim, advising that the cracking has been noted by a structural surveyor (this should cost them nothing other than time to write the letter/email). This usually means that the insurance company will carry out a monitoring exercise (the Building Research Establishment recommend monitoring any cracks for a minimum of one year) to establish if there is any progressive movement. Your future liability should be limited to the cost of the excess on the insurance providing the insurance company is happy for you to take over the insurance claim.

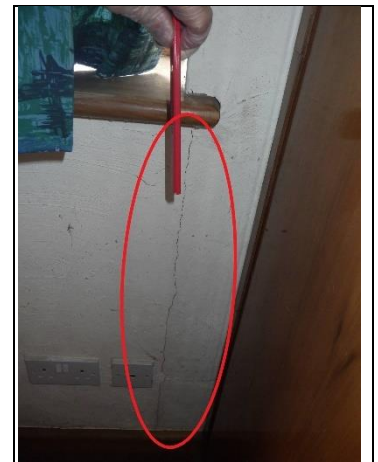
Vertical crack in ground floor left bedroom

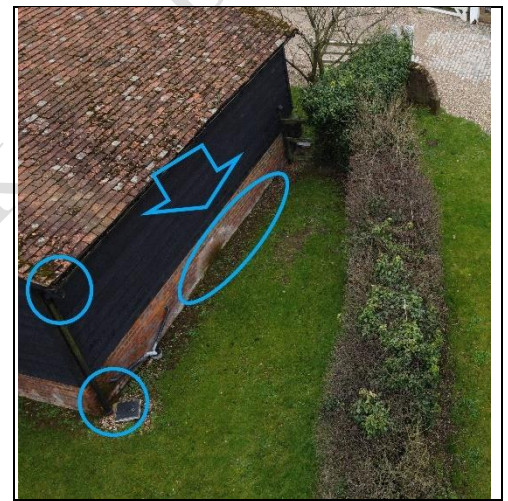
As we have already mentioned, around the property does seem to be damper than we would expect. We can see there are downpipes and also rodding eyes in this area. There is an area where the gutters look to be leaking (see blue arrow and blue oval) and the downpipe looks to be overflowing.

Dampness  
~ Aerial View - 360 Photo ~

**ACTION REQUIRED:** Again, all the gutters and downpipes need checking and particularly the underground area needs to be checked whether it is taking water away from the building. We much prefer to see a French drain around a building of this age which takes the water away. Again, you need to discuss this with the Conservation Officer before you carry it out as some may think it changes the appearance of the building too much.

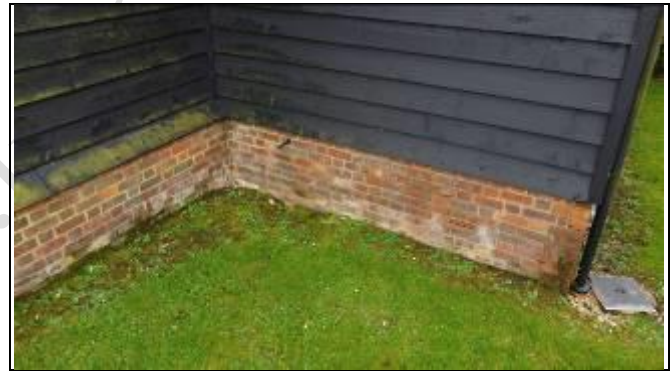
This has resulted in dampness to the brickwork. There looks to have been a bitumen damp proof course put in which was very popular in the 1950's-1970's. the bricks are spalling and generally deteriorating due to water damage.

Dampness to rear of property  
~ Aerial View - 360 Photo ~

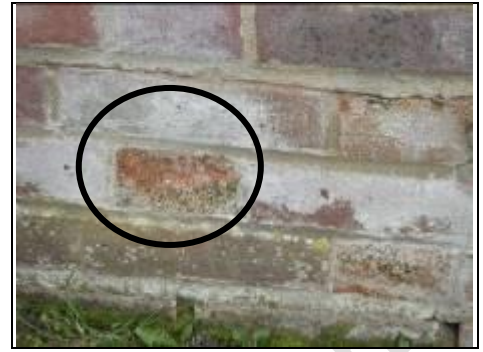
We would draw your attention to the deterioration of the brickwork at the base of the property which has used a mixture of a relatively soft red brick and cement mortar. We are not sure whether it was originally bedded in a lime mortar or not as it looks relatively new.

If it was bedded in a lime mortar originally then the cement mortar pointing is stopping it from breathing. If not, then unfortunately the cement mortar pointing and the soft red brick are not getting on particularly well which is leading to deterioration to the brickwork.

Spalling brickwork and dampness

- 1) Establish if it is lime and if it is lime you need to remember lime every time and lime takes time – see sketch below
- 2) If it is originally bedded in cement mortar then you need to accept this is an inherent defect and a characteristic of the building.

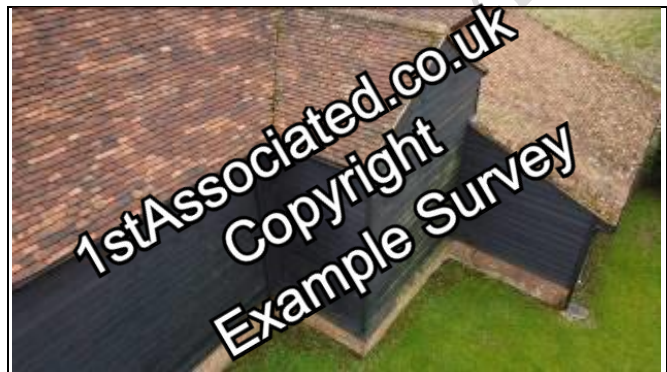
The weatherboarding is in need of decoration, the sooner this is carried out the better. We feel that perhaps it has deteriorated faster than it would have done if some of the gutters were not leaking. There may also be defects in the roof construction; please see our earlier comments with regards to changes that have been made and not thinking through the full effects of these changes.

Rear gable end where repairs taken place  
~ Aerial View - 360 Photo ~

Repair and redecorate. The weatherboarding will need regular painting every three to five years.

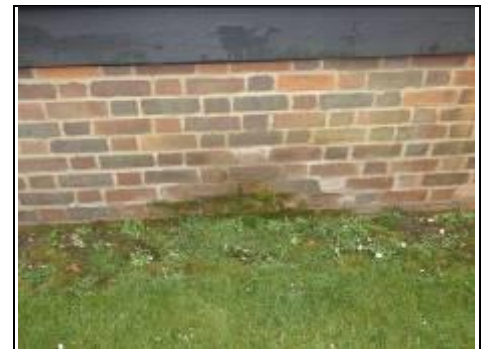
Leaking gutter

**ACTION REQUIRED:** It may sound obvious but it is often forgotten to not only repair the gutters and downpipes but also keep them regularly cleaned.

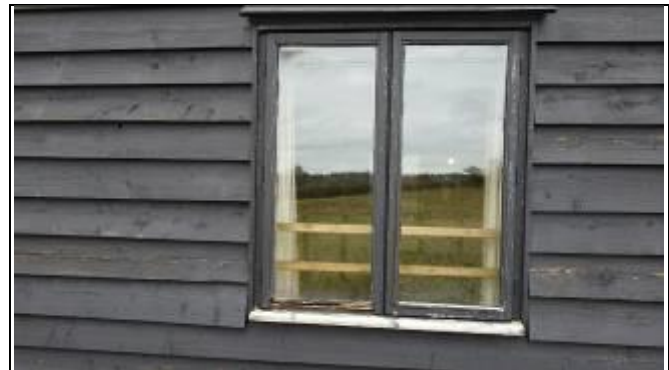
The windows have suffered in some areas from deterioration and dampness.

Deteriorating left gable end window  
~ Aerial View - 360 Photo ~

**ACTION REQUIRED:** We recommend work is carried out to the windows.

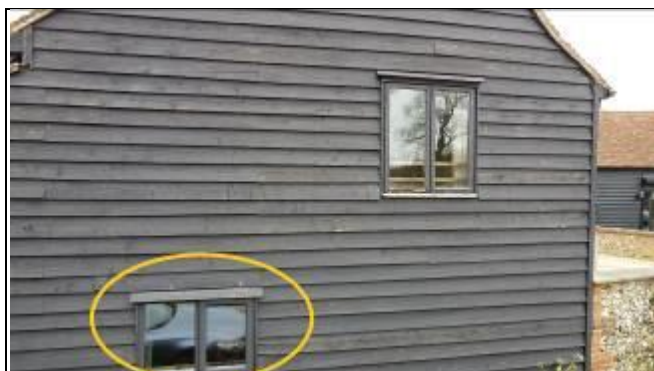
We also note there is a plastic window on the right hand gable. We would recommend this is replaced with a more appropriate timber window. Again, we would remind you that you are liable for this type of work that has been carried out which is inappropriate to a listed building.

Plastic window to gable end  
~ Aerial View - 360 Photo ~

**ACTION REQUIRED:** We recommend that you have a meeting with the Conservation Officer prior to purchasing the property to understand is there liable to be any action in relation to the inappropriate work that has been carried out on the property. The Conservation Officer may have some views on the type of window they like or indeed evidence from older photographs.

**ANTICIPATED COST:** We would anticipate costs of £5,000 plus depending upon what details are agreed with the Conservation Officer, how many windows are replaced and how many are repaired. Please obtain quotations.

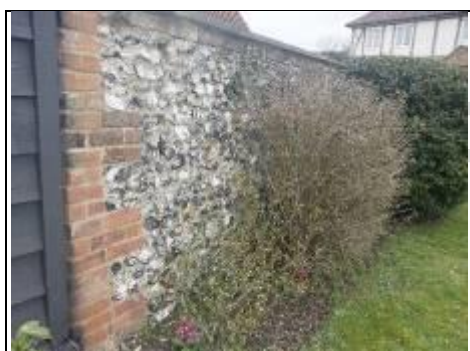
The flint garden wall is deteriorating and some areas have come loose. We would also add that garden walls such as this will have a limited foundation and it may be worth digging down the side to see how deep it is.

Flint/brick wall to left side

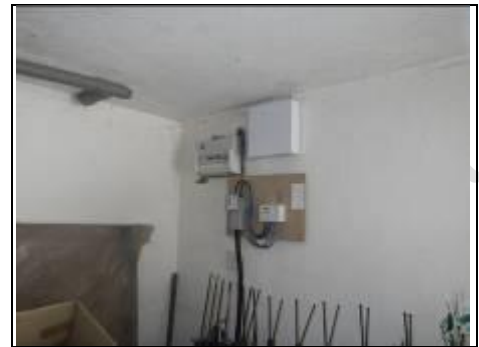
Dated fuse board

**ACTION REQUIRED:** We recommend a new fuse board with a fire resisting metal case and would advise as the property is changing occupancy the Institution of Engineering and Technology (IET) recommend a test and report. Any recommendations from the report should be carried out by a NICEIC registered, or equivalent, approved electrical contractor or similarly approved.

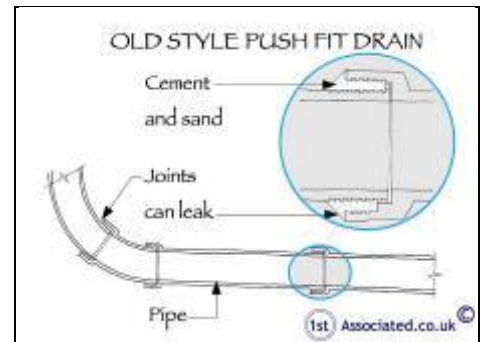
In older properties, such as this, drainage was often push fitted together rather than bonded together which means that they may leak over the years. Whilst we ran the tap for 15 minutes without any build up or blockages the only way to be one hundred percent certain of the condition of the drains is to have a closed circuit TV camera report.

Push fit drain

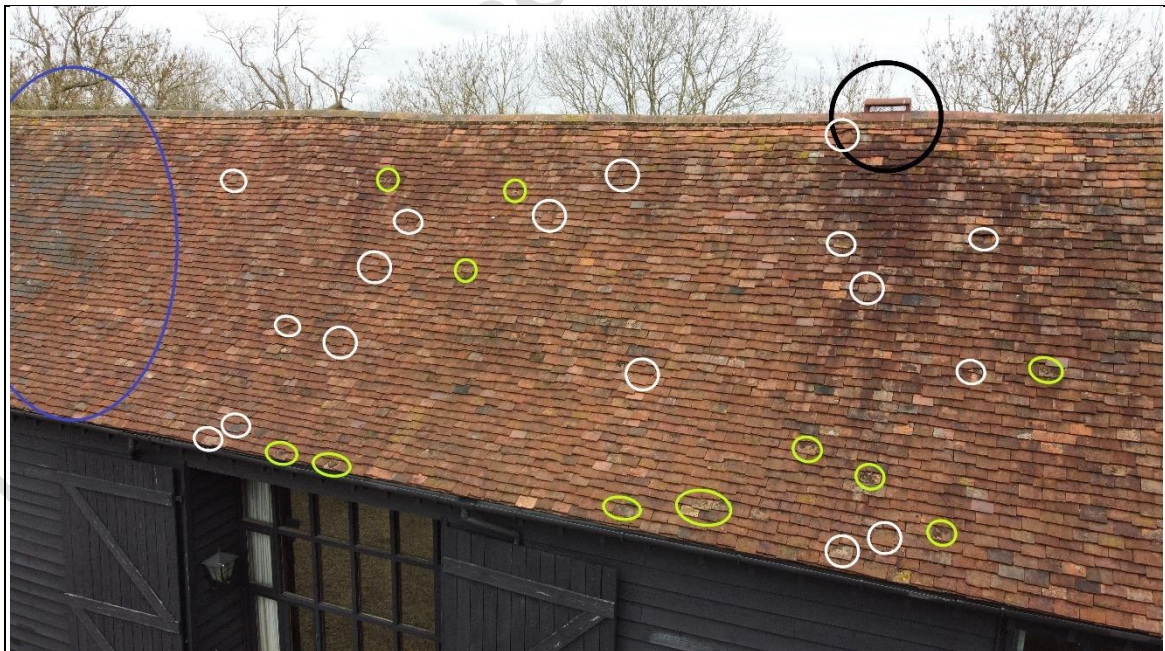
With this age of roof there will usually be a few missing or displaced tiles, this is nothing unusual, they do however need repairing to stop leaks.

Front roof – chimney vent (black circle)  
Spalling (yellow), broken, slipped or missing tiles (white)  
~ Aerial View - 360 Photo ~

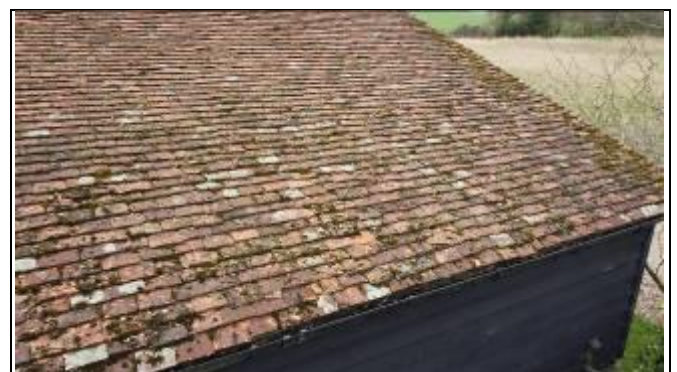
Moss to roof indicating surface starting to deteriorate  
~ Aerial View - 360 Photo ~

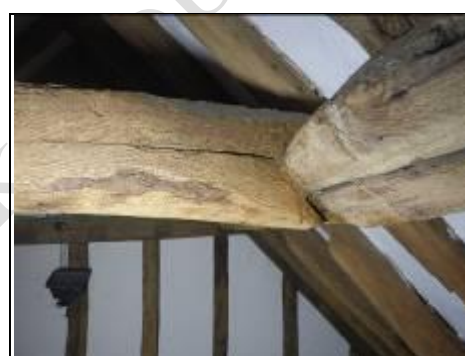
Woodworm

**ACTION REQUIRED:**  
Please see our comments in the Executive Summary.

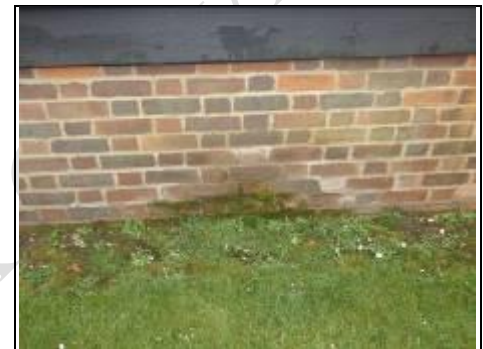
There are some leaks, however most people would be happy to live with these providing repairs are carried out before the winter.

Leaking gutter

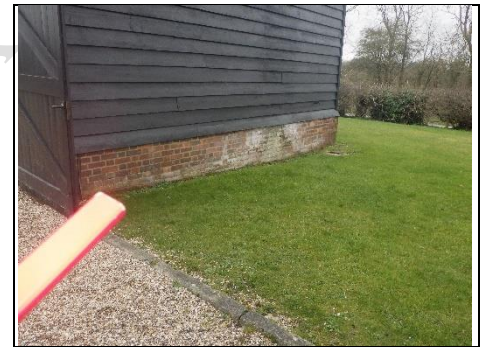
Dampness/deterioration to right gable

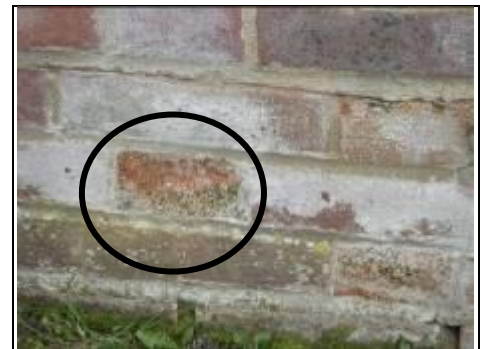
Spalling brickwork and dampness

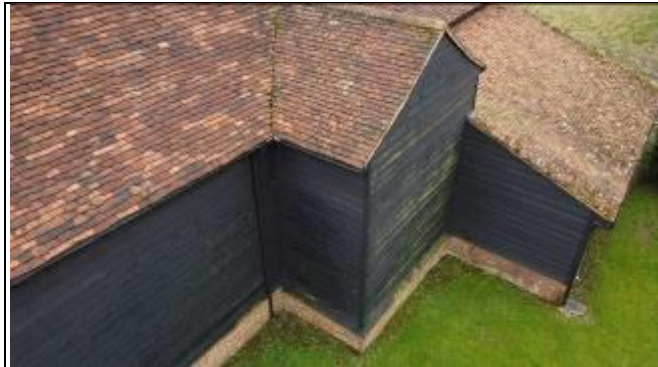
The weatherboarding is in need of decoration and has accelerated deterioration due to roof, gutters and downpipes problems. Work will need to be carried out to these before you redecorate.

Rear gable end where repairs taken place  
~ Aerial View - 360 Photo ~

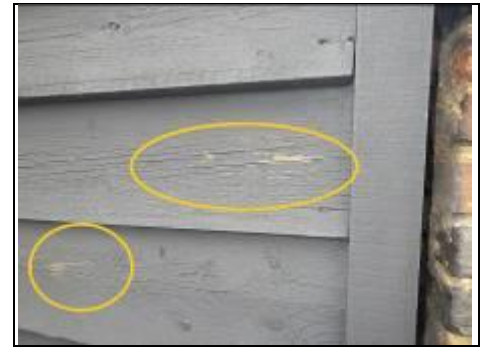
Areas of bare timber

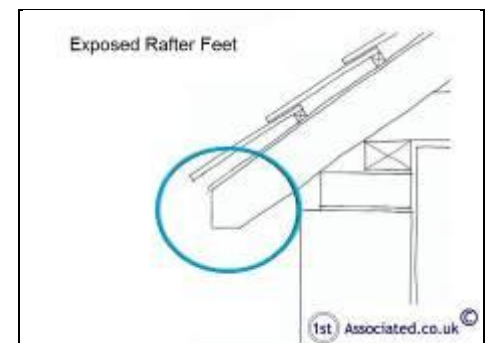
The fascias and soffits and exposed rafter feet are timber. They are painted / stained and we would comment they are in below average condition for their age, type and style partly as the gutters are leaking as mentioned. We often find they are in poor condition as they are difficult to redecorate.

Exposed rafter feet

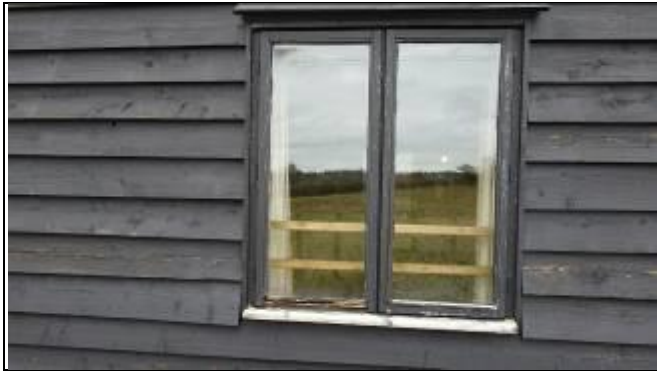
The property has timber windows with thin double glazing. We would specifically comment that they are generally in below average condition.

Deteriorating left gable end window  
~ Aerial View - 360 Photo ~

**ACTION REQUIRED:** Repair/replace subject to agreement from the Conservation Officer. Please see our comments in the Executive Summary.

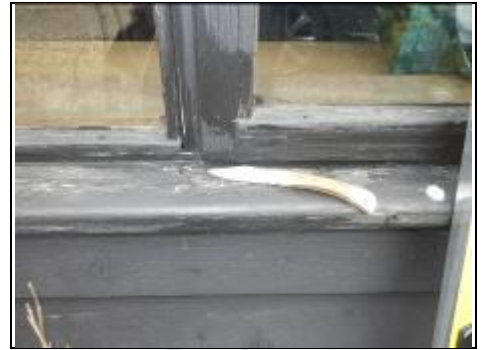
Work required to timber windows

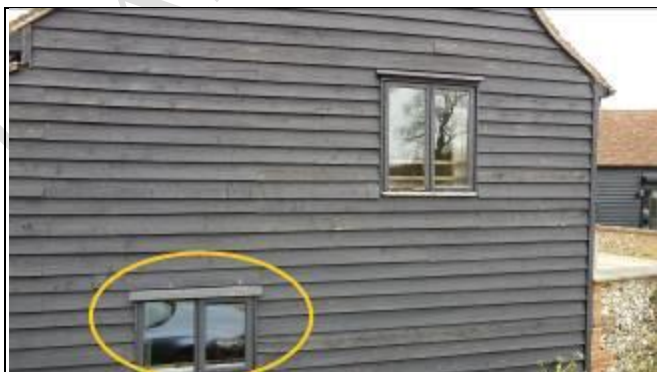
To the gable end is a plastic double glazed window with trickle vents, which generally look to be of an average quality. We would recommend this is replaced with a more appropriate timber window.

Plastic window to gable end  
~ Aerial View - 360 Photo ~

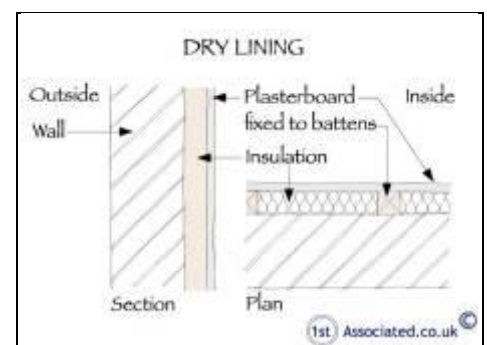
We do not know what is behind the infill panels; we would term them as being dry lined. We can see they are cracking and they sound from tap testing to be dry lined traditionally with timber battens.

Dry lining on battens

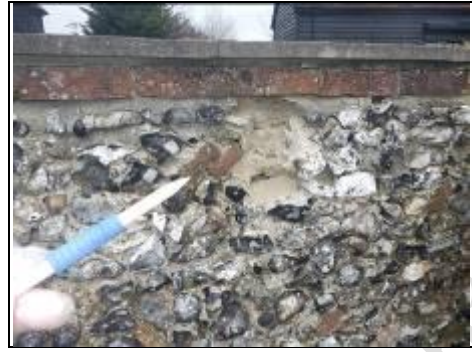
Deteriorating flint wall
