Timber Frame Example Residential Building Survey

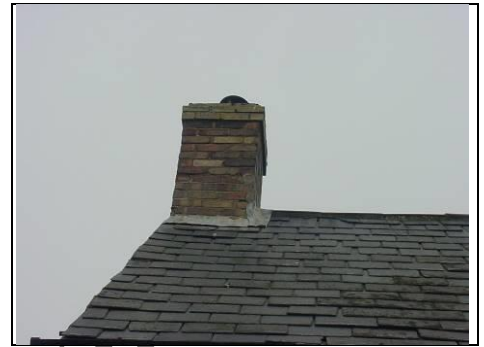
Rear left chimney

All four chimneys are weathered and require repair and repointing.

ACTION REQUIRED: Repair and repoint as necessary, check flashings and also check flaunchings (the top of the chimney).

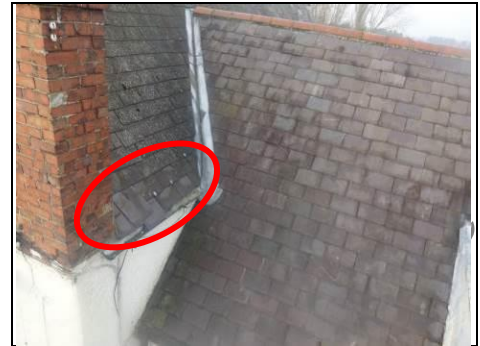
When you carry out the roof cover / slate roof repairs you must carry out repairs to the roof structure. There are various timbers that are split or are bending and need replacing particularly to the valley gutter to the rear and to the roof to the front right side.

Slipped slates and lead tingles to the front right roof
Aerial view – 360 photo

ACTION REQUIRED: We believe several of the roofs will require repair and or re-slating within the next five to ten years.

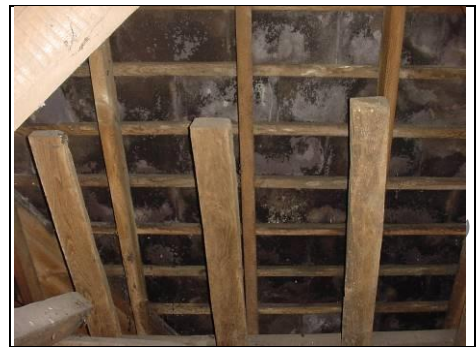
It should be noted that in some areas of the roof it has an older style of construction with no protective underlayer. This means that when the rain gets through and remember you have a lot of tingles holding the slates so there is no secondary protection.

No protective underlayer to older style construction

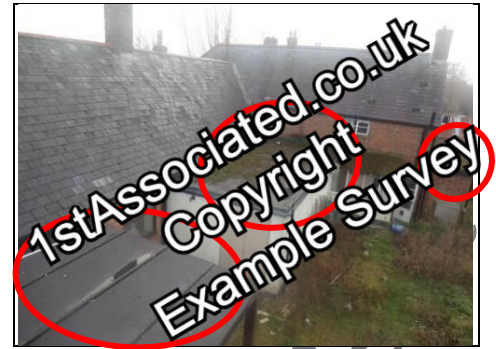
We do not believe these should be in your priority list as there are far more important things and their general condition is average, however there are signs of moss and water sitting on some of them which will lead to accelerated deterioration.

Flat roofs to the rear of the property
Aerial view – 360 photo

ACTION REQUIRED: We would start by clearing them of the moss. We feel that most roofs will be able to be patched repaired whilst you focus your efforts on the pitched roofs.

ANTICIPATED COST: Few hundred pounds for repairs, but sooner or later they will need replacing and the costs are likely to be in the thousands of pounds, particularly if you are using insulation and high performance elastomeric felt. Please obtain quotations.

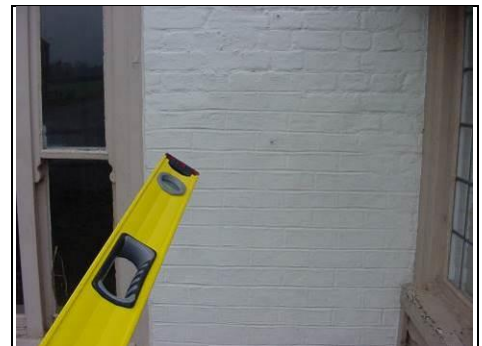
The brickwork is deteriorating considerably in some areas, to the point where it has had repairs. Unfortunately, these have been carried out wrongly in cement mortar which can cause more damage than good. Also there looks to be cement mortar to the front that has been painted over and made to look like bricks.

Cement mortar to look like bricks

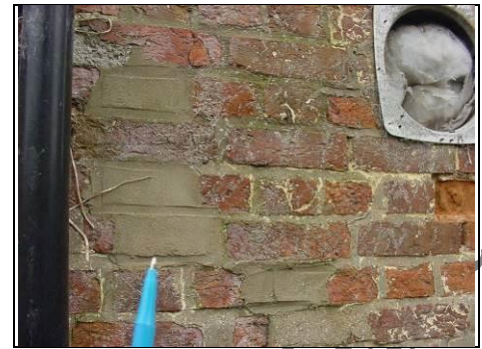
Ad-hoc pointing in cement mortar

ACTION REQUIRED: Remove all the cement mortar and replace with lime mortar and repair the bricks as necessary.

ANTICIPATED COST: £2,500 - £5,000 (two thousand five hundred pounds to five thousand pounds) this work will be carried out over a long period of time. Work is best carried out over the summer months. You need to find a good bricklayer that is experienced in using lime mortar; please obtain quotations.

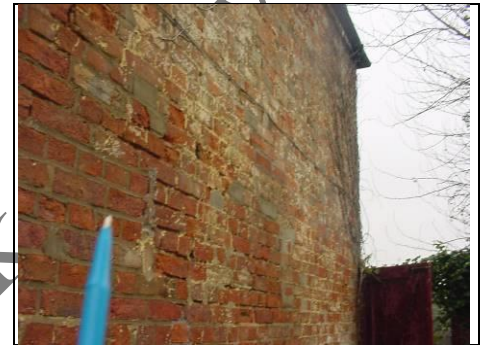
Whole bricks replaced with cement mortar

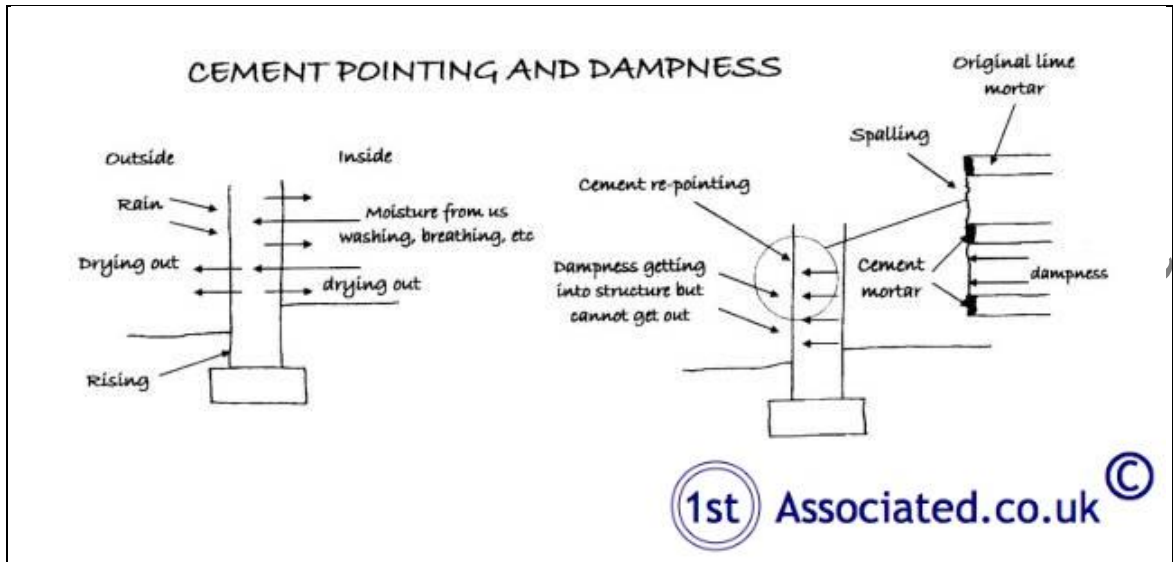
Unfortunately, the re-pointing, whilst well meaning, is not appropriate for this type of construction. A cement mortar has been used rather than a lime based mortar. We recommend you use lime mortar in any future repairs regardless of what the builders say! Using lime mortar will limit further damage to the brickwork, which is almost impossible to repair successfully. However, we would add that many, if not most, of the properties that are re-pointed are re-pointed wrongly; it is only in recent years that we have discovered the problems that can occur from it.

Cement pointing and dampness

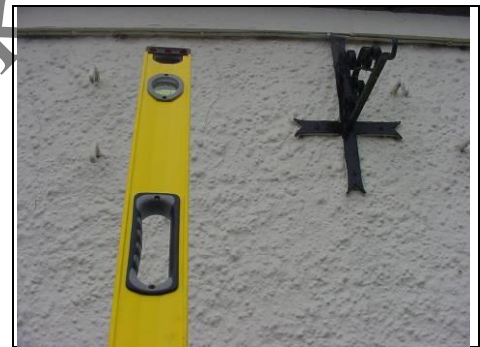
The bracket that looks like it is for a hanging basket may also be a tie bar.

Crack and possible tie bar

To the left side of the property we can see cracking. Unfortunately, they are very difficult to see in the photos. It does mean that movement is going on to the right side extension as tie bars are added to stabilise walls and offer cross bracing to them.

ACTION REQUIRED: We would recommend that you open up sections of the wall to see what the wall is constructed from and also to check if the tie bars are giving support to the structure.

The cracking needs monitoring. Before you legally commit to purchasing the property we would recommend the existing owners take out an insurance claim, advising that the cracking has been noted by a structural surveyor (this should cost them nothing other than time to write the letter).

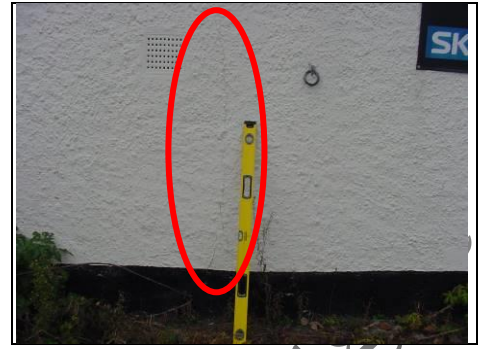
Vertical cracking to the right side render

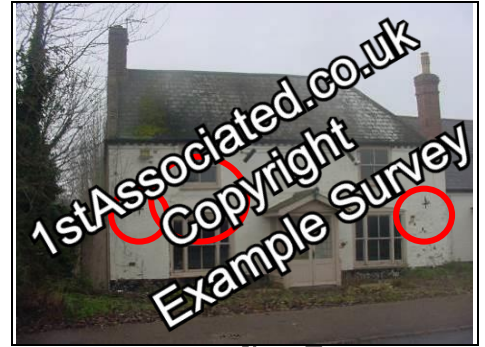
We suspect that there has been water discharging down the left side of the building which has caused deterioration.

Cracking and tie bars

ACTION REQUIRED: Stop dampness from roof and guttering. Stop rainwater draining from the roof and guttering down the walls. Check and repair lintels (they may be timber). Check and repair walls which may involve removing of the cement render externally and the modern plasters internally and allowing the walls to dry.

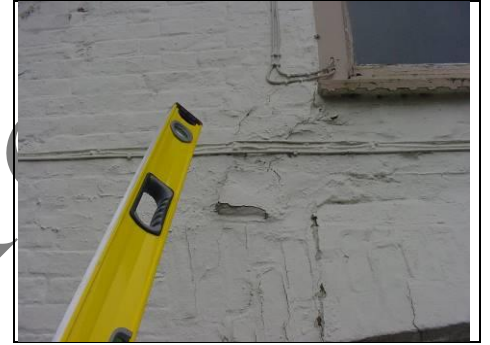
We would like to draw your attention to the cracking to the front windows and doors.

Cracking to the window

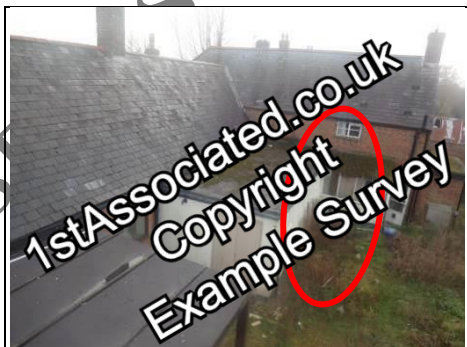
We noted cracking which we believe relates to structural movement that is all within the older part of the property. We do feel this is causing differential movement in the newer part of the property to the right side.

Cracking to the rear right
Aerial view – 360 photo

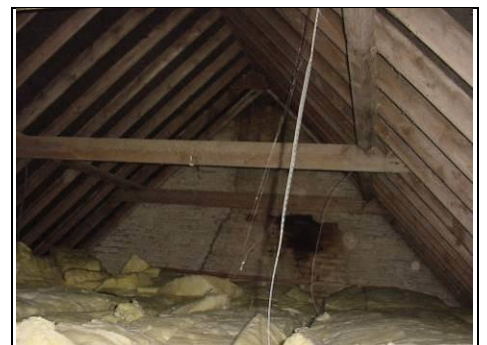
Crack on the front right, hidden
within the function room roof

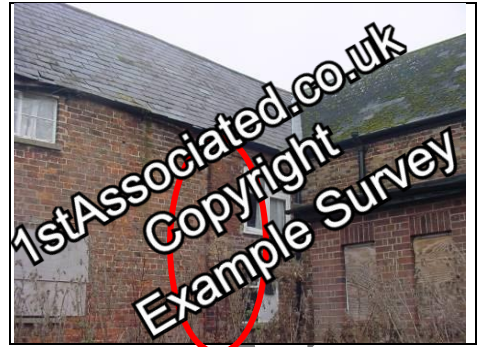
Vertical buttress

We can see movement to the rear of the property which we believe is due to poor ground conditions, possibly a flooding or swampy area to the rear and possibly peat.

Having said that, the movement looks to have been repaired for some time without any obvious signs of recent movement. We would however like to have the movement monitored.

We feel probably the best way forward is before you legally commit to purchasing the property, we would recommend the existing owners take out an insurance claim advising that the cracking has been noted by a structural surveyor (this should cost them nothing other than time to write the letter). This usually means that the insurance company will carry out a monitoring exercise (the Building Research Establishment recommend monitoring any cracks for a minimum of one year) to establish if there is any progressive movement. Your future liability will be limited to the cost of the excess on the insurance providing the insurance company is happy for you to take over the insurance claim.

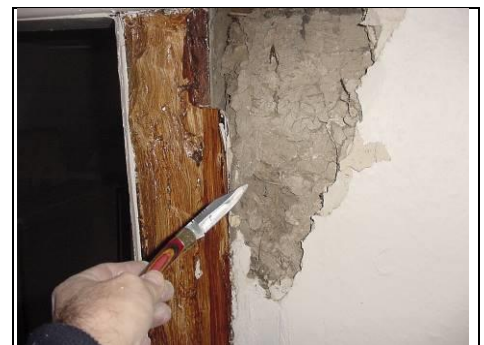
Wattle and daub in the walls

ACTION REQUIRED: We recommend opening up sections of the wall both internally and externally. You may well find some nice timber frame that enhances the look of the building.

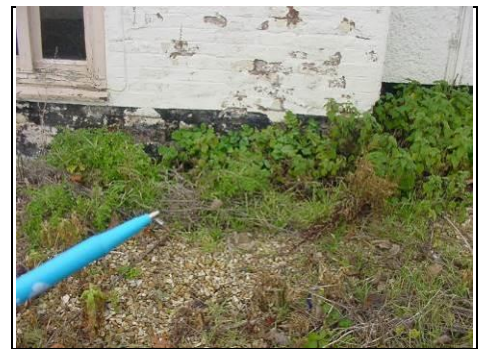
Ground level is high to front left

ACTION REQUIRED: Lower the ground level around the property and we would also recommend you add a French drain.

ANTICIPATED COST: £2,000 - £4,000 (two thousand to four thousand pounds); please obtain quotations.

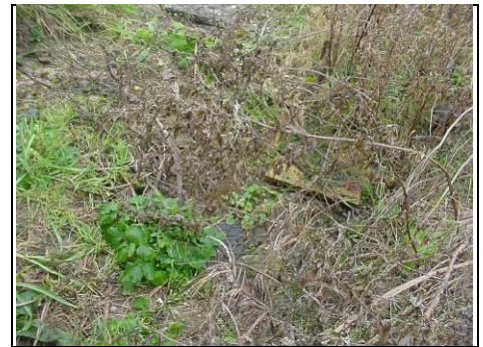
Swampy area

ACTION REQUIRED: We recommend soak aways are added to the entirety of the rainwater drainage, which will need to discharge as far away from the building as possible.

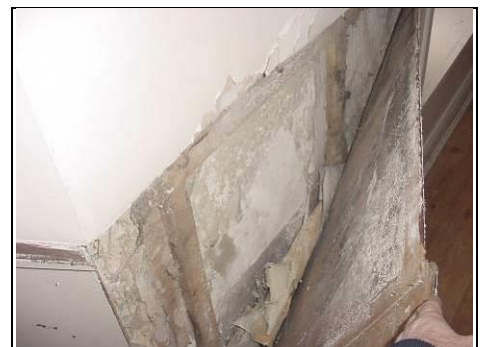
Perks of the dry lining / false wall is to hide the dampness coming through into the property which is considerable. Even with the repair work that we have mentioned you may get an element of dampness coming through. You have to consider part of the character of this building.

Dry lining internal walls

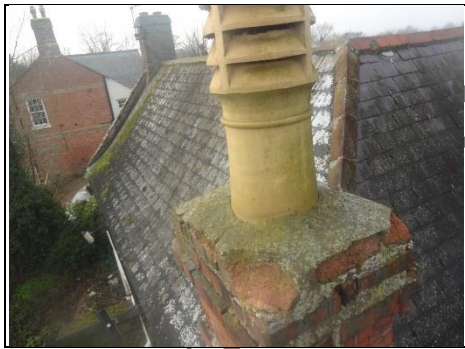
Chimney in below average condition
Aerial view -360 photo

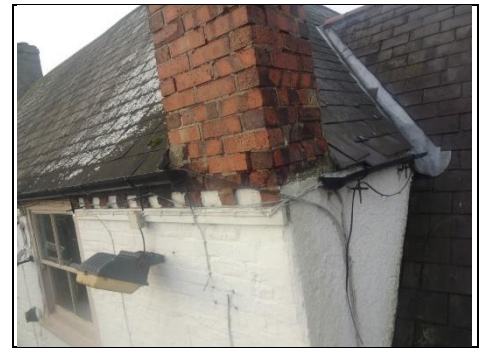
Chimney in below average condition
Aerial view -360 photo

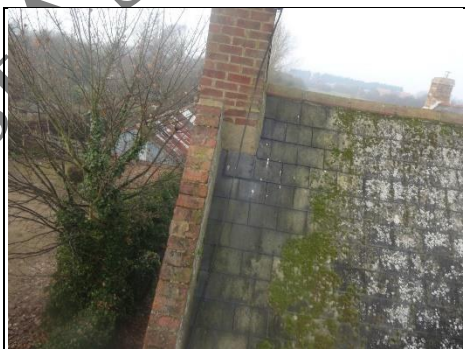
Moss on roof
Aerial view -360 photo

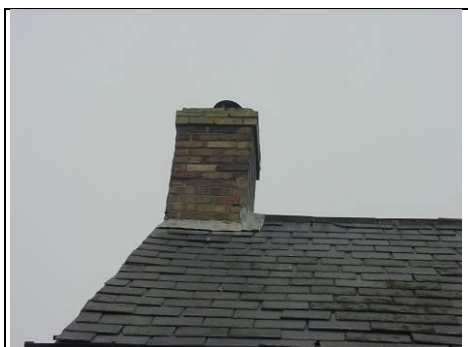
Rear left chimney

This chimney is brick finished with a cement flashing and one chimney pot. From what we could see from ground level it looked in below average condition considering its age, type and style.

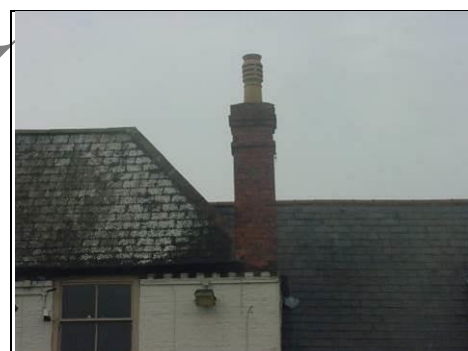
Front middle chimney

This is a large slender chimney which is brick finished with a cement flashing and one chimney pot. From what we could see from ground level we could see areas where there was no mortar and again from ground level it looked in below average condition considering its age, type and style.

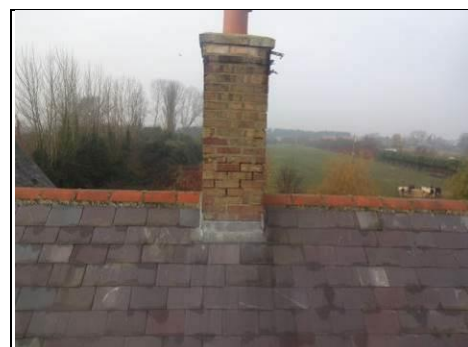
Front right chimney

This chimney is brick finished with a lead flashing and one chimney pot. From what we could see from ground level it looked in below average condition considering its age, type and style.

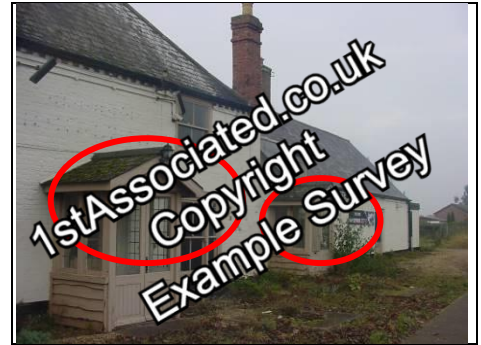
Front entrance roof

There are two small front entrance roofs to the property. Both of them are pitched with a manmade slate with a lot of moss of them. From ground level they look in below average condition considering the roofs age type and style.

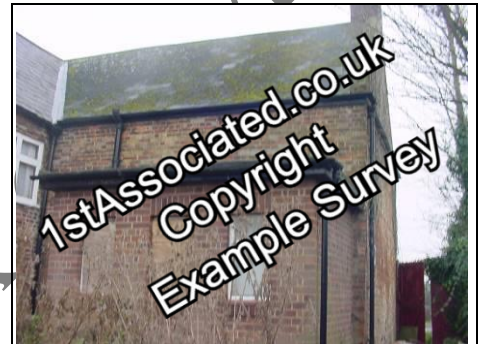
Far left flat roof

The far left flat roof is over the ladies' toilets. It is covered with felt and from ground level, this looks in below average condition considering the roofs age type and style.

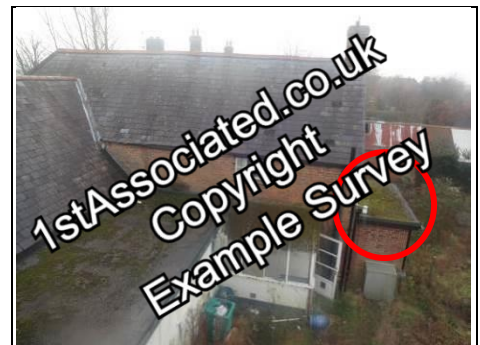
Rear left flat roof

The rear left flat roof is covered with felt and has a lot of moss sitting on it. From ground level, this looks in below average condition considering the roofs age type and style.

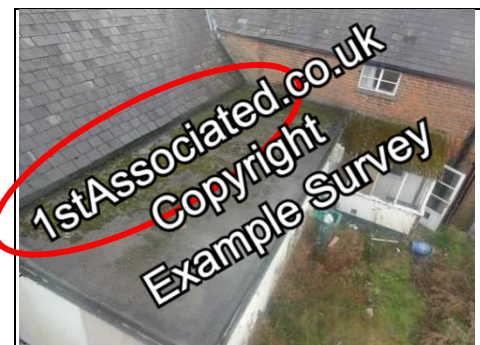
Rear middle flat roof

The rear left flat roof is covered with felt and again a lot of moss sitting on it indicating water is not draining away where the pitch meets the flat roof. Again from ground level, this looks in below average condition considering the roofs age type and style.

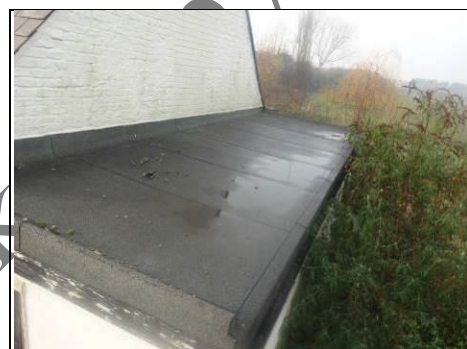
Right flat roof
Aerial view- 360 photo

The right flat roof is covered with felt with water sitting on it. From ground level, this looks in average condition considering the roofs age type and style.

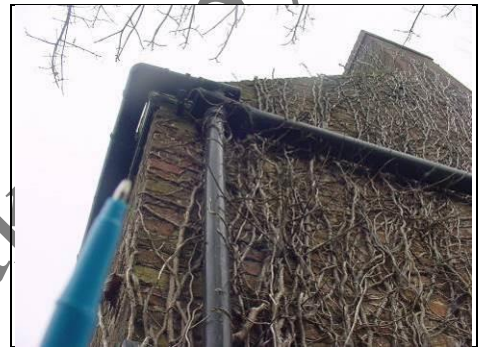
Gutter and downpipe

Generally, they are cast iron and are in poor condition.

We normally recommend keeping cast iron gutters and downpipes as much as possible, but in this case it does look like renewal will be the best way forward, subject of course to agreement with the Conservation Officer.

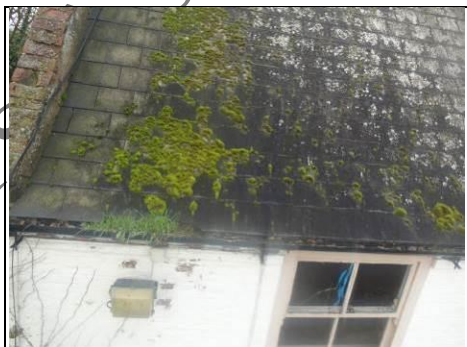
In addition, this building has been left over the years with a general lack of maintenance which all leads to the need to replace the guttering and downpipes and ensure the water is taken away from the building using soak-aways.

Grass growing in the gutter

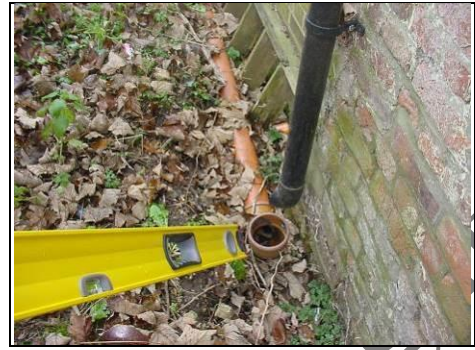
Far left side gutter not joined

ACTION REQUIRED: We recommend you repair the gutters and downpipes as soon as possible to stop water discharging down the building and damaging it. You will need to chat to the Conservation Officer.

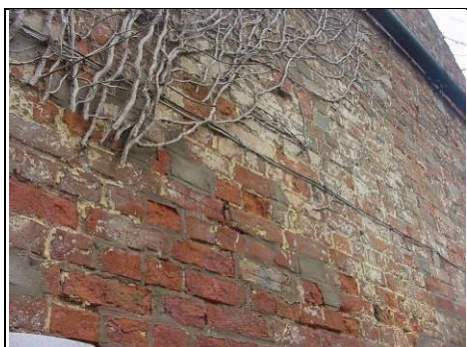
Unfortunately, the older brickwork has been wrongly repaired many times using cement to the joint and to cover whole bricks, which is such a shame. There are also areas where ivy has grown and causing deterioration.

Cement repointing, bricks replaced with cement mortar, lime wash and ivy

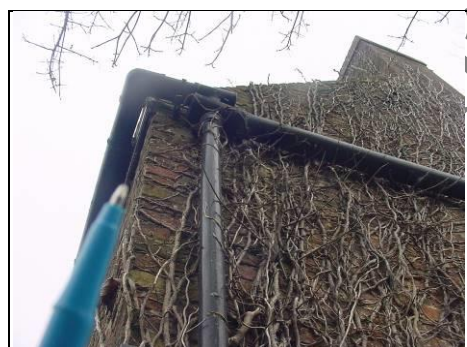
Ivy causing deterioration

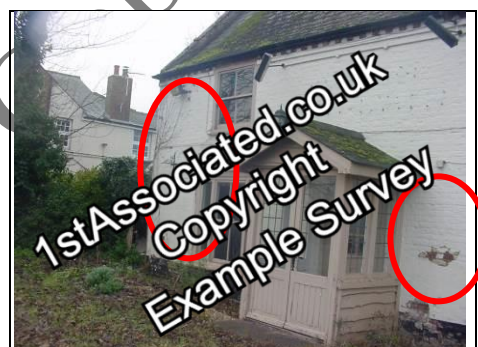
Bricks re-created to left and right in we believe a cement mortar

ACTION REQUIRED: We recommend you open up several sample areas to see exactly what the construction is. We would specifically draw your attention to the front of the property to the left side (under Roof A in our roof plan), where the brickwork looks to have been re-created using a cement mortar or similar with the joints drawn into it.

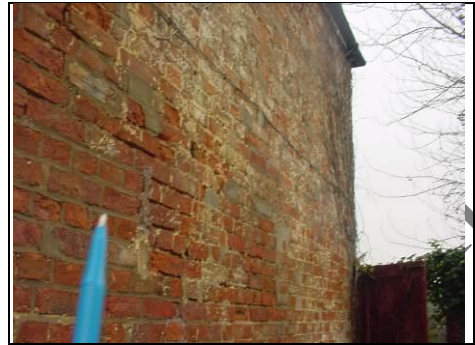
Gable end left hand side

The gable end is a fine example of how not to maintain and look after a building. This looks to have had a combination of ivy growing off it with some still remaining and it has had cement repairs which unfortunately will cause more damage than good, however having said there is also considerable weathering on this gable end.

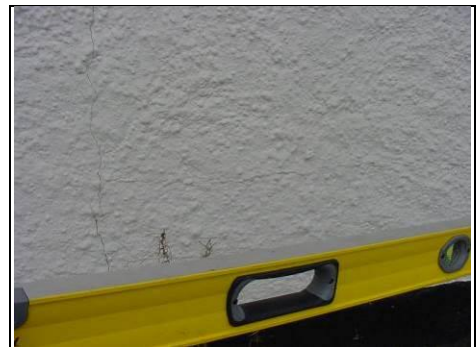
Horizontal hair line cracking

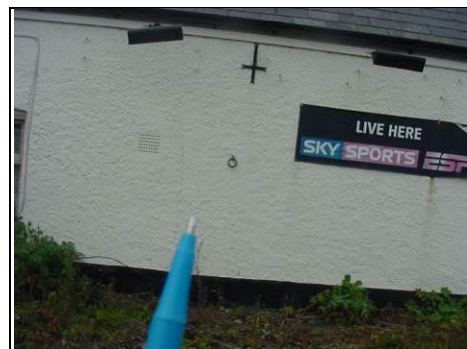
Horizontal cracking and the black area to the base where the drip is

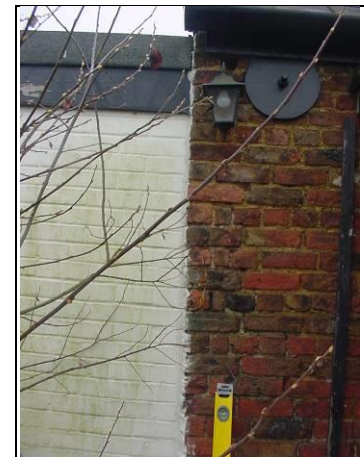
Brickwork with problems
to the rear right

We would leave this area to better understand how to carry out brickwork repairs.
