# RESIDENTIAL BUILDING SURVEY

XXXXXXXXXXXXXXXXXX,  
Marylebone,  
London ,  
W1U xxx

Prepared by:  
XXXXXXXXXXXXXXXXXXXX  
INDEPENDENT CHARTERED SURVEYORS

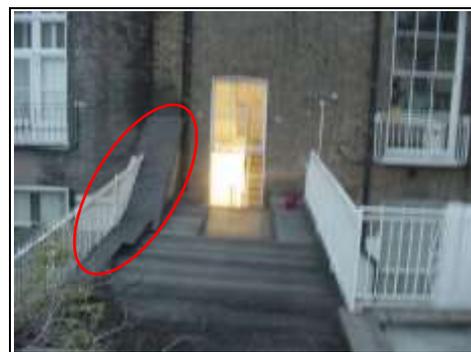
We can see that the courtyard to Apartment Two and the shared terrace to the rear of the property have a coping stone that looks to have leaked over the years. We can see that the joints of this have been tarred to the left hand side and the parapet wall has been completely tarred to the right hand side.

Rear right hand side parapet wall has been completely tarred

**ACTION REQUIRED:** We would recommend that lead cappings are added to the parapet walls including the one on the main roof.

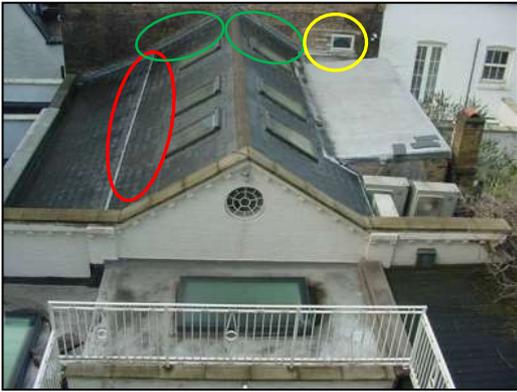
Rear of Apartment Two  
Awkward valley gutter (red)  
Straight lead flashings instead of stepped (green)  
Gutter leaking onto property (yellow)

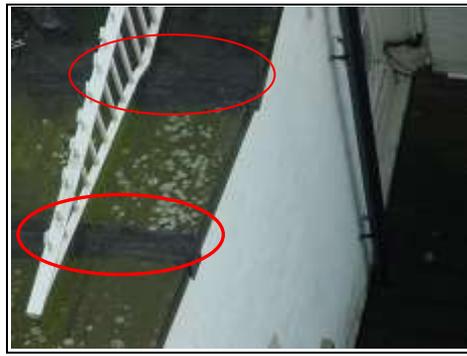
Left hand side of courtyard  
Repairs to the parapet wall

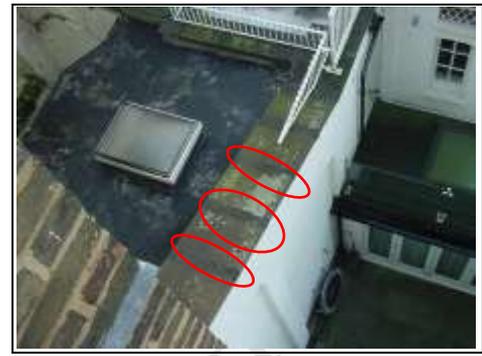
Courtyard to apartment two – repairs visible

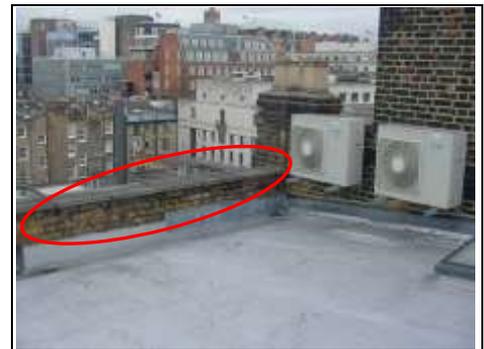
Main roof parapet wall

**ANTICIPATED COST:** Lead work can be expensive but does offer the best watertight solution in our opinion. We would expect costs in the region of £10,000 to £20,000 for a complete solution. For temporary tar repairs, as

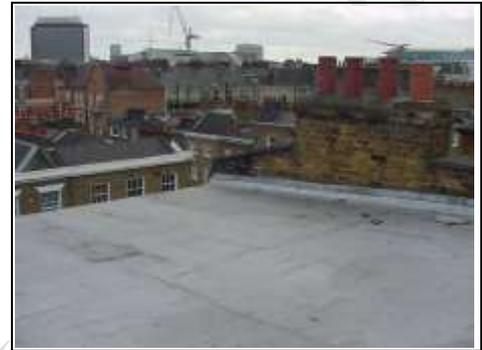
Main roof

The main roof has a shallow pitched Asphalt roof. Generally Asphalt roofs are considered to be the Rolls Royce of flat roofs and we would always recommend repairing them rather than replacing them, except for a fairly few exceptions where there are major problems and with no insulation present.

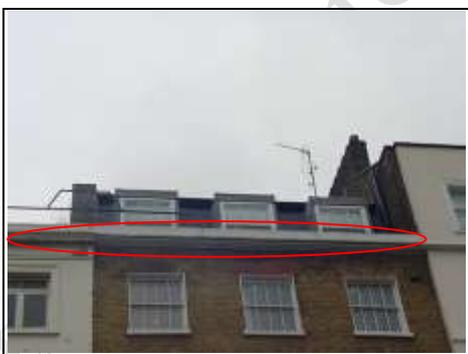
To the front of this Asphalt roof is a box gutter detail where we think rainwater is getting in. The problem may be caused by the poor detailing to the box gutter around the dormer windows, see further on in this section.

Awkward box gutter

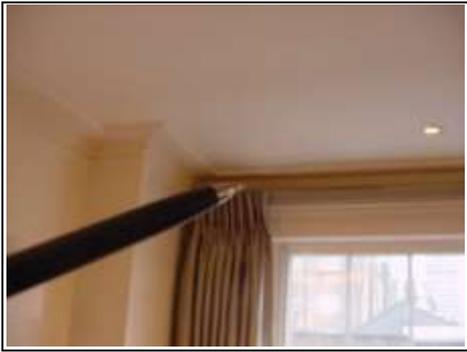
Damp staining at window

**ACTION REQUIRED:** There are various testing systems to use on Asphalt roofs to pinpoint the leak. The main problem with this type of roof is that where the leak is getting in is not necessarily where the staining is seen. However as said, this is the Rolls Royce of roofs and should be kept if at all possible. Adhoc repairs should be carried out and solar reflective paint added to the roof to prolong its life. In addition to this there may also be dampness coming in via the lead work. This is precarious to carry out repairs to and will require a cantilevered scaffolding to give access and to allow a full inspection.

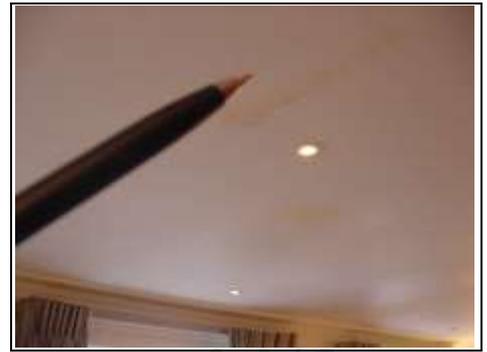
Damp staining relating to the main roof

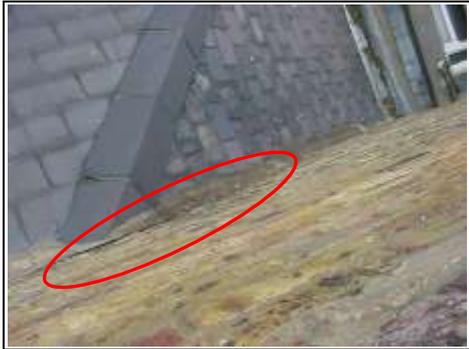
The adjoining property still has the original butterfly roof. There is cracking visible between the concrete fillet that has been used and the parapet wall of this property.

Cracking to concrete fillet

**ACTION REQUIRED:** Ideally this should have a lead flashing as dampness can get into the top floor apartment from your neighbour's property. We recommend speaking to the neighbour to advise them of the problem. If they are not happy to carry out the work it may well be worth you carrying out the work.

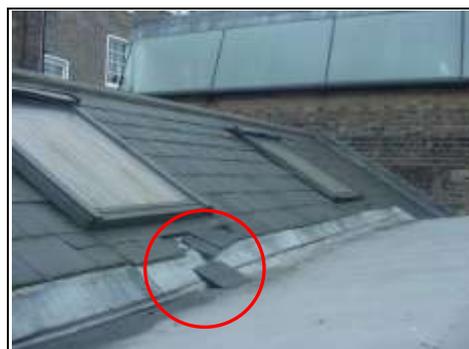
As mentioned there is a pitched roof to the rear of Apartment Two which forms the cathedral ceiling within the apartment. This has been re-roofed at some point with a manmade slate, this would typically have been during the 1990's. We noted that some slates have already been displaced to the rear right hand side.

Slates displaced

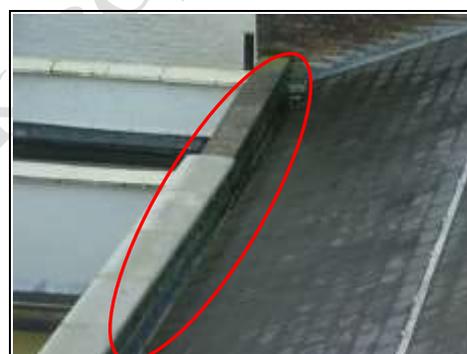
To the left hand side there is an awkward gutter that we believe is leaking. Again as with the main roof, box gutters really can be problematic particularly in this case where any water that discharges from the gutter actually goes into the walls.

Awkward box gutter that we believe is leaking

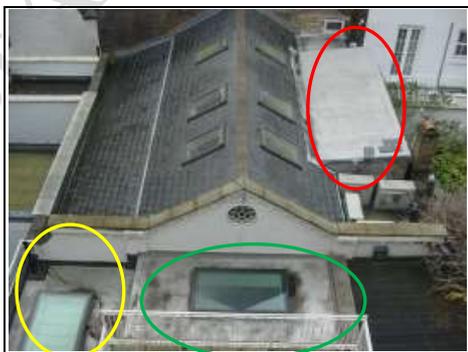
Flat roofs

There are various flat and shallow pitched Asphalt roofs to the rear and we could see that rucking and deterioration is starting to occur.

**ACTION REQUIRED:** Patch repairs will be required in the next few years. As mentioned Asphalt is the Rolls Royce of roofing materials as long as it maintained.

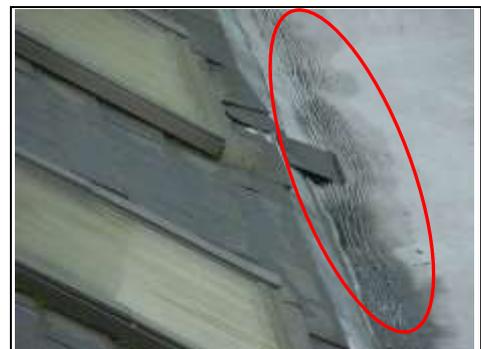
Roof to the right hand side is starting to deteriorate and ruck

**ANTICIPATED COST:** A few hundred pounds if carried out before the roofs leak, thousands if left; please obtain quotations.

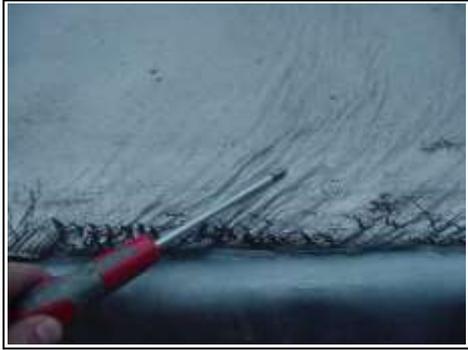
Deterioration to roof

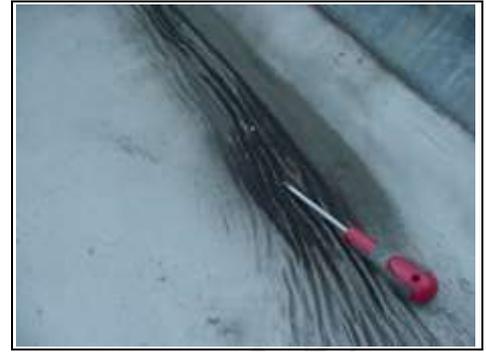
Deterioration and rucking

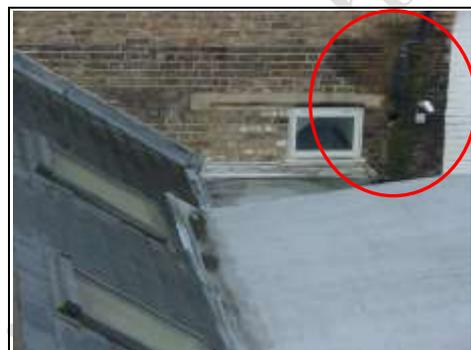
To the rear of the property, above the single storey right hand side area of Apartment Two, we can see that the adjoining property has uncoupled guttering which is allowing water to discharge down their wall and also down yours.

Neighbours gutter leaking onto your wall

**ACTION REQUIRED:** Speak to the neighbours but we would recommend that you repair it if you do not get any response.

**ANTICIPATED COST:** A few hundred pounds, this will stop dampness getting into your building; please obtain quotations.

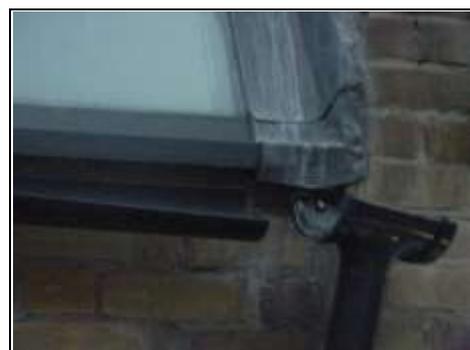
Guttering is broken

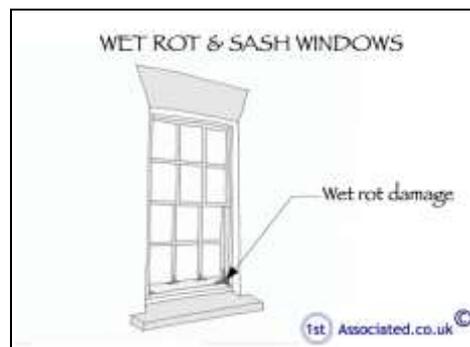
The timber is likely to be good quality and we would only recommend repair in the areas susceptible to wet rot as shown in our sketch. We do find there is a pressure to replace such windows and often, with a window of a lesser quality over the long term.

Wet rot in sash windows

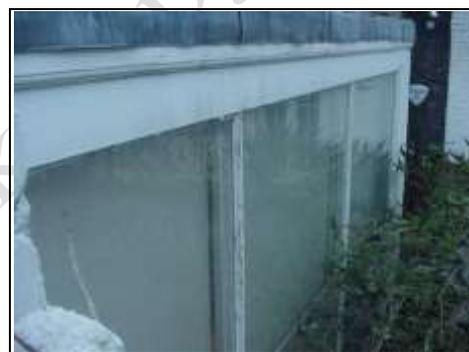
Rear windows

There are large fixed/picture windows hidden by blinds at the time of the survey. These do not look to be of good quality or condition particularly as they have thin mullions (the vertical timbers on the windows). We also think that the detailing at roof level is poor and we recommend that an up-stand is added to this area to minimise any wind driven rain coming off this section.

**ACTION REQUIRED:** We would recommend redecoration in the summer of 2014 and would be looking to renewing the windows dependent upon what is found during the redecoration.

**ANTICIPATED COSTS:** The difficulty is accessing this area which is likely to require scaffolding and we would expect costs in the region of £2,000 to £4,000.

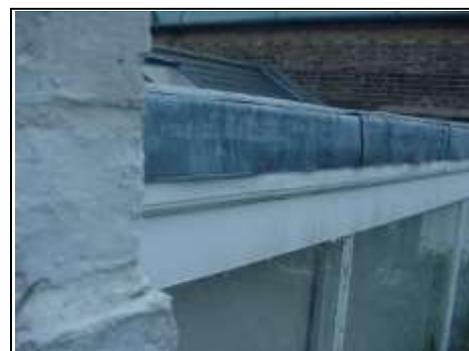
Poor detail requires a gutter, assuming it is not hanging over next doors property

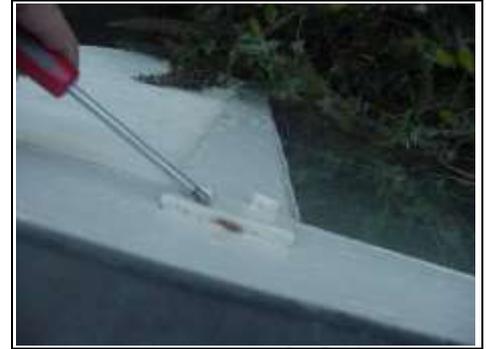
Rusting to metal work on timber windows

You could equally decide that rather than redecoration it would be worth replacing them, in which case as these are large picture windows we would replace them with large modern double glazed windows. However, the windows may have to be timber due to the listed building requirements.

Replacement costs are likely to be in the £7,000 to £15,000 market with the increase due to the scaffolding required and also because they will need to be custom made.

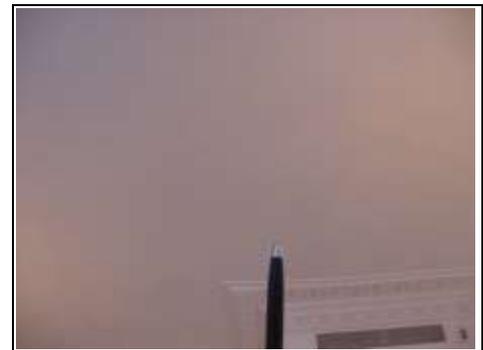
There has been some movement in the structure which is difficult to see due to the dry lining that has been used which effectively adds a false wall around the property. However, we can see hair line cracking and raking cracks around the lift shaft and the staircase area. We believe this is due to a combination of reasons.

Cracking around the lift area in Apartment Four

1. There can often be movement where there is a staircase and this could be due to the timbers being embedded into the wall and deteriorating over time.
2. The lift has been added at some point in time which will have involved structural work and adds a more solid element to buildings that were designed very differently and this can result in cracking such as this. We have inspected the property externally

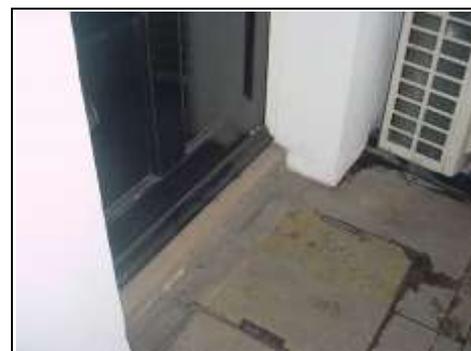
There are various manholes throughout the property. The ones we found require specialist lifting equipment and so we were unable to open them.

Manhole cover not lifted at entrance to the apartments

**ACTION REQUIRED:** The only way to be 100% certain of the condition of the drains is to have a closed circuit TV camera report.

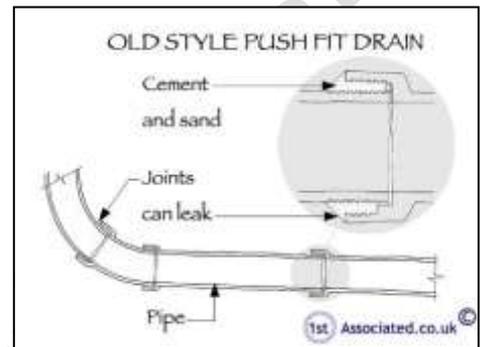
In older properties, such as this, drainage was often push fitted together rather than bonded together which means that they may leak over the years. Whilst we ran the taps for 15 minutes without any build up or blockages the only way to be 100% certain of the condition of the drains is to have a closed circuit TV camera report.

Push fit drain

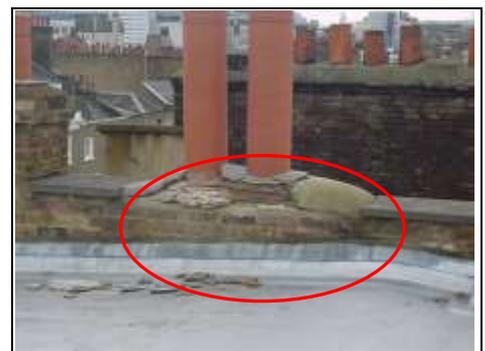
This chimney is brick built finished with a lead flashing and several chimney pots. From what we could see from ground level it looked in below average condition considering its age, type and style due to the condition of the flashing

Left hand chimney needs repairs

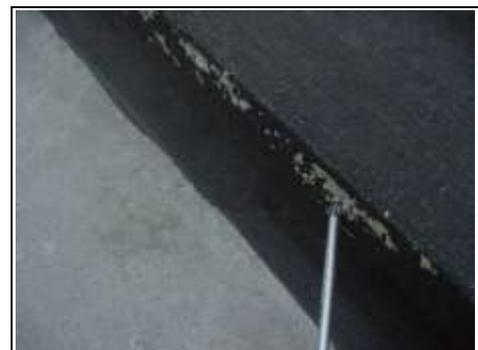
Damage to parapet wall

**ACTION REQUIRED:** We are recommending that all walls have lead cappings added. Please see our comments within the Executive Summary.

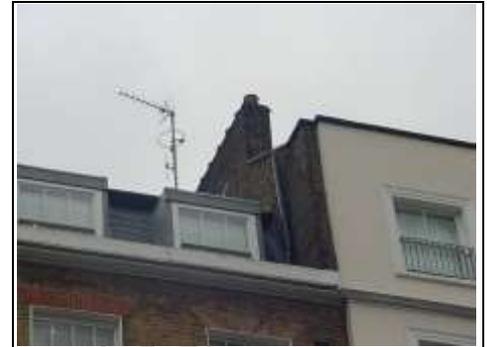
Dormer window

There are dormer windows to the front of the property which may have leaks due to the poor detailing to the box gutter. The dormer windows are lead covered. There does appear to be a leak internally.

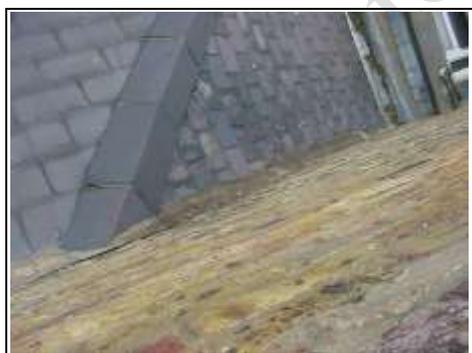
The neighbour's roof beds onto this property. Where a cement mortar has been used instead of a lead flashing hairline cracking is visible.

Neighbours roof beds onto this property. Cement mortar has been used rather than lead flashing

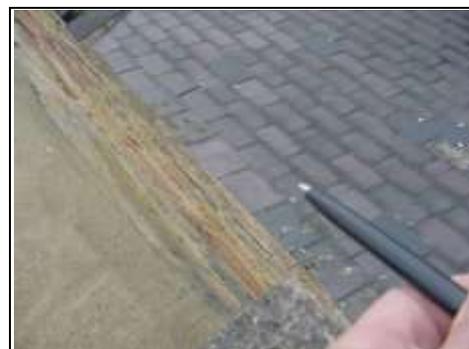
Hairline cracking.

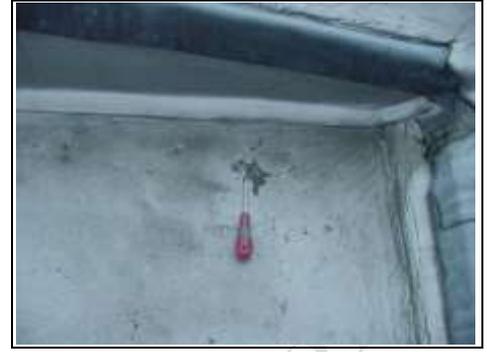
Solar reflective paint is  
wearing away

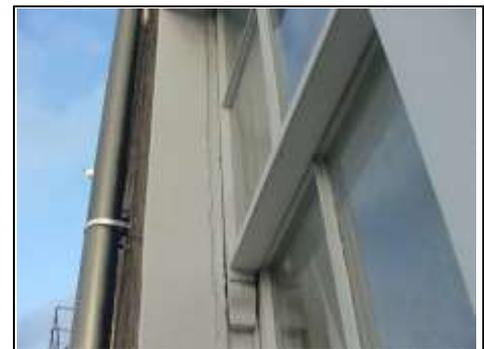
Hairline cracking to render on the reveals of the windows

We would add that any hairline cracks that appear need to be sealed as soon as possible to stop dampness and water getting in and causing blisters and hollow areas in the render.

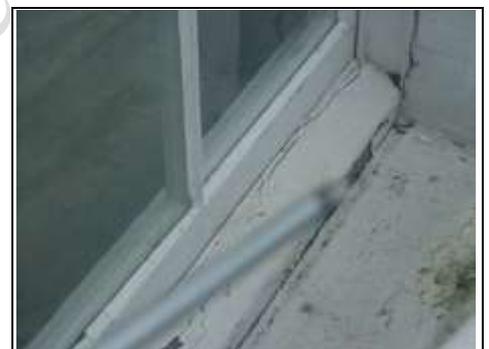
Timber windows need redecorating

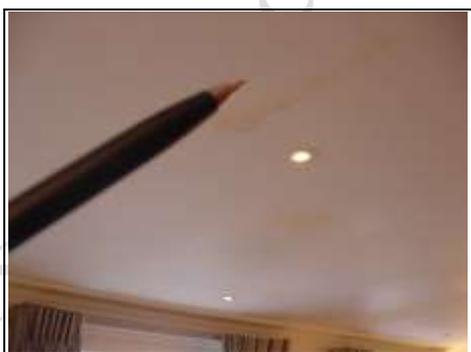
A leak has been painted over in the drawing room in Apartment Five

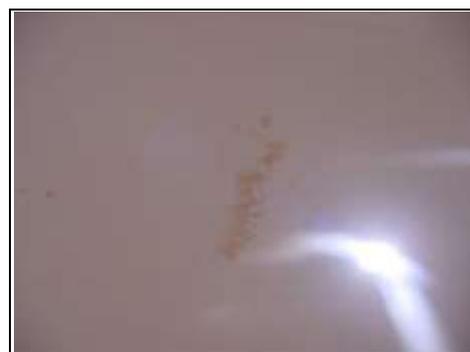
Dampness coming into the ensuite from the kitchen above in Apartment Two

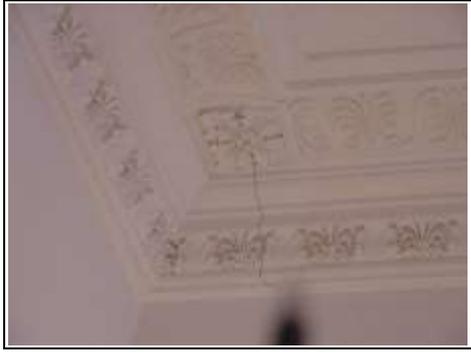
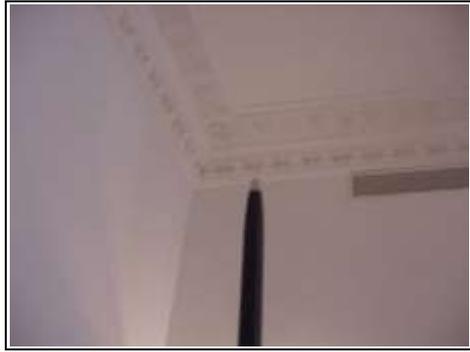
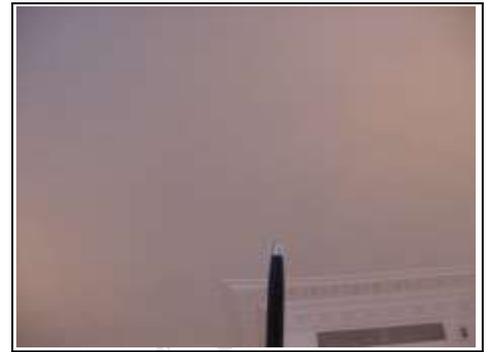
Cracking around the lift area in Apartment Four

**ACTION REQUIRED:** Please see our comments within the Executive Summary.

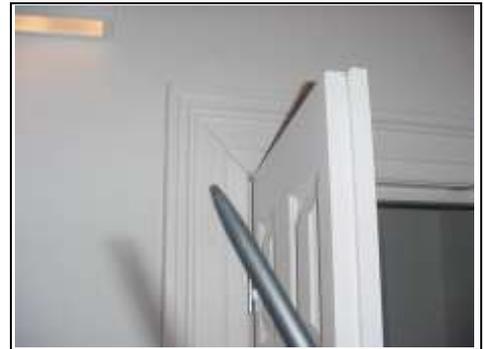
Cracking around entrance door to drawing room, Apartment Four

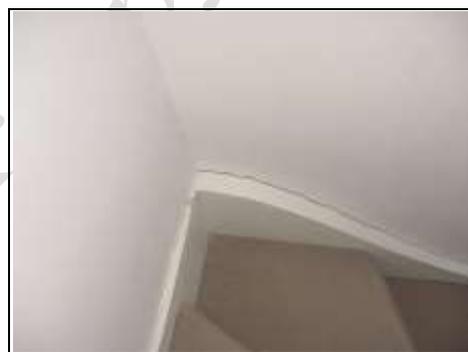
Cracking on stairs in Apartment Two leading down to bedrooms

**ACTION REQUIRED:** Please see our comments in the Executive Summary.

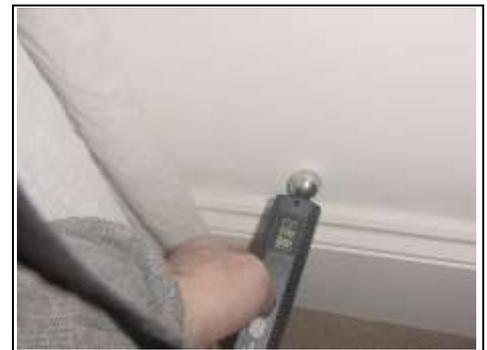
A random visual inspection and tests with a moisture meter have been taken to the perimeter walls. In this particular case we have found minor dampness to the lower ground floor. Looking at the detail externally we think that levels are higher but they are effectively hidden by the dry lining

Testing for dampness but the walls are dry lined

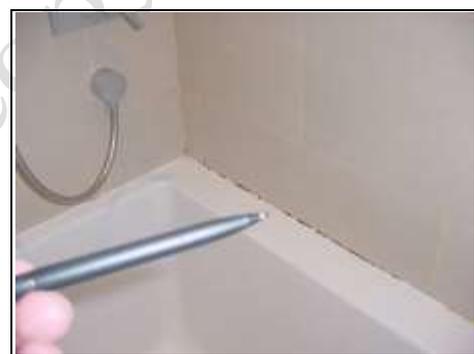
Condensation in bathroom  
Apartment Three

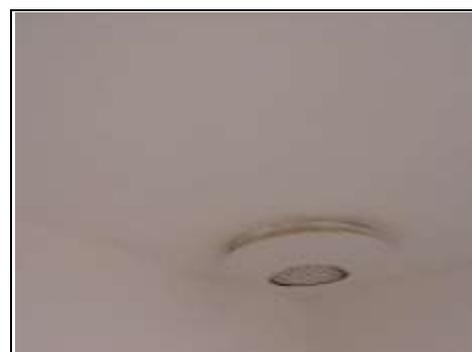
Extract fan is inadequate in bathroom of Flat Three
