# RESIDENTIAL BUILDING SURVEY

West Sussex, RH11

**Detached  
Tudor  
Property**

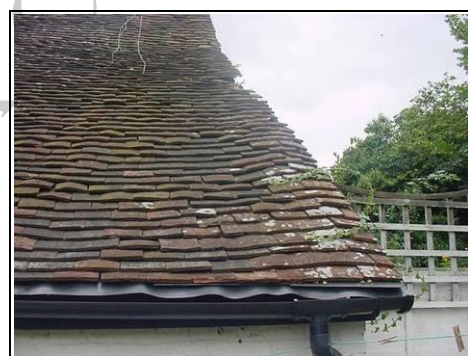
Where the old oak pegs have rotted away, and in some cases they have been replaced with ferrous nails, these have rotted or rusted.

Peg tiles

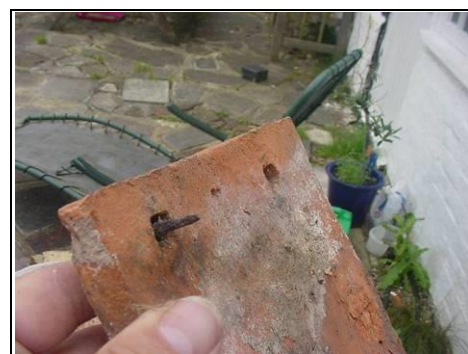
Close up of peg tile

More immediately and to get you through the winter of 2011 you need to replace all the cracked and missing tiles with similar. You also need to get a supply of hand made clay peg tiles for future use.

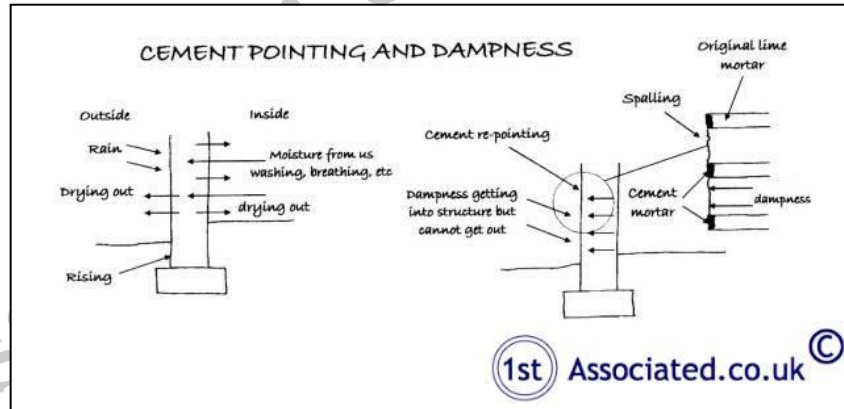
The chimney needs some work generally from repointing. You also need to check to see if it has been repointed in a cement mortar or lime mortar. It looks from ground level to be cement mortar.

Cement pointing

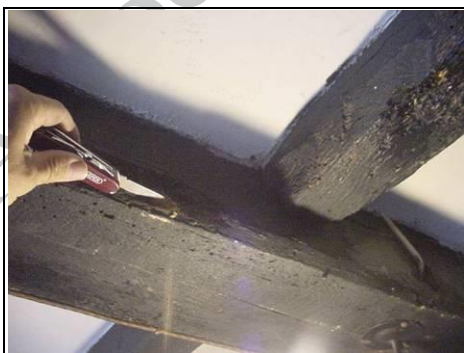
Internal spine beam with newish frass

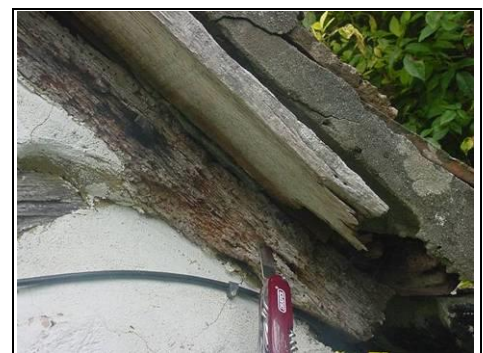
External timbers with woodworm which no longer looks to be active

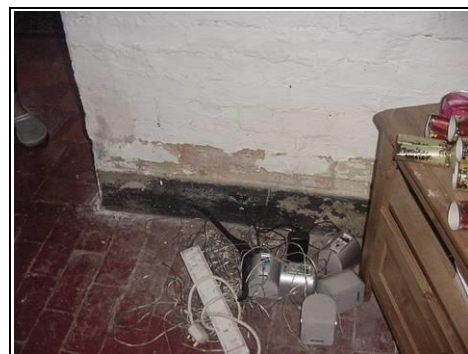
Lots of rising damp – paint coming off, we believe this to be a plastic based paint

**ACTION REQUIRED:** We would recommend that a French Drain is added around the property to lower the ground level which will lower the dampness.

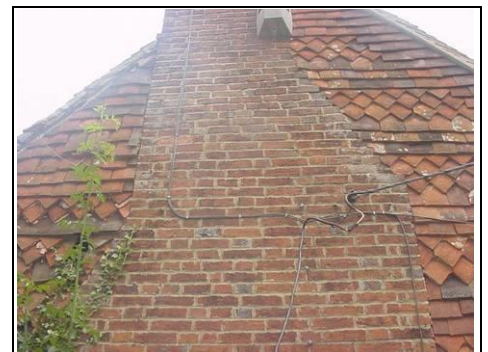
Chimney one – wrongly repointed  
in a cement mortar

**ACTION REQUIRED:** We feel the best way forward is to have a close look at the chimney from the top (using the tower scaffold that we have recommended you buy).

**ANTICIPATED COST:** We would set aside the sum of £750 to £1,500 to carry out repairs/rebuilding work. Please obtain quotations. Ultimately you will need to repoint the chimney in a lime mortar.

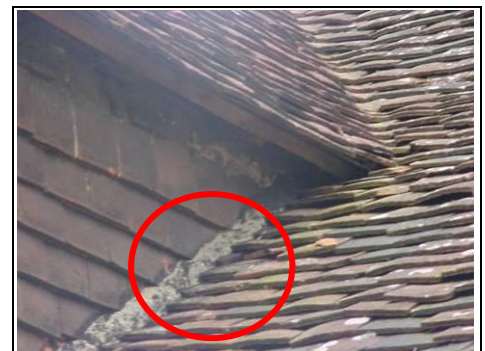
We can see some cement flashings. They may well be lime mortar judging from the colour. We would normally recommend a lead flashing but you do need to take guidance from your Conservation Officer with the local council on this as to what was authentic and it may be a lime mortar in this case.

Cement flashings rather than  
lead flashings

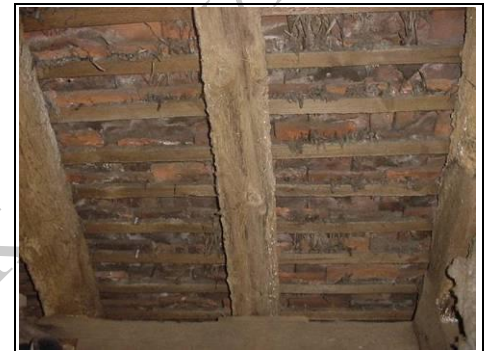
When we inspected the loft space we found there was no underfelt. It is therefore possible that during periods of heavy and prolonged driving rain some water penetration could take place through the roof coverings. At the time of our inspection this was not occurring.

No protective underlayer  
(no sarking felt)

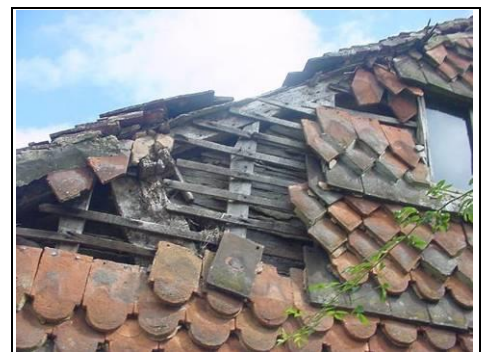
We noted vertical tiles coming off to left hand side of building.

Vertical tiles coming off to left hand side of building

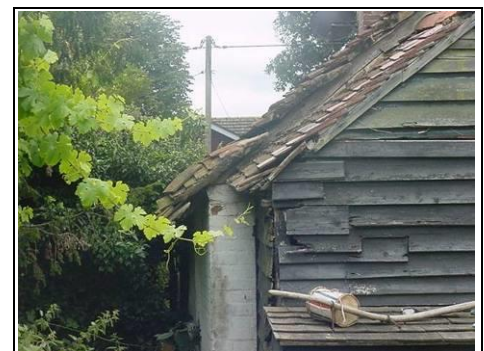
This shiplap boarding certainly has seen better days and needs tidying up, however you do need to focus mainly on getting the building wind and watertight before the winter of 2011.

Shiplap boarding deteriorating

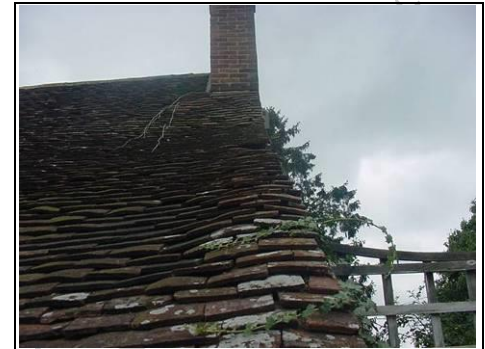
Cut back all ivy

**ACTION REQUIRED:** We would recommend that the ivy is cut down.

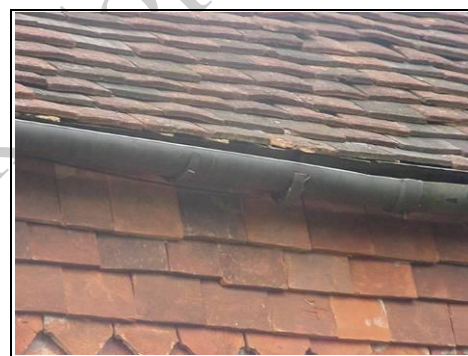
This gutter does not look to have a fascia board

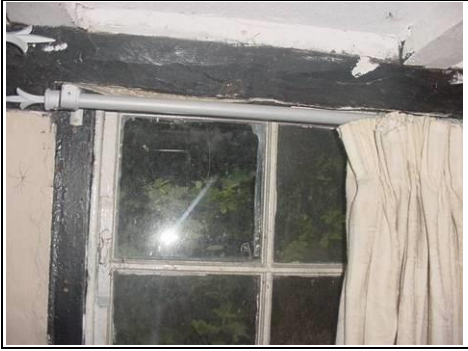
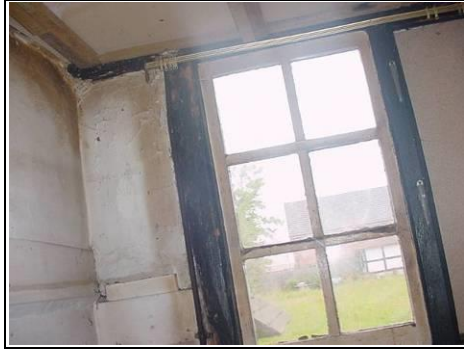
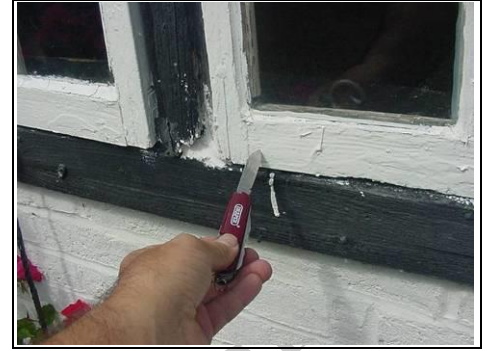
The windows are generally single glazed and therefore they will be draughty and cold in the winter months so you need good thick curtain and/or secondary glazing (like we mentioned). The ones that we have recently seen have been carried out by picture framers with glass in them and were a work of art.

Variety of windows – all in need of redecoration

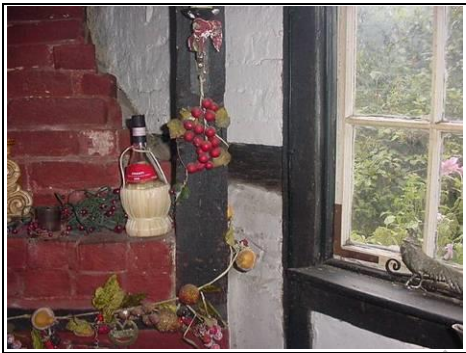
Metal bracket repair to a window

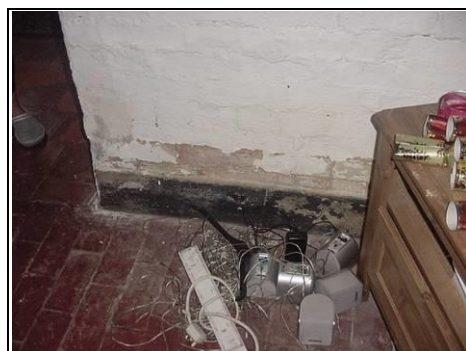
Lots of rising damp – paint coming off, we believe this to be a plastic based paint

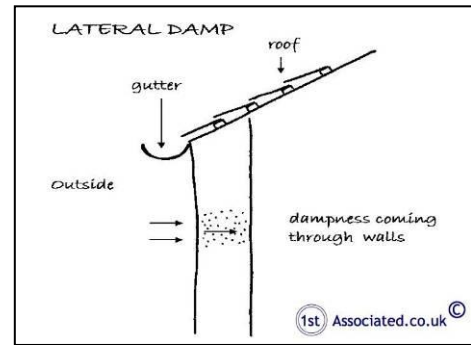
There is some lateral dampness. It is mainly to the walls on the ground floor, the vertical tiling is protecting the upper floor to some extent. Again, repointing is needed and you need to get this building breathing to reduce the dampness but you will never get rid of all of it.

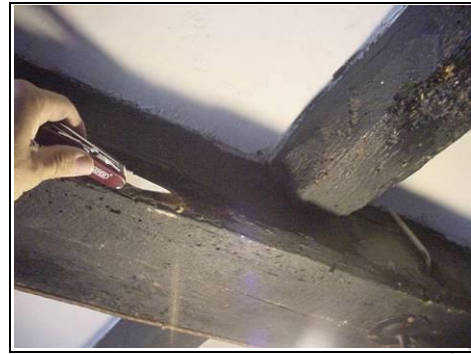
Woodworm with frass

**ACTION REQUIRED:** Please see our comments in the Executive Summary.

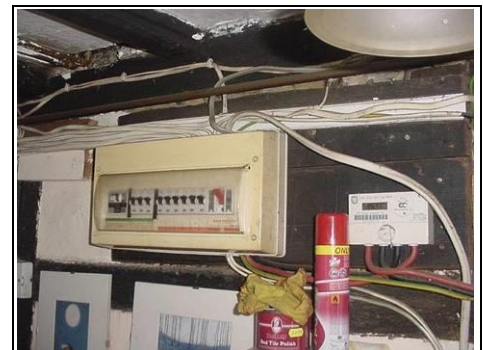
The electric fuses and consumer units were located in the kitchen. The fuse board looked dated and not the best currently available.

Fuse board

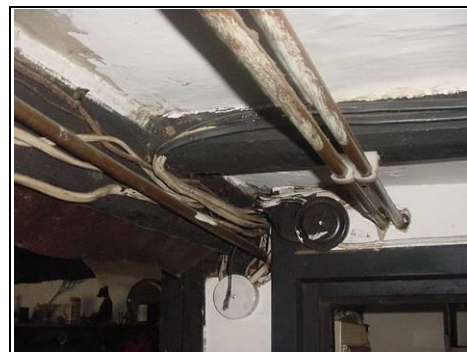
Surface mounted plumbing – plumbing could be better concealed

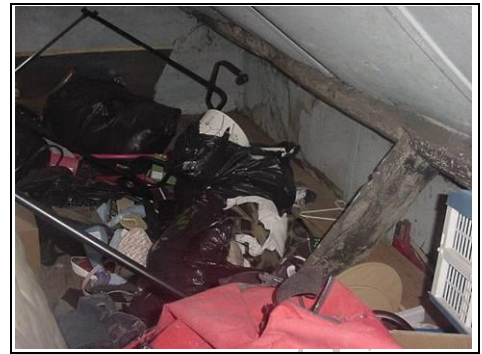
Some of the rooms were full of stored items particularly the rear store and the store rooms/cupboards off each bedroom
