RESIDENTIAL BUILDING SURVEY

XXXXXXXXXXXXXXXXXX,
XXXXXXX, Coventry,
West Midlands,
CV7 xxx

**Two bedroom
Semi-detached
Listed property**

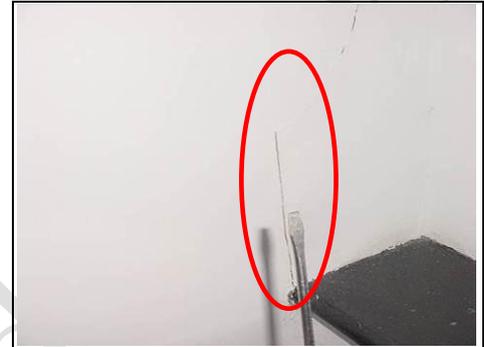
There are, however, cracks within the property for example to the top of the stairs and in the right hand bedroom. We believe these relate to the use of modern Gypsum plaster rather than a traditional lime plaster which the property would originally have had.

Crack at the top of the stairs

ACTION REQUIRED: Overtime to replace the modern plaster with an older style lime plaster.

ANTICIPATED COST: This really depends upon how the work is carried out. It could be carried out in small sections as patch repairs in which case the cost will be about £100 (one hundred pounds) at a time or as whole rooms in which case it will be £300 plus (three hundred pounds plus); please obtain quotations.

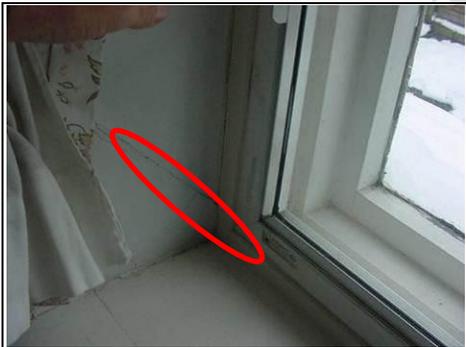
Crack near window of right hand bedroom

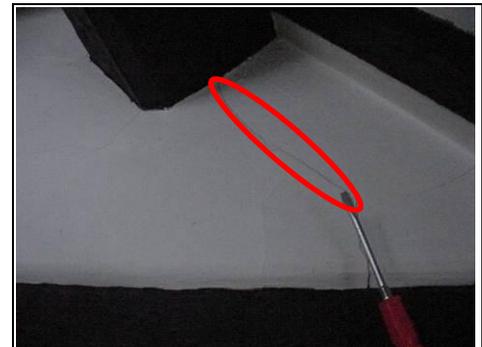
Crack in the right hand bedroom

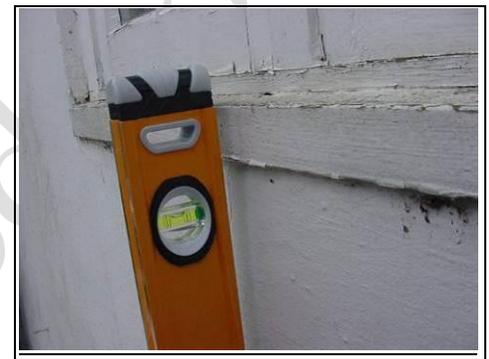
As is fairly common with this age, type and style of property the timber frame is out of square vertically and horizontally. It is important to establish if this building is settled in this position or if there is progressive movement. From what we can see there is no indication that there is any progressive movement.

Level shows the walls are out of true

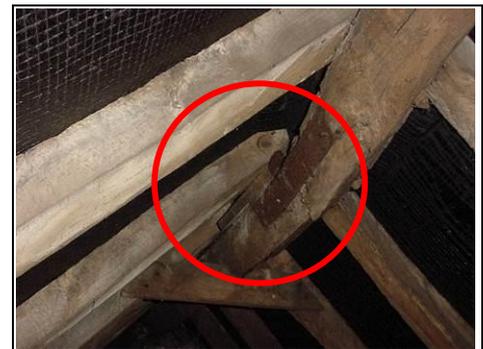
A metal bracket has been added where the ridge timber has given way in the right hand side roof. This is rusting. We would recommend a new metal bracket is added

Metal bracket added to broken ridge timber

ANTICIPATED COST: To replace the metal bracket £200 - £400 (two hundred to four hundred pounds); please obtain quotations.

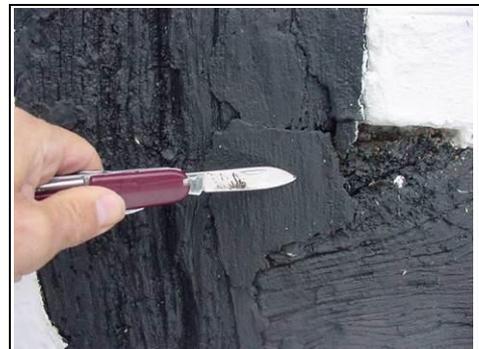
Cement or plastic repair

ACTION REQUIRED: A systematic repair and maintenance of the timber structure externally elevation by elevation in conjunction with the local authority Listed Building conservation officer. We would work one elevation at a time i.e. rear elevation, gable end elevation and then front elevation. We suggest one elevation is repaired per year and as such this will be a learning pattern for yourself and the Listed Building control officer who will possibly want to have an involvement with this property.

ANTICIPATED COST: We would set aside the sum of £1,000 to £1,500 (one thousand to one thousand, five hundred pounds) per elevation to carry out repairs probably splicing in new timbers subject to

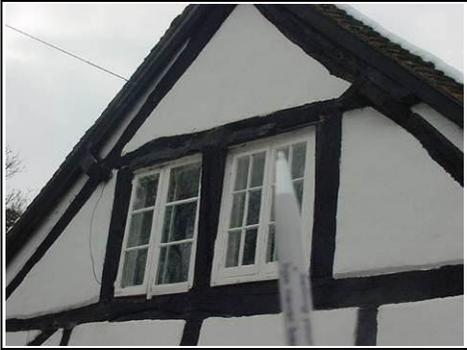
Our investigations are therefore focused on the primary structural timbers. We can see that repairs have been made to these over the years and also repairs have failed and work is required. A good example of this is the window to the gable end where we can see a hole that is a repair that has failed. We can also see next to it that there is a cement or plastic repair.

Hole above the window in gable end wall

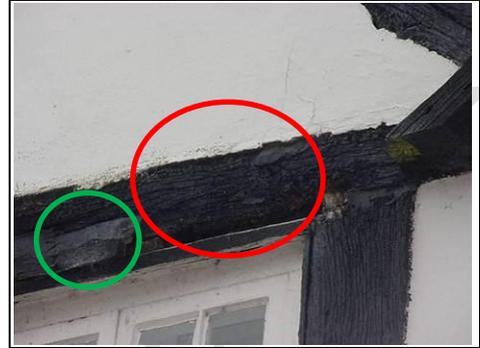
Hole above the window in gable end wall (red)
Cement or plastic repair (green)

From what we can see at ground level we don't believe there are any major problems with the structural frame but we do believe repairs need to be carried out.

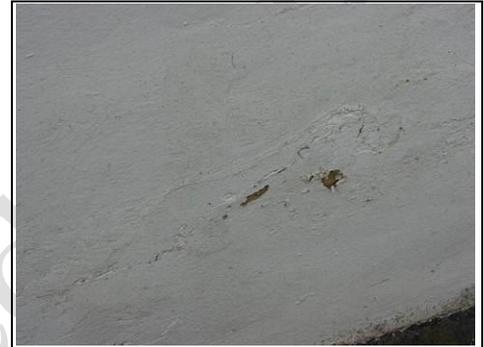
Paint peeling off and blistering on gable end wall

ACTION REQUIRED: Repair, prepare and re-decorate.

ANTICIPATED COST: In the region of £2,500 to £4,000 (two thousand five hundred pounds to four thousand pounds); please obtain quotations.

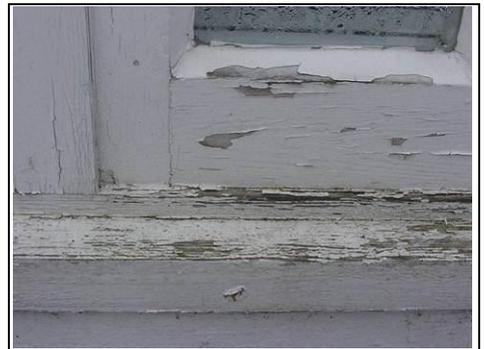
Paint peeling off the windows

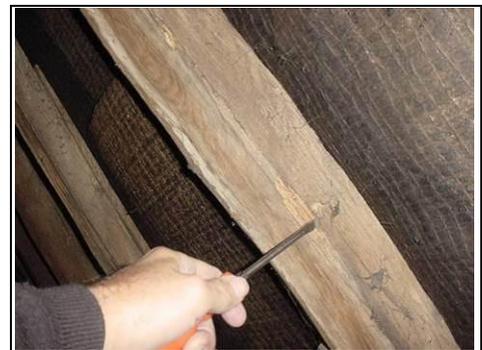
We can see that there is some dampness within the roof probably caused by the torn protective underlayer and the house being unoccupied. As is often the case where there is dampness there is woodworm. In this case it is minor woodworm and not what we would describe as structurally

Minor woodworm

ACTION REQUIRED: Seal the roof by repairing the protective underlayer/sarking felt.

ANTICIPATED COST: In the region of £500 - £1000 (five hundred to one thousand pounds) to carry out an internal repair which although is not ideal would improve matters. At the same time we would recommend ventilation tiles are added to reduce dampness and woodworm in the roof; please obtain quotations.

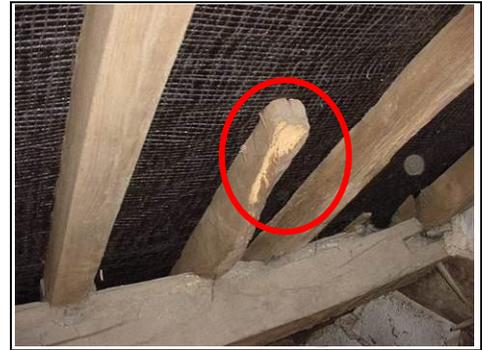
It does however warrant the benefit of further investigation. It is easier to see woodworm during their breeding season in the spring months where you can look for frass (chewed up wood that looks similar to sawdust). We would be more than happy to return to inspect the property during the spring months.

Signs of old woodworm

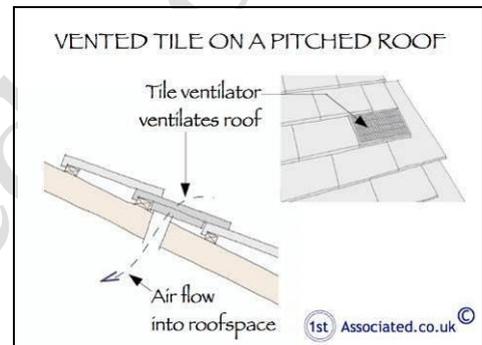
Vented tiles should be added

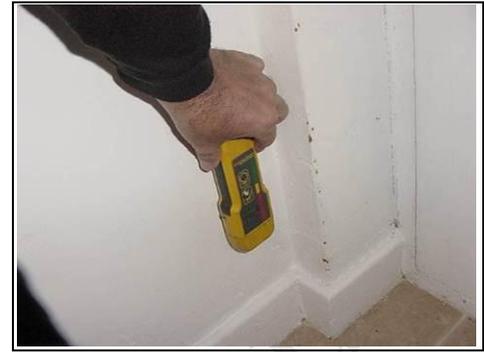
We were surprised the dampness was relatively low considering the property has been vacant albeit the heating has been on. The main dampness that was found was to the central wall areas. From our question and answer session with the present owners they advise that the dampness has been in place for years.

Minor dampness and rusting to the corner bead

ACTION REQUIRED: It is very difficult to get rid of the dampness internally without major work. We certainly would not recommend inserting a chemical damp proof course in this age of property. We would initially re-plaster in a lime based plaster and a breathable paint to see how this improves matters. We would also recommend the adding of a French Drain (please see our comments below) to allow the water to go around the water rather than through it.

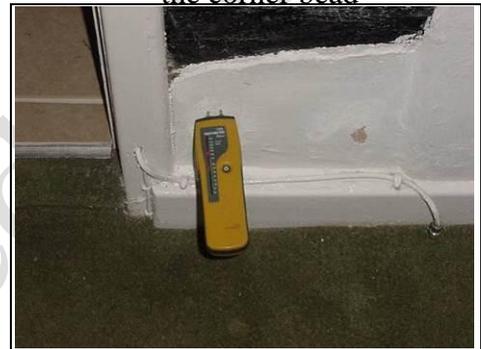
Dampness in the central wall within the lounge

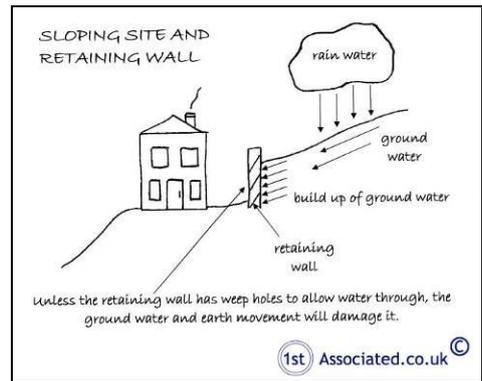
The property sits on a sloping site and as such the water needs to travel from the top of the site to the bottom of the site and the property is in the way. We noted there is a retaining wall in the garden and ideally this should have some weep holes in it to allow the water to travel through.

Sloping site

We do recommend with this age of property to have a French Drain added to run down the gable end side of the property. Care does need to be taken when this is carried out to ensure you do not damage the structural frame. However from what we can see there is bedrock to the right hand side.

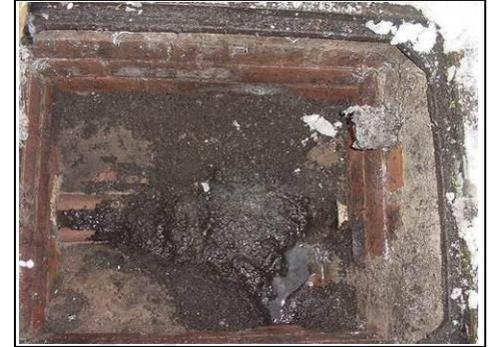
We lifted the rear drain and we could see that this had not been used for some time (the water had been turned off when we carried out the survey).

Drain may be blocked

ACTION REQUIRED: It may simply be a case of running the water to clear the drains or it may be necessary to power jet the drains. However, we would take care with this on older drains such as this which are a push-fit style as there can be problems. Ideally we would recommend a Closed Circuit TV camera report of the drains is carried out.

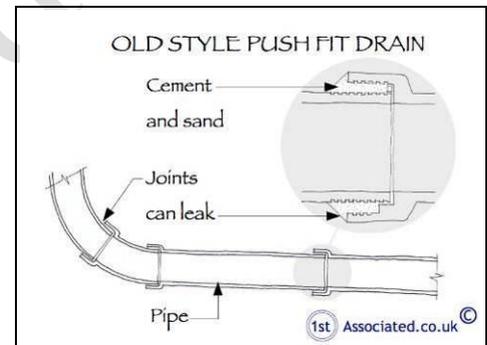
Push fit drain

as this, that drainage was often push fitted together rather than bonded together which means that they may leak over the years and tree roots can get in.

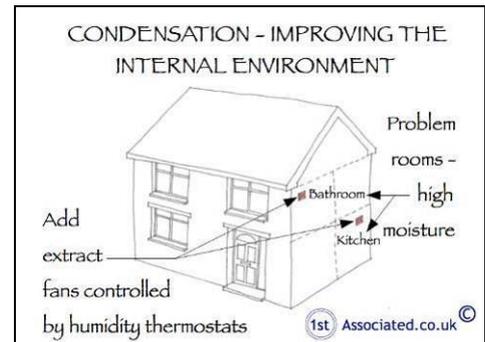
Condensation

ACTION REQUIRED: We would always recommend that you have large humidity controlled extract fans fitted in the kitchen and bathroom and any other areas likely to get condensation such as if you were to use the second bedroom to dry clothes in.

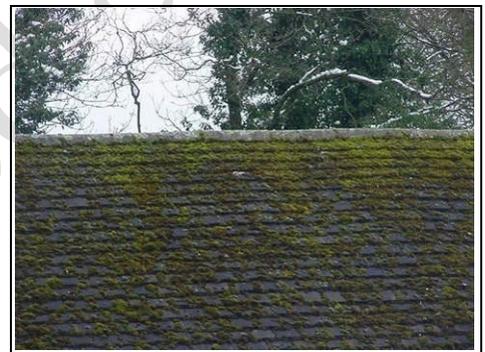
The roof is pitched and clad with a small nibbed machine made tile. This is possibly concrete as it has a large moss covering which is common for this type of roof. This is likely to have been replaced in the 1970's and from ground level, this looks in average condition considering the roofs age type and style.

Main roof with moss on it

ACTION REQUIRED: We would recommend clearing the moss. Please see our comments with regards to the sarking felt in the Executive Summary.

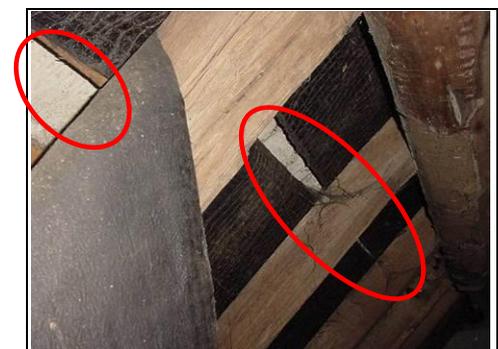
There are some splits and gaps in the underlay that need repairing.

Splits and gaps in the underlayer

ACTION REQUIRED: Please see our comments within the Executive Summary.

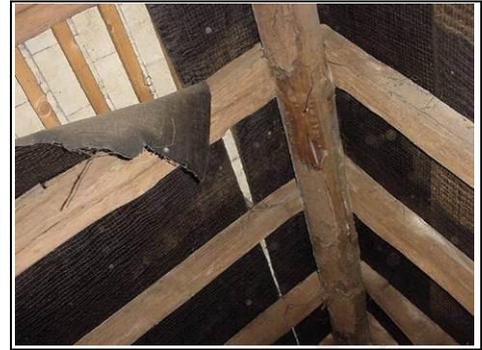
Quartered timber with bark left on in left side roof.
Underlayer torn

2. The woodworm in the roof. We would recommend increasing the ventilation and have the roof re-checked in the spring months.
3. The securing of the purlins by adding additional props.

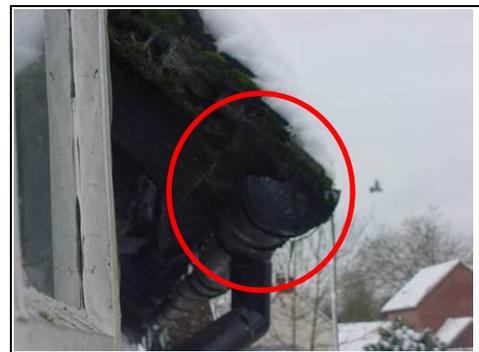
The guttering to the rear looks to be out of alignment but we really could not tell if there were any problems due to the snow. We noted that the gutters were full.

Guttering out of alignment

ACTION REQUIRED: Realign the gutters. We would recommend you stand outside the property next time it rains heavily and see how well the drains cope with the rainwater particularly looking at the guttering and the joints.

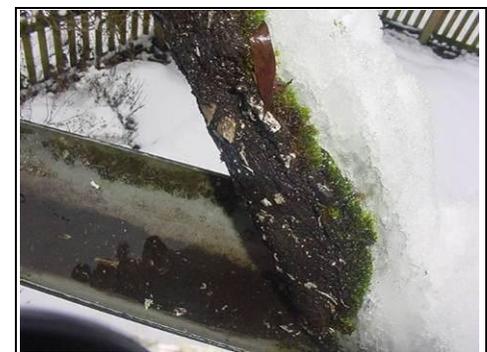
Gutters need cleaning

We would also recommend that the gutters and downpipes are cleaned out, the joints are checked and the alignment checked to ensure that the gutters fall towards the downpipes.

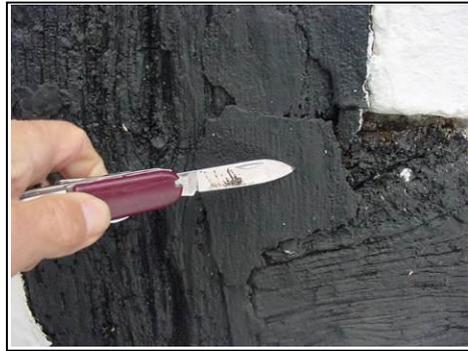
Plastic wood repairs to the timber structure

ACTION REQUIRED: Please see our comments within the Executive Summary.

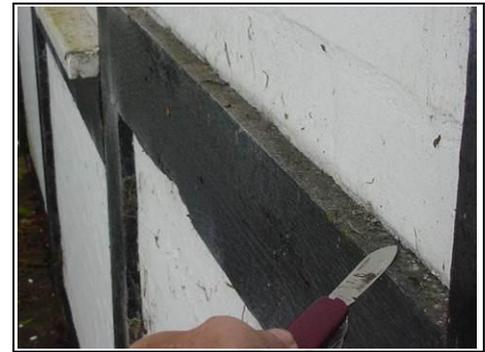
Stick on timber to right hand side extension

Timbers needs re-staining

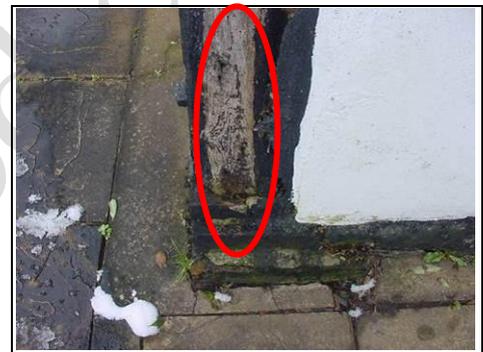
Timber needs re-staining

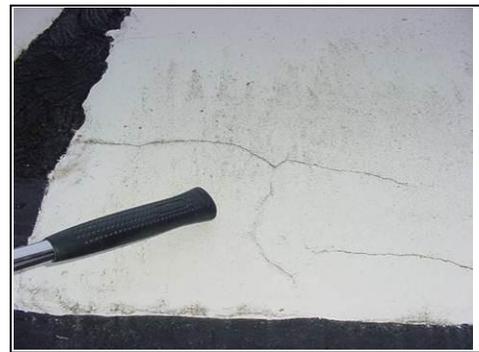
We always take a second look at the render as it may be hiding wattle and daub. We have carried out a tap test (literally hitting the render with the back of a hammer). We found some hollow areas where the cracking is visible.

Loose render around the cracking

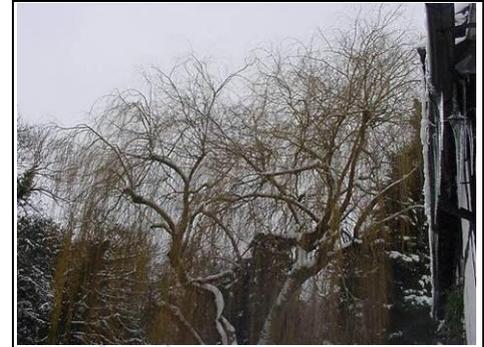
Willow tree

ACTION REQUIRED: We would have a cup of tea meeting with the next door neighbour to understand their thoughts and ideas with regards to the tree and the problems it's caused with regard to their drains. Please see our comments within the Executive Summary.

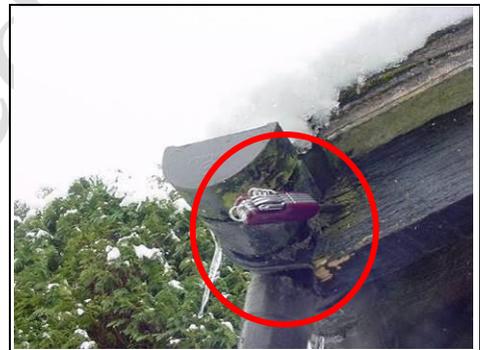
Wet rot to barge board

ACTION REQUIRED: Make sure gutters and downpipes are watertight before carrying out any work on fascias and soffits.

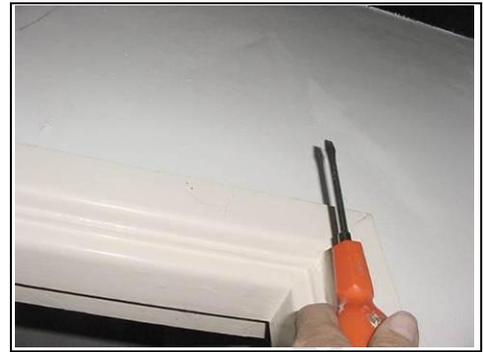
The property has been built in bays as is typical with older timber framed properties. Internally we can see a modern plaster has been used. There are numerous areas of cracking which we believe to be due to the modern plaster being used rather than a lime plaster. We would have to take samples of the plaster to fully understand how it is made up.

Crack in plasterboard on first floor

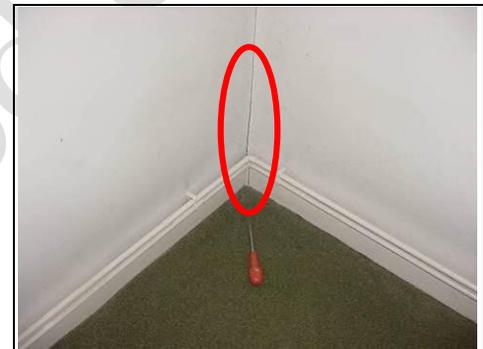
Crack in front right hand

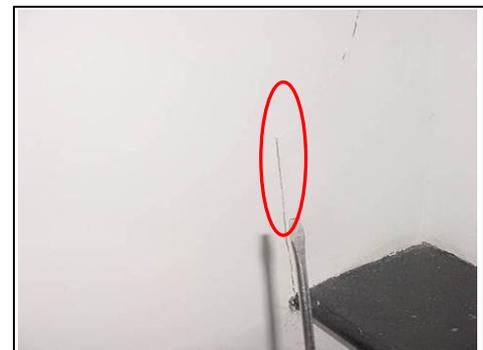
Crack at the top of the stairs

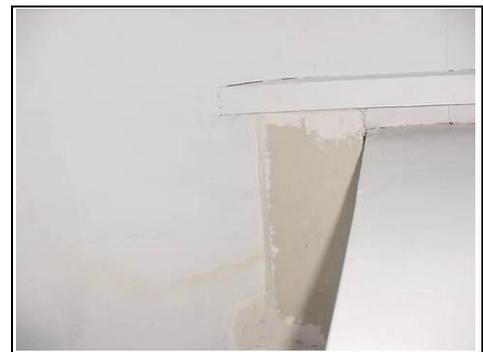
New plastering around the chimney indicating that some dampness is getting in

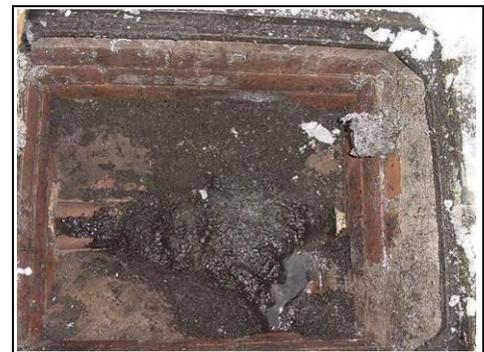
At the time of the inspection the rear drain appeared blocked. However this may be because the water has not been turned on for some time. We would recommend initially running the taps to see if it does unblock. It may even be that this rear drain is for the rainwater pipe and there may be a hidden drain underneath the snow. We would generally comment in older properties, such

Manhole is full

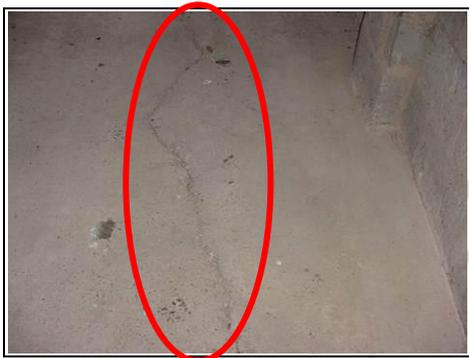
Crack in the floor follows the line of the building

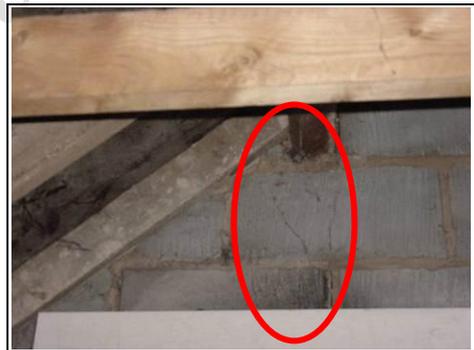
Crack can be seen in the block work
