RESIDENTIAL BUILDING SURVEY

Shooters Hill, London,
SE18 xxxx

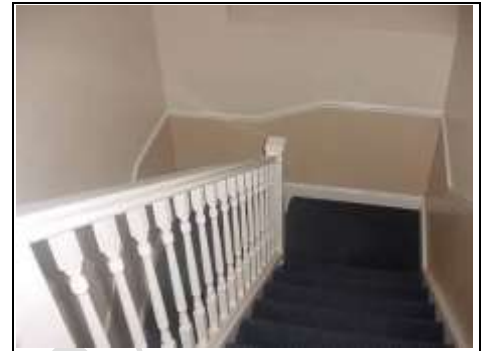
Communal stairwell
These would benefit from
re-decoration

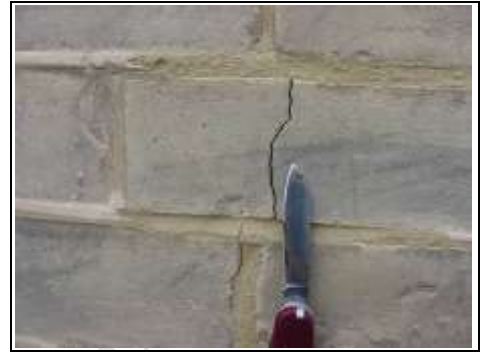
We can see vertical cracking in the bricks particularly to the right hand side wall. Internally there is also cracking particularly to the rear right hand bedroom.

Vertical crack in the brickwork

ANTICIPATED COST: Usually, if there are any problems, as stated above it will be limited to the excess of the policy. You do need to speak to the freeholder about this and inform them that your survey has identified that there has been/is movement in the property albeit minor at present; please obtain quotations.

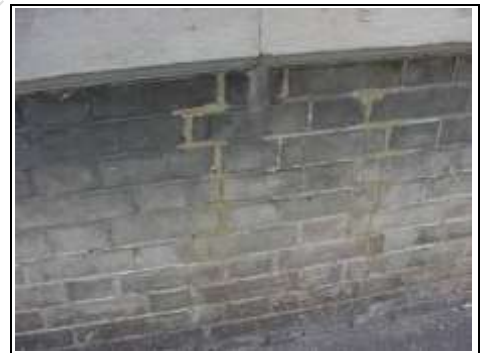
Repairs to cracking

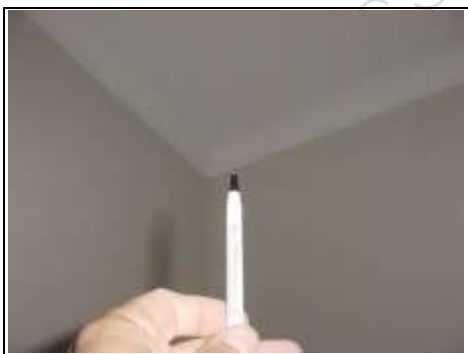
Internal cracking

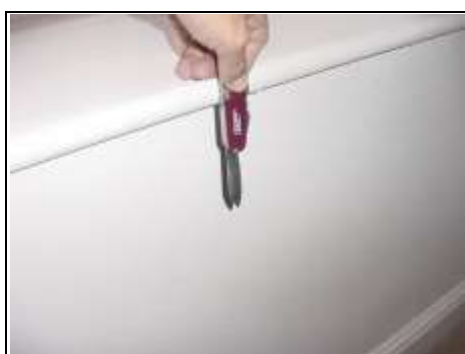
Cracking- lounge - front right

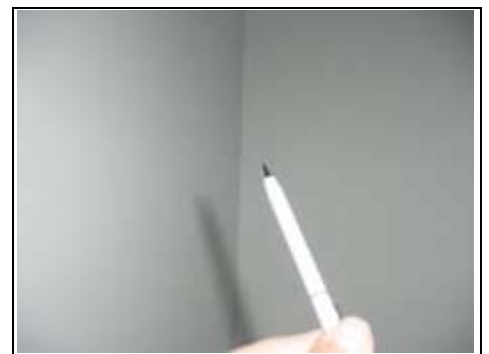
Cracking – rear right bedroom

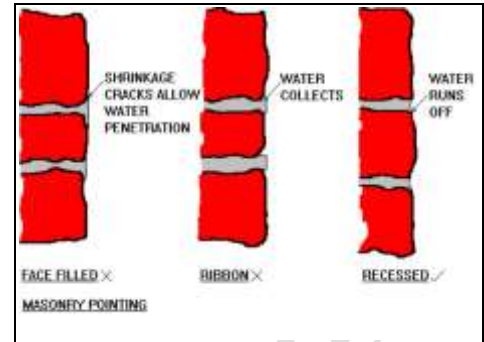
Unfortunately the cement re-pointing, whilst well meaning, is not appropriate for this type of construction. A cement mortar has been used rather than a lime based mortar. We recommend you use lime mortar in any future repairs regardless of what the builders say! Using lime mortar will limit further damage to the brickwork, which is almost impossible to repair successfully. However, we would add that many, if not most, of the properties that are re-pointed are re-pointed wrongly; it is only in recent years that we have discovered the problems that can occur from it.

Re-pointing

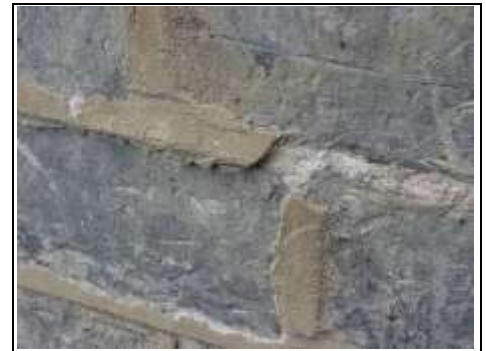
Poor re-pointing.
Just a skim coat we are amazed it has stayed on.

Re-pointing coming away

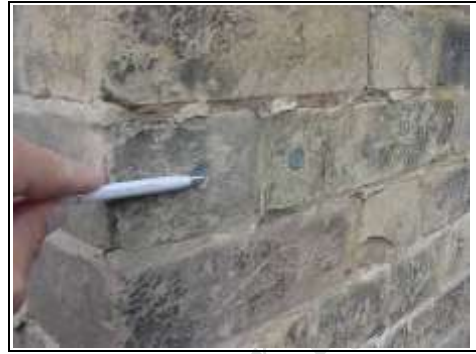
Damp proof course – right hand side of property

ACTION REQUIRED: We would recommend that you meet your downstairs neighbour for a cup of tea before you purchase the property to ask if they still suffer from any damp problems.

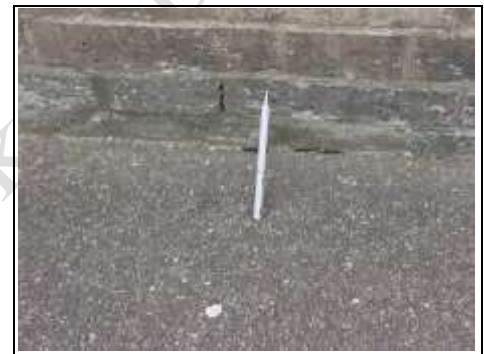
Damp proof course is too low for the ground level

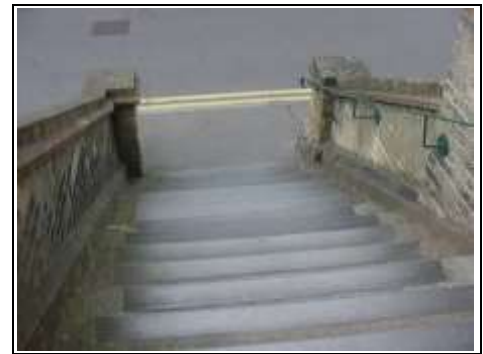
Dampness may be coming in via the stairs

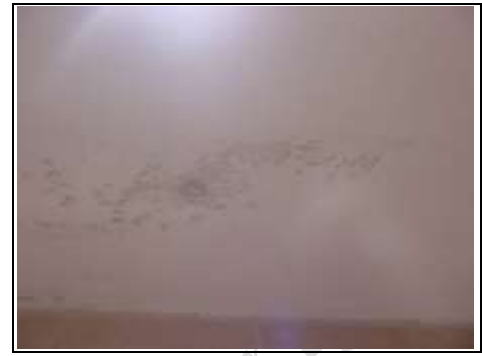
We noted mould in the internal bathroom. Whilst the mould and condensation may be partly due to the lifestyle of the previous occupant we would recommend that you install large humidity controlled extract fans. We would add that it will be a struggle to stop the problem of condensation altogether due to the design of the bathroom being internal and also the low ceiling height.

Mould in the bathroom

ACTION REQUIRED: Add large humidity controlled extract fans to the bathroom and ideally the kitchen. The beauty of humidity controlled extract fans is they switch on and off by themselves.

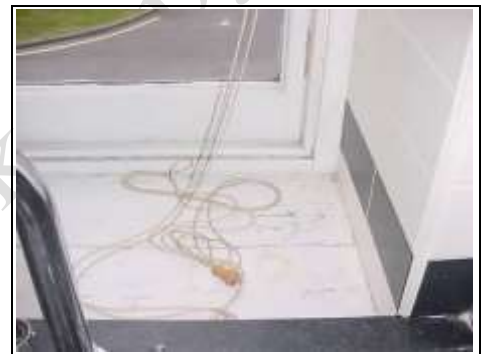
We can also see what looks like condensation to the sliding sash windows. This may be water ingress via wind driven rain. You may wish to think about a secondary glazing system assuming that the landlords and the local authority/ listed buildings planners give approval.

Kitchen window sill.
Signs of condensation.

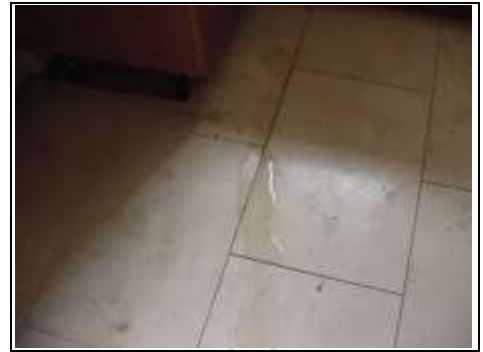
The kitchen floor has been laid on top of the old kitchen floor and has been cut around the units. In our experience this means that if there is any water that leaks (there was a leak at the time of our inspection) the water can get behind the units and under the floor causing the floor to blister (lose its grip) and also dampness can enter the apartment below.

When we ran the tap water leaked onto the floor

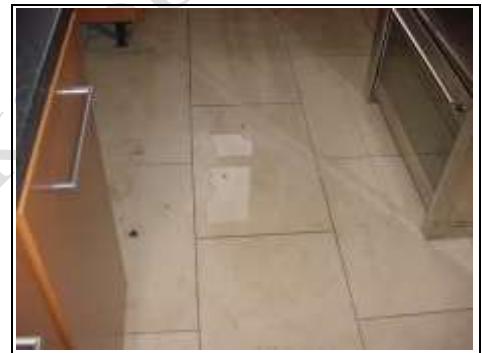
Leak in the kitchen

ACTION REQUIRED: Check the plumbing under the sink. Ideally you should tile under the kitchen units so that there is not a drop in that area where water can get in. As previously mentioned you need to have a cup of tea meeting with your downstairs neighbours.

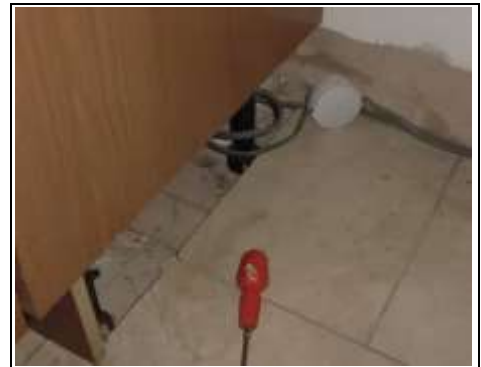
Tiled floor has been laid on the old floor and cut around the units

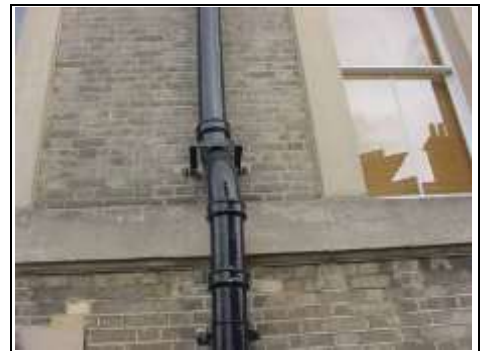
What we have noticed is that it looks like you have asbestos downpipes (we cannot be certain as they have been painted over many times. A good management

Possible asbestos downpipes

Our insurance company require us to advise we are not asbestos specialists. We recommend you have an asbestos survey carried out by a specialist asbestos company.

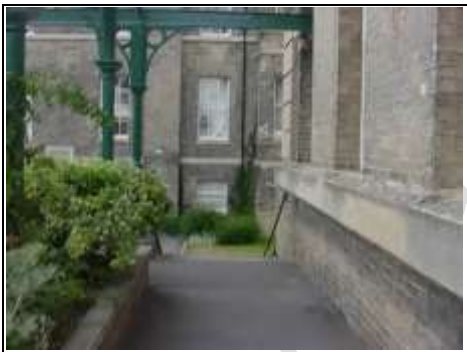
It was noted when we carried out the survey that other occupiers literally walk right past your window to the side of the property and to the rear. The entrance to the block of properties is at the rear. You need to revisit the property and make sure you are happy with this.

Passage way to the side of the property passes your windows

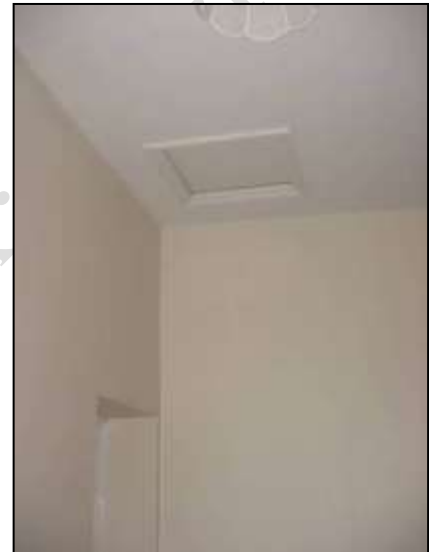
We did not feel we could safely access the roof space with the ladders that we had and more importantly be able to get out of the roof space!

Very high Roof access
Our ladder was not long enough

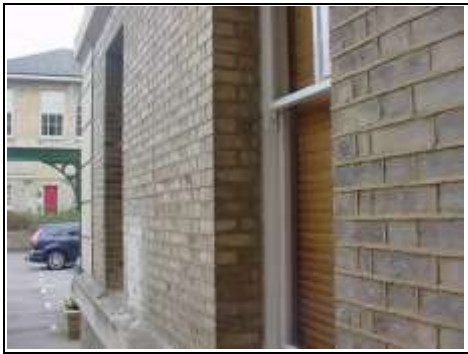
From what we can see, whoever carried out the re-pointing does not understand the usual process of working on a Listed building.

Re-pointing carried out in cement and not lime

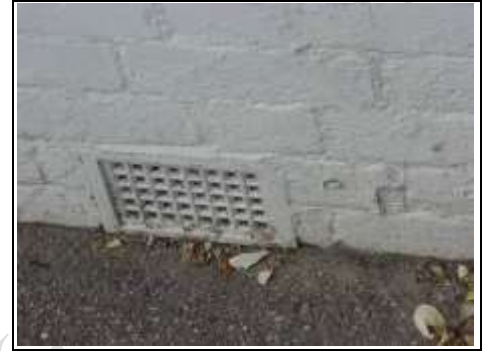
We smelled gas here. Is this the gas vent for the boiler in the property below.

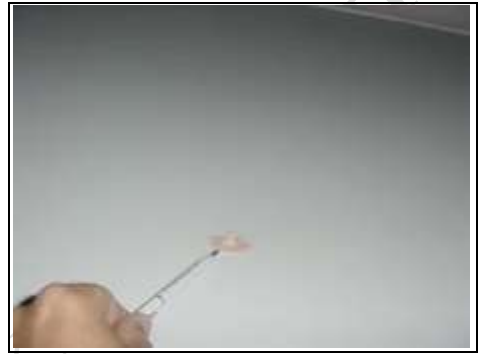
In some areas we can see popping which is where the plasterboard does not cover the nails sufficiently and has popped off.

Skim coat of plaster coming away

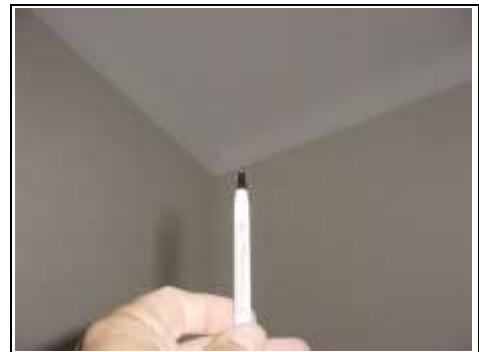
We noticed some cracking internally although it is quite difficult to see on the photos. The cracking internally and externally is a concern.

Cracking

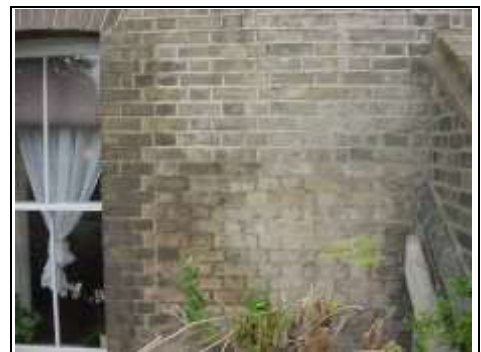
We noted that the downstairs neighbours flat, which is where the damp proof course was inserted, had what looked to be a wet area to the front of the property which may be from a leaking rainwater gutter at high level (check next time it rains heavily). Remember that this flat is partly underground and that it is directly under your property. We knocked on the door to ask about this but did not get an answer. Our concern is that this dampness may affect your property.

Wet area to flat below – right hand side of property

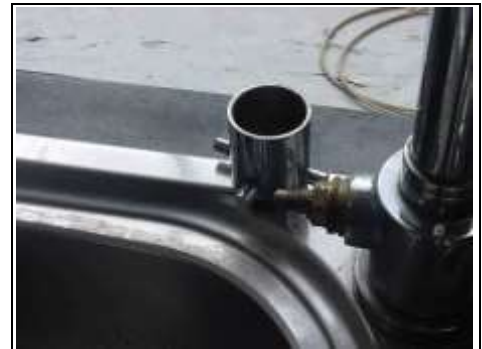
We found the kitchen in average condition, subject of course to some wear and tear as one would expect. Please note our comments with regard to the floor in the Executive Summary and the tap did come off in our hand.

Tap fell off in the kitchen

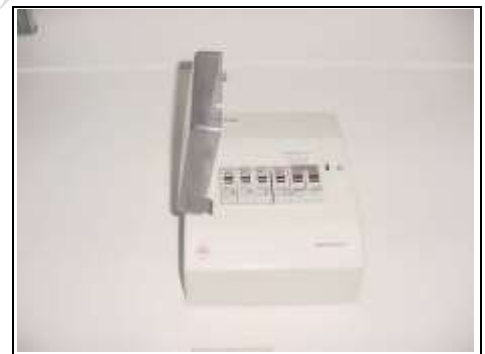
The electric fuses and consumer units were located in the hallway to the right hand side. The fuse board looked to be dated, circa 1990's, which was when the property was refurbished, better are now available. In multi occupied properties a defective fuse board can be particularly dangerous.

Fuse Board

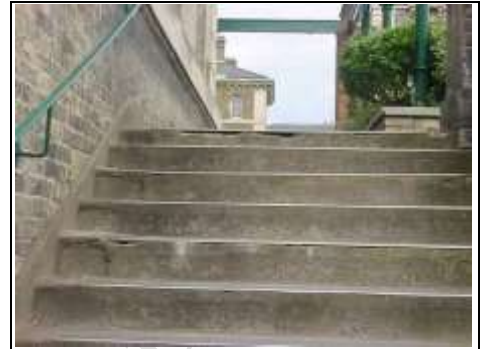
Stairs need repairing
