RESIDENTIAL BUILDING SURVEY

Worcestershire
WR10

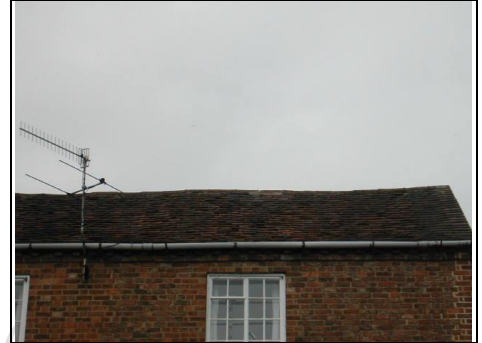
Roof

- a) The roof is undulating and there are some missed and slipped tiles.
- b) The valley gutter has been repaired in the past. We could not see any evidence of leaks but it will require regular maintenance. There is evidence of some sludge in the gutter and some slipped and loose tiles.

ACTION REQUIRED: The roof and valley gutter will require regular maintenance.

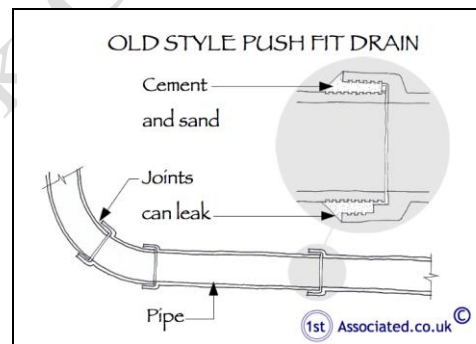
In older properties, such as this, drainage was often push fitted together rather than bonded together which means that they may leak over the years. The only way to be 100% certain of the condition of the drains is to have a closed circuit TV camera report.

Push fit drain

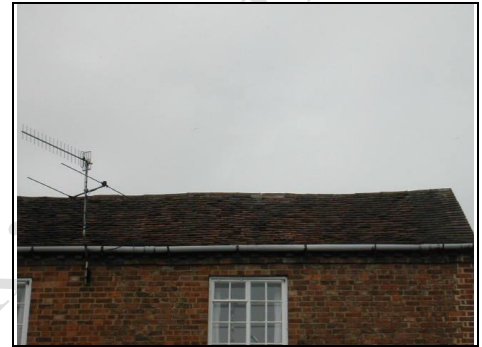
Front roof

The covering of both pitches is plain clay tiles. We noticed that some tiles have slipped on both the front and rear pitches. The profiles of the roof pitches are undulating and there are gaps in the mortar to the ridge tiles.

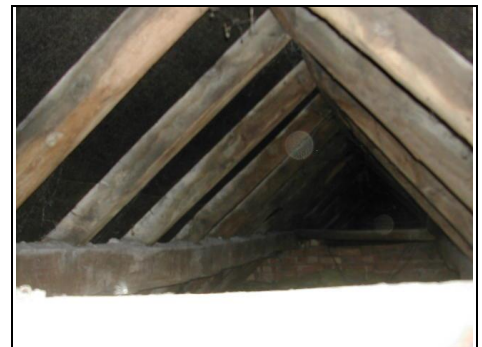
Roof timbers

The vendor informed us that there have been some roof leaks in the past and that these have been repaired. When viewed inside the roof space the lower part of the roof slope has been re-boarded. The valley gutter has been re-lined. However there is some sludge and pooling of water in the gutter together with some slipped tiles.

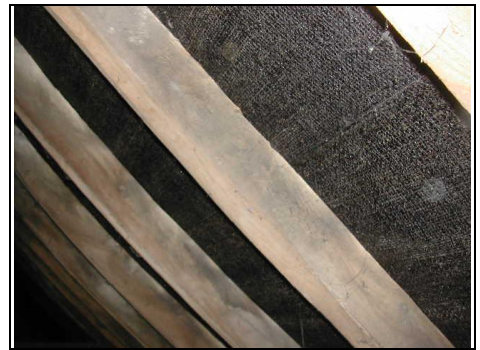
Roof rafters

We believe that at some stage within the last 25 years some rafters have been renewed, as they are regular in shape compared to the purlins, which we consider to be original to the property.

We noted one split purlin and a purlin that has a bowed shape.

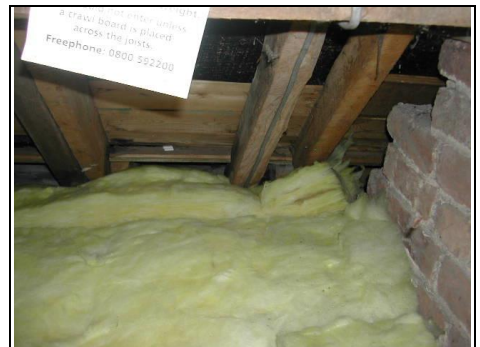
Re-boarding to the base of the valley gutter

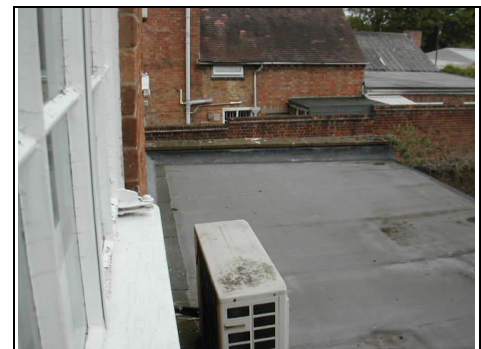
Flat roof

From what we could see this roof looked to be fair condition with some evidence of water pooling. There is a low height parapet wall at the end of the roof. This requires some minor pointing and checking the top of the parapet is secure.

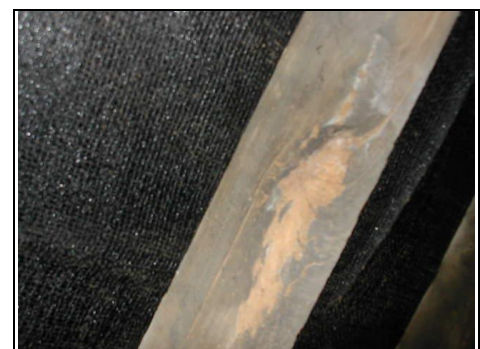
- Evidence of wood boring beetle in many areas.
- A split and bowed purlin.
- Incomplete areas of brickwork forming the end walls.
- Inadequate roofing insulation in places.
- Poor pointing of brickwork.
- Deflection in the gable wall.

Evidence of wood boring beetle

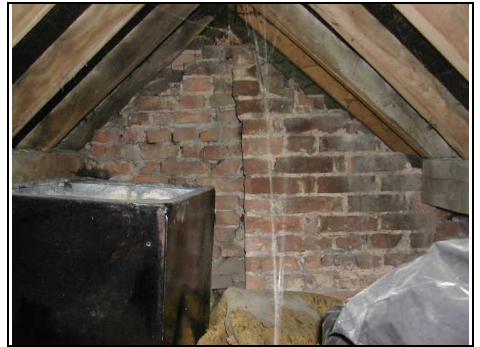
Deflection in end wall

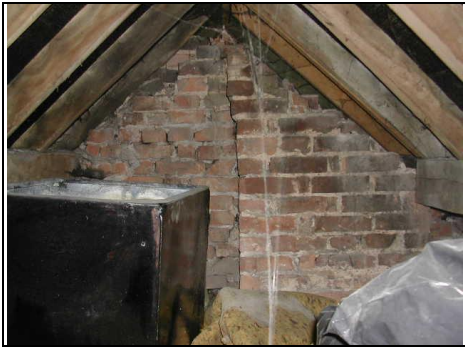
We noted one redundant water tank plus another, which we presume is the header tank connected to the central heating system.

Old water tank

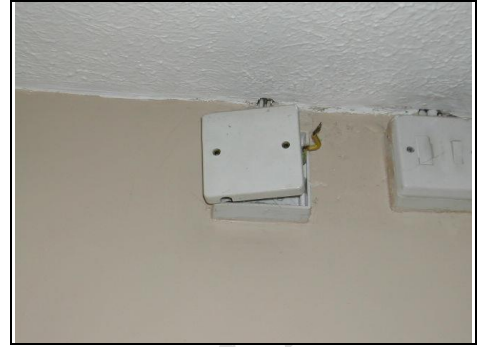
We can often identify the age of an electrical installation by the age of wiring found in the roof. In this case there are a number of older sockets and wiring plus some new wiring and fuse boards.

Loose electrical box

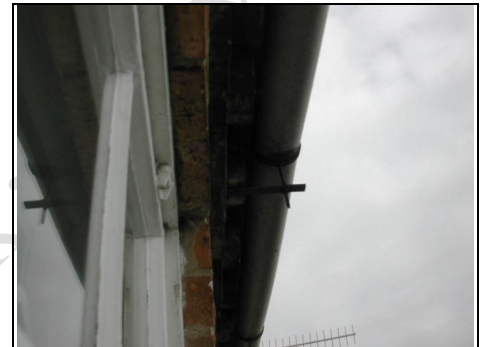
Plastic gutter to rear elevation

The downpipes feed directly into the ground so if there were a blockage then the drain would have to be opened up. This is a practice we are not particularly keen on; we would much prefer a gully.

ACTION REQUIRED: We would always recommend you stand outside the property next time it rains heavily and see how well the drains cope with the rainwater particularly looking at the guttering and the joints.

We would also recommend that the gutters and downpipes are cleaned out, the joints are checked and the alignment checked to ensure that the gutters fall towards the downpipes.

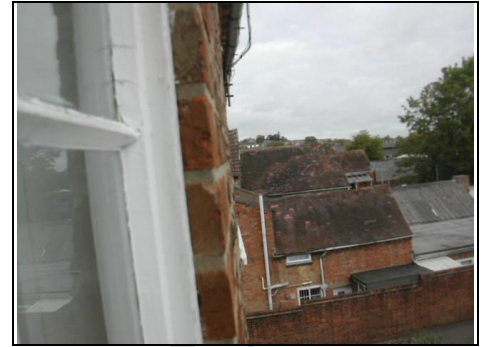
The rear elevation wall bows out which is an area of concern. Without opening up the structure we are unable to say whether this movement is continuing.

Bow in outer wall

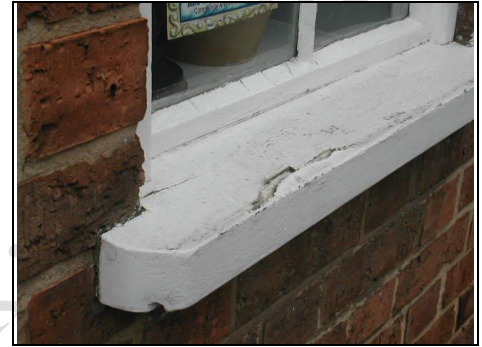
External decorations are mostly fair but some areas will require attention in the next 12 months.

Poor decorative condition

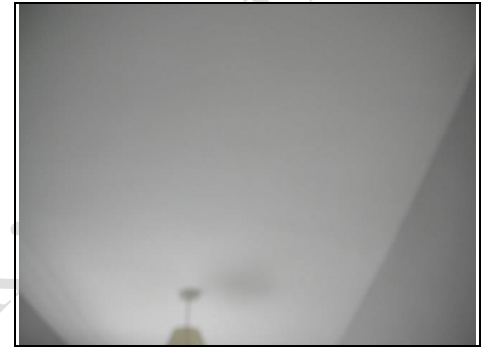
Several rooms contained ceilings that are undulating and which contained a number of cracks. This is not entirely unexpected in a property of this age.

Undulating ceiling

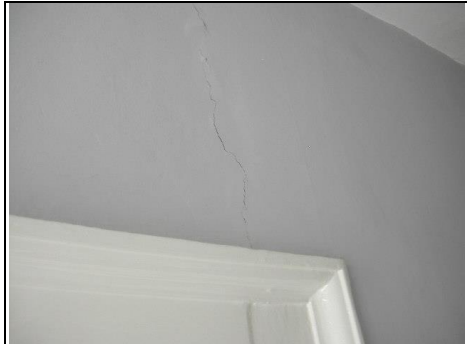
Internal wall cracks

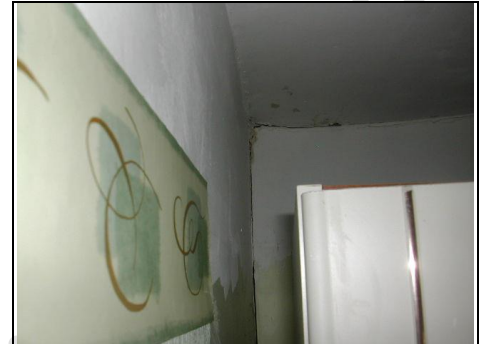
Cracks in Bedroom 3

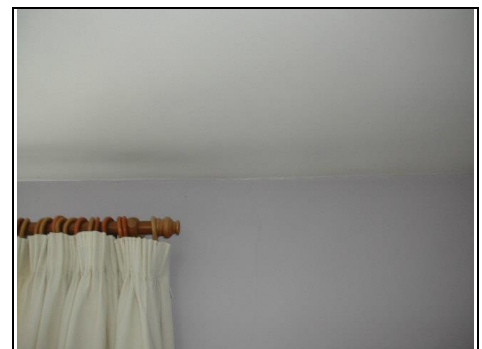
Originally these would have been constructed with a wet plaster, possibly a lime plaster and we think this remains to be the case. Walls are not flat and true and there are numerous cracks most notably around the lintels at the top of windows. We noted the rear elevation wall is bowed and this will require close monitoring to ensure the wall remains stable.

Cracking above window lintel

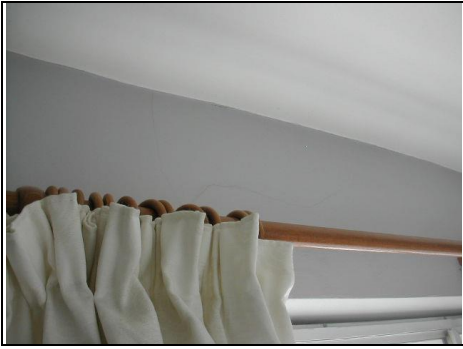
Cracks in external wall above window

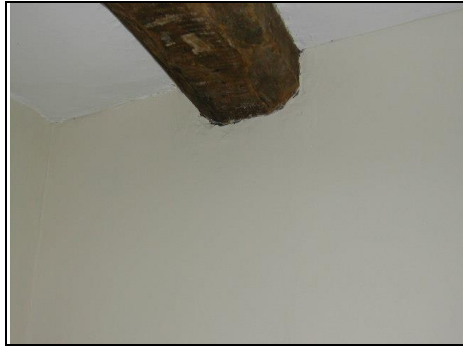
Cracks around centre beam

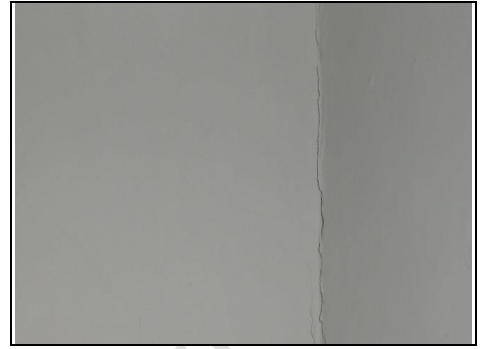
Wall cracks

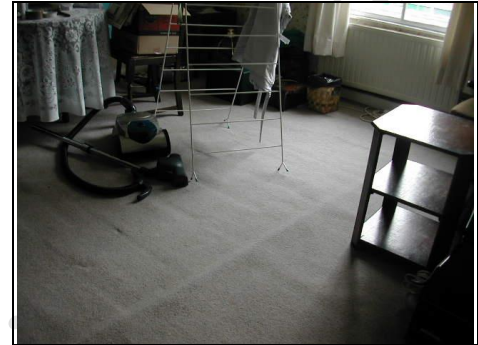
Reception room 2 floor

As with most older properties; the ground floor is not level and true. There are several areas of significant undulation most notably on the first floor landing at the top of the stairs; we noted this is consistent with the position in the rear wall that bows out. We believe that this is not unusual for a property of this age and type. We would only be able to ascertain whether there any serious structural issues with the floors if we opened up the structure.

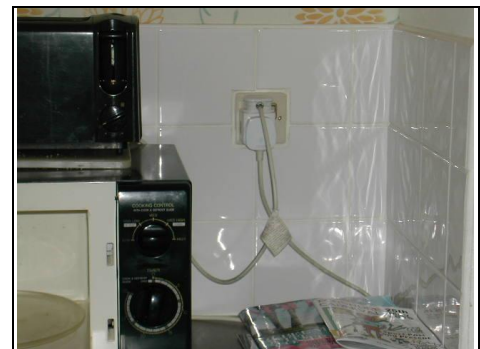
The electric fuses and consumer units were located in the porch. The fuse board looked newish but we noted older style sockets and fuse boards.

Older style sockets
