Georgian/Regency Example Residential Building Survey

The property is Grade II Listed, as found in BritishListedBuildings.co.uk

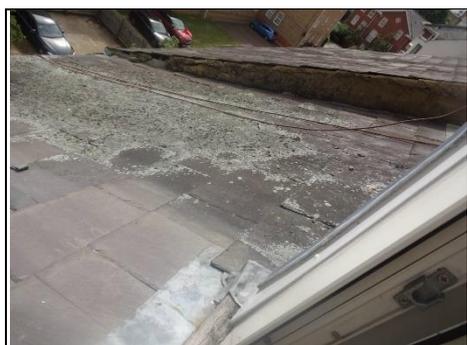
The roof is clad with a slate, some of these slates look to be suffering. It looks like the nails are starting to rust from a phenomenon known as nail sickness. Generally it is the nails that are the weakest part of a slate roof where they rust away over the years. Unfortunately we have no way of seeing the underside of the slates as the roof access areas are lined and there was a room formed within the roof. We can however see that lead tingles have been used. Lead tingles are used where the nails have rusted away as it is very difficult to replace individual slates and costly on a high level roof such as this.

Deteriorating slates to right

ACTION REQUIRED: We would look at doing one lot of high level work which includes the upstand mentioned earlier and also slate repairs and also check the dormer roofs which we could not see properly.

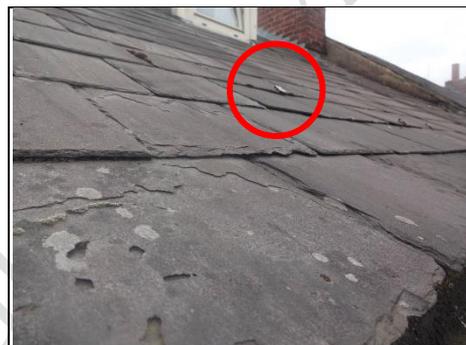
Deteriorating slates (tingle circled)

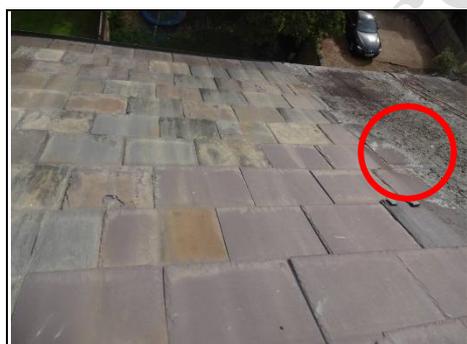
Tingles

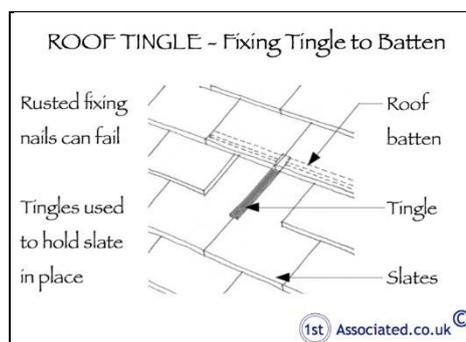
Tingles

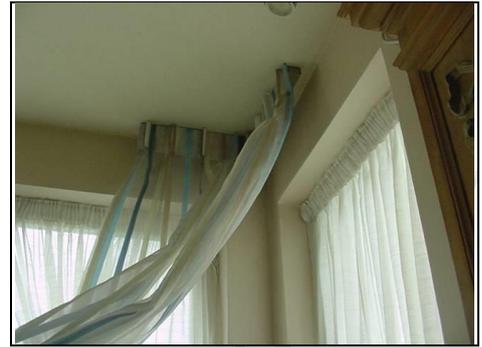
There is a mixture of timber windows and metal windows. We noted staining around some of the windows. We spoke to the owners about the staining around the metal windows to the rear and they advised that they thought they were leaks from when the windows were first carried out and no longer leaked.

Staining to windows

We were wondering whether this could also be condensation as this often occurs with metal windows particularly where there is a mixture of different types of windows (in this case timber and metal) particularly with a modern central heating system which has made the property far warmer than it ever was originally with coal fires.

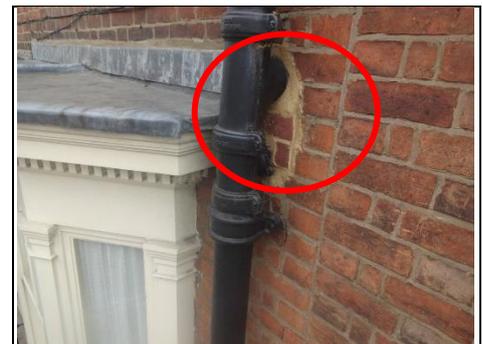
With older properties you will hear a lot about the use of lime mortar and cement mortar. We tend to find a lot of properties that have been wrongly repointed in a cement mortar however the idea behind lime mortar is now better understood and generally listed properties are moving towards lime mortar. We can see in this property that there has been some cement repairs to the outside of the property. This causes a smothering effect of the property so it cannot breathe and let the dampness out. Over time you need to replace the cement mortar.

Cement repair

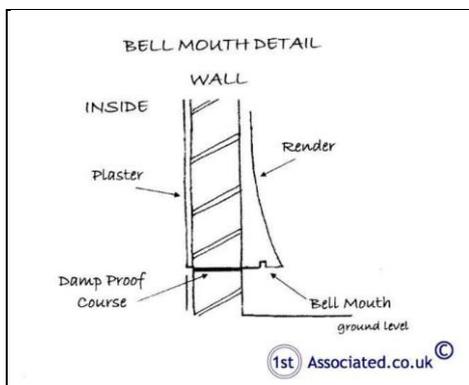
To the rear of the property there is a large area of painted render which looks like it has been finished in a harder cement mortar. We could also see cracking in it and what looks like cement mortar repairs as well. We would prefer a bell mouth detail here.

Bell mouth detail

ACTION REQUIRED: Interestingly, if you look to add drip details on this we would discuss it with the Listed Building Officer before you do it. Although it is a defect it may be considered part of the style of this property.

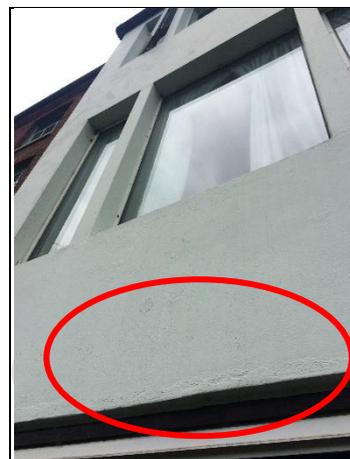
Repair

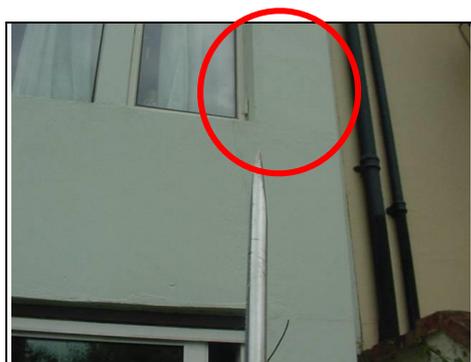
Vertical cracking

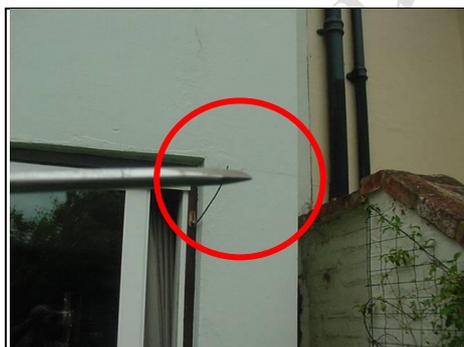
Horizontal cracking

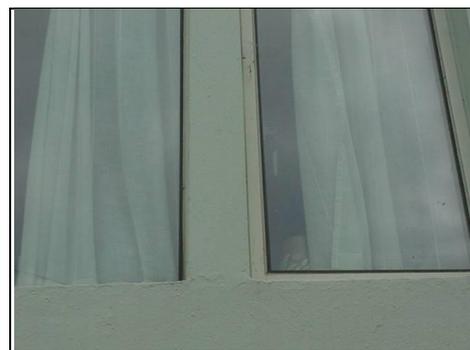
Repair around window area

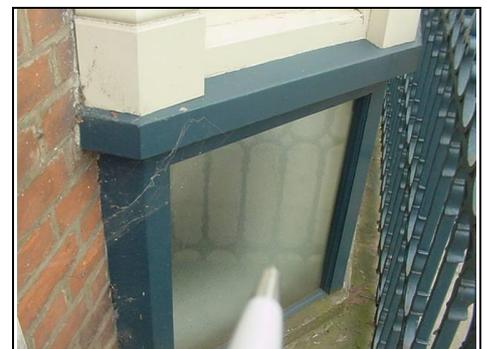
Glazed window to front not to listed building standard

ACTION REQUIRED: We would recommend legal advisors obtain a full list from the present owners as to what they have and have not done and what they consider previous owners have not done. Then arrange an informal ‘cup of tea’ meeting with the Listed Building Officer and show them the list and ask if they have a photographic record of the property as many local authorities do have.

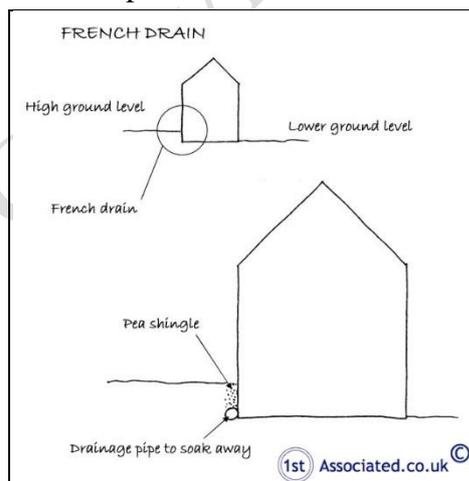
We found some dampness to the lower ground floor as we would expect. Basements were never meant to be dry or as what we would term as habitable rooms. The use of it as a bathroom to the front and a kitchen to the rear is probably ideal. There tends to be problems where these rooms are used for sleeping in.

Dampness in basement area

French drain

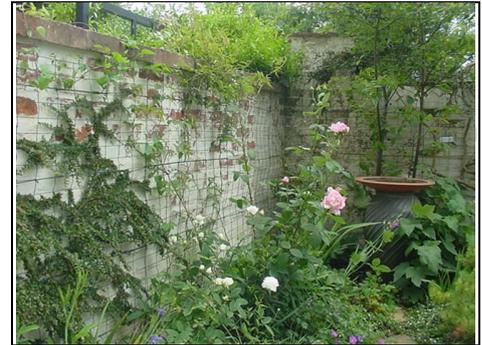
The rear garden wall is slightly unsafe and worse for wear. We could see it is built in a red brick which is starting to deteriorate and also some of the capping is not ideal, possibly because of the conifers and trees nearby. We tend to find that garden walls are built without proper foundations.

The photograph also shows where next doors garden wraps around behind yours and there looks to be a table and chairs directly next to your wall which again may not be ideal for privacy.

Garden wall

ACTION REQUIRED: With regards to gardens walls you always have to have discussions with regard to who owns what and who does what, etc.

ANTICIPATED COST: We recommend you set aside the sum of £500 to £1,000 assuming that the adjoining owners will also pay some money.

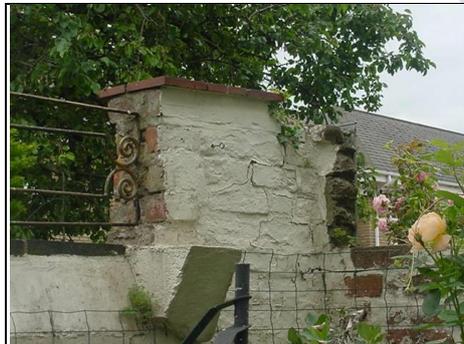
Cracking to wall

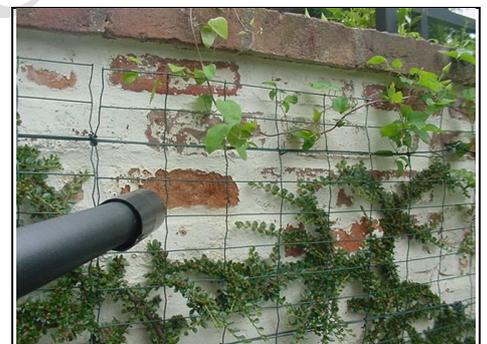
Spalling brickwork

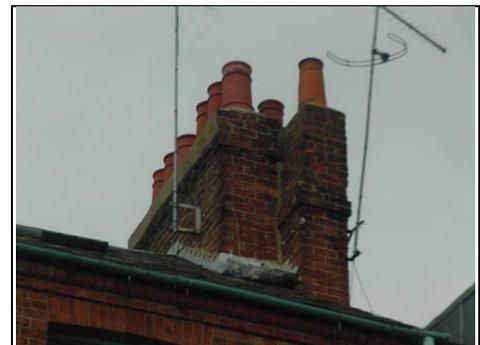
This is a large brick chimney with a lead flashing and numerous chimney pots. From what we could see from ground level we noted some deterioration to the soft red brick.

We noted aerials attached to the chimney which we are not keen on as it cuts into the brickwork rather like a cheese wire cutting into cheese.

Chimney

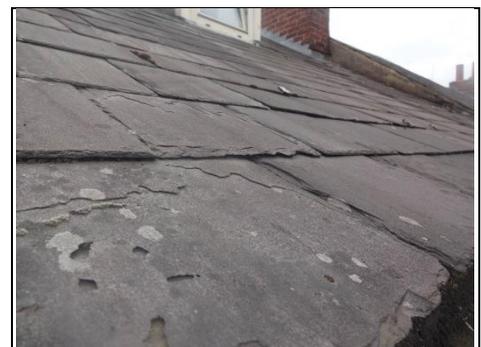
The main roof is pitched and clad with slates and, from ground level, this looks in below average condition considering the roofs age type and style.

Deteriorating slates

ACTION REQUIRED: Please see our comments in the Executive Summary.

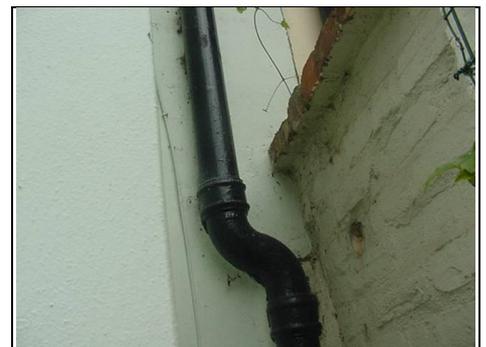
Possible rusting to cast iron

We also recommend that the gutters and downpipes are cleaned out, the joints are checked and the alignment checked to ensure that the gutters fall towards the downpipes.

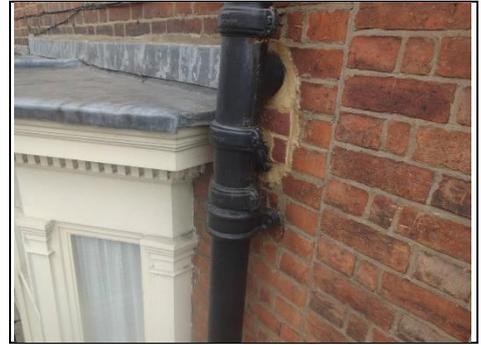
Generally Flemish Bond brickwork is liable to penetrating dampness internally, dependent upon the condition of the brickwork and the exposure to the weather. It is essential that external faces be kept in good condition. In this case we noted cement mortar repairs.

Cement mortar repairs

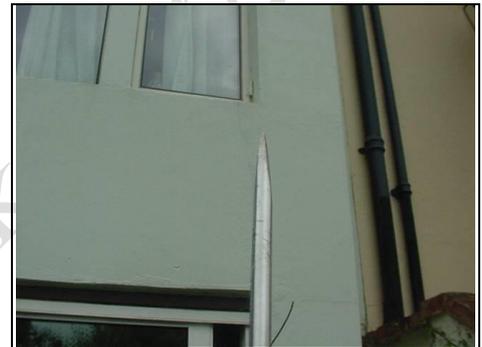
Hairline cracking to rear box bay indicating that render has got too high a cement content

ACTION REQUIRED: Please see our comments in the Executive Summary.

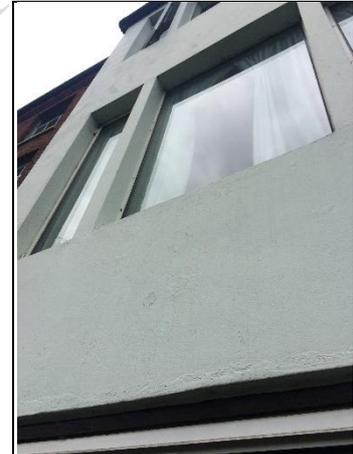
Repairs to render
We would prefer a bell
mouth detail here.

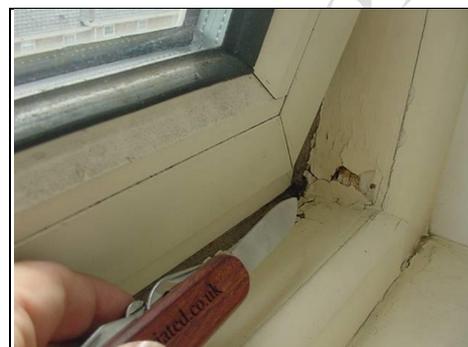
Rot to rear window

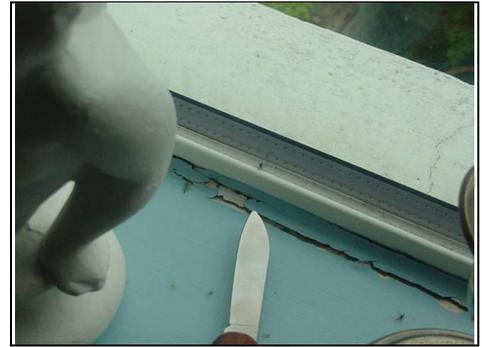
Cracking to box bay window sill on first floor rear window

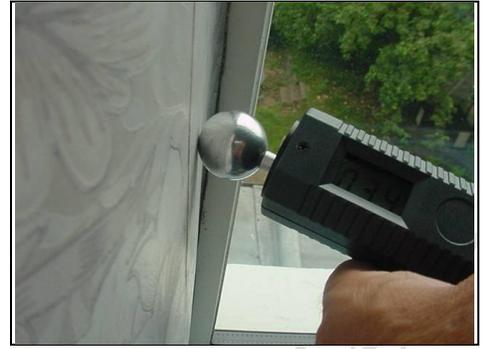
Lateral dampness in window reveal

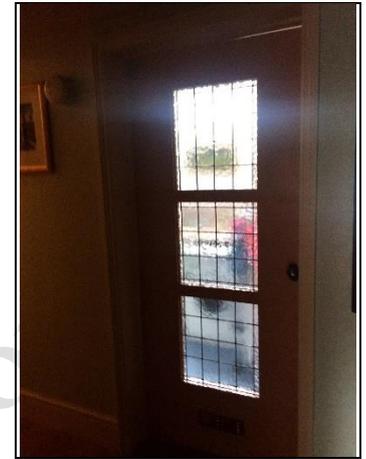
The property has some quite unique doors with glazing. Care has to be taken with older glass as it tends to shatter and break differently to a modern safety glass. In fact if the building was not listed we would recommend removing and replacing the doors with safety glass.

Glazed door

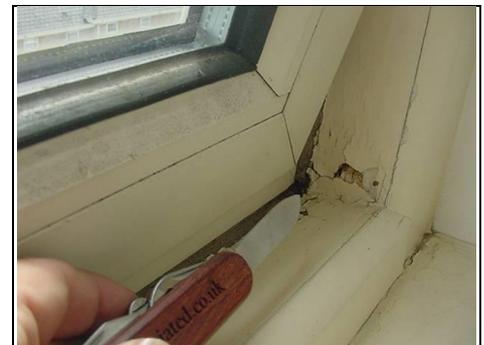
Rot to rear window

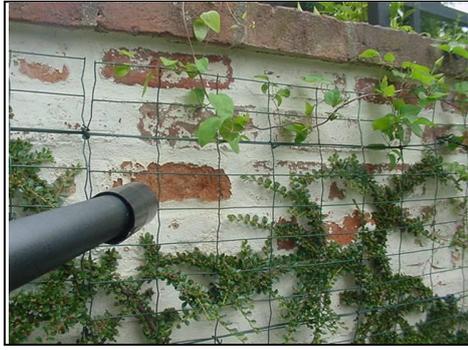
Spalling brickwork to rear garden wall

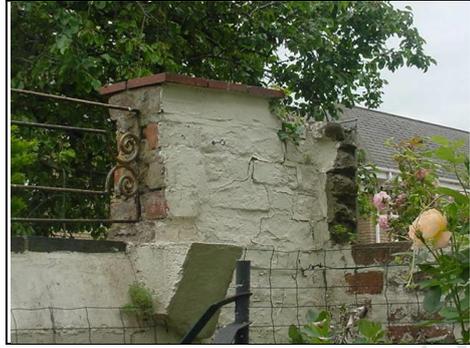
Rear right corner of garden wall needs repair
