HERITAGE STATEMENT AND IMPACT ASSESSMENT

XXX Public House
XXX
XXX
Hertfordshire SG12 XXX

Prepared by:
XXXX Limited
INDEPENDENT CHARTERED SURVEYOR

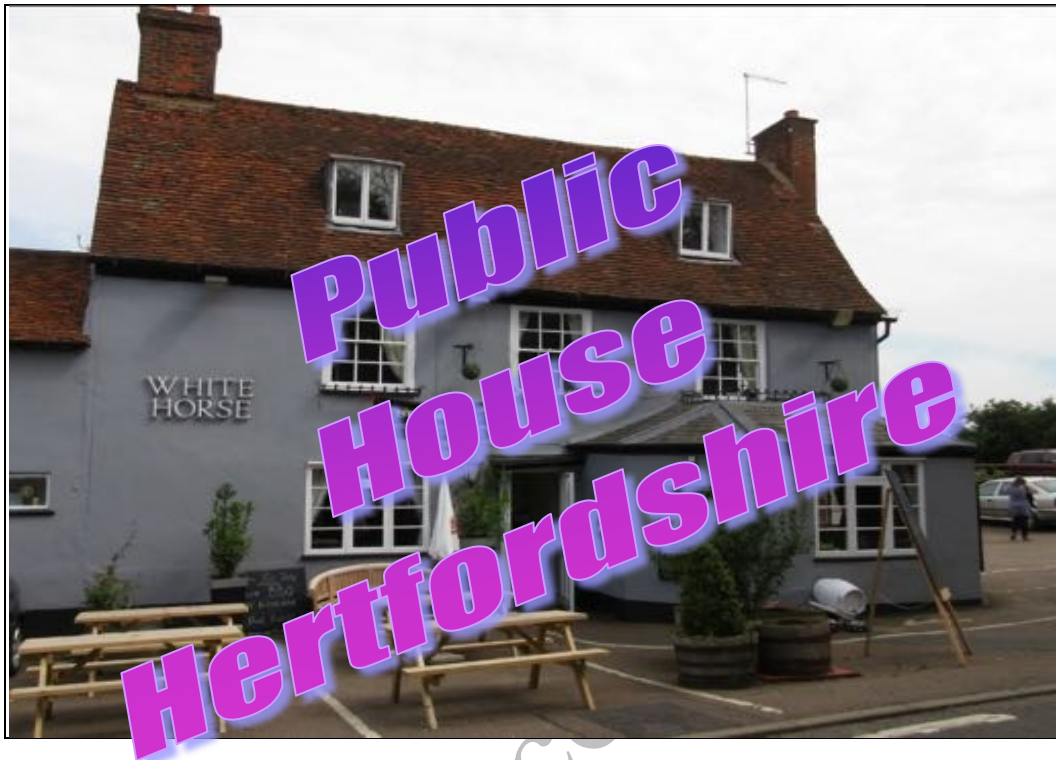
Front Elevation from East

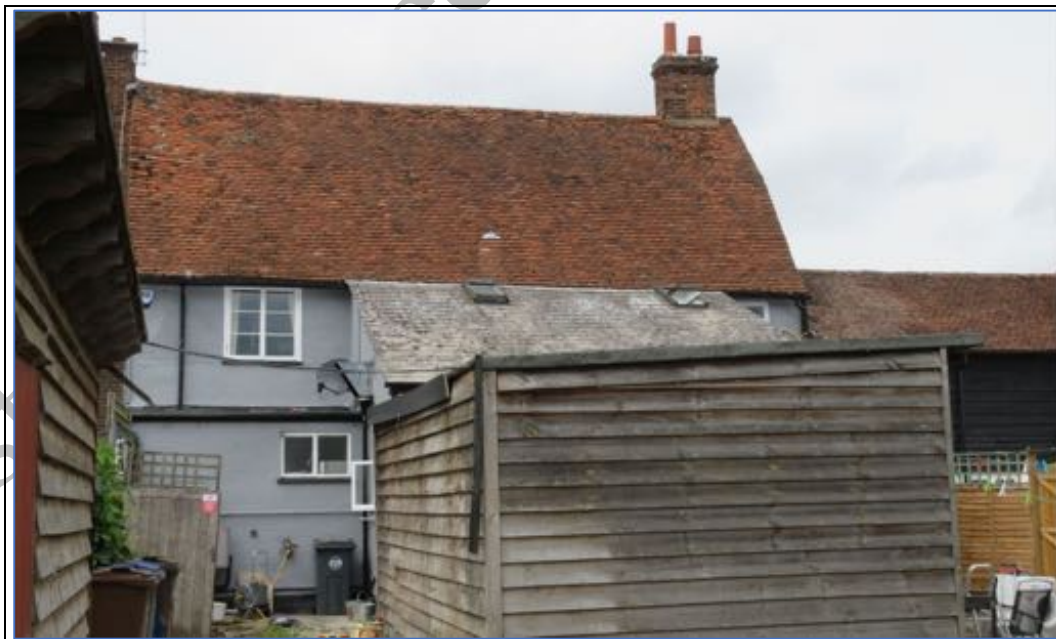
Rear of XXX from West

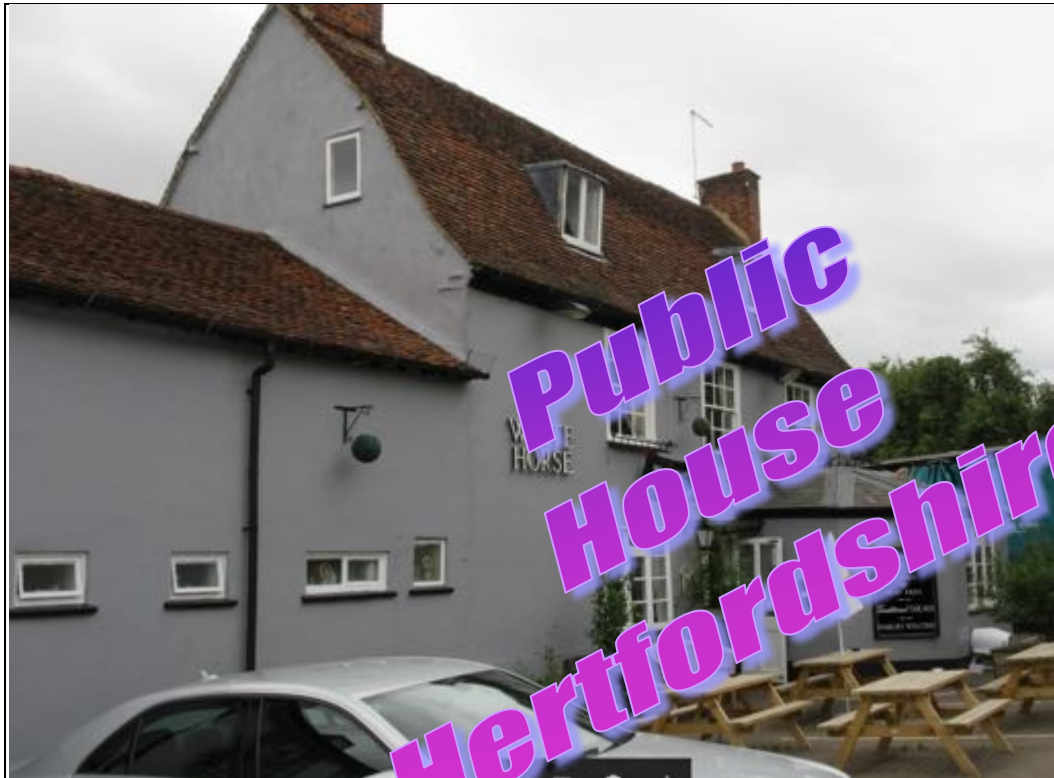
Front/side Elevations from North-East

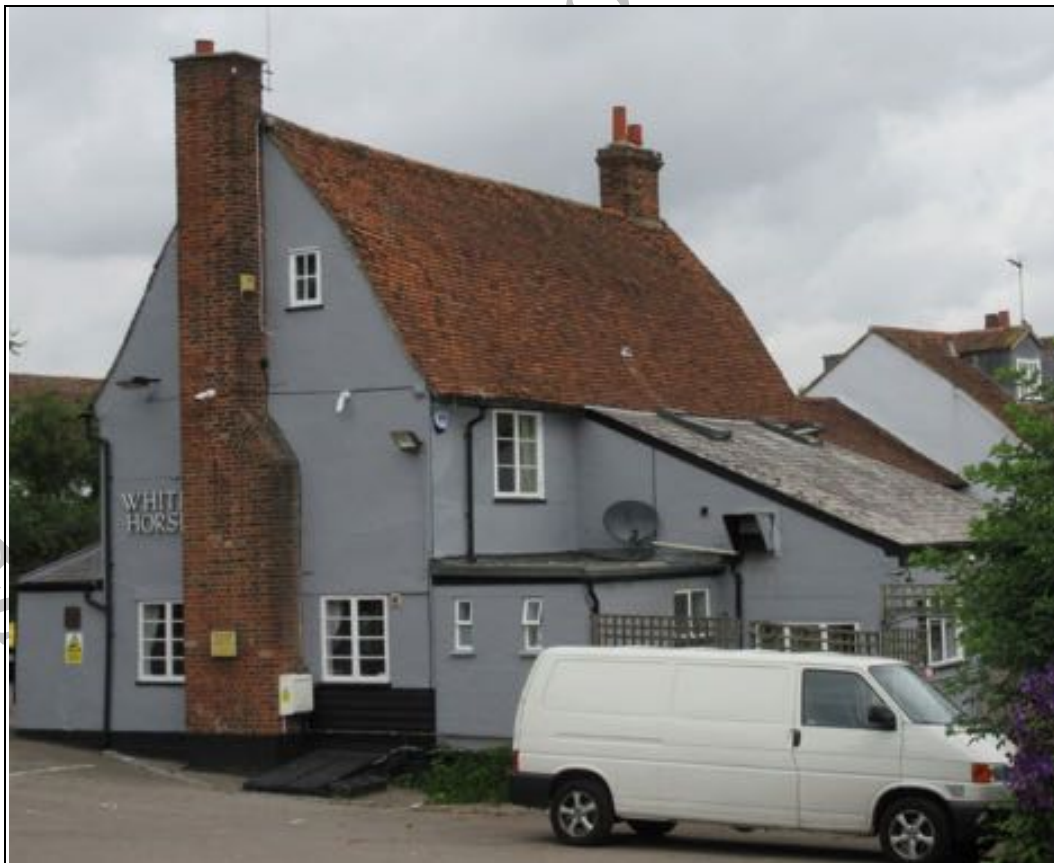
Gable end & extensions from South-West

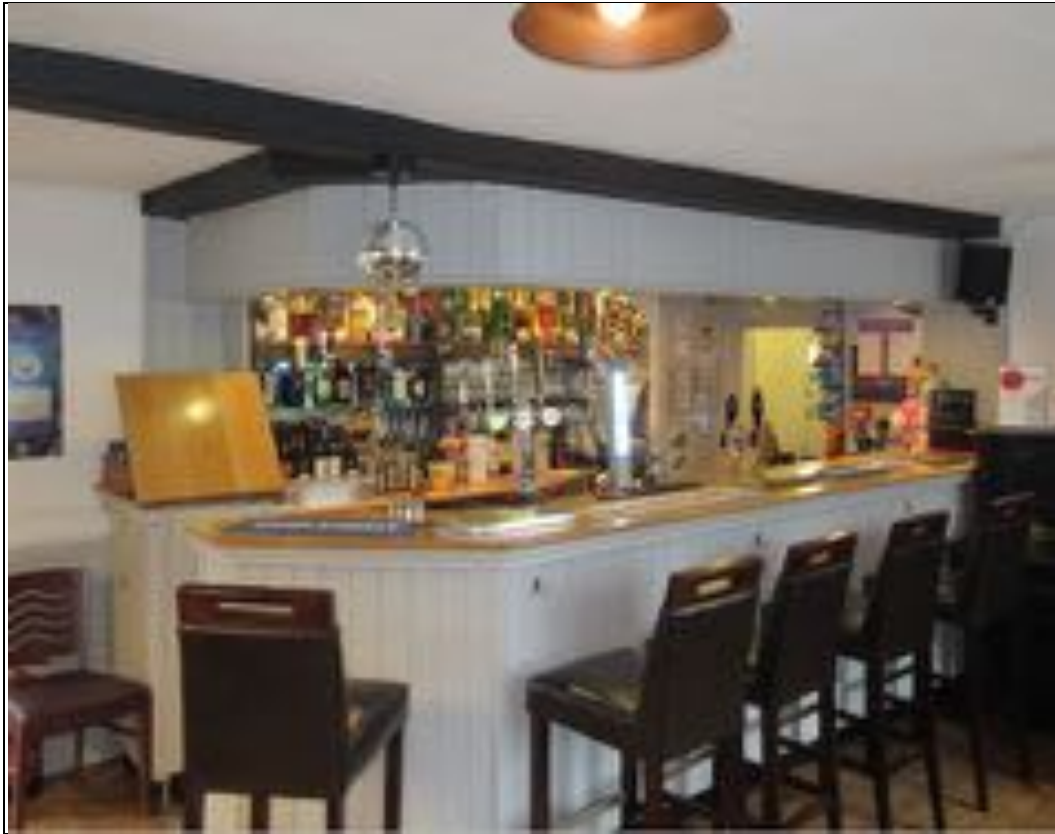
Bar area of room on right side.
Note doorcase at rear served originally as external door.

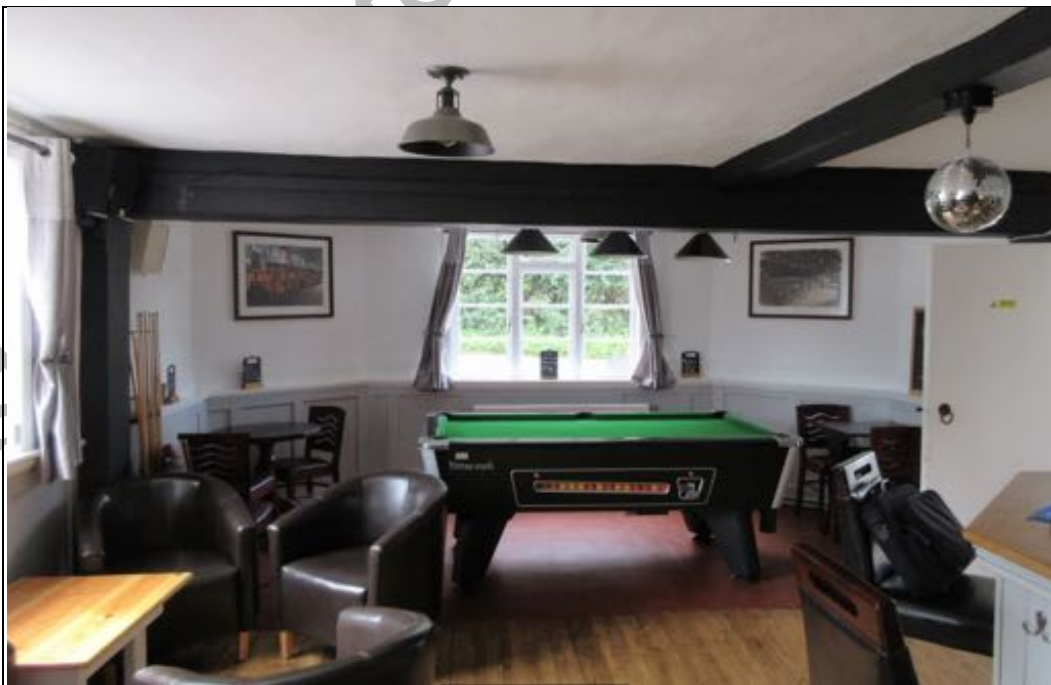
Internal view of polygonal c19th extension
Marketing by: _____

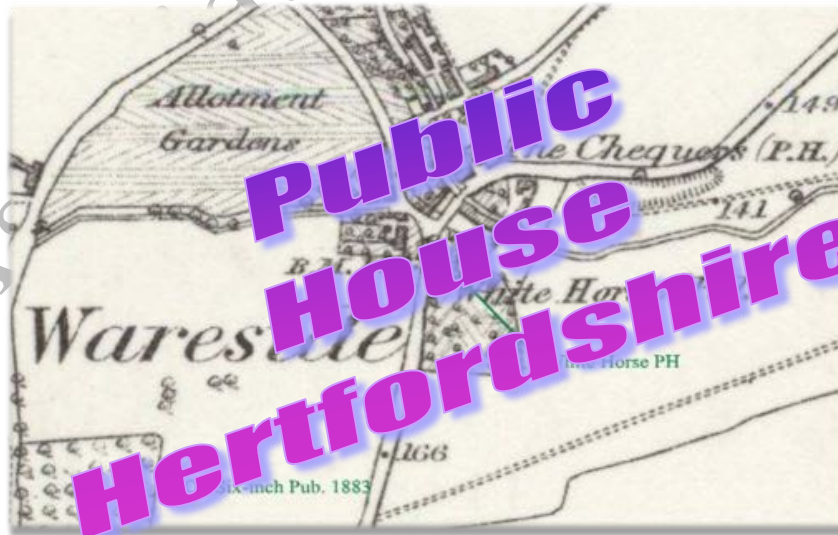
'Sheet 030', in *Map of Hertfordshire* (Southampton, 1873-1885), *British History Online* <http://www.british-history.ac.uk/XXXXX> [accessed XXX].

We have inspected the first series of Ordnance Survey maps for this area: Six-inch version published 1883.

- 3.3.1) The earliest map reference found was the Tithe Awards of 1845 in which the extent of the estate is shown including both the detached cottage to the south and the associated range of barns to the east; subsequently demolished.

- 3.3.2) The first edition OS map 1883 and the conveyance plan 1885 show the arrangement as above.
- 3.3.3) Whilst there appears to be little change in the early to mid c.20th, save the loss of the cottage, by 1973 the range to the rear had been removed and the current rear extensions are shown.

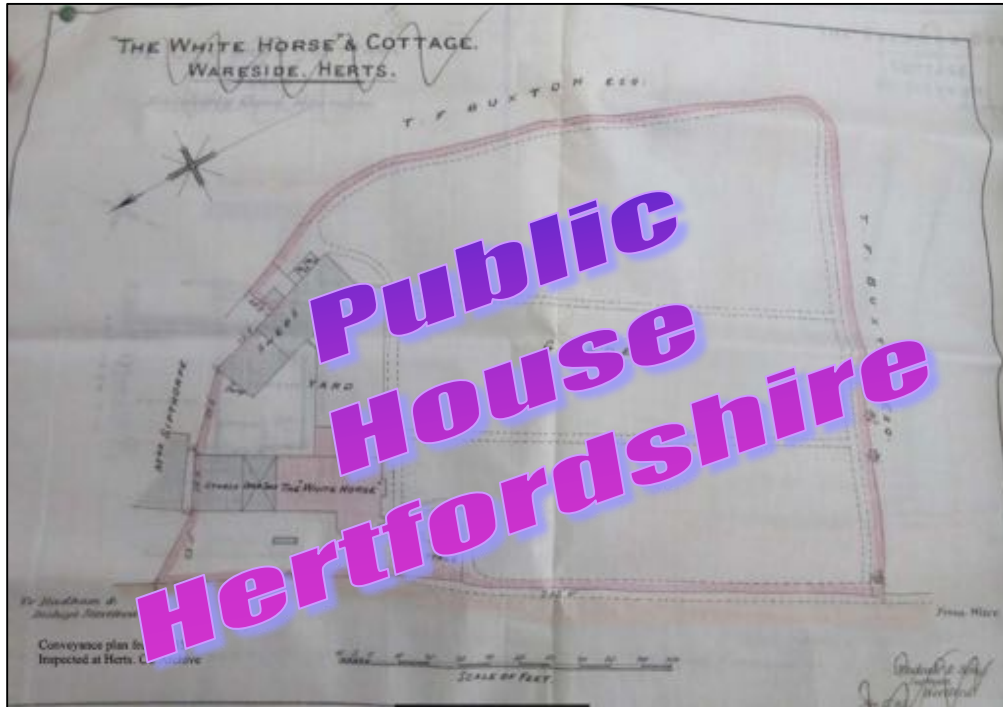
3.2.1) Deed maps 1885 Conveyance plan of XXX Accessed Herts CC Archive

- 3.3.4) The conveyance plan shows clearly the extent and relationship of the buildings in the curtilage of the XXX PH. Additionally the relative sizes of the buildings, some not extant is shown.

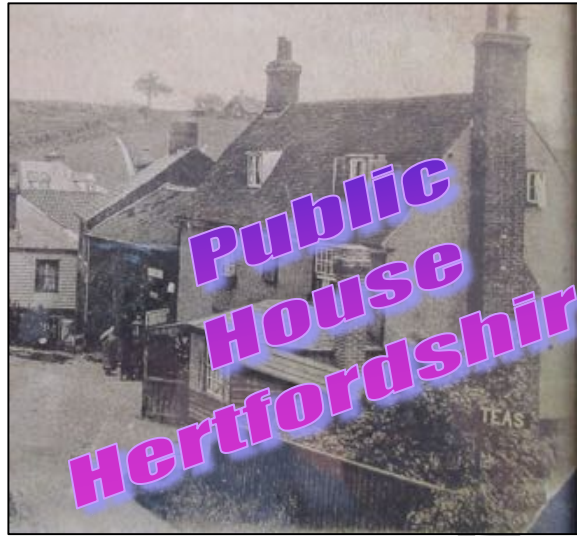
5.0.1) Image from late c.19th or early c.20th

Note chimney stack to front SW extension, 1919 sales particulars indicate use as wash-house. That side of building was private accommodation at that time, the alehouse occupied the ground floor room to the left.

Also note 1st floor advertising sign, window inserted at later date.

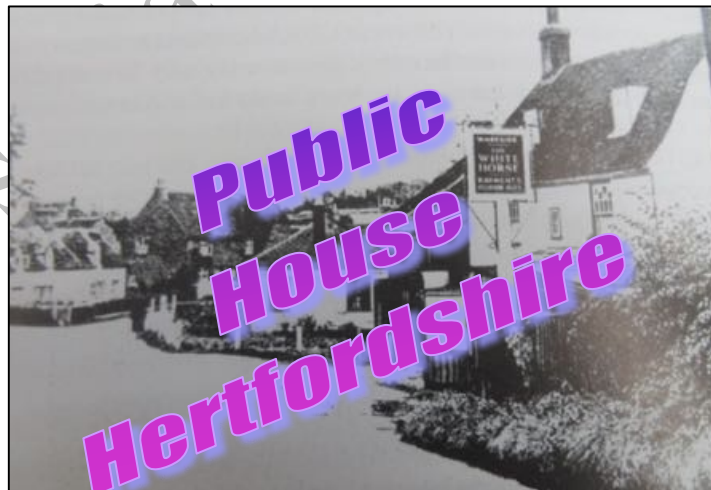
5.0.2) Image from 1940s (XXXX a Miscellany of Histories)

By this time an additional window was inserted in 1st floor to replace sign. Chimney to 'wash-house' removed by this time and sign on post erected. Elevations have been painted.

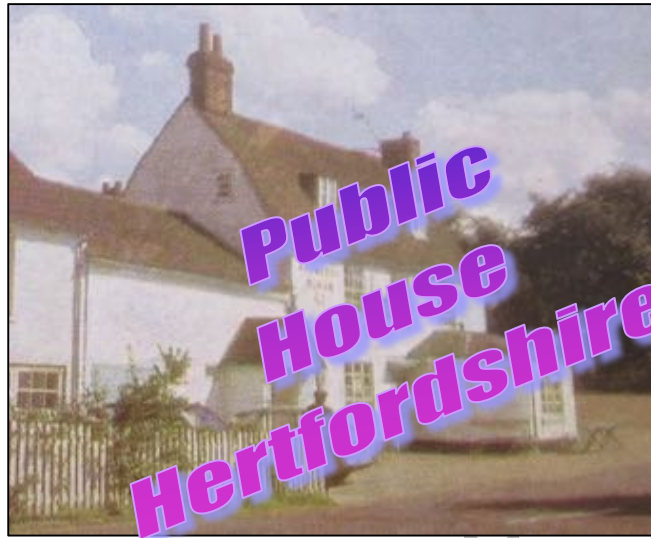
5.0.3) Image from Hertfordshire Life magazine 1967

Note addition of porch and door to barn/cart-shed, also now rendered/ painted. First floor centre window of house now enlarged to match those on either side; window to extension replaced, no longer vertical sliding sash.

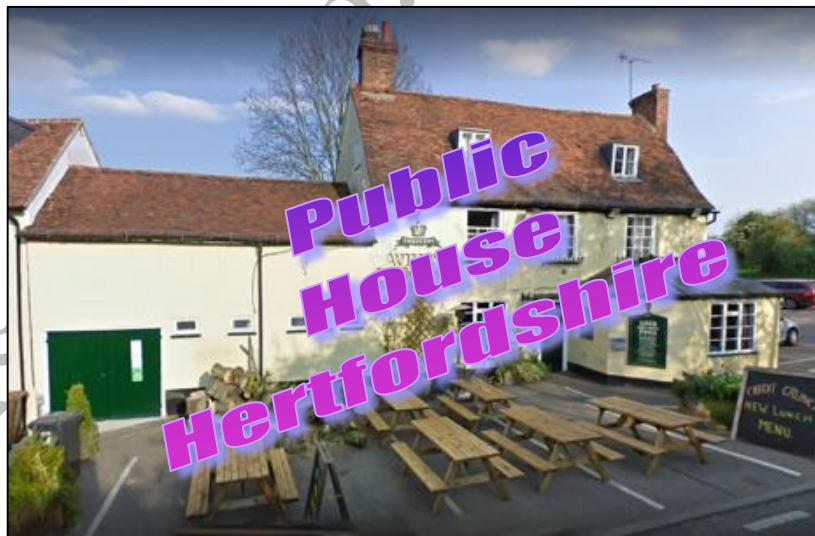
5.0.4) Image from 2009 (Google Maps)

Whilst in previous (XXXX) ownership; main changes from before are to barn: Insertion of 4 N^o windows for WCs., removal of porch and door, Insertion of vehicular double-doors. Change of colour to painted elevations. Addition of floodlighting and some additional elements, plant containers, to 1st floor windows and roof of polygonal front extension.
