RESIDENTIAL BUILDING SURVEY

XXXXXXXXXXXX,
XXXXXXXXXXXX,
XXXXXXXXXXXX,
XXXXXXXXXXXX,
Essex,
CB10 xxx

INDEPENDENT CHARTERED SURVEYORS

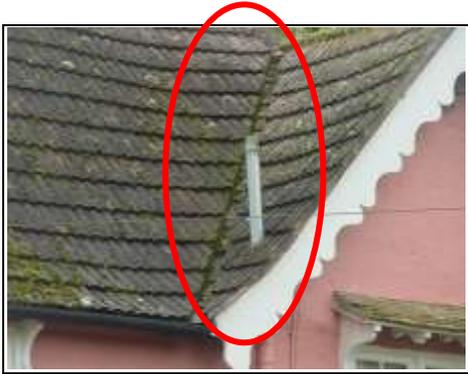
During our question and answer session with the owners they advised that there had been problems with the valley gutters and also parts of the roof leaking which had ultimately led to the replacement of the original concrete tile valley gutter with a lead valley gutter.

Original concrete tile valley gutter still present in some parts of the property

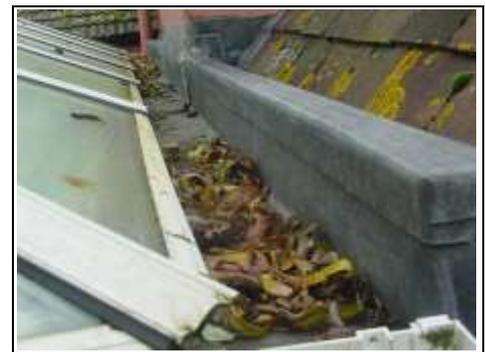
There is an awkward box gutter to the rear of the property which is catching a lot of leaves which will need constant cleaning.

Leaves in hidden box gutter to rear

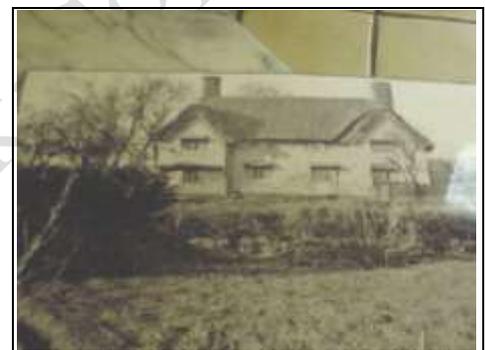
From the pitch of the roof we thought the roof would be thatched. Later on during our question and answer session we asked to see some old photographs. One of the photographs they showed us was an old photo they had been given of the property with a thatched roof.

Old photo of property with thatched roof

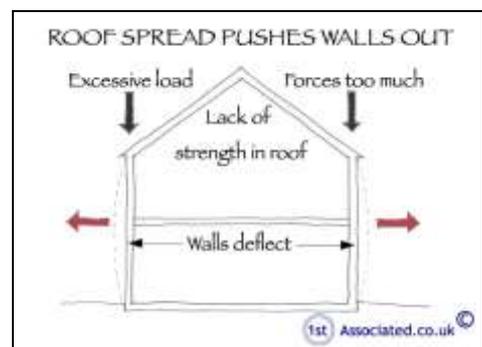
The property now has a concrete tile roof which is a much heavier roof. Typically roofs were replaced in the 1960's and 1970's with a heavier concrete tile roof. We believe this has caused stress and strain on the property as a whole and has had an impact on the roof and the walls causing roof spread.

Roof spread

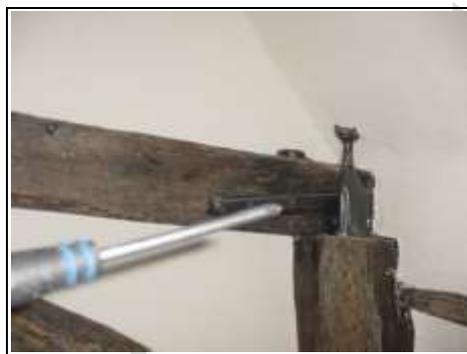
Central bracing

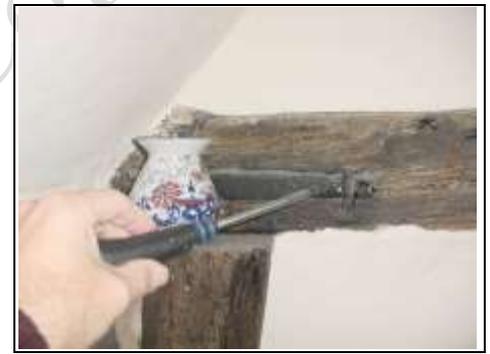
Bracing to corner

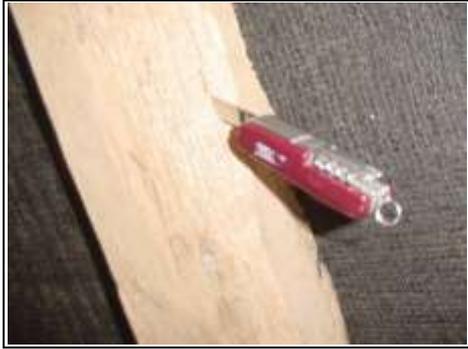
Whilst we would expect most old properties to have some woodworm (in fact we would be concerned if they didn't), the property still does look to have woodworm and we noted frass which means that it is likely to be active although the best time of year to identify whether it is active is in the spring breeding season.

Woodworm

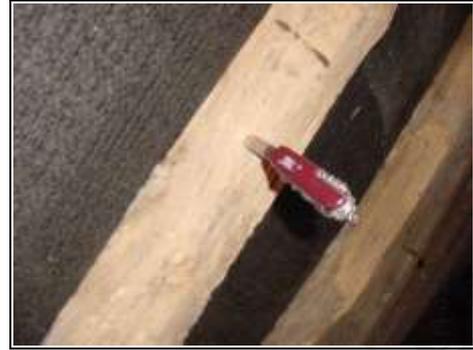
Knife could go far into roof

Limited inspection of the roof

In the limited areas we could see it was affecting about thirty percent of the timbers. Whilst repairs can be carried out you do need to allow for these as part of your negotiation. We would expect costs to be incurred will be in the region of £15,000 - £30,000 as this is likely to be expensive as this is a listed building and you will have to do the work to a set way. An alternative that would be worth considering would be to lighten the load of the roof by having it thatched. We passed a local thatcher on our journey to the property:

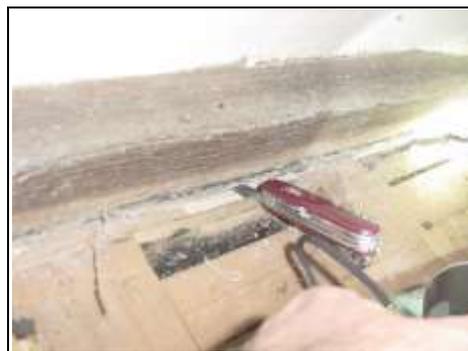
There are two key areas where there seems to be problems which is to the front left hand corner and to the left hand side. In addition to this the rear right hand gable and the right hand side we could not investigate this area (kitchen and office area). However where we have been able to investigate in the lounge, where we lifted part of the carpet, the wood parquet flooring underneath it, we were able to see what we believe to be the sole plate. Within the sole plate we found rot which we believe is partly due to the high ground level but also the concrete floor within the property that effectively acts like blotting paper.

Knife going into sole plate

1) You need to check and confirm the sole plate to the entirety of the property by opening up and exposing it so you understand the full extent of the problem. This will mean removing render externally to the front left hand side, the left hand side and the rear of the property (old sections) and carry out any necessary repairs.

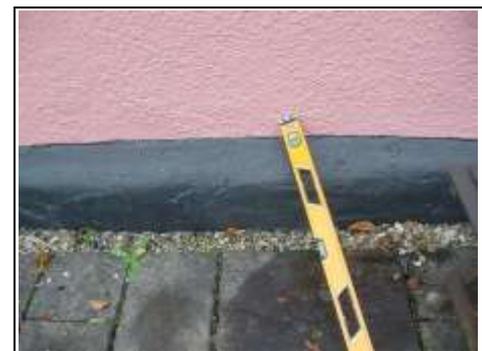
Plinth may be hiding original sole plate

2) Reducing the ground level around the property and adding French drains where necessary to get the water away from the property and giving any rainwater a definite path from the top of the hill to the bottom.

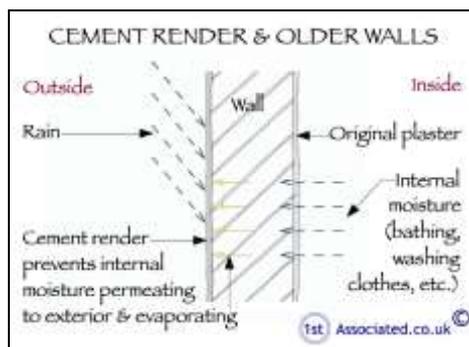
The outside of the property has cement render which effectively will be causing accelerated deterioration to the timber structure behind it. It is not that uncommon to have a cement render but you do need to consider the accelerated deterioration it causes to the structural frame together with the other issues in this report.

Cement render

ACTION REQUIRED: Many people would be put off purchasing from this point alone. If you do decide to purchase then we would recommend you remove all the render to one gable end during the summer and warmer months of 2015 and examine the timber frame. We would be more than happy to help and advise further when the render has been removed.

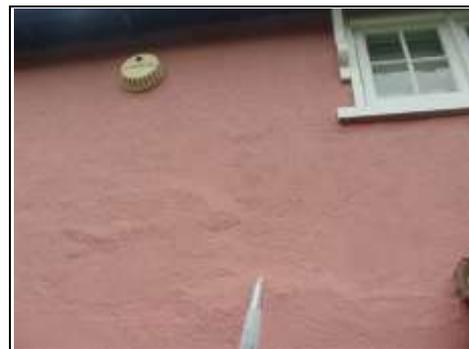
For example we can see hairline cracks to the front of the property which should be sealed during the warmer months. We would expect to be redecorating this property every three to six years.

Hairline cracking

ACTION REQUIRED: Seal cracks and repair any blown areas.

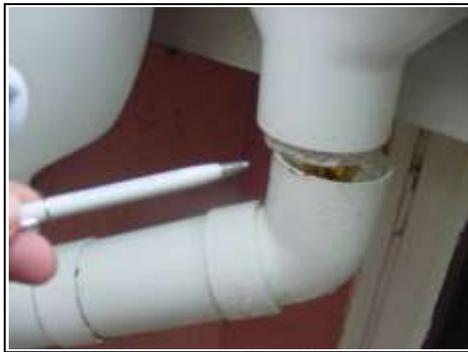
Downpipes are not fixed properly or have not been checked

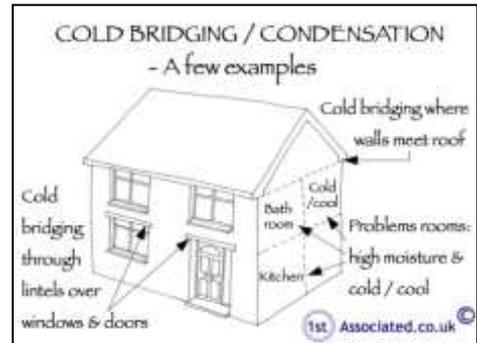
This is a phenomenon where warm moist air meets colder surfaces and can lead to black mould being caused. Particularly in this property we would expect it to be, if you are not careful, within cupboards as there is a lack of airflow in these areas so they can be colder than the rest of the room if you recall, as we demonstrated within the bathroom area.

Cold bridging/thermal bridging

ACTION REQUIRED: We would recommend large humidity controlled extract fans be added to kitchens, bathrooms and drying areas.

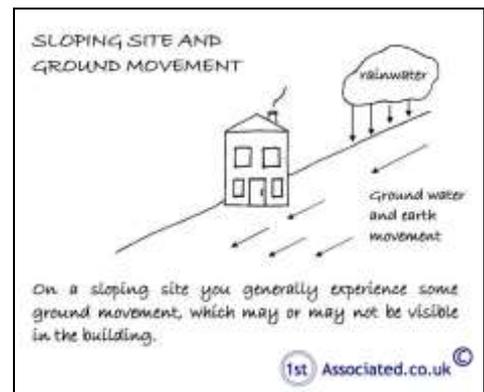
We generally found rising damp throughout the property. This partly relates to the relatively high ground water table in the area which is why you have a pond so close. Also, the lack of a defined path for the water which we have mentioned elsewhere within this report.

ACTION REQUIRED: Carry out work to reduce the ground level, add French drains as necessary to give any rainwater a path to go from the top of the ground to the bottom without going through the house.

ANTICIPATED COST: You do need to stand outside the property the next time it is raining hard and check but we would expect costs to be in the region of £2,500 - £5,000; please obtain quotations.

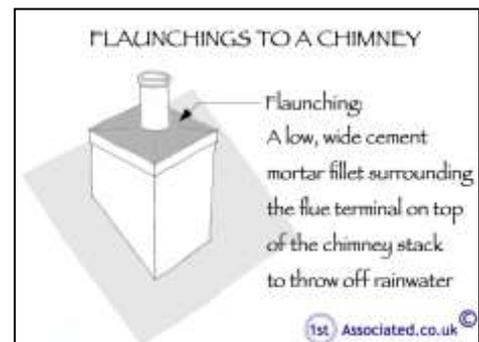
Unfortunately we were unable to see the top of the chimney properly known as the flaunching, we therefore cannot comment upon them.

Flaunchings

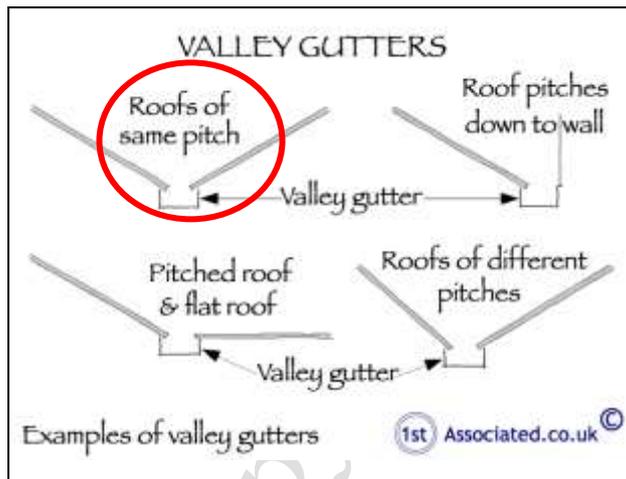
This property has valley gutters. Valley gutters are formed where two roofs meet and these are generally problematic.

Replacement valley gutter to front left side which current owner carried out

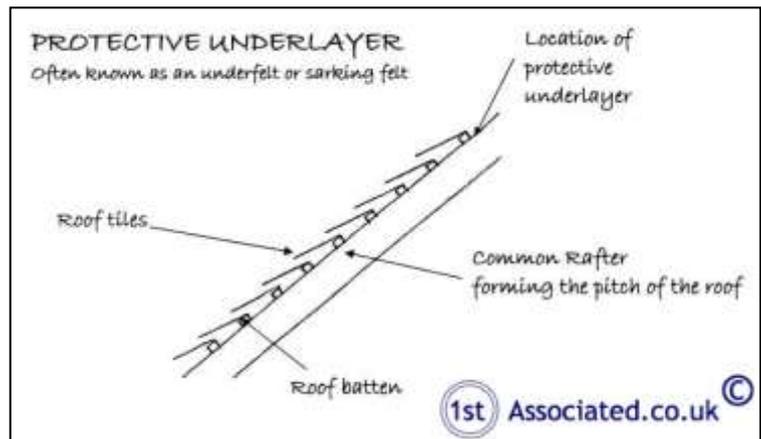
Protective Underlayer

When we inspected the loft space we found a Hessian base Bitumen membrane. This type of membrane has been used since the 1960s. We generally found it to be in average condition, with damage in some areas which is what we typically find. We could also see the peg fixing to the coupled roof.

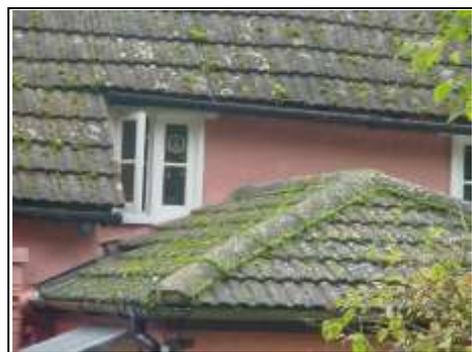
The roof is hipped and clad with concrete tiles as the main roof. We would comment that this is a very shallow pitched roof and sometimes wind driven rain can get into it. Also, as you can see the water does not discharge off it that quickly and you get a more than average build up of moss.

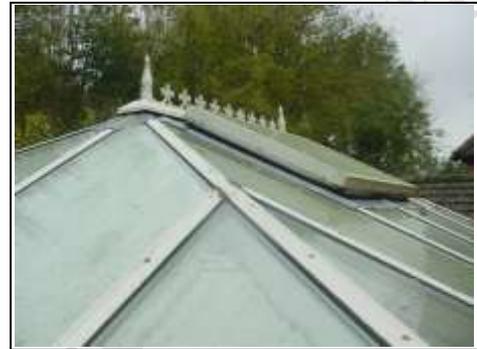
The conservatory roof is glass and has a slight layer of moss which would benefit from being cleaned. However the worst bit about the conservatory roof is the awkward detail it makes with the rear of the property and has an awkward box gutter detail.

Conservatory roof starting to moss over

ACTION REQUIRED: Please see our comments in the Executive Summary.

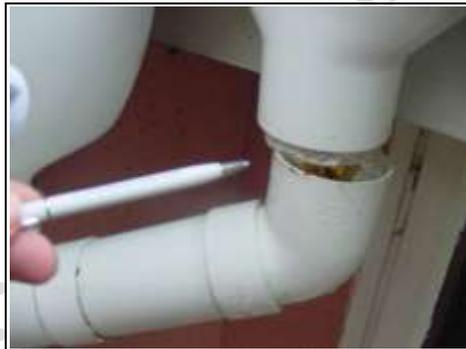
Downpipes are not fixed properly or have not been checked

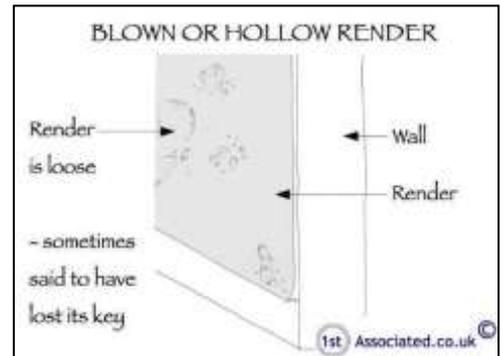
We have carried out a tap test (literally hitting the render with the back of a hammer). There were hollow areas which can be good or bad with cement render. You do need to open it up.

Blown or hollow render

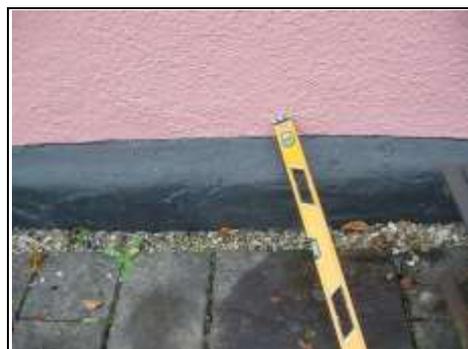
To the base of the render there was a ledge which means the water will sit onto it.

Ledge may be hiding original sole plate

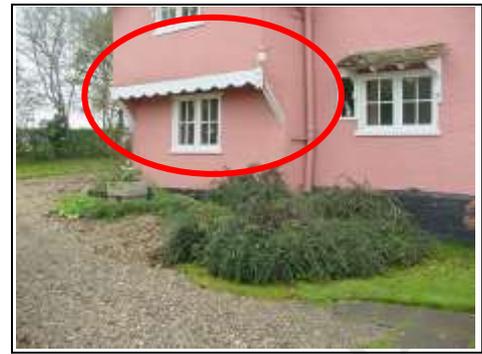
Jetty to front left

There are no stress marks around the jetty to indicate isolated problems.

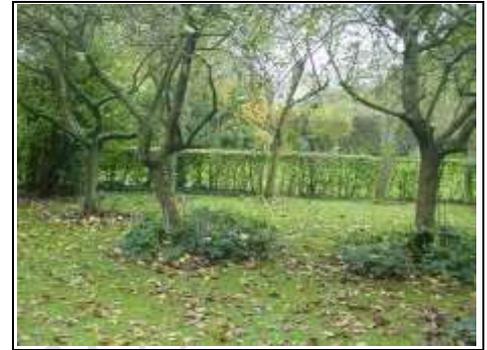
Trees

There are trees within what we would term as influencing distance but you do need to speak to your insurance company as they may have a different interpretation for insurance reasons.

ACTION REQUIRED: We would recommend an arboriculturalist (not a tree surgeon) is asked to view the property and give a ten year plan for maintenance.

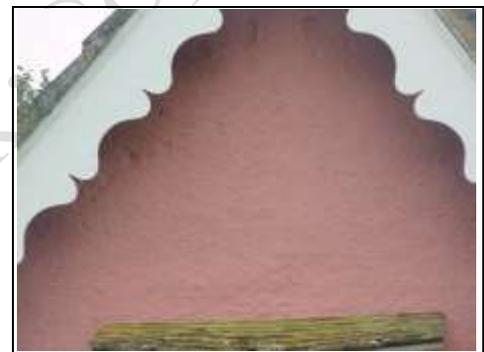
Decorative bargeboards

The fascias, soffits and decorative bargeboards are timber. They are painted and we would comment they are in average condition for their age, type and style.

ACTION REQUIRED: Make sure gutters and downpipes are watertight and asbestos pipework is replaced before carrying out any work on fascias and soffits.

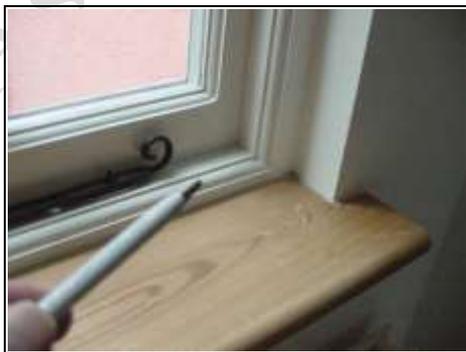
Double glazing which you should not have without permission on a listed building

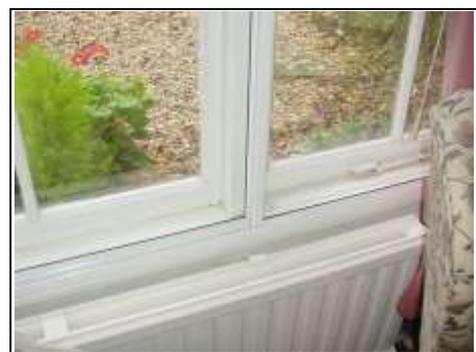
Secondary glazing to many of the windows

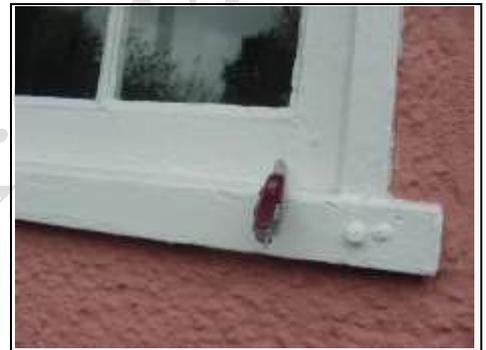
Knife test satisfactory

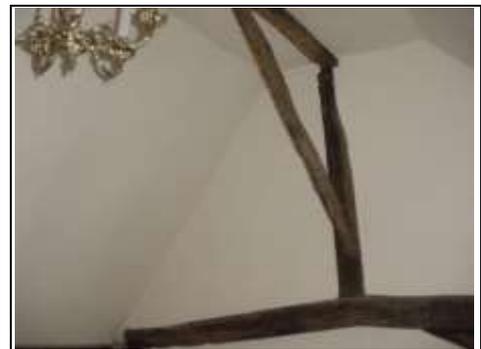
In some of the rooms, as mentioned, there has been additional support in the form of metal bracing but also in the form of triangulation of timbers which has happened over the years.

Triangulation of timbers

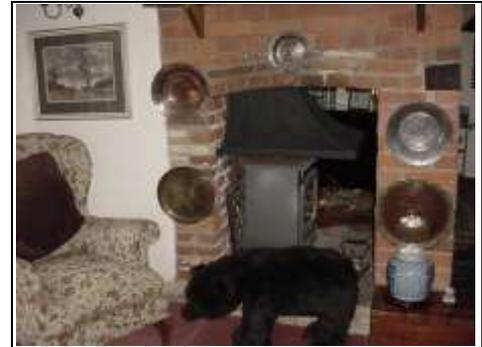
The chimney breasts are located to the left and right hand side (all directions given as you face the front of the property). To the left hand side there is a small inglenook style fireplace which had a modern burner added.

Central fireplace in lounge

It is strongly recommended that flues be cleaned and checked for obstructions prior to use to minimise the risk of hazardous fumes entering the building.

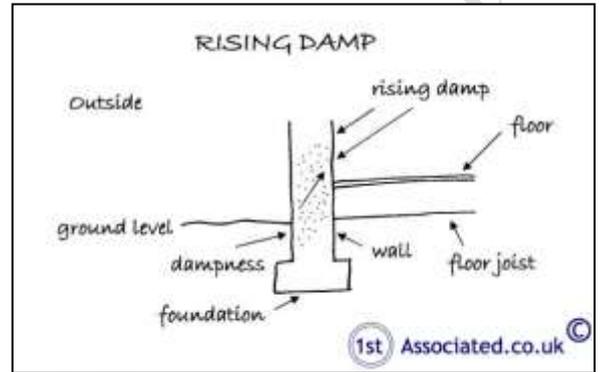
Rising damp

A visual inspection and tests with a moisture meter have been taken to the perimeter walls. In this particular case we have found what we would term as significant rising damp generally around the property with the exception of the newer extensions and conservatory.

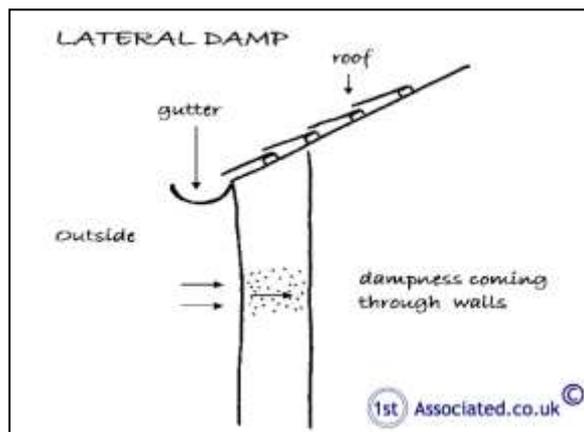
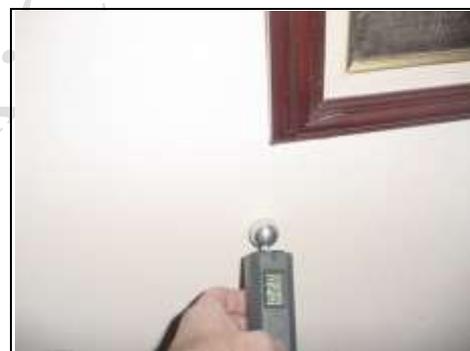
We used a resistance meter on the external walls. We have not found significant lateral dampness.

Testing for lateral dampness

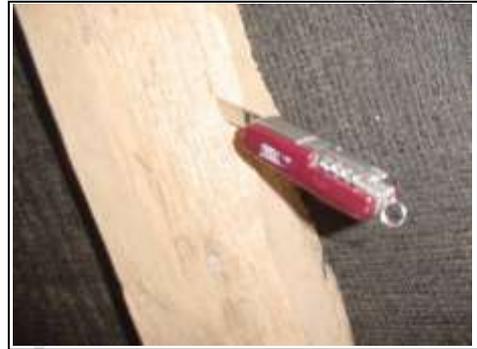
Woodworm

The roof /floor are the main area that we look for woodworm as well as the actual traditional timber structural frame. Within the roof we found visual signs of significant woodworm activity.

We would comment in this instance that our main concern is the depth in which our knife went into the timbers which was 1-2 inches or 25-50mm.

ACTION REQUIRED: Please see our comments in the Executive Summary. Our access has been limited by insulation and the stored items. We would be happy to return if all the stored items and the insulation in the roof are removed so we can have full access.

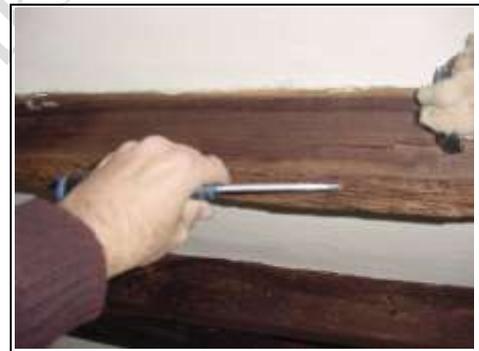
Historic woodworm in lounge as opposed to active woodworm

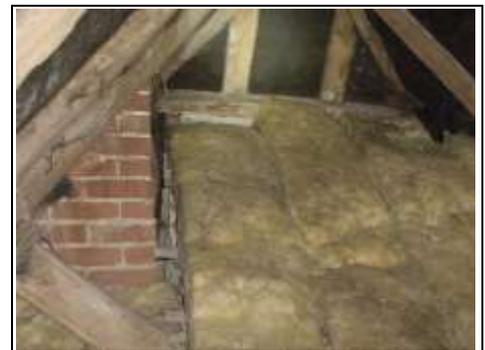
Insulation

We believe that this roof may be over-insulated and causing condensation.

Although current regulations recommend a lot of insulation in the roofs (currently 300mm) this is not necessarily the best thing for a timber frame building as it can promote condensation and an ideal environment for woodworm. You should ensure that the roofs remain well ventilated; the more insulation the better they need to be ventilated.

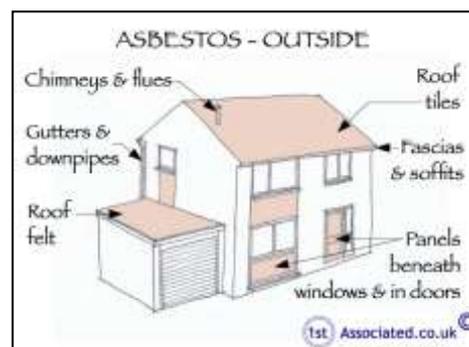
Asbestos externally

ACTION REQUIRED: If you wish to confirm you are 100 percent free of asbestos you need to have an asbestos survey carried out. Please see our comments in the Executive Summary.

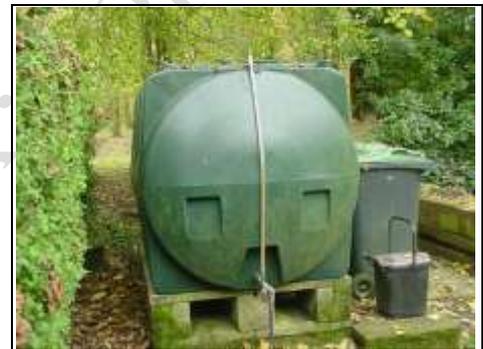
We were pleased to see that the oil tanks are plastic. These usually replace the older metal tanks that can rust and they typically have a double lining, meaning that if they leak they leak into the outer lining.

Plastic oil tank

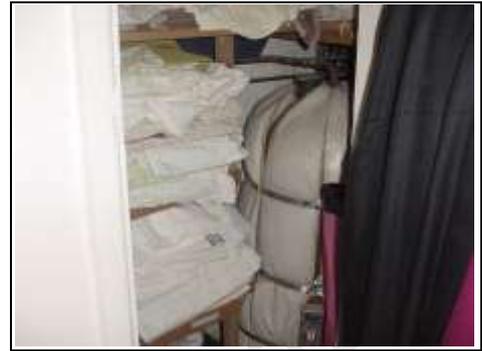
The hot water cylinder is located in the office on the first floor. It has an insulation jacket rather than factory lagged which indicates that it is relatively old. This cylinder will therefore not have the same thermal properties as a modern factory insulated cylinder. The problem with these is that they can leak at any time.

Older style hot water cylinder

ACTION REQUIRED: We recommend replacing. Please see our comments in the Executive Summary.

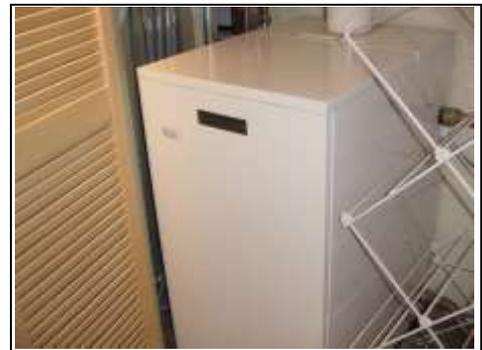
Boulter boiler

The boiler was located in the ground floor front office, it is manufactured by Boulter.

Our limited inspection of the hot water and central heating system revealed no evidence to suggest any serious defects but we would nevertheless recommend that the system be tested and overhauled before exchange of contracts and that a regular maintenance contract be placed with an approved heating engineer.

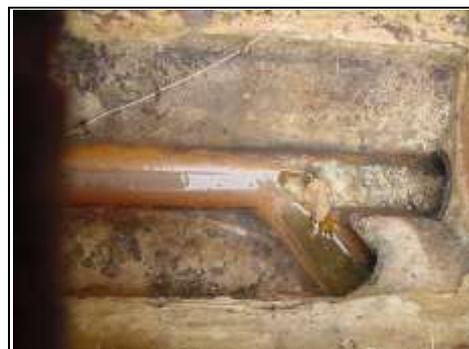
We duly lifted the cover and found it to be free flowing at the time of our inspection.

From what we could see it is concrete built.

Shallow drain close to front of property

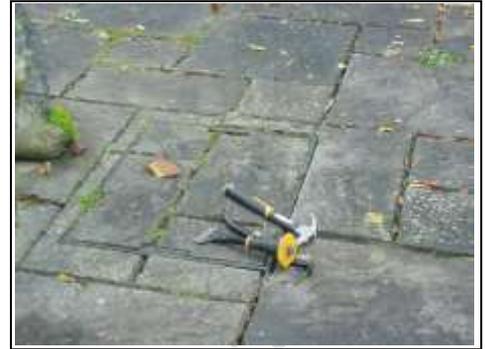
We were unable to lift this manhole therefore are unable to comment.

Manhole to front right corner

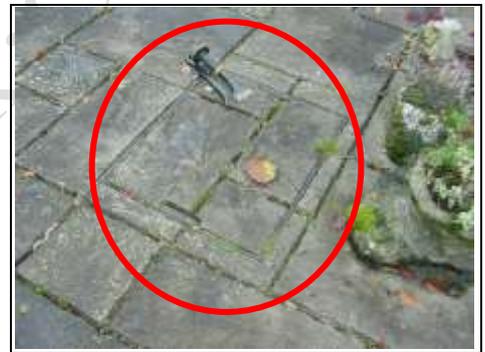
We were unable to lift this manhole therefore are unable to comment.

Manhole rear right corner

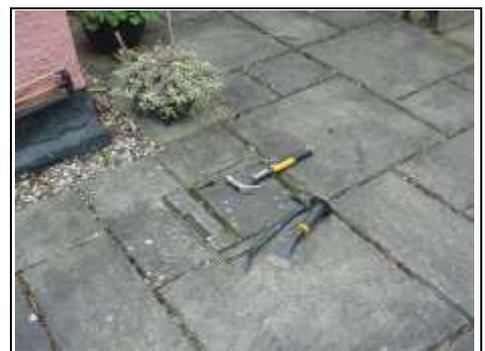
We were unable to lift this inspection chamber therefore are unable to comment.

Manhole to rear that we could not lift

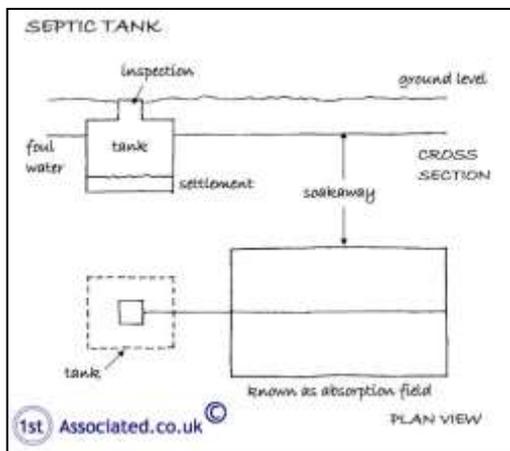
Septic tank

In this case the septic tank is concrete. We were advised it had been emptied only a few days before the survey which was good for us as rarely can we see into them. However there was a lot of water in the tank so it does look like it was filled up with ground water which is common with older septic tanks such as brick and concrete whereas the GRP plastic tanks are sealed. There were minor roots visible.

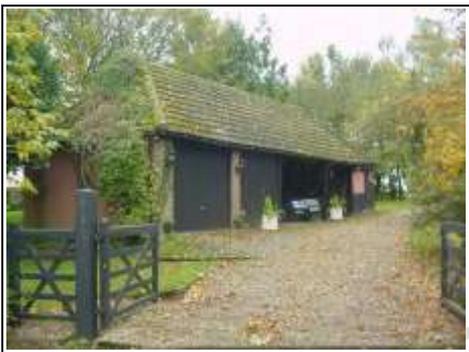
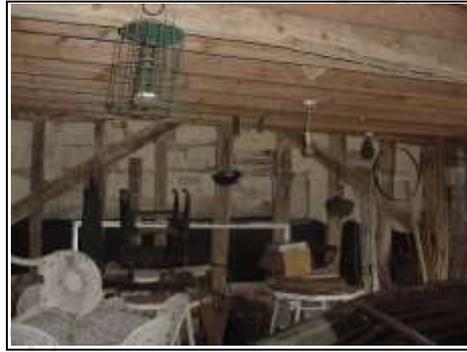
Garage

There is a garage with two single car areas and open parking space, workshop area and wood store. This is a wood structure, some of it we noted to be quite old and we found woodworm within the older parts of the structure. It really depends upon what this is going to be used for and how frequently to how much you spend on repairing it.

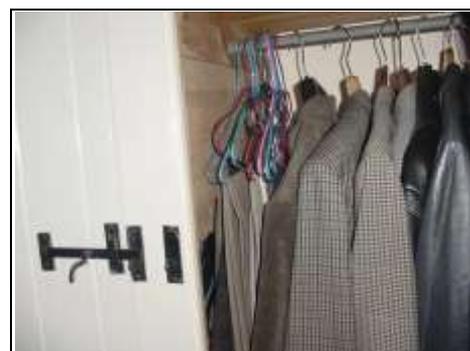
- 1) We did not have full access to the roof.
- 2) We did not open up the ground floor or the first floor as we could not see a way to do it without causing damage.
- 3) The amount of stored items limited our view.

Stored items limited view
