JOB REFERENCE: xxxxxxxxxxxxxxxxxxxxxxxxx

SCHEDULE OF CONDITION

We have been instructed to inspect and prepare a Schedule of Condition for The White Horse, xxxx, XXXXXXXXXXX, XXXXXXXX, XXXXXXXX.

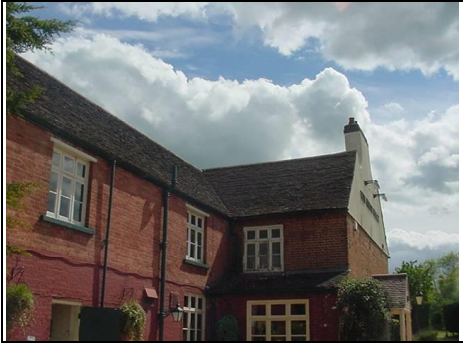
Front External Elevation

Front view from left side

DESCRIPTION	CONDITION	ACTION REQUIRED
<p>Chimney: Brick build rendered chimney Paint finished</p>    	<p>Weathered and cracking to rear</p>    	<p>Repair and make watertight</p>

Back of deteriorating peg tiles

Spalling to ridge and tiles

Broken and missing tiles

<p>Walls:</p> <p>Flemish bond brickwork generally with low level painted Flemish bond brickwork to left side</p> <p>Incorrectly repointed in cement mortar</p>   <p>Crack above door</p>   <p>Vegetation growth indicating dampness</p>   <p>Dampness to base of brickwork</p>	<p>Hollowing out of bricks Spalling Concaving of bricks</p>   <p>Wrongly repointed in cement</p>       <p>Moss impregnated into brick</p>	<p>Removal of all cement mortar, repointing in a lime mortar and repair to brickwork.</p> <p>Exclude from lease</p>
---	---	---

Overhaul of roof and general repair and replacement of spalling tiles.

Exclude from Lease and/or repair works to be carried out by property owners and/or joint high level inspection with the landlord's surveyor to be carried out prior to signing of the lease or legal completion of the lease from high level cherry picker or equivalent.

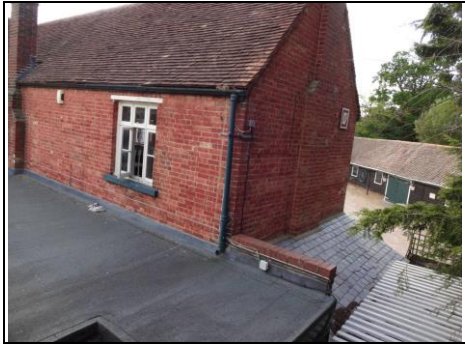
Left External Elevation

(limited view due to dog compound)

DESCRIPTION	CONDITION	ACTION REQUIRED
Chimneys: Brick		See front elevation
Roofs: Low level slate roof	Slates displaced/slipped Build up of leaves

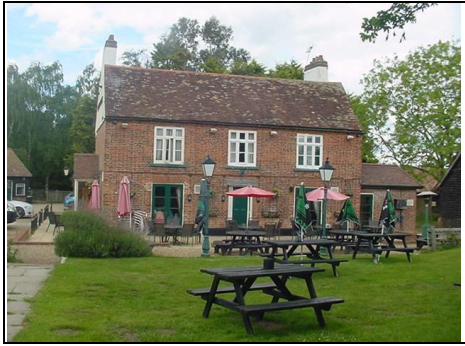
Right External Elevation

DESCRIPTION	CONDITION	ACTION REQUIRED
Roofs: Tiles	Missing, spalling and deteriorating	See front elevation General overhaul of roof Exclude from lease
Gutters and Downpipes: Cast iron and plastic		See front elevation Clear
Walls: Flemish bond brickwork	Wrongly repointed in cement mortar	See front elevation Remove all cement mortar and repoint in lime mortar Exclude from lease
External Detailing: Windows: Casement	Two top windows particularly badly painted over rotten timber	Splice in new timber. It may be more economical to replace the windows subject to Listed Buildings Consent Repair, prepare and redecorate Exclude from lease

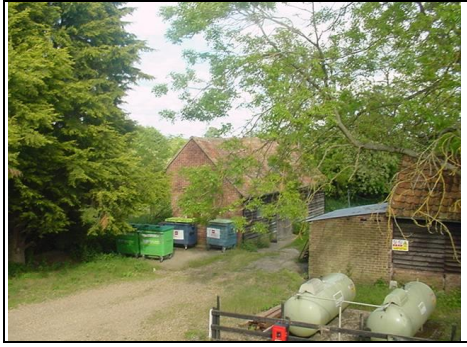
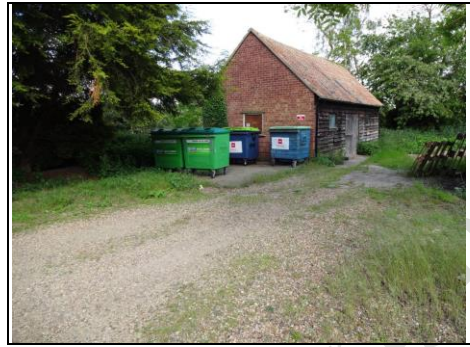
Rear Barn

(No internal access gained)

DESCRIPTION	CONDITION	ACTION REQUIRED
Roofs: Pantiles Slate at base Glazed section		
Gutters and Downpipes: Plastic	Electric wiring hanging off	Ensure all gutters are watertight and falling towards the downpipe and clear. Repair downpipes and secure as necessary, ensure downpipes are clean and clear.

Walls: Left Gable: Flemish bond brickwork Front: Shiplap boarding Right Gable: Shiplap boarding	Ivy Boarded over sign No entry sign Ivy	Remove vegetation Remove vegetation
External Detailing: Windows: Two timber windows Doors: Double timber doors	Average Average	Repair, prepare and redecorate. Repair, prepare and redecorate.

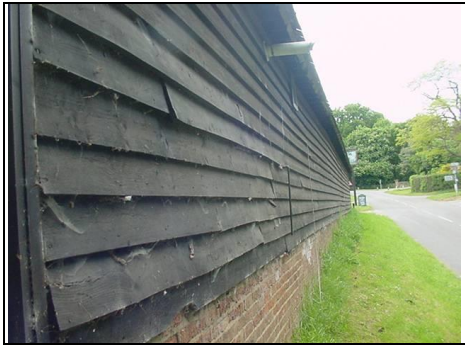
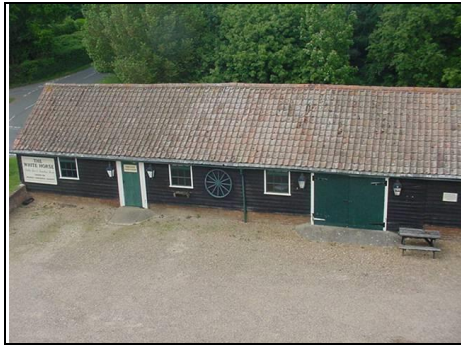
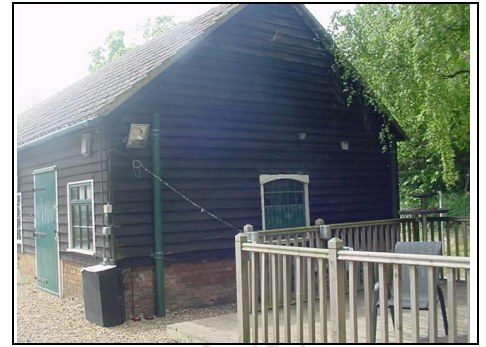
Function Room

DESCRIPTION	CONDITION	ACTION REQUIRED
Roofs: Pitched, clad with pantiles Glazed old style roof		
Gutters and Downpipes: Plastic		Ensure all gutters are watertight and falling towards the downpipe and clear. Repair downpipes and secure as necessary, ensure downpipes are clean and clear.
Walls: Flemish bond brickwork

<p>Dampness front wall</p>	Cracking rear left corner Dampness

<p>Clear Resolve dampness</p>
<p>External Detailing:</p> <p>Windows: Timber</p> <p>Doors: Timber</p>	<p>Dated</p> <p>Dated</p>	<p>Repair, prepare and redecorate.</p> <p>Repair, prepare and redecorate.</p>

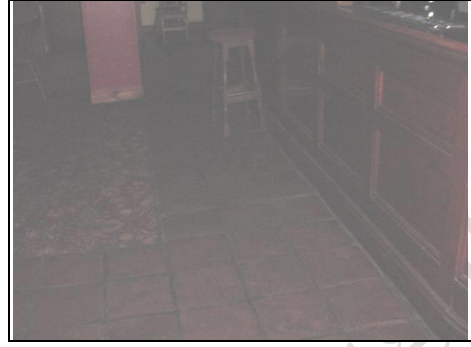
Lobby area to main bar
(we apologise for quality of photo)

DESCRIPTION	CONDITION	ACTION REQUIRED
Ceiling: Painted	Part painted

Repair, prepare and redecorate
Walls: Painted	Dated	Repair, prepare and redecorate.
Floors: Carpet	Worn	Clean/replace.
Detailing: Entrance Door: Timber Single width	Marked and worn to base Missing vision panel	Sand, prepare, repair and restrain.or replace

<p>Internal Door: Glazed</p>	  <p>No safety Kitemark</p>	<p>Replace with British Standards safety glass</p>
<p>Services:</p>		<p>See Services Section</p>

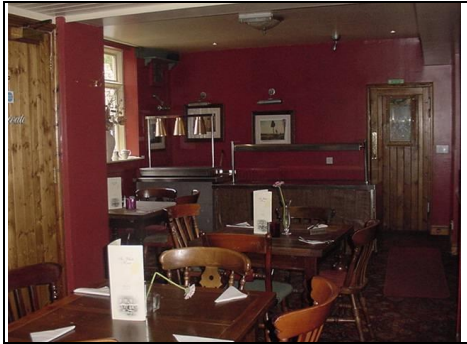
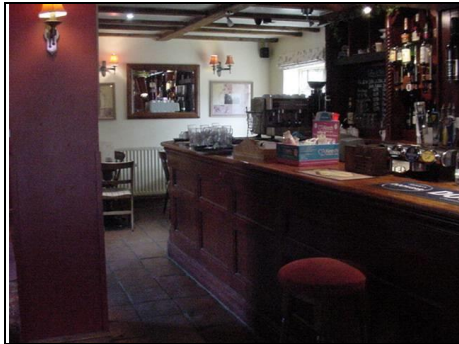
Main Bar – L-shaped

(Seating on left side threadbare)

<p>Threadbare seating</p>	<p>Replace Resolve dampness</p>

<p>Floors:</p> <p>Mixture of tile and carpet</p>  	<p>Undulating</p>  	<p>Deep clean tiles</p> <p>Clean/replace carpet</p>
<p>Detailing:</p> <p>Windows:</p> <p>Mixture single and double glazed casement windows</p> <p>Doors:</p> <p>Timber with vision panel – into kitchen</p>   <p>Door to cellar</p> <p>Door to private living accommodation</p>	<p>Note, wet rot, etc painted over externally</p>   <p>DIY painting</p> <p>Dated</p>  	<p>Repair, prepare and redecorate</p> <p>Sand, prepare and re-stain</p>

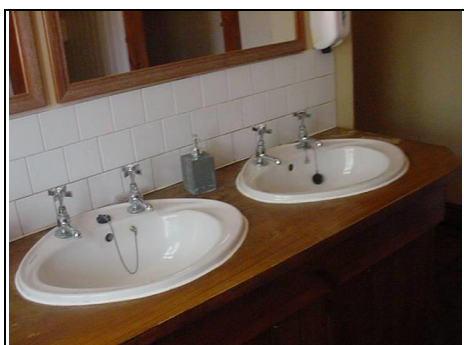
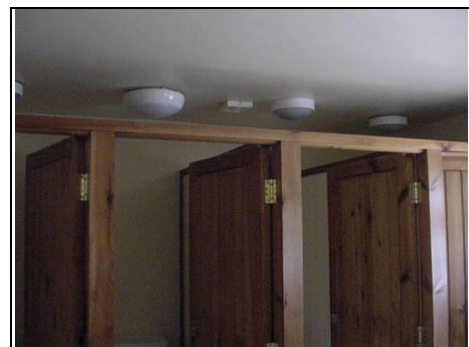
Ladies toilets

DESCRIPTION	CONDITION	ACTION REQUIRED
Ceiling: Painted	Dated	Repair, prepare and redecorate.
Walls: Painted Dry lining/False wall to Perimeter WC's divided by vertical boarding Splash back tiling around vanity units	Dated Hiding dampness

Dated Dated	Resolve dampness Repair, prepare and redecorate. Repair, prepare and redecorate. Deep clean
Floors: Tiles	Dated	Deep clean

<p>Detailing:</p> <p>Windows:</p> <p>Two casement windows Top hung Double glazed frosted glass</p> <p>Doors: Timber with door closures</p>	<p>Dated</p> <p>Dated</p>	<p>Repair, prepare and redecorate</p> <p>Sand, prepare and redecorate</p>
<p>Sanitary Ware:</p> <p>Four WC's</p> <p>Vanity unit with three wash hand basins</p>	<p>Black mould in mastic and service duct</p> <p>Worn top</p>

<p>Replace mastic. Deep clean</p> <p>Replace</p>
<p>Services:</p> <p>Extract Fan</p> <p>Manhole cover</p>	<p>Dated</p>

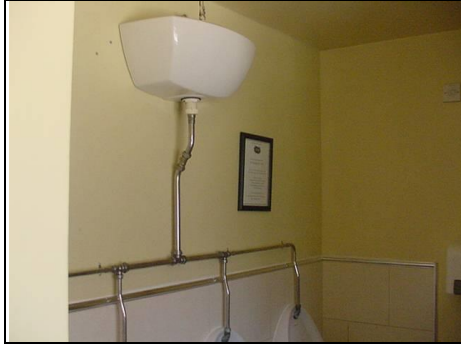
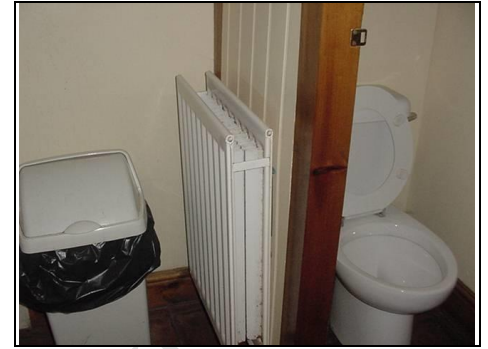
Urinals

DESCRIPTION	CONDITION	ACTION REQUIRED
Ceiling: Painted	Dated	
Walls: Splash back tiling around urinal	Dated Old fixing points	Fill holes. Repair, prepare and redecorate.
Floors: Tiles	Worn

<p>Detailing:</p> <p>Windows:</p> <p>Two casement windows Top hung Double glazed frosted glass</p> <p>Doors:</p> <p>Timber</p>	<p>Dated and worn cills</p>

<p>Dated</p>	<p>Repair, prepare and redecorate</p> <p>Sand, prepare and redecorate</p>
<p>Sanitary Ware:</p> <p>WC</p> <p>Two Wash hand basins</p> <p>Four Urinals</p>	<p>Dated</p> <p>Tap tops missing Mould to mastic</p> <p>Dated</p>	<p>Deep clean</p> <p>Replace taps Remove mould and re-mastic Deep clean</p> <p>Deep clean</p>
<p>Services:</p>		<p>See Services Section</p>

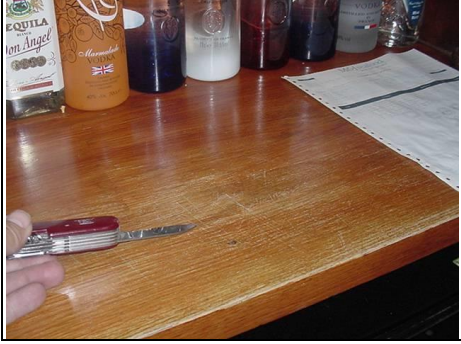
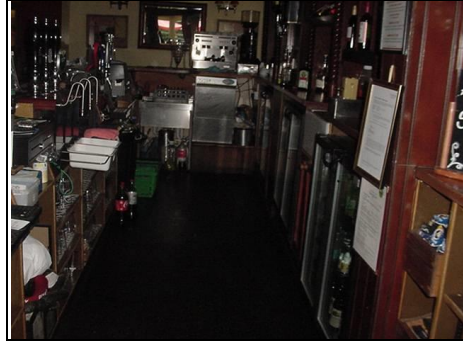
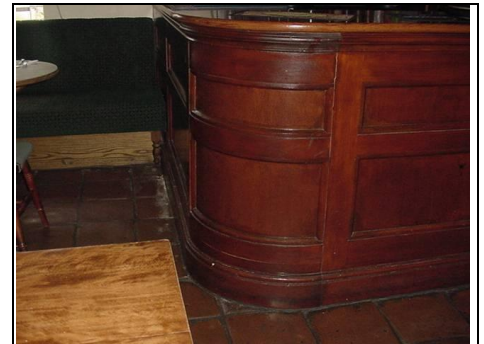
Bar Servery Area

DESCRIPTION	CONDITION	ACTION REQUIRED
Ceiling: Painted	Dated	Repair, prepare and redecorate
Walls: Wooden back bar	Average Worn worktop	Clean, repair, prepare and re-vanish.
Floors: Vinyl style flooring	Dated	Clean/replace
Detailing: Timber bar top to front of bar	Worn

Sand, prepare and re-stain
Services:		See services section

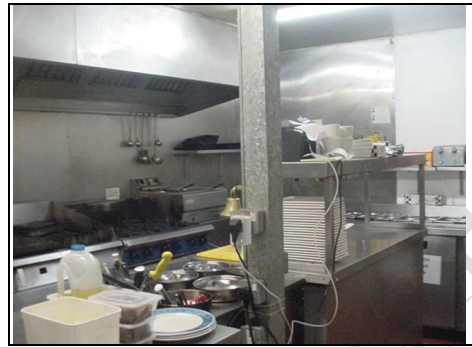
Cooking area

DESCRIPTION	CONDITION	ACTION REQUIRED
Ceiling: Painted	Dated Joints proud	Rub back joints. Repair, prepare and redecorate.
Walls: Stainless steel	Dated	Clean
Floors: Vinyl style flooring	Joints splitting Marks where old style skirting Some areas need replacing	Replace
Detailing: Doors: Entrance door from main bar Door to function room and outside left side	Marked Marked	Repair, prepare and redecorate Repair, prepare and redecorate

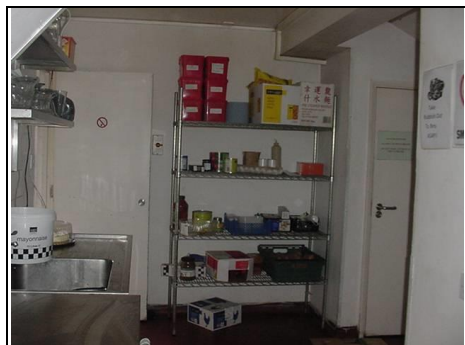
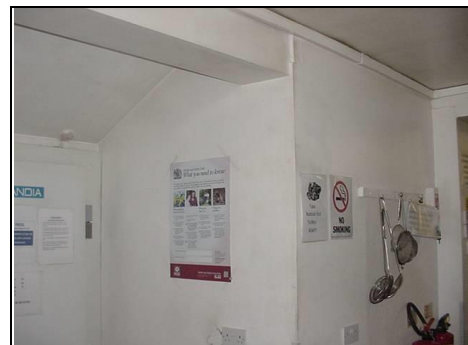
DESCRIPTION	CONDITION	ACTION REQUIRED
Ceiling: Partly vaulted	Heavily stained underneath single pitched right side roof

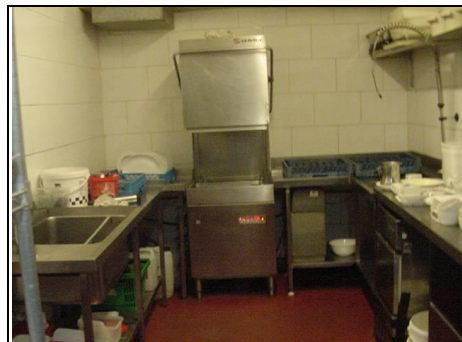
Burn marks to floor

DESCRIPTION	CONDITION	ACTION REQUIRED
Ceiling: Painted	Undulating	Deep clean, repair, prepare and redecorate.
Walls: Large tiles	Dated Old fixing points	Deep clean, repair, prepare and redecorate
Floors: Vinyl style flooring	Burn marks	Deep clean, repair and/or replace
Equipment: Stainless steel sink and drainer Kitchen units:	The equipment has not been inspected. We have assumed that the equipment meets the appropriate Local Authority approval and standards.	
Services:		See Services Section

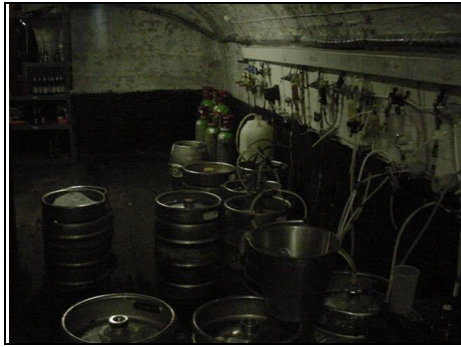
Cellar

DESCRIPTION	CONDITION	ACTION REQUIRED
Ceilings and Walls: Vaulted Painted	Dampness and mould

Resolve dampness Repair, prepare and redecorate. Meeting with Environmental Health Officer recommended
Floors: Concrete Rubber mat covering large proportion of floor	Dampness Uneven Areas broken up at the bottom of the cellar drop

Repair floor
Detailing: Doors: Timber panelled door	Average	Repair, prepare and redecorate.

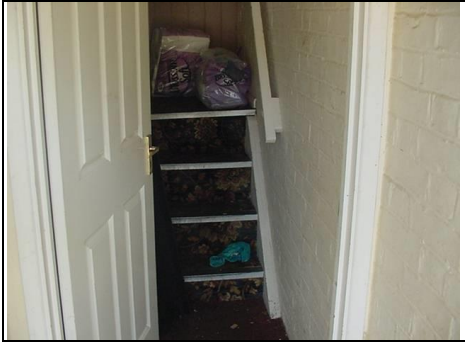
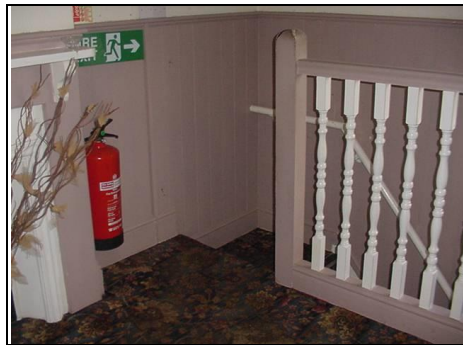
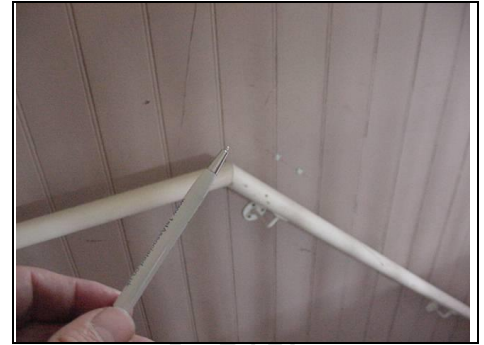
Access Stairs to Function Room and Corridor

DESCRIPTION	CONDITION	ACTION REQUIRED
Ceiling: Painted	Dated	Repair, prepare and redecorate
Walls: Painted brickwork Painted plasterboard Painted timber boarding	Dated damp to base Dated Dated

Damp to base	Repair, prepare and redecorate. Repair, prepare and redecorate. Repair, prepare and redecorate.

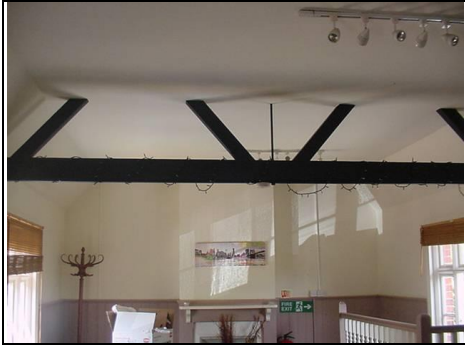
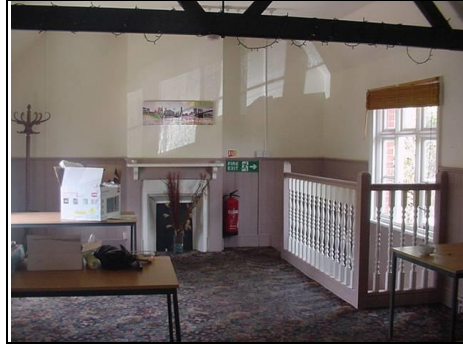
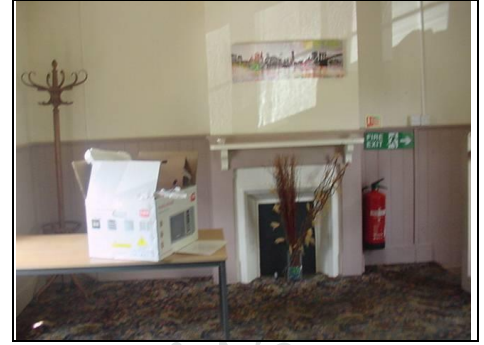
Function Room – front left

DESCRIPTION	CONDITION	ACTION REQUIRED
Ceiling: Vaulted Modern Queen Post Roof visible No access to roof

Dated	Repair, prepare and redecorate.
Walls: Embossed wallpaper Dado rail Timber boarding approx. 1.5m Fireplace – left Fireplace - right	Dated Heavily marked Blocked and vented Vented	Repair, prepare and redecorate. Sand, prepare and redecorate.
Floors: Carpet	Worn	Clean/replace

Detailing: Windows: Casement Doors: Flush timber door Access to Private living accommodation	Rot externally Dated	Repair, prepare and redecorate Repair, prepare and redecorate
Staircase: Rear left side		
Services:		See Services Section

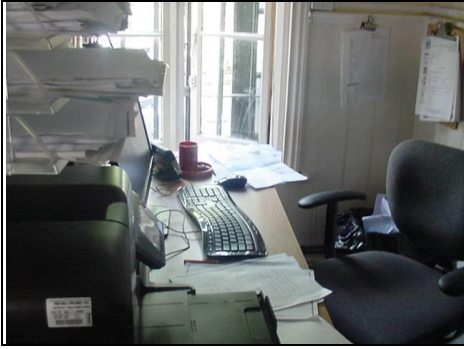
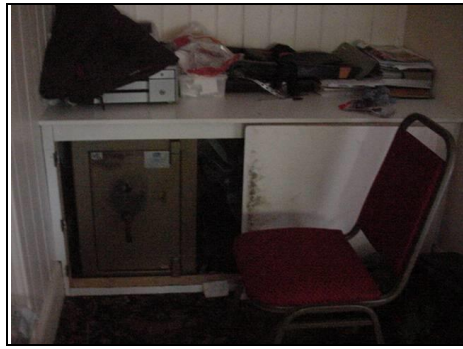
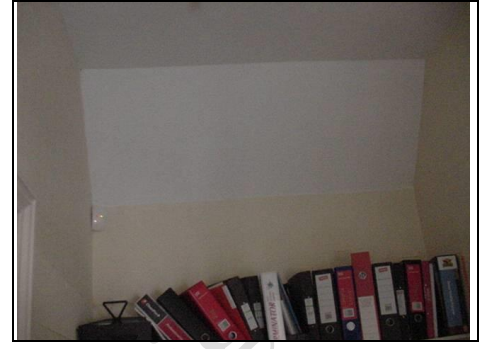
Office to Middle

DESCRIPTION	CONDITION	ACTION REQUIRED
Ceilings: Vaulted No access to roof	Hairline cracking	Repair, prepare and redecorate
Walls: Embossed wallpaper Dado rail Painted boarding approx. 1.5m	Movement cracking	Repair, prepare and redecorate
Floors: Carpet	Worn	Clean/replace
Detailing: Windows: Casement Doors: Vision panel door	Dated Boarded over	Repair, prepare and redecorate Repair, prepare and redecorate

Cupboard: With safe	Dated	Repair, prepare and redecorate
Services:		See Services Section

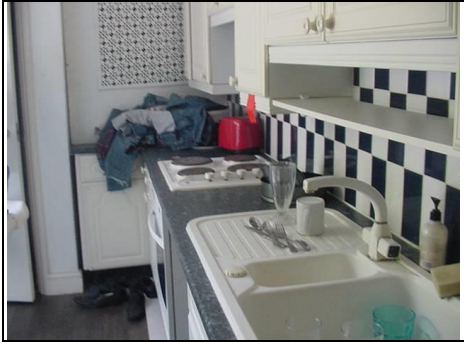
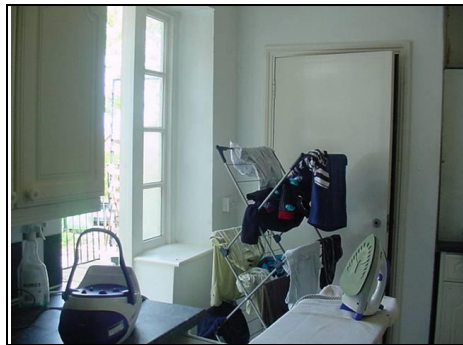
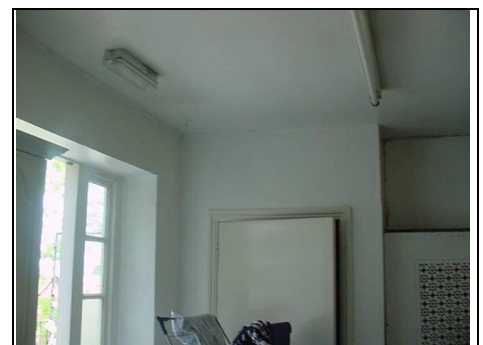
Domestic Kitchen to Middle

DESCRIPTION	CONDITION	ACTION REQUIRED
Ceiling: Painted	Dated	Repair, prepare and redecorate
Walls: Painted Wall mounted unit	Dated	Secure around boiler Repair, prepare and redecorate.
Floors: Vinyl Floor mounted unit Step	Dated Nosing damaged  	Deep clean – we recommend changing to a safety floor Replace nosing and deep clean

<p>Worktop damaged</p>

<p>Boiler cupboard</p> <p>Balcony:</p> <p>Glazed door leading to balcony</p> <p>Paving</p> <p>Metal handrail</p>  	<p>Unvented</p> <p>Unvented</p>   <p>Washing machine leaking down onto main bar below</p> <p>Stored items on it</p> <p>Bed carcass acting as a security railing</p>  	<p>See Services Section</p> <p>Gas safety check</p> <p>Stored items to be removed</p> <p>Add security railing</p>
---	---	---

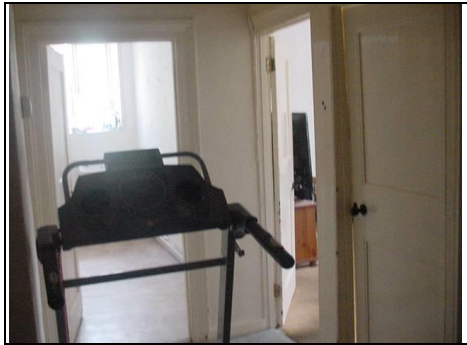
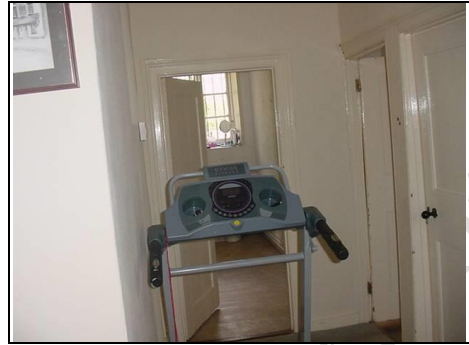
Landing for private living accommodation

DESCRIPTION	CONDITION	ACTION REQUIRED
Ceiling: Painted Access to roof	Dated	Repair, prepare and redecorate.
Walls: Embossed wallpaper	Dated	Repair, prepare and redecorate.
Floors: Carpet	Dated	Clean/replace

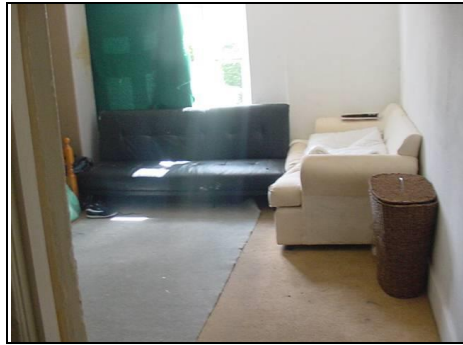
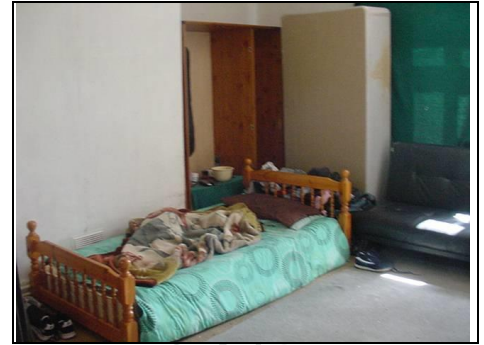
Bedroom one externally

DESCRIPTION	CONDITION	ACTION REQUIRED
Ceiling: Painted plasterboard	Undulating ceiling Leak Hole

Resolve dampness Resolve leak to peg tile roof. Repair, prepare and redecorate.
Walls: Wallpapered Chimney breast	Dampness Vented

Resolve dampness Resolve leak to peg tile roof Repair, prepare and redecorate.
Floors: Carpet	Average	Clean/replace

<p>Detailing:</p> <p>Windows:</p> <p>Casement</p> <p>Doors:</p> <p>Painted panel door</p>	<p>Black mould Painted over rot externally</p> <p>One hinge loose</p>

<p>Remove mould. Repair, prepare and redecorate</p> <p>Repair, prepare and redecorate</p>
<p>Services:</p>		<p>See Services Section</p>

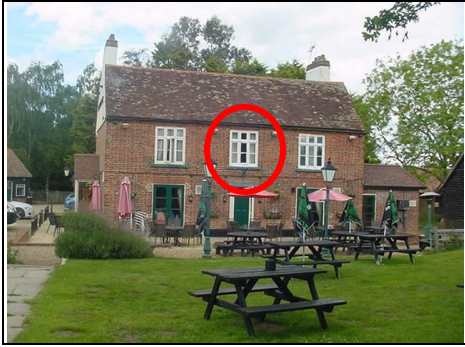
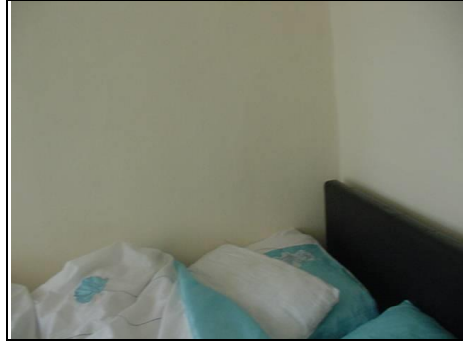
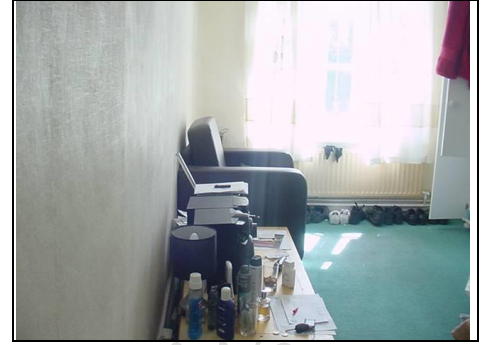
Bedroom Two – middle right

DESCRIPTION	CONDITION	ACTION REQUIRED
Ceiling: Wallpapered	Dated Undulating ceiling Damp staining to ceiling/wall

Resolve dampness Resolve leak to peg tile roof Repair, prepare and redecorate.
Walls: Wallpapered	Dated Damp staining

Resolve dampness Resolve leak to peg tile roof Repair, prepare and redecorate.
Floors: Carpet	Average	Clean/replace

<p>Detailing:</p> <p>Windows:</p> <p>Casement</p> <p>Doors:</p> <p>Painted panel door Rising hinges</p>	<p>Black mould Rot noted externally</p> <p>Dated</p>	<p>Remove mould. Repair, prepare and redecorate</p> <p>Repair, prepare and redecorate</p>
<p>Services:</p> <p>Single panelled radiator</p>		<p>See Services Section</p>

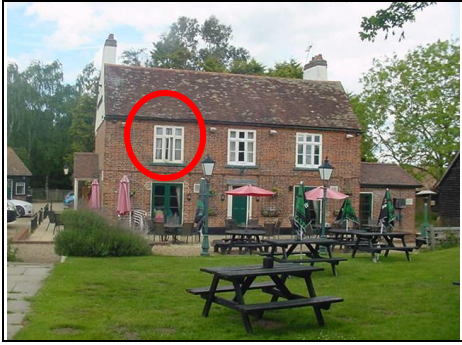
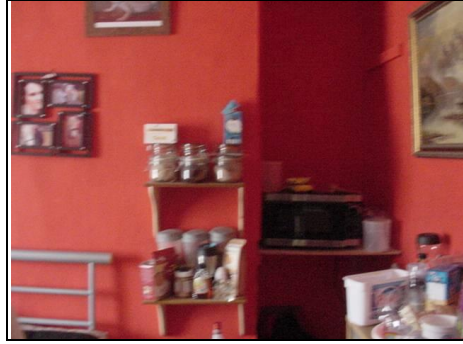
Bedroom Three – front right

DESCRIPTION	CONDITION	ACTION REQUIRED
Ceiling: Woodchip wallpaper	Dated Undulating ceiling Dampness	Resolve dampness Resolve leak to peg tile roof Repair, prepare and redecorate.
Walls: Red painted Chimney breast	Dated Dampness Blocked Unvented	Resolve dampness Resolve leak to peg tile roof Repair, prepare and redecorate.
Floors: Carpet	Worn	Clean/replace
Detailing: Windows: Casement Doors: Locked door	Black mould Rot noted externally Dated	Remove mould. Repair, prepare and redecorate Repair, prepare and redecorate

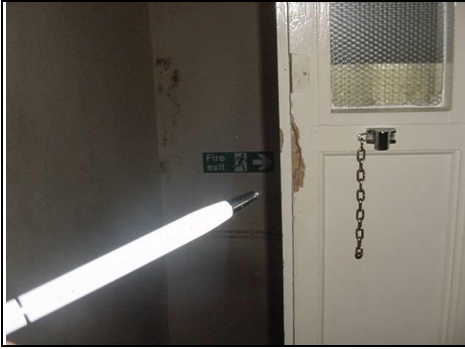
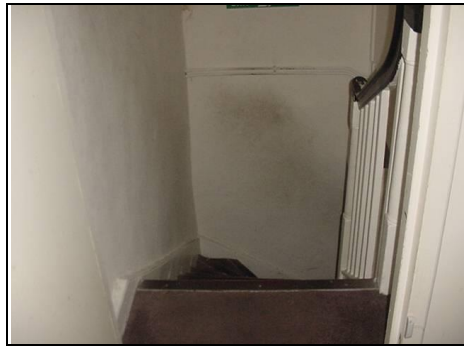
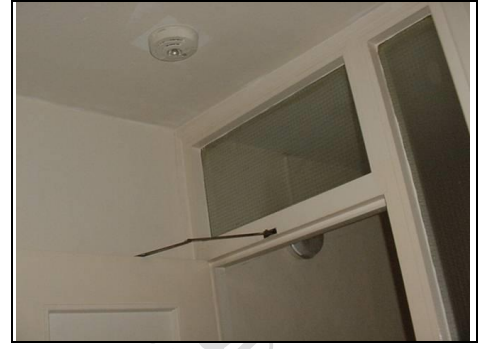
Second Stairs leading down to Pub

DESCRIPTION	CONDITION	ACTION REQUIRED
Ceilings: Painted	Dated	Repair, prepare and redecorate
Walls: Painted	Dated	Repair, prepare and redecorate
Floors: Carpet	Worn	Clean or replace
Detailing: Doors: Vision panel door Stairs: Carpet Handrail: Timber	Boarded over Timber damage to frame

Closed Lobby Area		
Meant to be a fire enclosure but please note there are no fire falls within roof space.	Undulated	Repair, prepare and redecorate
	Dated	Repair prepare and redecorate
Painted ceiling	Worn	Clean or replace
Painted walls	Damaged	Repair prepare or redecorate or replace
Carpet		
Glazed timber door		
Services:		See Services Section

Worn Dated	Replace with Fire Door Clean or replace Repair, prepare and redecorate

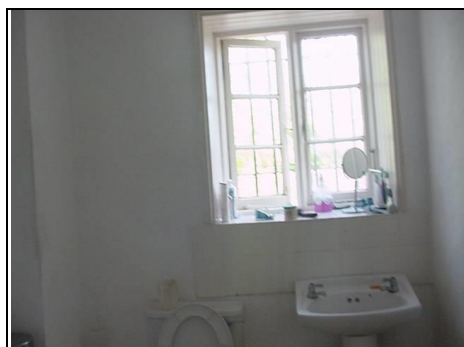
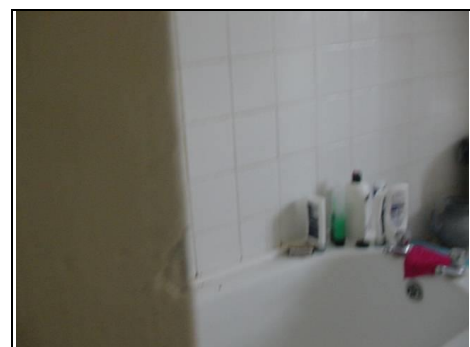
Bathroom

DESCRIPTION	CONDITION	ACTION REQUIRED
Ceiling: Painted	Leak from roof Undulating

Resolve dampness Repair peg tile roof Repair, prepare and redecorate.
Walls: Textured paint	Dampness

Resolve dampness Repair, prepare and redecorate.
Floors: Vinyl	Worn	Deep clean or replace

<p>Detailing:</p> <p>Windows:</p> <p>Casement</p> <p>Doors:</p> <p>Painted Timber</p>	<p>Dated</p> <p>Dated</p>	<p>Repair, prepare and redecorate</p> <p>Repair, prepare and redecorate</p>
<p>Sanitary Ware:</p> <p>Bath</p> <p>Wash hand basin</p> <p>WC</p>	<p>Black mould</p>

<p>Deep clean</p> <p>Replace mastic where mould is</p>
<p>Services:</p>		<p>See Services Section</p>

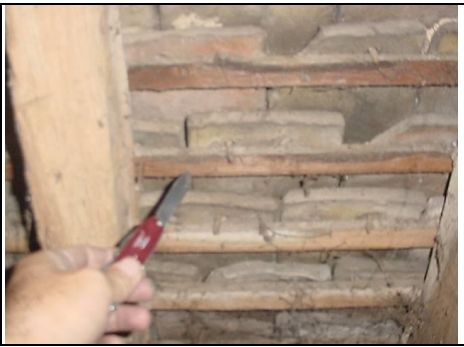
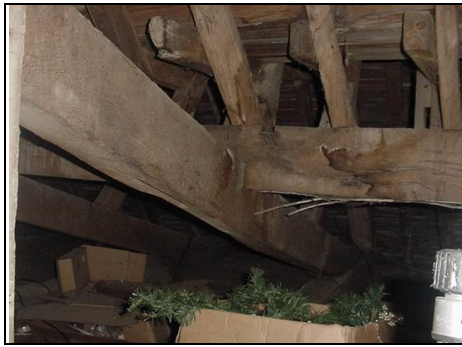
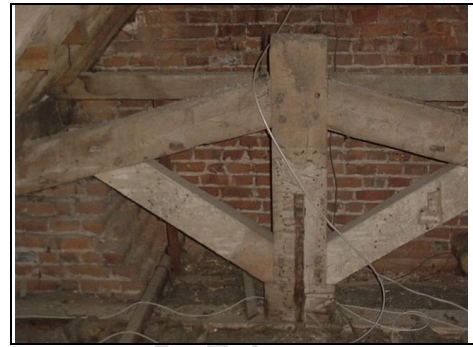
Internal Roof

DESCRIPTION	CONDITION	ACTION REQUIRED
Roof Access: Via hatch from landing in private living accommodation No lights, ladder or secured floorboards		Add ladder, lights and secured floorboards
Roof Structure: King post truss roof

Right side roof timbers	Make watertight and clean
Roof Timbers:	Woodworm Damp staining to timbers

<p>Back of lead lining on valley gutters damaged in some areas DIY repair</p>

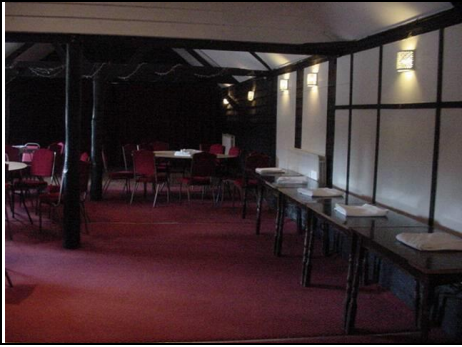
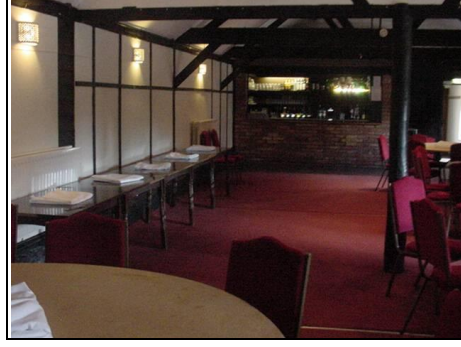
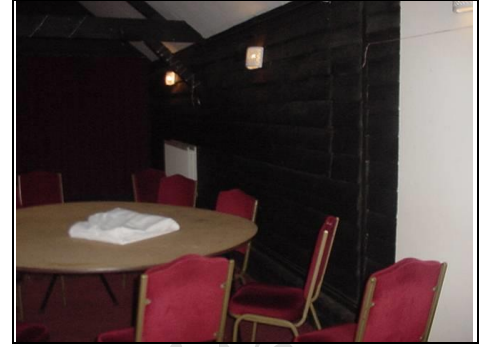
Function Room

DESCRIPTION	CONDITION	ACTION REQUIRED
Ceiling: Embossed wallpaper Queen Post exposed rather roof	Dated

Repair, prepare and redecorate.
Walls: Wallpaper Timber covers over the joints to the walls Shiplap boarding <u>Low Level</u> Painted brickwork	Dated Dampness/condensation to bar area	Resolve dampness Repair, prepare and redecorate.
Floors: Carpet Vinyl	Dated

<p>Fire exit door</p>	<p>Repair, prepare and redecorate</p> <p>Repair, prepare and redecorate</p> <p>Repair, prepare and redecorate</p>
<p>Stage:</p>	<p>Impact damage and marked</p> <p>Stored items behind stage</p>

<p>Stored items behind stage</p>	<p>Repair, prepare and redecorate</p> <p>Remove stored items</p>
<p>Bar:</p> <p>Brick built</p> <p>Timber top</p>

<p>Dated</p> <p>Broken</p>	<p>Repair, prepare and redecorate</p> <p>Replace</p>

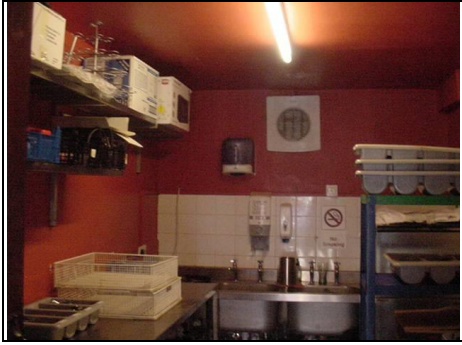
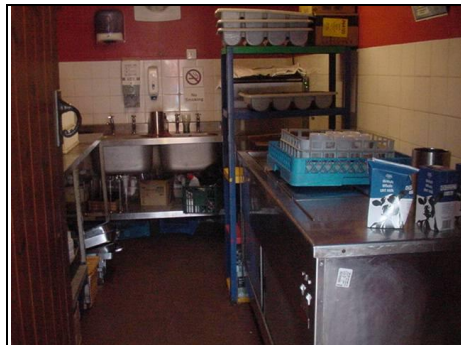
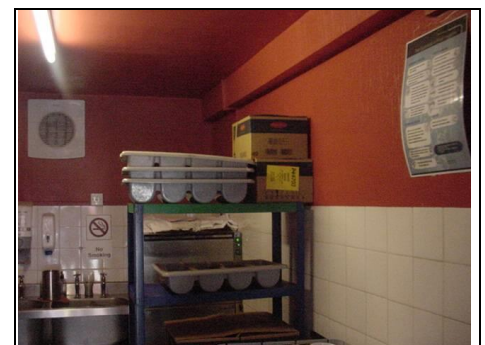
Preparation area/Kitchenette

DESCRIPTION	CONDITION	ACTION REQUIRED
Ceiling: Painted	Dated Dampness/condensation	Resolve dampness Repair, prepare and redecorate
Walls: Part painted Tiles to approximately 1.75m	Dated Dampness/condensation Ingrained dirt	Resolve dampness Repair, prepare and redecorate. Deep clean
Floors: Vinyl style flooring	Dated	Deep clean or replace
Detailing: Doors: Flush painted timber Timber ledge and brace door	Dated Dated	Repair, prepare and redecorate Repair, prepare and redecorate

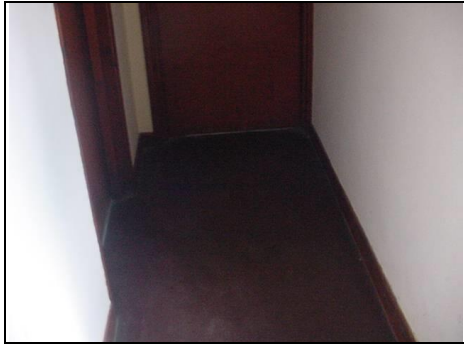
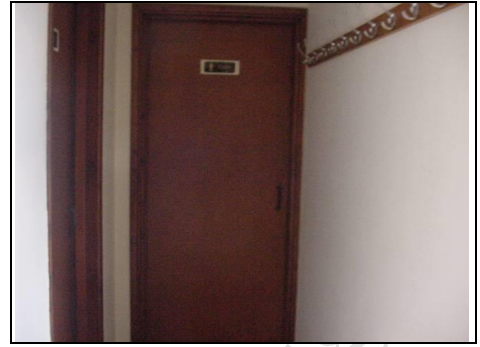
Lobby Corridor

DESCRIPTION	CONDITION	ACTION REQUIRED
Ceiling: Textured paint	Dated	Repair, prepare and redecorate.
Walls: Painted	Cracks	Repair, prepare and redecorate.
Floors: Vinyl style flooring	Dated	Deep clean

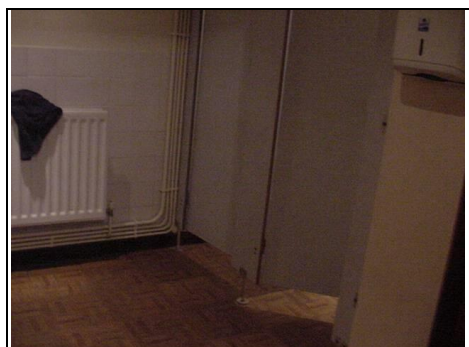
Ladies toilets

DESCRIPTION	CONDITION	ACTION REQUIRED
Ceiling: Textured painted	Dated	Repair, prepare and redecorate
Walls: Painted Tiles to approximately 1.2m Formica partitioning	Dampness Old fixing points	Resolve dampness. Repair, prepare and redecorate. Fill holes/replace tiles and re-grout
Floors: Vinyl Tiles	Dated Dated	Replace Deep clean
Detailing: Doors: Flush painted panel doors	Impact damage	Replace
Sanitary Ware: Two WC's Two Wash hand basins	Dated Dated, rusting brackets	Deep clean Deep clean

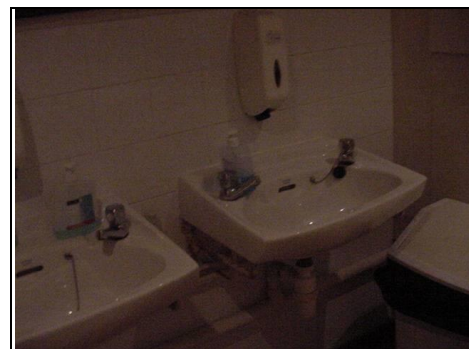
Wash hand basins

<p>Rusting to brackets on wash hand basins</p>	
Services: Valiant Boiler boxed in

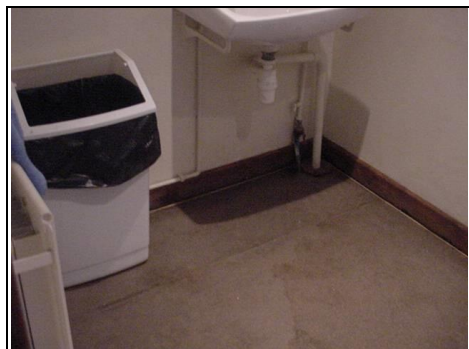
Gents toilets

DESCRIPTION	CONDITION	ACTION REQUIRED
Ceiling: Painted Access hatch into roof	Dated	Repair, prepare and redecorate
Walls: Painted Tiles Timber boarded partition for WC	Dampness Old fixing points	Resolve dampness. Repair, prepare and redecorate. Replace tiles and re-grout
Floors: Vinyl	Running water and dampness around urinals

Resolve leak
Detailing: Doors: Timber panelled	Dated	Repair, prepare and redecorate
