COMMERCIAL BUILDING SURVEY AND PROPERTY APPRAISAL

Large Building to be used for Commercial Use

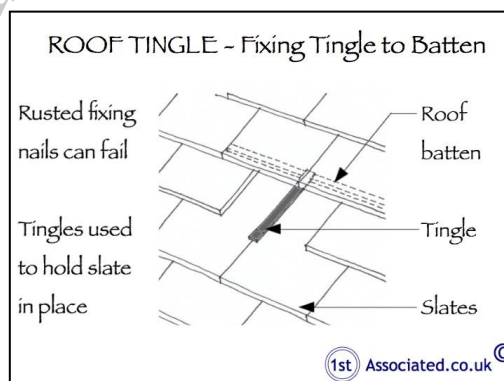
The main roof is clad with slates. We can see there have been various repairs using lead tingles. These indicate that the nail fixings are rusting, often known as nail sickness. We generally recommended where there are more than a dozen to two dozen tingles visible that re-roofing is likely in the near future, which is the case in this instance.

Close up of slates showing lead tingles to front of building

ACTION REQUIRED: Re-roof over next few years. There are no major visual signs internally (to the ceilings) that the roof is a problem. Having said that, we have not been in the actual roof space of these areas.

ANTICIPATED COST: In the region of £100,000 to £150,000 to re-roof or carry out major repairs. You need to obtain quotations, quotes will depend on whether you scaffold over the property to form a temporary roof or take the risk that there won't be adverse weather whilst you are carrying out the work.

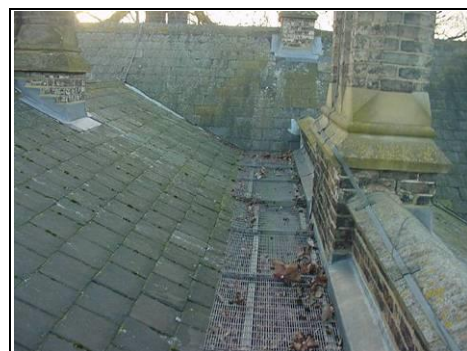
To the front of the property where we could inspect it, we found a box gutter. This we believe is allowing dampness into the walls.

General view of roof showing box gutters

ANTICIPATED COST: Included in the main roof works.

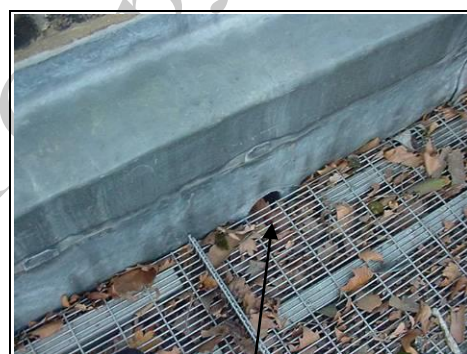
Example of how the box gutter gets blocked with the arrow showing where the outlet is in the parapet wall to the front of the property

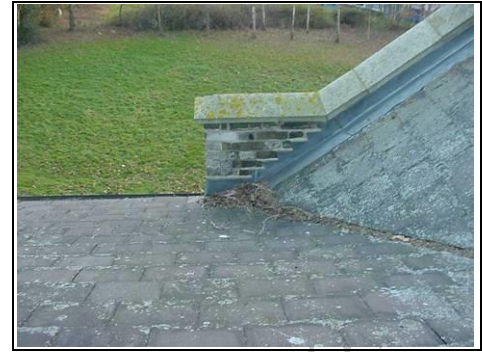
Ongoing maintenance battle against the leaves and branches blocking the gutters up on the roof

ACTION REQUIRED: Clear vegetation.

ANTICIPATED COST: Included in the main roof works.

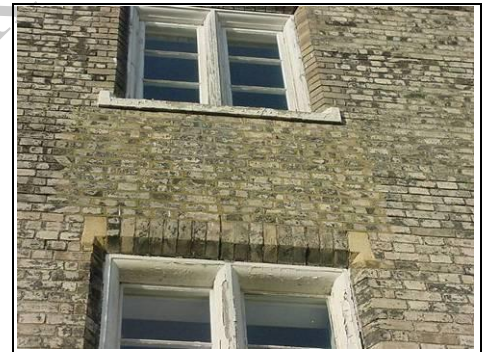
Weathering has occurred particularly to the rear left hand side under the windows and also where it is overflowing from gutters and hopper heads and downpipes.

Weathered brickwork

ACTION REQUIRED: The process needs to be clearing of the gutters and roofs of debris and a regular planned maintenance programme be adopted. Then to check the gutter joints, checking that they fall and their lining, tarring if necessary to the downpipes, and only then to re-point in an appropriate lime based mortar to the correct pointing style to the external of the property.

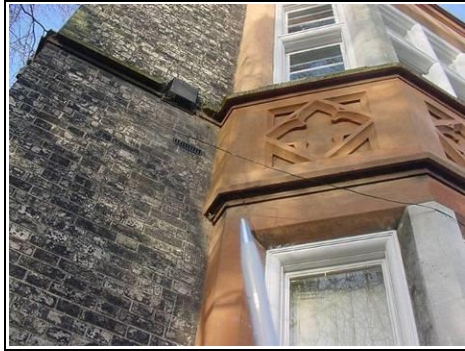
4.3 Movement in rear double bay window

Movement in double bay to rear at high level

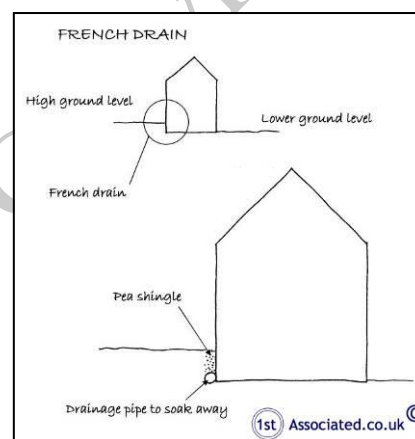
There is rising damp throughout the property. It was particularly noticeable in the basement/cellar area where we would expect there to be dampness. It is also visible in the left hand corridor at ground floor level. We feel it may also be present in other ground floor rooms, although there is timber panelling that may be hiding it. Spalling to brickwork from dampness

ACTION REQUIRED: We feel some form of French gully around the property would be the best way of reducing the dampness and managing the dampness but this only needs to be carried out once investigations have taken place. We recommend the property is monitored for at least a year.

ANTICIPATED COST: In the region of £30,000 to £50,000; please obtain quotations.

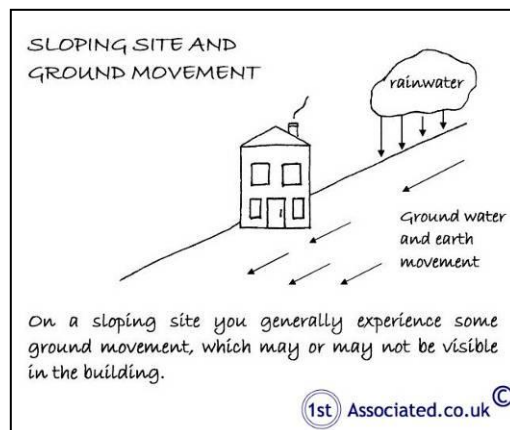
Sloping Site

Whilst the sloping site is not pronounced there is a fall from the front elevation of the property to the rear of the property and as such water would wish to pass from one side to the other, which we believe it is presently doing through the basement.

The sketch obviously over-emphasises the slope in this instance.

ACTION REQUIRED: Please note our comments with regard to the basement and the holes in there and managing the ground water around the property.

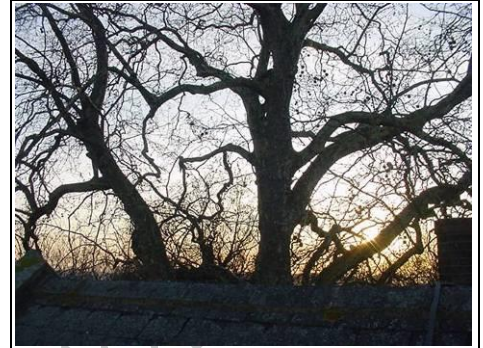
This is a Listed building and a regular planned maintenance programme needs to be carried out, not only to the roof but to the property as a whole.

Trees need regular maintenance

ACTION REQUIRED: Carry out regular maintenance.

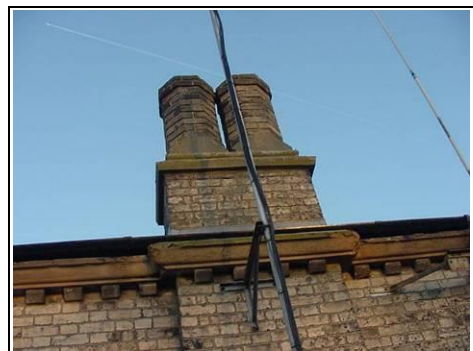
We were unable to get a close up view of some of the chimneys

ACTION REQUIRED: The majority of the chimneys will required some repointing. We noticed some work had been carried out in a hard cement mortar which may cause spalling to the brickwork.

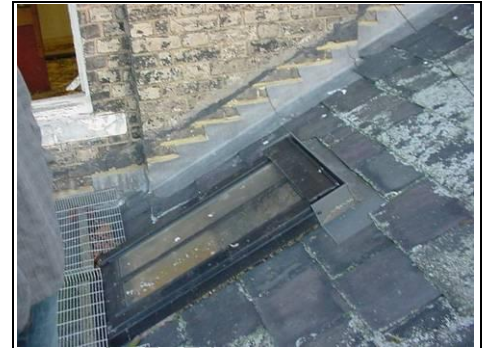
Roof light one – main building left hand side front

You also have some older style roof lights which have been repaired with Flashband or a similar material.

Flashband is a sticky backed felt which is best used for temporary repairs only.

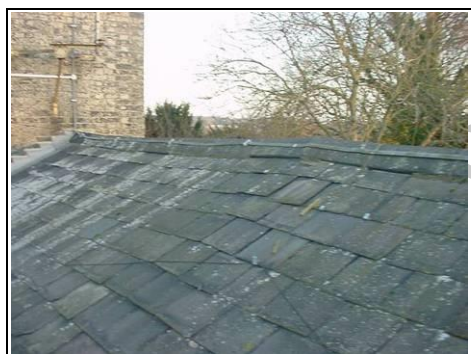
Left hand roof

The roof is pitched and clad with slates, with box gutters. From ground level and front roof level this looks in average to below average condition considering the roofs age type and style.

We were able to access the front roof and inspect this more closely where we could see lead tingles were present, as well as there being some cracked and slipped slates.

ACTION REQUIRED: We feel that the roof may have nail sickness, which is the rusting of the nail fixings. Please see our comments in the Executive Summary.

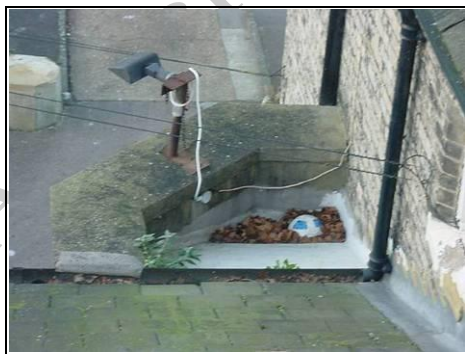
Left hand Oriel roof

As you can see in the photos these are collecting a lot of leaves and this needs to form part of your regular maintenance programme. Equally you can see there is difficulty in accessing this area.

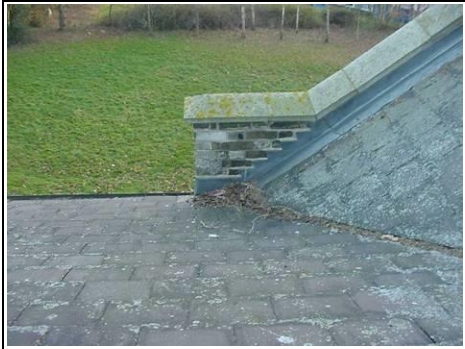
As with many roofs that have been extended and altered over the years you have some awkward details that simply need regular maintenance. The problem is that regular maintenance tends to be forgotten about in the scheme of things.

Blocked valley gutter

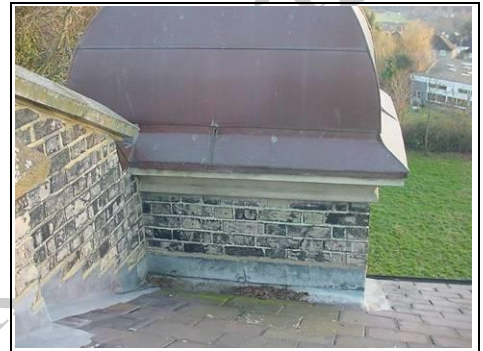
Natural areas due to the way the roof has developed that are awkwardly detailed, such as this one with the rear turret roof being a trap for leaves and water

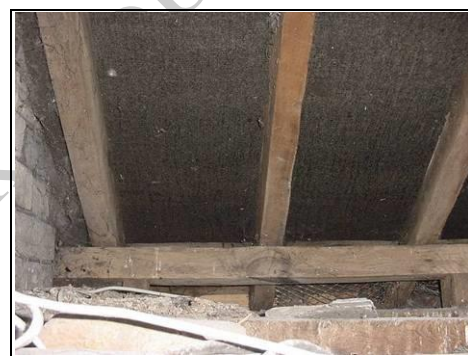
Protective underlayer

When we inspected the loft space we found a Hessian base Bitumen membrane. This type of membrane has been used since the 1960s. We generally found it to be in average condition, it is damaged in a few more places than we normally find. We also noticed the darker timber indicating dampness getting in.

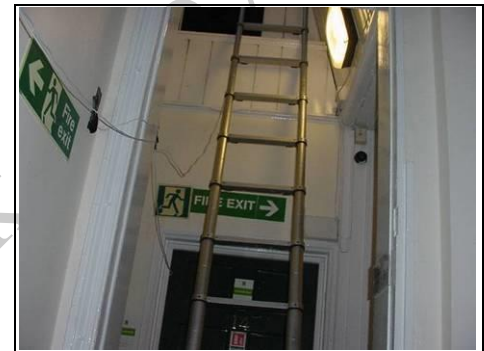
One areas is adjacent to Room 14 and the other was from within Room 18. There is no loft ladder or electric light in either of the roofs. There was some secured floor boarding in roof adjacent to room 14. We recommend a general upgrade in the access to the roofs.

Access to roof adjacent to room 14
(old numbering)

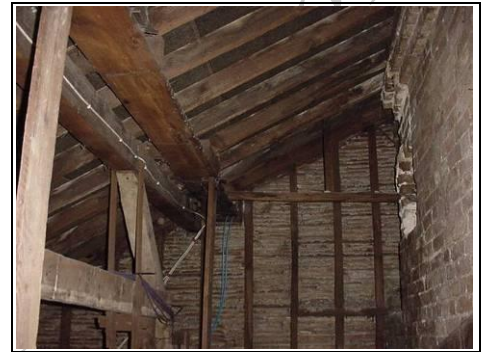
Roof visible from within access adjacent to room 14

Our examination was limited by the general configuration of the roofs. What we could see in this roof was average to below average, with dampness visible around chimney for example and signs of woodworm. It is, however, feasible there are additional problems in the roof that are hidden from view, particularly as we have only seen approximately thirty percent of the roof structure.

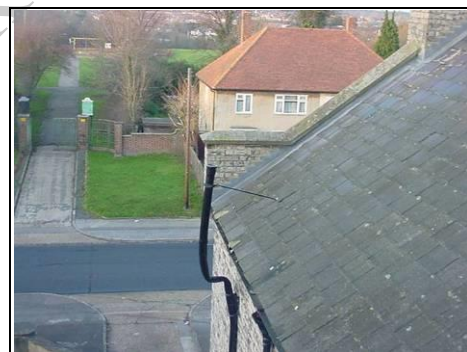
The property has a mixture of cast iron and lead soil and vent pipes. The lead pipes add to the overall character of the property but can cause a problem with repair and deterioration.

Lead vent pipe

ACTION REQUIRED: Redecoration of gutters and downpipes and soil and vent pipes.

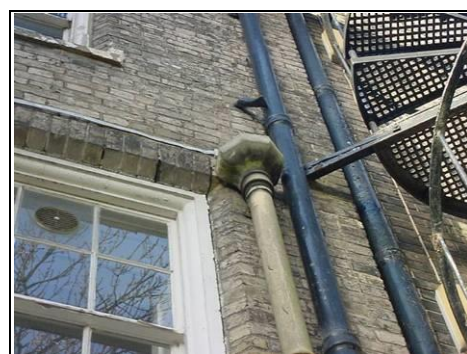
Lead pipework

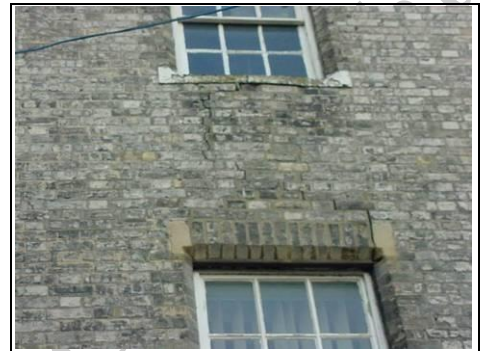
The property is built in a brick originally in a lime mortar in what is known as Flemish bond brickwork which has been repointed with cement mortar. We would recommend a programme of gradually re-pointing the whole of the property.

External picture of brickwork

ACTION REQUIRED: We would recommend a programme of repointing the whole of the property.

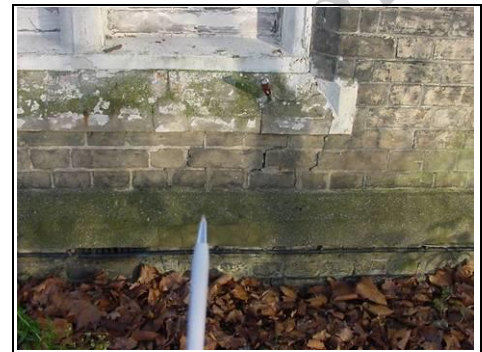
All modern properties should incorporate a damp proof course (DPC) and good building practice dictates that a differential of 150mm (6 inches) should be maintained between the damp proof course and ground levels. In this case, we can see a plinth that looked to be concrete around the property.

Plinth around property.
Also note deterioration to
brickwork

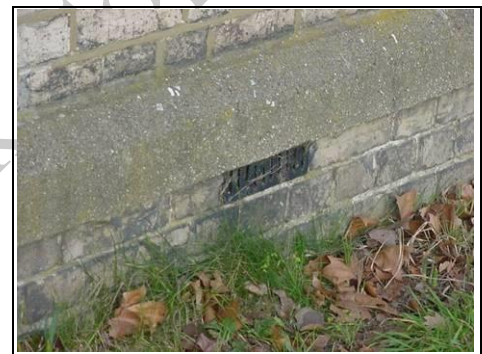
Airbricks that lead into cellar

ACTION REQUIRED: You need to ensure that all air bricks are clear and allowing a flow of air to minimise dampness and you do have a lot of dampness in the cellar.

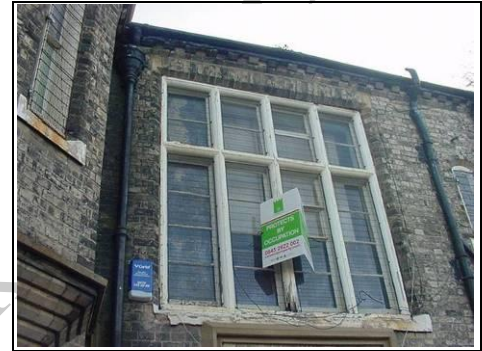
Fascia and soffit is hidden behind the guttering

As we have noted, the gutters are blocked with leaves and other tree debris so we feel they will be overflowing. We can see to the rear that they have overflowed to such an extent that they have weathered the pointing to the brickwork. It seems therefore very likely that the timber behind the gutters will also have been affected.

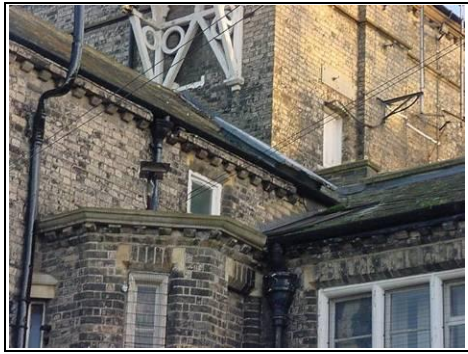
The way we have used this term is strictly not architecturally correct. We have used it to identify the windows to the corner of the front of the property that look out over the front of the building. Our main concern with this area is the flat roofs and the difficulty of access to them rather than the windows themselves, which are suffering in the same way as the majority of the windows from the lack of redecoration.

Oriel window on left hand side

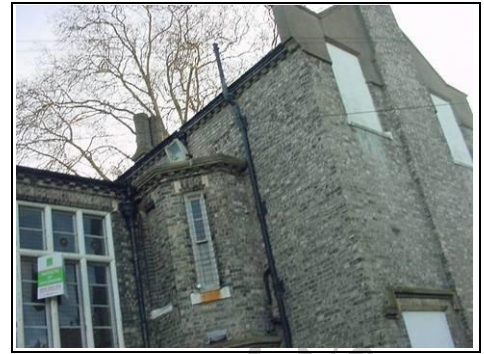
Oriel window on right hand side

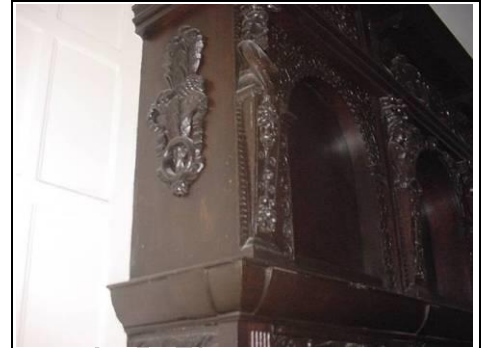
Wood carved fireplace

ACTION REQUIRED: Your solicitor needs to specifically ask the existing owners if any chimney breasts have been removed and if so whether Building Regulations Approval been obtained.

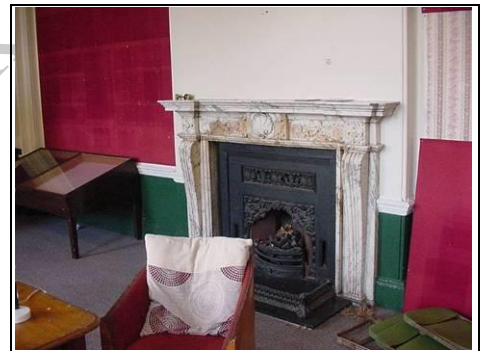
Fireplace in cinema room

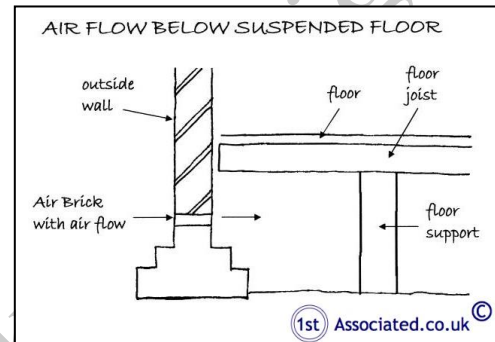
We can also see a spine beam within the basement to the front left hand side and can also see that many of the timbers have rotted away and been replaced which is partly why there is cracking in it.

We believe it would be prudent to open up sections of the floor adjacent to the walls to check the condition of the timbers in these areas as this could be one of the contributory factors to the movement in the property.

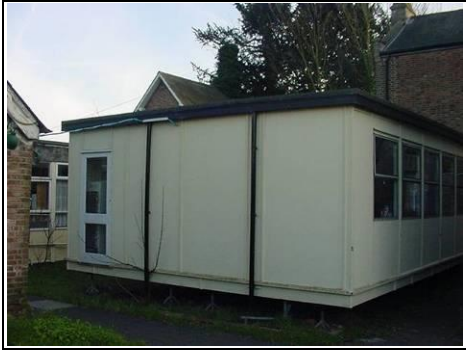
Portakabin that is being used as the kitchen
at time of inspection

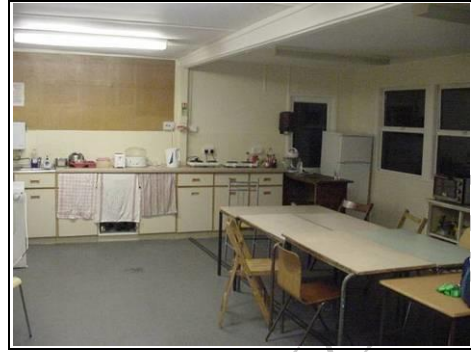
Makeshift Portakabin kitchen

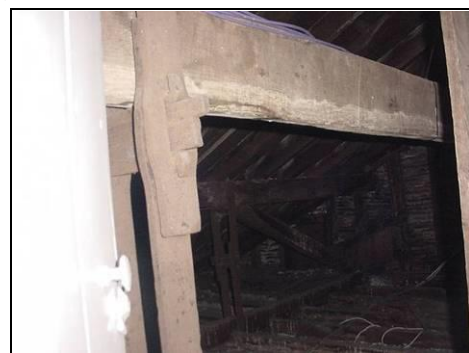
Conditions are present for woodworm with the dampness and the warming up of the environment and with the occupation of the XXX people. The roof is the main area that we fear there is woodworm in this instance as we can see what looks to be old woodworm attack within the roof access adjacent to Room 14.

There are no obvious visual signs of what we would term as active or structurally significant damage, however we are aware that this time of year woodworm activity is minimal. In many properties there is an element of woodworm that is not active. Our inspection is usually restricted by insulation covering some of the timbers and general stored items in the roof, as it is restricted throughout the property by general fixtures and fittings.

Woodworm to front left hand side roof

ACTION REQUIRED: If you wish to be 100 per cent certain we would recommend a specialist report but we would wait until the spring months when the woodworm is more active.

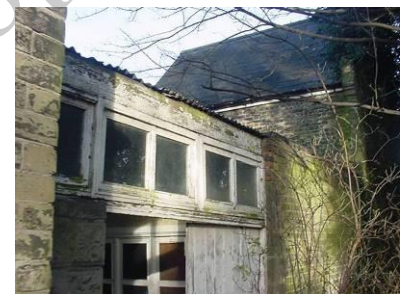
Right hand side
