# RESIDENTIAL BUILDING SURVEY

XXXXXXXXXXXXX,  
XXXXXXXXXXXXX,  
xxxxx Somerset  
BA5 xxx

INDEPENDENT CHARTERED SURVEYORS

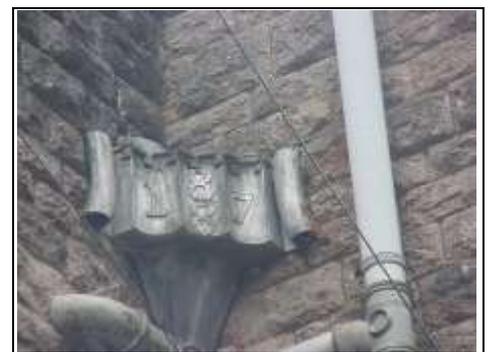
Hopper head showing date 1887

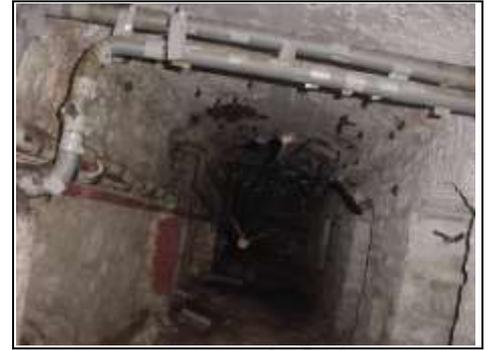
- 1) Store facilities running under the main building, at head height and lower. Protected bats live within them.

Bats in basement

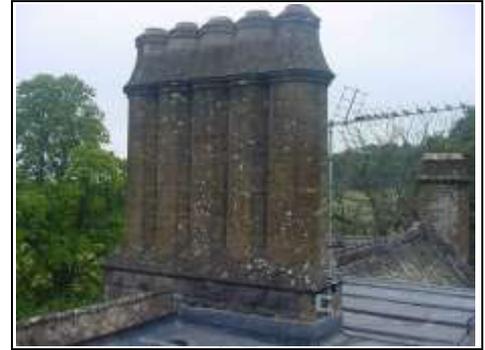
Middle rear chimney

We would also recommend cutting back the trees particularly to the right hand side to enable better sunlight and also some repointing work to the stonework. We would specifically draw your attention to the chimneys on the left and right side which look to be in need of some work although they will be difficult to access other than by scaffold. Scaffold costs on this height of property alone can run into many thousands of pounds due to its height which is why no doubt one of the reasons in the past this work has not been carried out and work has only been carried out on a limited nature to the areas that are easy to reach.

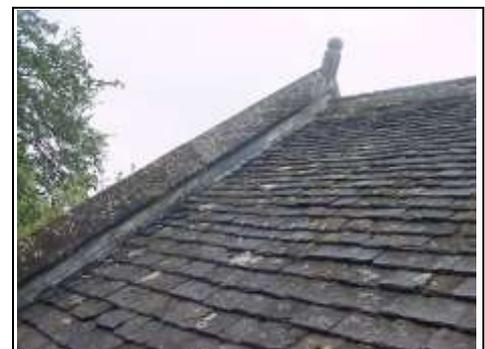
We note that some of the roof stone slates have deteriorated and have been fixed with a lead tingle, which indicates the nails are rusting. Ideally these should be replaced properly. There is also an outside chance the roof has nail sickness, which is where the fixing nails have rusted away and as such then sections of the roof will need to be replaced. This can only really be ascertained by removing sections of the roof and having a close look. It is this risk that we are concerned about with the high level work areas.

If you look closely you can see that lead tingles have been used in the centre of this roof.

**ANTICIPATED COST:** We would set aside the sum of £20,000 to £40,000 for high level work as you are likely to need a scaffold access in some areas and also there may be problems with the nail fixings deteriorating to the slates. Having said that good maintenance will keep this roof going for many years to come and you may wish to wait until there are major roof leaks before commencing work. Quotations required.

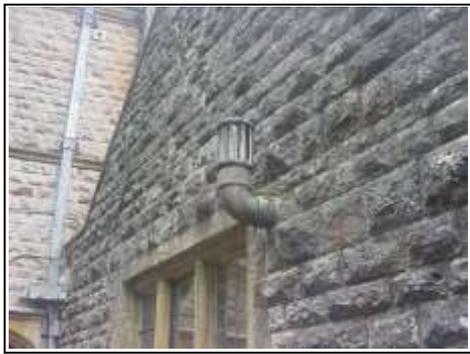
There are various asbestos flues externally and we also expect there to be a flue into the boiler internally. The immersion heater service cupboard on the first floor looks also to have some asbestos.

Asbestos flue

**ACTION REQUIRED:** You need to get a Local Authority approved asbestos contractor to carry out tests and a report and ideally remove. The problem with having asbestos on the property is anticipated problems for any future purchasers. Please note we are not asbestos surveyors.

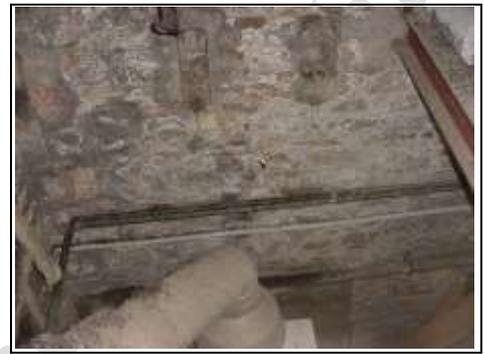
Asbestos going down to boiler in handyman's room and boiler room

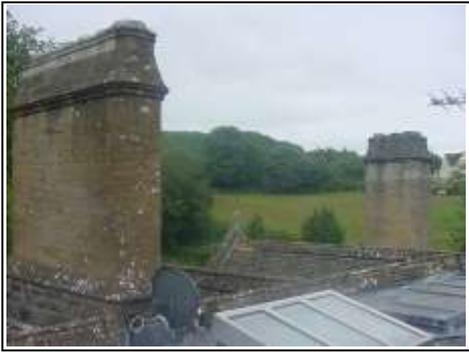
This property has six main chimneys; three to the front and three to the rear. On the visible sides they were all in reasonable condition. We would, however wish to have a closer look at the front left hand chimney and the two chimneys to the right hand side. The front left hand chimney seems to be coming away from the property slightly. This looks to be a historic problem as we can see repairs have been carried out. To the right hand side the chimneys are suffering due to the trees blocking the sunlight and lack of air movement in the area, as is the right hand elevation in general.

The two front left hand side chimneys

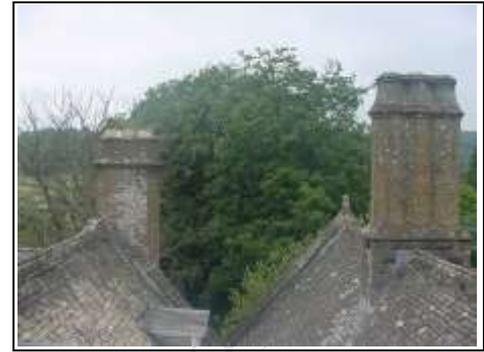
Two right hand chimneys

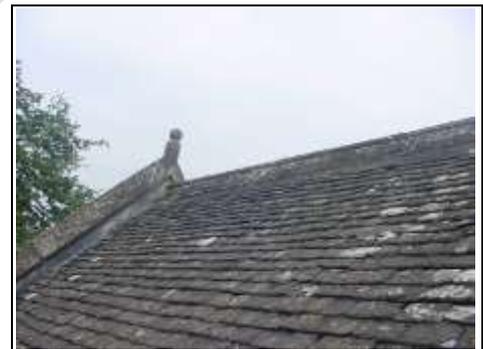
Parapet wall

There are stone parapet walls formed to the gable of the roofs. We were pleased to see that these had lead flashings and stone cappings. Whilst it should be appreciated we were viewing them from a distance, what we could see looked in average condition. We noted in the roof damp staining. Please see our comments in the Executive Summary.

**ACTION REQUIRED:** You need to closely check the lead flashings around the parapet walls as part of a maintenance programme.

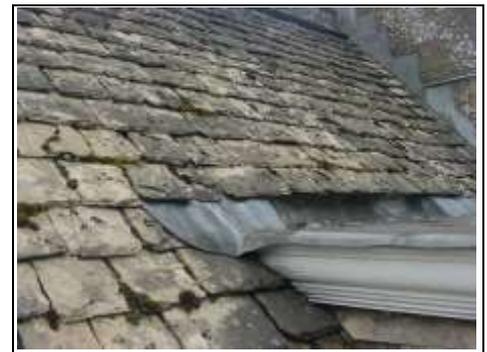
Close up of slates

In other areas there is some deterioration to the surface of the stone slates and moss coverings particularly to the left hand side (see below section).

Having said that, visually internally there are no signs of major leaks and due to the cost of scaffolding to gain access to any areas to carry out repairs we recommend a good maintenance programme rather than replacement.

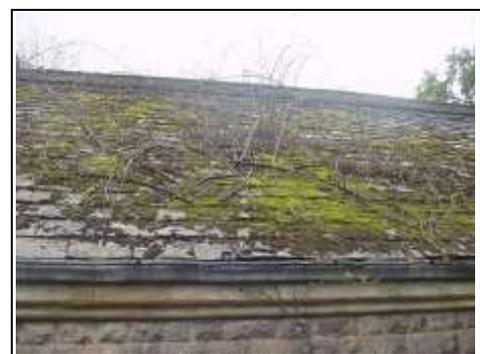
The worst area of roof that we can see is at low level to the left hand side where the kitchen and store area is. There is no obvious reason for its poor condition. It may have been covered with a tree or bush for some time and had water sitting on it.

Close up showing excessive moss

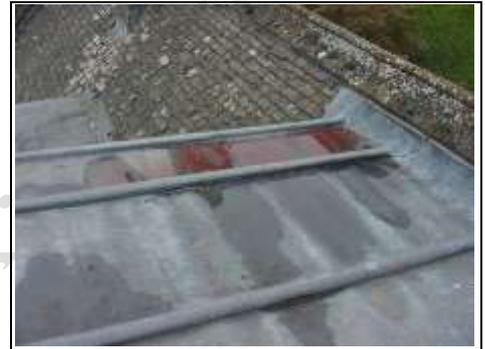
Water ponding

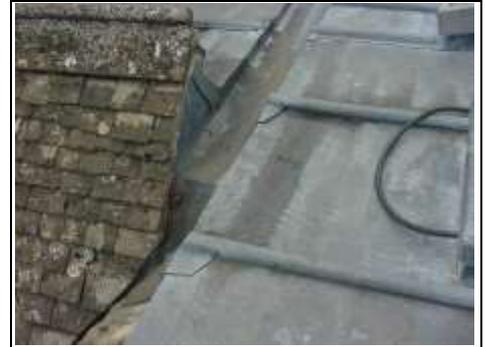
Water ponding

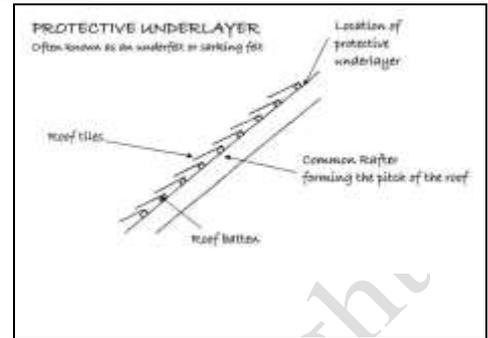
We were looking under the roof to see the decking and would normally expect to see a protective underlayer of Hessian. We have not seen that in this instance and believe that the majority of the stone slates may be very old, and possibly had major repairs since the 1970's.

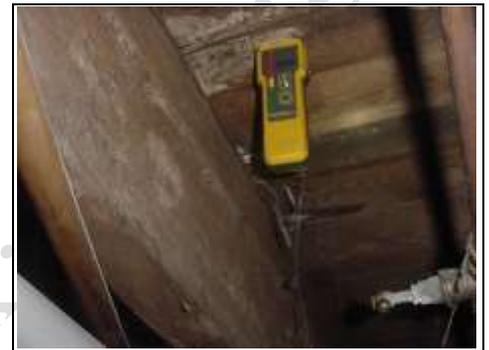
We have spoken about problems with condensation occurring over the water tank areas which has the lead flat roof above it and we have spoken of areas of the valley gutters where dampness is getting in.

Dampness coming through the flat roof below the lead work

**ACTION REQUIRED:** We recommend lids for the water tanks and venting of the area, although we would add that it is very constricted in these areas and you may wish to look at relocating the water tanks.

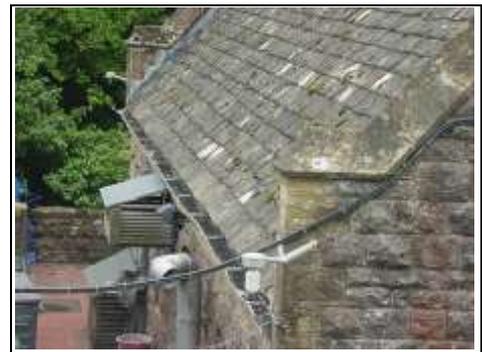
Lead gutter on left hand side of building

We do however think you need to carry out proper repairs to the gutters and we noted that in the gutters and valley gutters some of them had Flashband repairs and we would also suggest that you review the various methods that Sid uses to get to the roofs to ensure you are happy with them on a health and safety point of view. Please note our earlier comments about buying a tower scaffold.

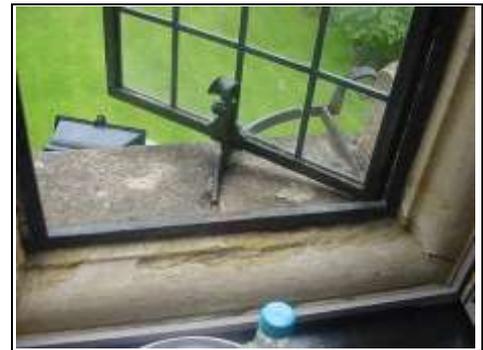
Internal stone repairs to the windows

**ACTION REQUIRED:** Initially we recommend cutting back of trees around the property to allow sunlight and air circulation. We also recommend the purchase of a good quality tower scaffold (see earlier photo) to first of all aid investigation and then maintenance of the property with a safe access.

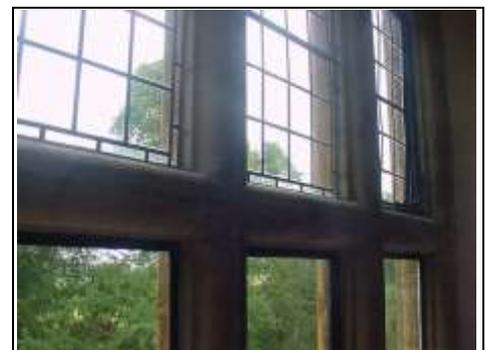
We would refer you to the walls section where we have talked more about the stone windows but we would comment that the stone window sills and some of the detailing around them are suffering from deterioration, in some areas with moss sitting on them. We would recommend this is removed, this together with allowing more sunlight and air circulation around the building and sensible repairs are recommended within the next few years.

Close up of leaded light windows 53

**ACTION REQUIRED:** The metal windows themselves in many cases have suffered from rusting and warping and we can't open them. You will need to diligently work around the property making good the windows and redecoration. As mentioned in the Executive Summary we would recommend that you work elevation by elevation to achieve this task.

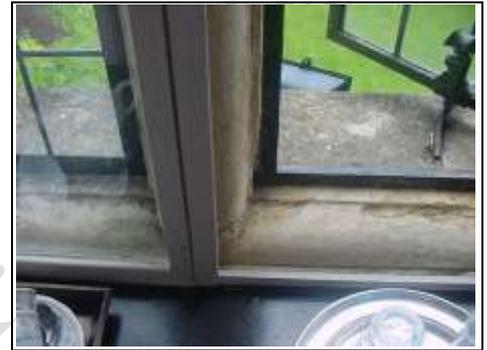
Secondary glazing and stone repairs if you look closely

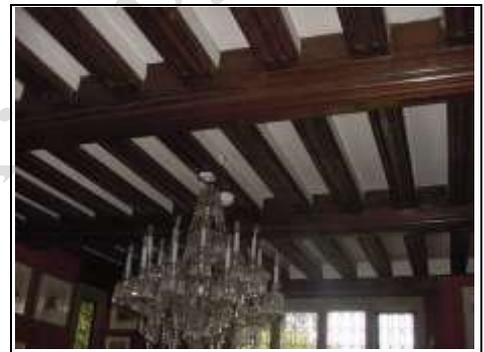
Spine beams

In some rooms we can see spine beams and the floor boards have been used horizontally rather than vertically, as this is typical in this age of property.

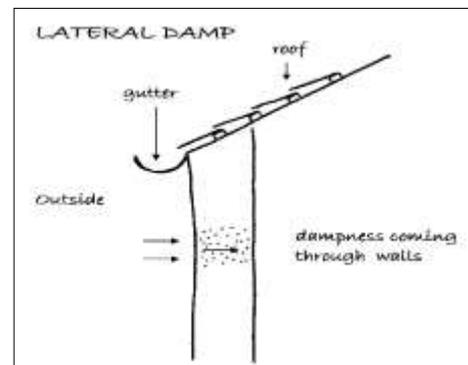
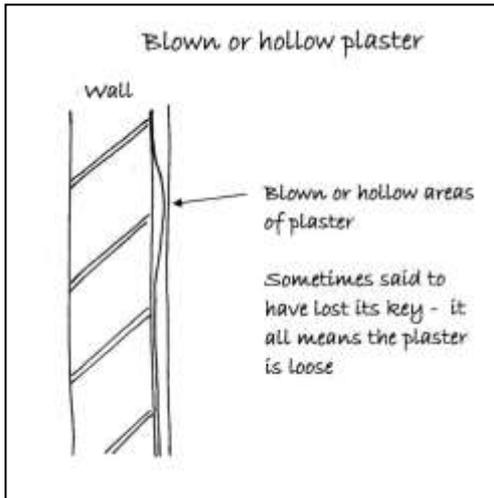
Tests were taken with a moisture meter at random points to the perimeter walls and we did get damage readings. We also noted above average amount of blown plaster, indicating dampness is coming in the walls.

Testing for and finding lateral dampness!

Please see our comments with regard to repointing externally and also checking and keeping the gutters, downpipes and hopper heads, etc, in good condition.

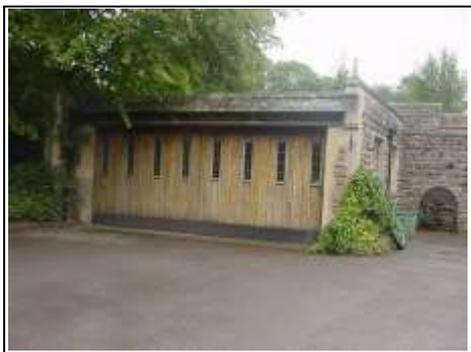
Garage

The property has a double garage. It has a flat roof with a central drainage point, which is liable to blockage from leaves etc, and the tree that overhangs it. It is built in coursed stonework, with timber doors and stone mullion windows with metal casements and leaded lights. We can see it has been repointed in a cement mortar and there is cracking to the rear left hand side. There is also rubble stone walling to the bottom left hand corner.

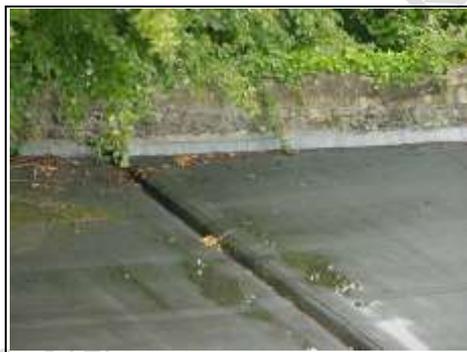
Central drain to flat roof

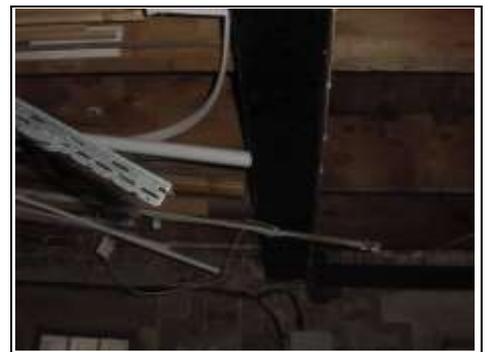
We can see internally that there is a metal beam present that has had some rusting. This indicates that repair work is needed to the roof.

Inside the garage

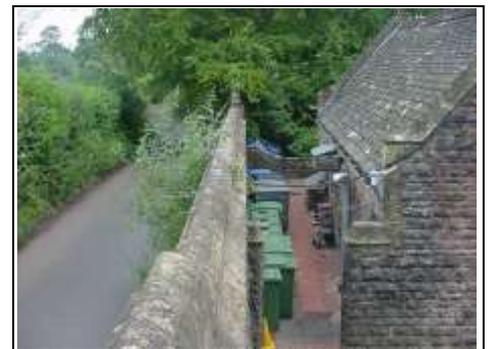
We noted that when we were on the roof of the garage we could see the adjoining road over the boundary wall. This shows just how considerable the change in levels are and how important it is to have a good drainage system in front of the house. We imagine there would have been a great deal of water that has travelled across the car park over the years causing dampness into the front of the property. Please see our comments on this.

Differing ground levels
