A review of a Victorian Flat with black mould

How one of our Surveys can help you

We have recently carried out a survey for the owner of a flat in a converted three storey Victorian property.

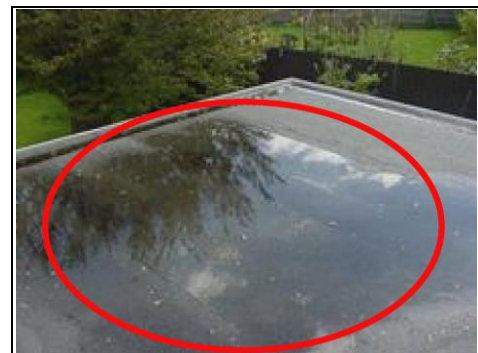
The property had a flat roof to the rear; this is a roof with no pitch or fall. Water is unable to run off this type of roof and we could see ponding which adds weight to that section of the roof and causes deterioration.

Example of ponding on a flat roof

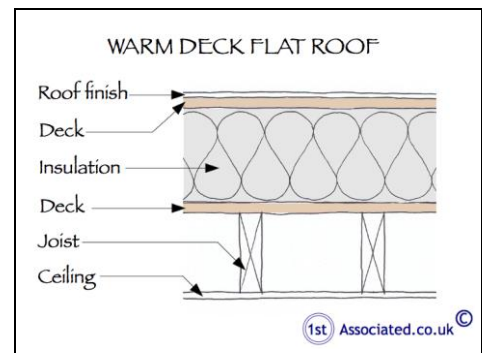
We also believed this to be a cold flat roof with no insulation and would have preferred it to be a warm flat roof with insulation.

Warm flat roof
