# Stone Built Example Residential Building Survey

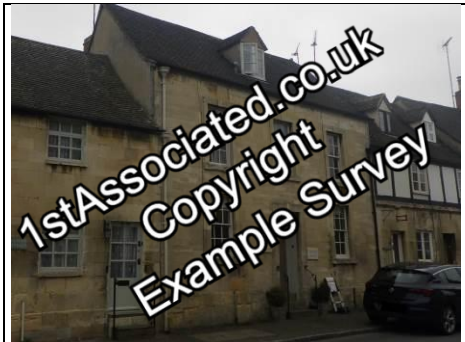
Front view

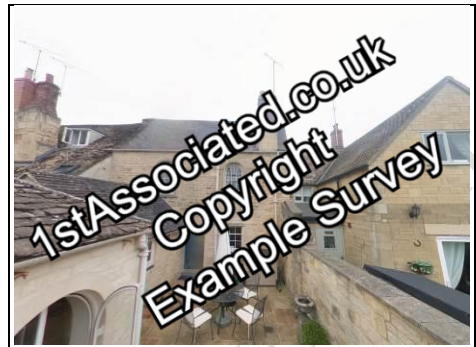
Rear view

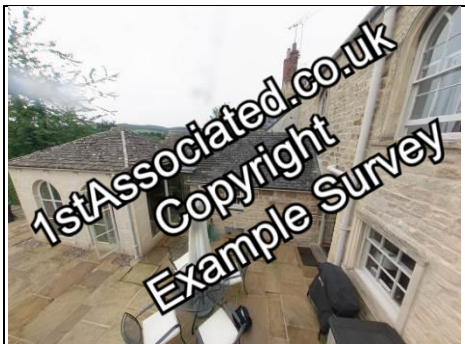
Rear extensions

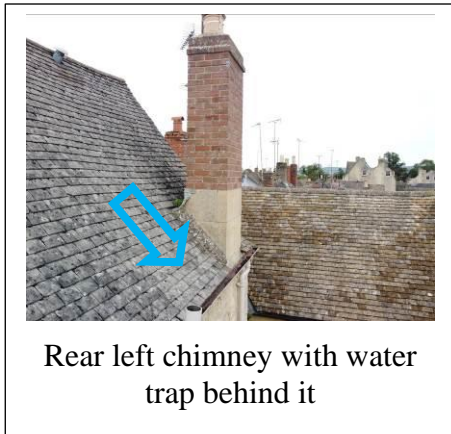
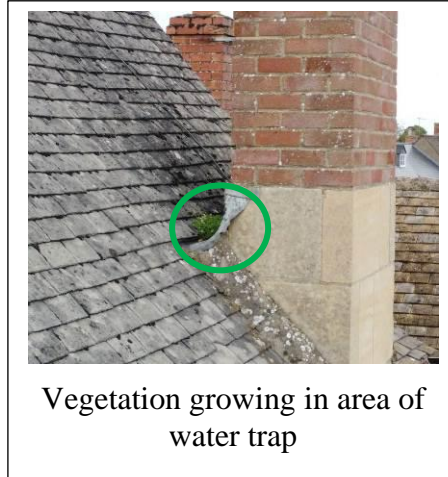
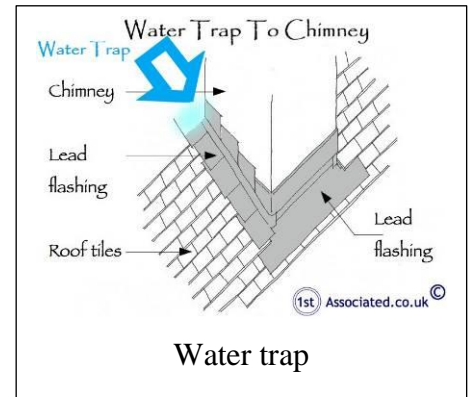
The rear left chimney has a water trap behind it and it also has a cement flashing to the sides, which generally crack and can allow water in and we much prefer to see a lead flashing. This could be allowing dampness into the roof; please see our later comments with regard to wood destroying insects.

We noted there looks to be vegetation growing from the water trap area.

**ACTION REQUIRED:** Clear the vegetation and check the cement flashing, ideally replacing it with a lead flashing, as in our opinion it is a better and more appropriate material for older properties.

**ANTICIPATED COST:** In the region of £500 to £1,000, however this is high level work and accessing it, particularly if scaffolding is needed, this cost could double if not treble. Please obtain quotations before legally committing to purchase the property.

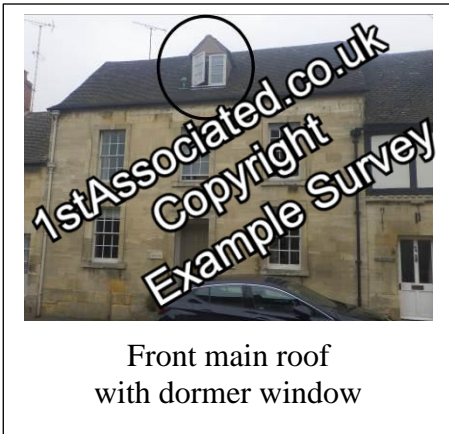
There is a dormer window to the front of the main roof. We noted a crack in the render, which has been partially repaired, therefore this is a known about problem.

Front main roof  
with dormer window

**ACTION REQUIRED:** Repair the render on the dormer and make watertight.

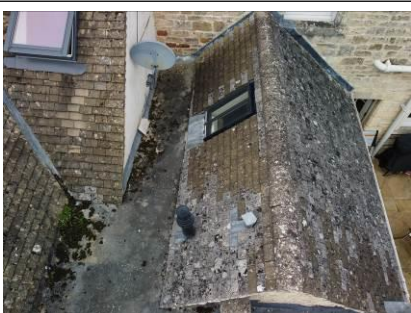
This is a pitched roof over the kitchen, with one roof window. We noticed that the ridge tiles have weathered over time and now need re-bedding. We also noticed there is a straight flashing where the kitchen roof meets the wall, we prefer a stepped flashing as it is bedded into the joint and straight flashings like these tend to come away. This would need monitoring.

We would also add there is a flat roof running beside this roof, which is your neighbour's roof. This could lead to water and dampness getting into the area.

Rear pitched roof, giving extra head height in kitchen

**ACTION REQUIRED:** Repair ridge of roof. Bed lead flashings with a plumber's mastic, ideally replacing with a stepped lead flashing.

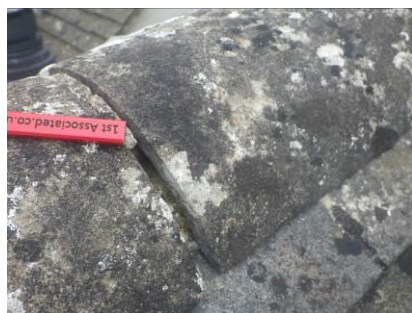
Ridge needs re-bedding

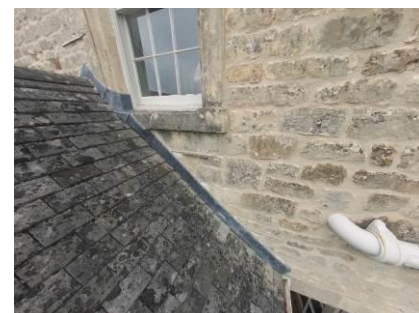
Straight flashing where it meets the wall; prefer a stepped flashing

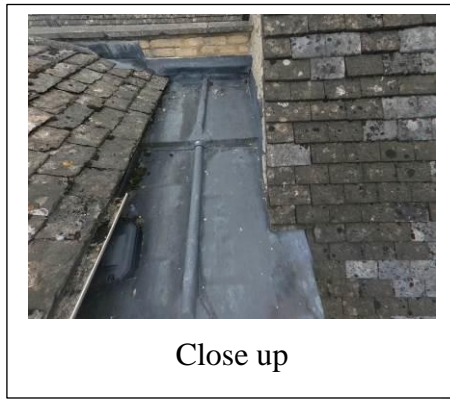
We have referred to the lead flat roof covered area as the link corridor roof, however that corridor also carries under the pitched kitchen roof which we have spoken about earlier. Some of the lead detailing, particularly the flashing, looks like it could be leaking, although there are no obvious signs internally.

Close up

**ACTION REQUIRED:** Monitor.

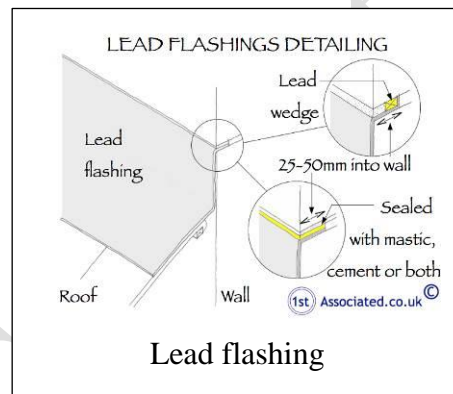
Lead flashing

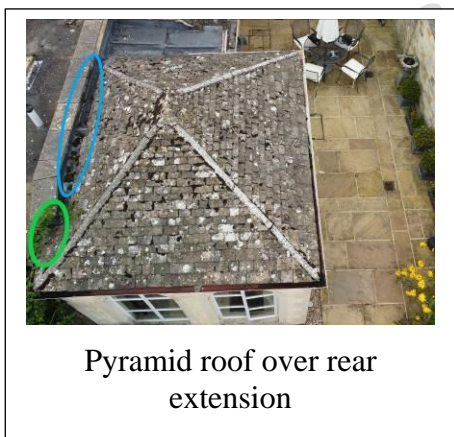
This is a pyramid roof, clad with limestone slate. We noted cracking to some of the slates. There is a parapet wall/box gutter where it meets next door. The leadwork runs all the way along a parapet wall detail, which needs checking.

Pyramid roof over rear extension

**ACTION REQUIRED:** Generally overhaul roof, replacing damaged tiles/slates and repair flashing details;

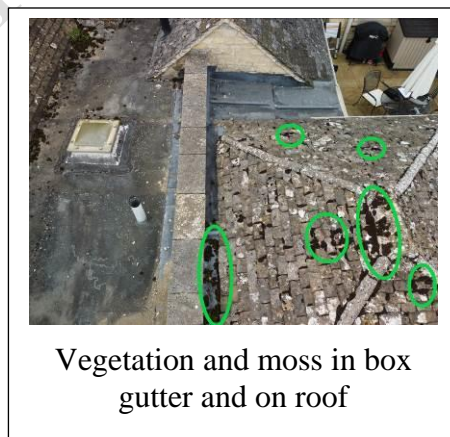
Vegetation and moss in box gutter and on roof

**ACTION REQUIRED:** Repair, prepare and redecorate or replace cast iron and, as previously mentioned, clear the moss from the box gutter.

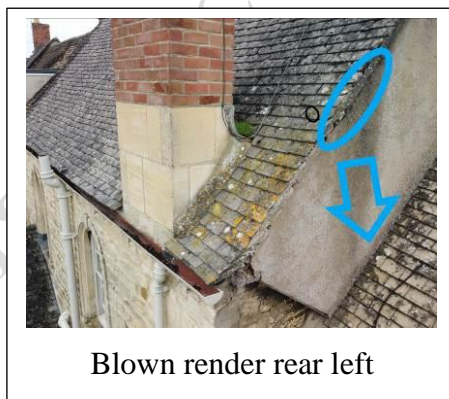
The render to the left gable (all directions given as you face the property) is deteriorating (coming away) near the chimney (see blue oval and blue arrow below). Gaps can still be seen and water damage is occurring in this area. We can also see there may be bulging/movement in this area (white oval), indicating there may be problems with the structure beneath, which could be a timber frame or deteriorating stonework.

Blown render rear left

We think the render moving is probably the effect of deterioration to the structure below; although it is difficult to be certain without opening up the structure.

The bulge in the render and also the water damage, we think on the balance of probability will mean it is highly likely there are some problems in this area.

**ACTION REQUIRED:** Remove all the render and check the condition of the gable end and carry out repairs, and see if it is a timber frame, although it may also be a rubble stone wall.

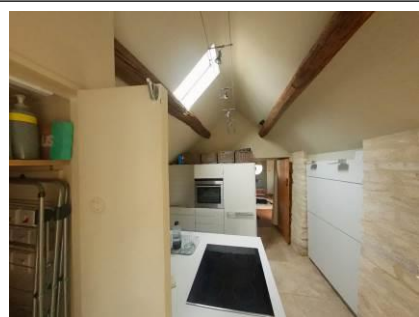
Vaulted ceiling in kitchen

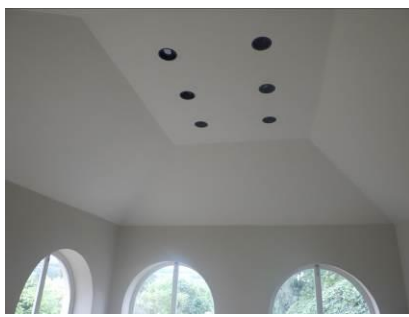
Partly vaulted ceiling in dining area

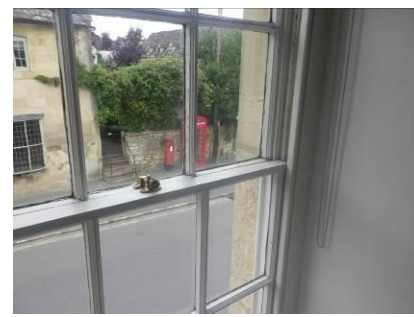
Single glazed timber sliding sash window

**ACTION REQUIRED:** We suggest you ask the current owners for copies of the bills throughout the year and also ask if they take any specific measures during the winter months, such as secondary glazing to the sliding sash windows.

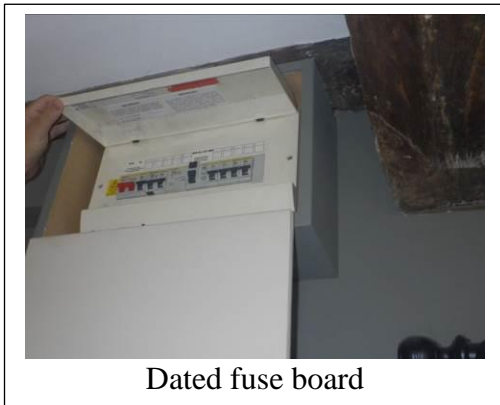
Dated fuse board

**ACTION REQUIRED:** We recommend a new fuse board with a metal casing; modern standards require half hour to one hour fire resistant casing around a fuse board.

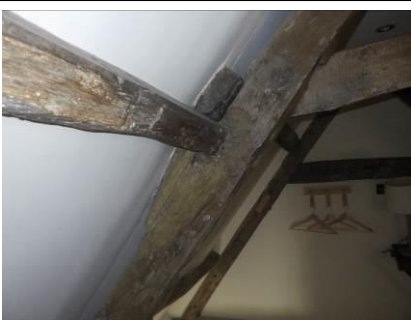
Roof structure

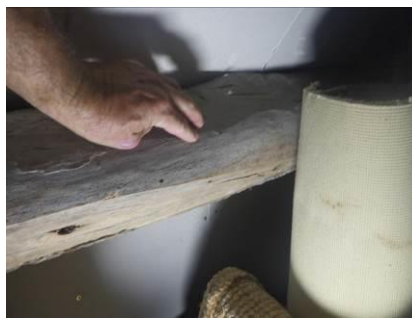
We believe we have identified some wood boring insect activity within the property, found in the room formed in the roof. Unfortunately, as the majority of the roof structure cannot be seen (only approximately 5%) it is very difficult to be conclusive.

Finding frass

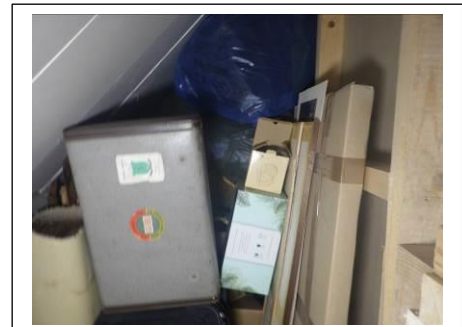
Stored items limited our view

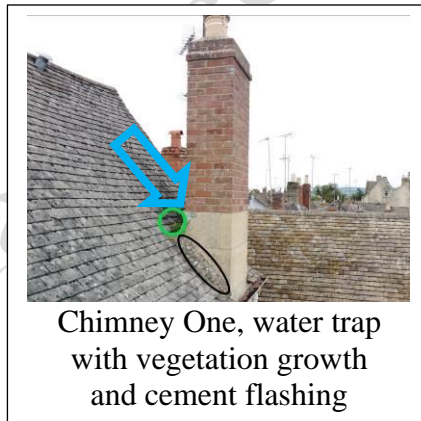
Chimney One, water trap with vegetation growth and cement flashing

**ACTION REQUIRED:** Work is needed to both chimneys.

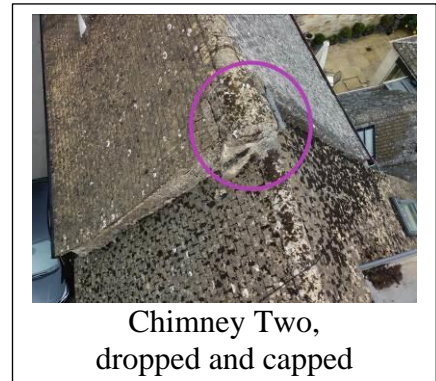
Chimney Two, dropped and capped

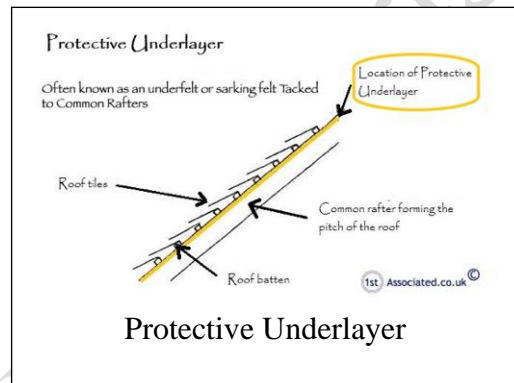
Due to the rooms formed in the roof we were only able to see around 5% of the roof structure and were unable to see if there is any protective underlayer due to the plasterboard and insulation that form the room in the roof.

**ACTION REQUIRED:** The only way to be certain is to open up the roof.

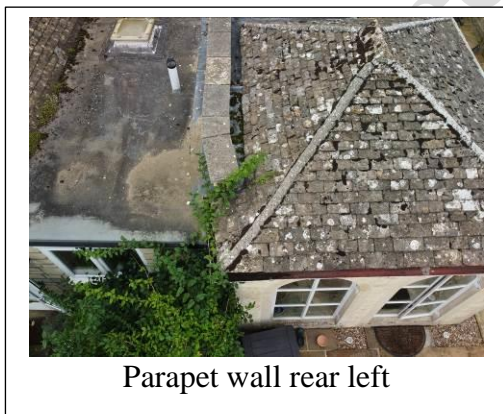
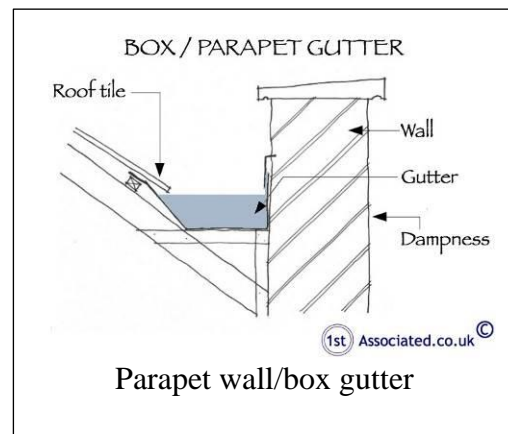
This roof is a pyramid roof, clad with limestone/Cotswold stone slates. There is a parapet wall with box gutter to the left side and we think this could be problematic.

**ACTION REQUIRED:** Please see the Executive Summary.

Clear moss off roof and out of parapet/box gutter and regularly inspect, otherwise we think you are likely to get dampness in the dining room area.

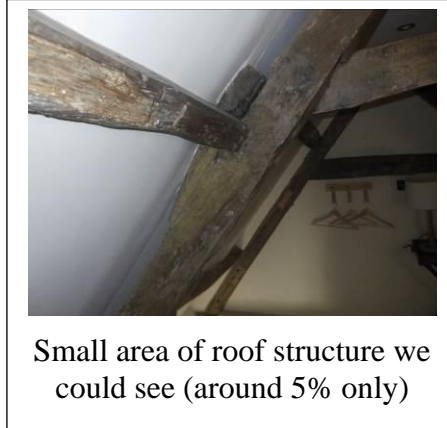
Small area of roof structure we could see (around 5% only)

We recommend the roof is opened up to be checked, as well as checked once it is emptied of stored items.

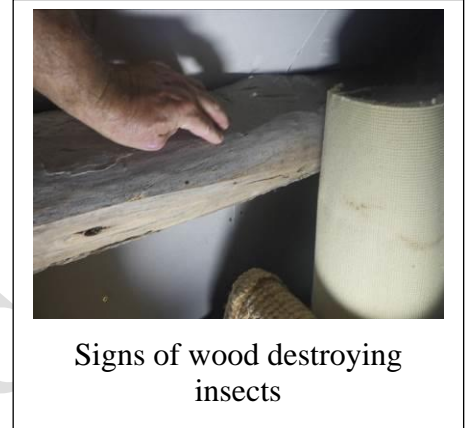
Signs of wood destroying insects

Our examination was limited by the rooms formed in the roof and the mass of stored items. What we could see was generally found to be in below average condition for its age, type and style. We found some frass in the roof, which generally indicates active wood boring insects. It is also feasible that there are further problems in the roof that are hidden.

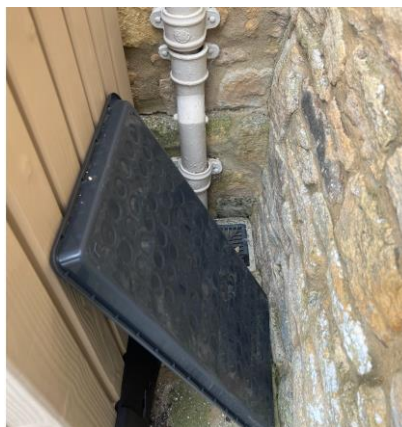
Downpipe going into drain to front

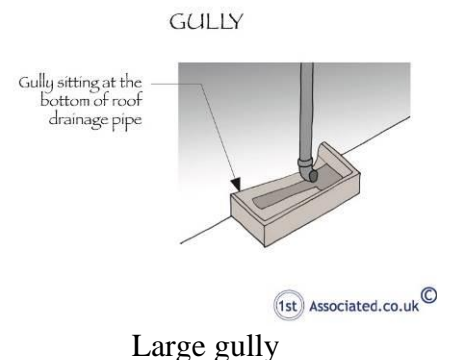
We were pleased to see the downpipe to the front of the property is channelled underneath the path. To the rear there is a sort of gully; we would recommend a better gully is put in place to minimise water getting into the base of the property.

Downpipe to back

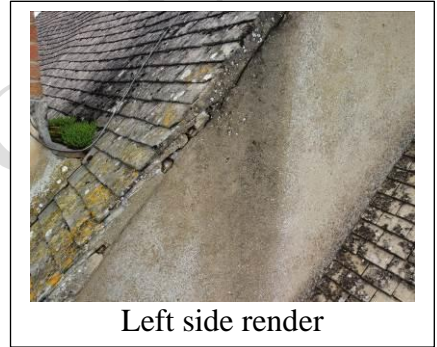
Left side render

There is smoothish render to the left and right gable ends at high level. The render to the left side gable end is deteriorating, with some water getting behind it. To the right side we can see a rougher plaster, which look to have been repaired several times and it looks like there may be a hole in it as well.

The walls are finished with stonework, with Ashlar limestone/Cotswold stone to the front and a coursed semi-irregular stone to the rear, with some render to the left side. There may well be a timber frame underneath and we recommend the rendered areas are opened up to check.

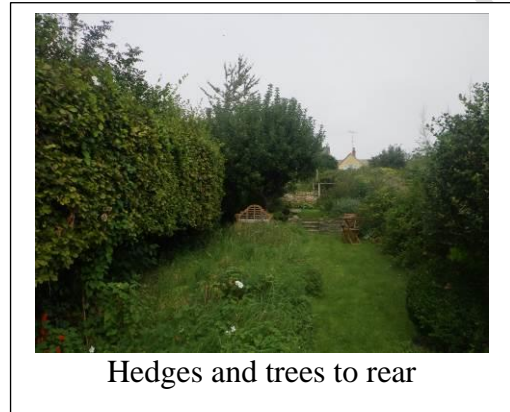
There are trees and hedges to the rear, and are some distance from the house and look to not be within what we would term as influencing distance but you do need to speak to your insurance company as they may have a different interpretation for insurance reasons.

Hedges and trees to rear

**ACTION REQUIRED:** You do need to ensure they are regularly maintained, particularly the larger trees. Do not forget the end of the garden drops down the hill towards the River.

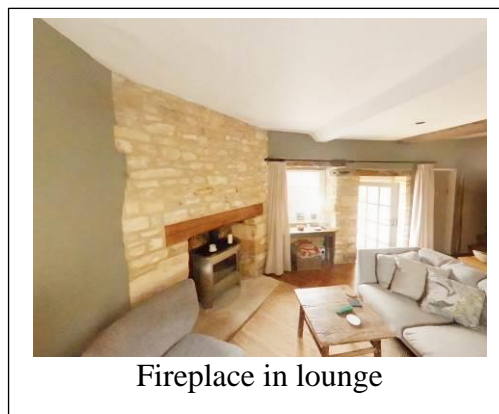
Fireplace in lounge

**ACTION REQUIRED:** If you do intend to use the fireplaces then we recommend a chimney sweep checks the lining and that the chimney/s are clear and open up the chimney pots if required.

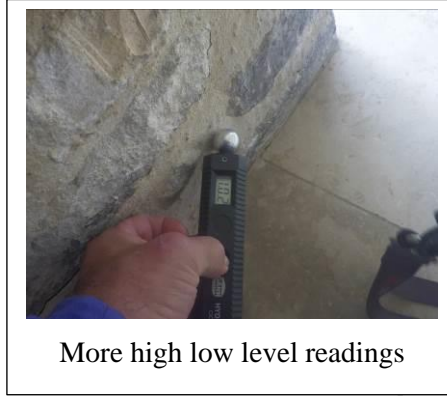
More high low level readings

In this particular case, we have found high low level damp readings to the rear of the property and also in the kitchen corridor area.

**ACTION REQUIRED:** Please see the Executive Summary.

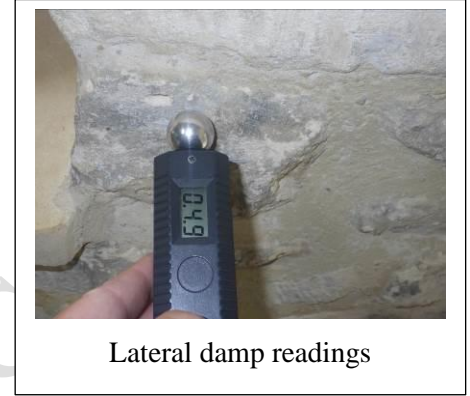
Lateral damp readings

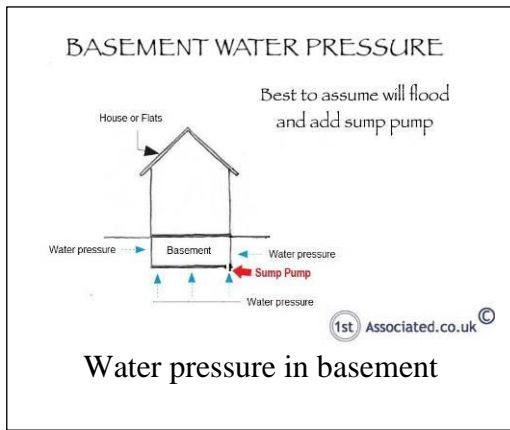
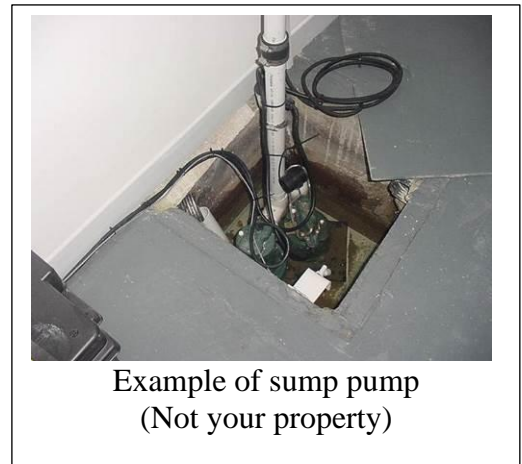
The property has a below ground cellar. This is in below average condition for its age, type and style and was very wet at the time of the survey, which could be due to a spring in the area. We would normally expect to find a cellar relatively dry at this time of year.

**ACTION REQUIRED:** Please see the Executive Summary.

As mentioned, we recommend you add a sump pump.

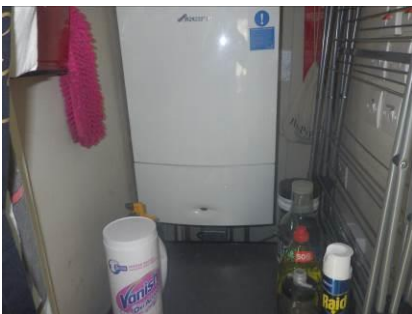
Worcester boiler

**ACTION REQUIRED:** As a matter of course, it is recommended that the entire gas installation is inspected and made good, as necessary, by a Gas Safe registered contractor. Thereafter the installation should be serviced annually.

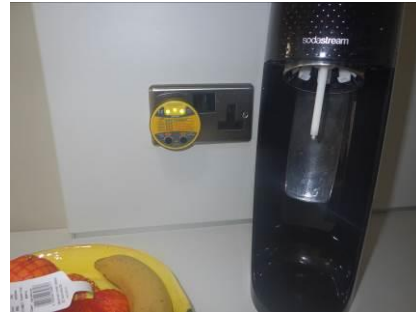
Satisfactory earth test

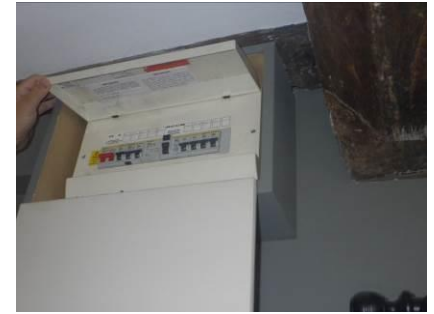
Dated fuse board

The fuse board is located in the lounge by the front door. The fuse board looked from the 1990s - 2015 and better are now available. We recommend it is replaced with a metal cased modern fuse board.

**ACTION REQUIRED:** Replace. Please see the Executive Summary.

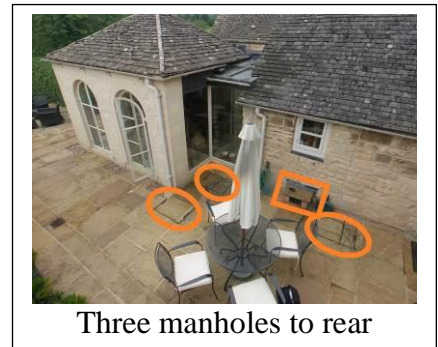
We have identified three inspection chambers / manholes to the rear of the property.

We were unable to lift the covers due to them being formed in the paving slabs therefore are unable to comment.

Three manholes to rear

Key for above photo	
Orange ovals	Three rear manholes
Orange square	Air vent from cellar for

**ACTION REQUIRED:** We recommend a closed circuit TV camera report of the drains to check their condition.

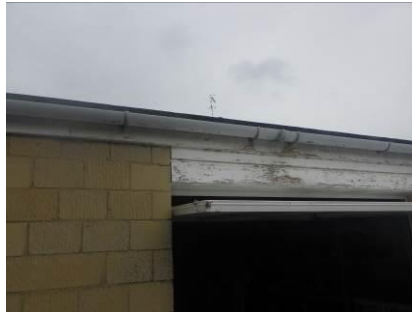
Timber above door needs redecoration
