# Timber Frame Example Residential Building Survey

# INTRODUCTION

Firstly, may we thank you for your instructions of xxx; we have now undertaken an independent Building Survey (formerly known as a Structural Survey) of the aforementioned property. This Survey was carried out on xxx.

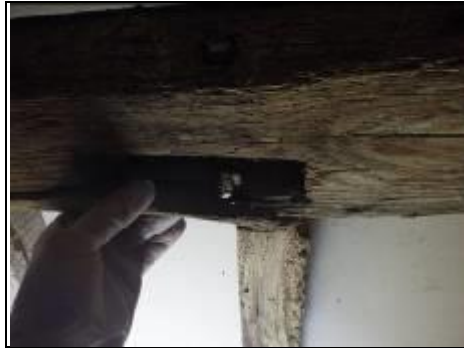
Old fixing points show many alterations to the timber frame

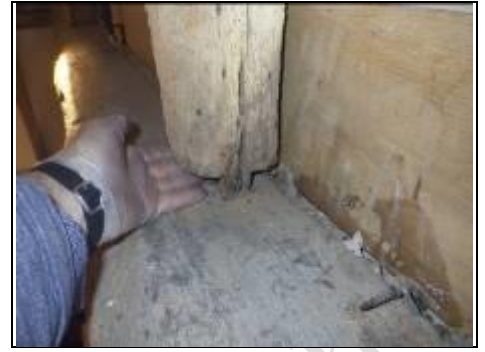
Vertical timbers mortise and tenon joint not working

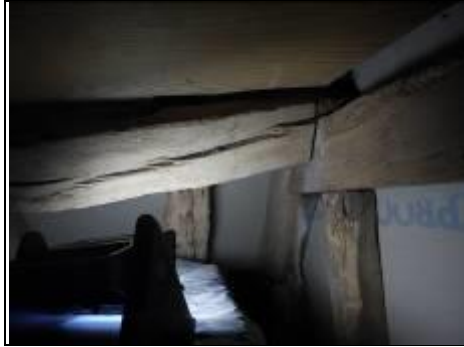
Splits in timber

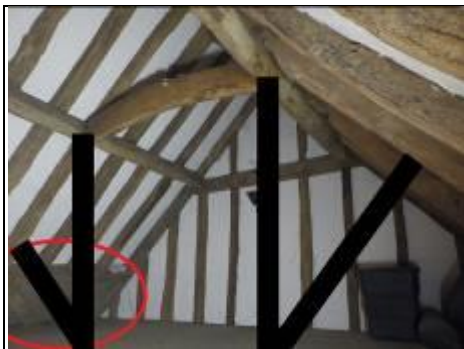
The roof structure has five bays which should be formed by four queen post roof trusses between which there are common rafters. One of the queen posts is missing in part and may have been missing for many decades/centuries. However, we feel this is having an impact to the roof to the left side (all directions given as you face the front of the property). We also examined the tiles to the front left corner (if you recall we spoke to you about these) where there is some visible movement. We feel that these problems relate to part failure in the roof support on this side.

Queen post frame missing to the left side of the property

**ACTION REQUIRED:** Initially we would recommend monitoring however we feel it is likely that work will be required to the area above the left side bedroom. Often strengthening can take place with timber or metal. Further investigation is required.

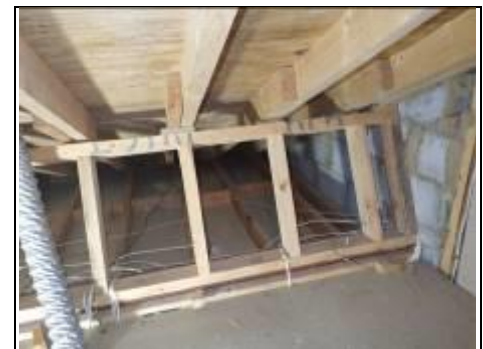
Rear left catslide roof is boarded and supported by purlin with struts at same width as the ceiling joists.

**ACTION REQUIRED:** Your legal advisor to check and confirm that permission was obtained to change the roofing material otherwise you will have a legal liability.

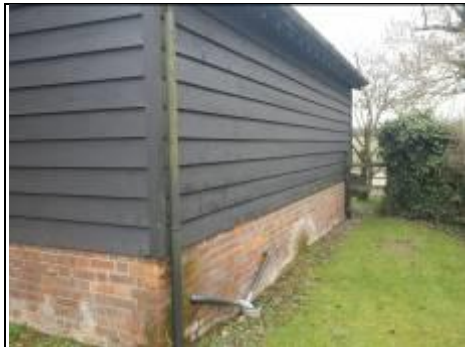
There is dampness to the shallow pitched roof/catslide roof area. This area is dry lined/false walled which hides dampness which is why we believe you need to better manage the dampness in the property.

Dampness to rear of the cat slide roof/left bedroom

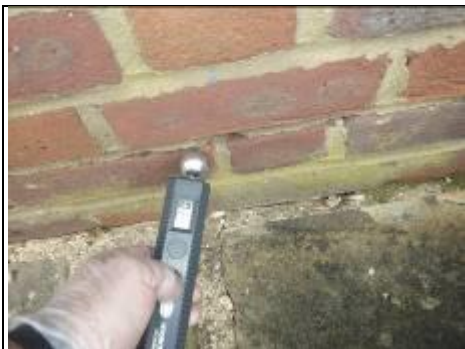
This has resulted in dampness to the brickwork. There looks to have been a bitumen damp proof course put in which was very popular in the 1950's-1970's. the bricks are spalling and generally deteriorating due to water damage.

Dampness/moss visible to base of the property

**ACTION REQUIRED:** We have already mentioned a French drain and land drain would be beneficial to the property and also there may be benefits to planting trees.

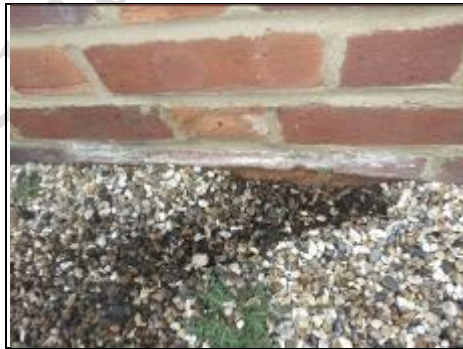
Water sitting against the property due to sloping site

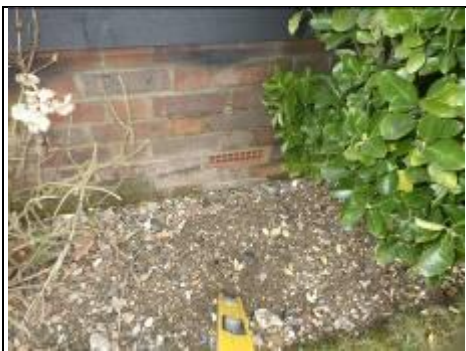
If it was bedded in a lime mortar originally then the cement mortar pointing is stopping it from breathing. If not, then unfortunately the cement mortar pointing and the soft red brick are not getting on particularly well which is leading to deterioration to the brickwork.

Soft red bricks repointed with a cement mortar

- 1) Establish if it is lime and if it is lime you need to remember lime every time and lime takes time – see sketch below
- 2) If it is originally bedded in cement mortar then you need to accept this is an inherent defect and a characteristic of the building.

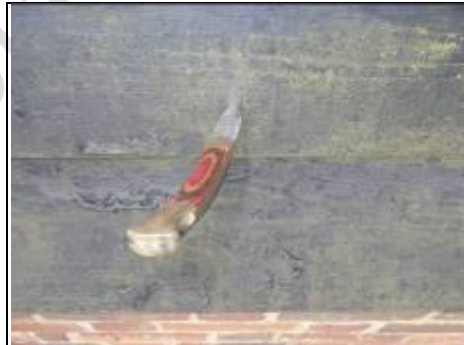
Knife test to weatherboarding

Repair and redecorate. The weatherboarding will need regular painting every three to five years.

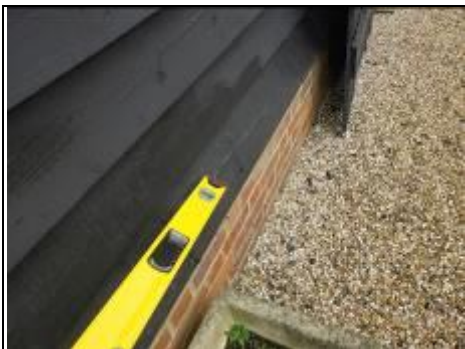
Angle timber over brickwork would this be better in lead this would need conservation officer's approval

We would reiterate our earlier comments with regard to the detail where the weatherboarding meets the brickwork at the base of the property which we feel is likely to be an area where you get accelerated deterioration. We would recommend a lead detail in this area which you need to discuss with the Conservation Officer; even if it is a lead detailing underneath the weatherboarding.

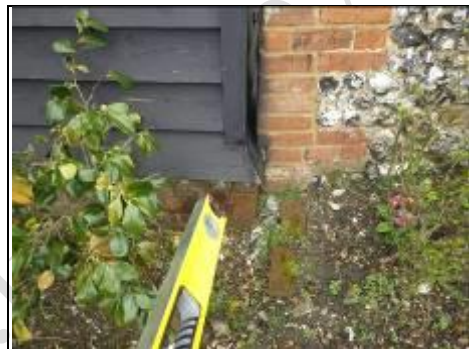
Deterioration to angle timber over brickwork

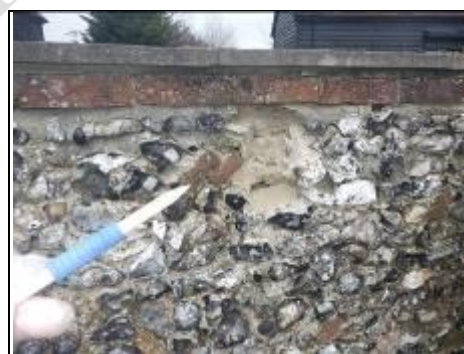
Deteriorating flint wall

**ACTION REQUIRED:** Your legal advisor to check and confirm when the walls were constructed and if permission was obtained if they are relatively recent. The deterioration to the flint wall needs appropriate repair which looks to be bedded in a lime mortar.

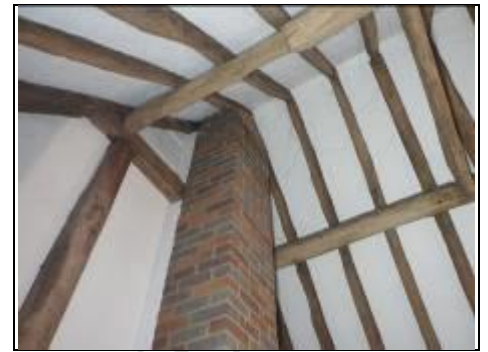
Chimney to right we assume this goes in to the ridge vent

**ACTION REQUIRED:** Your legal advisor to check and confirm this has

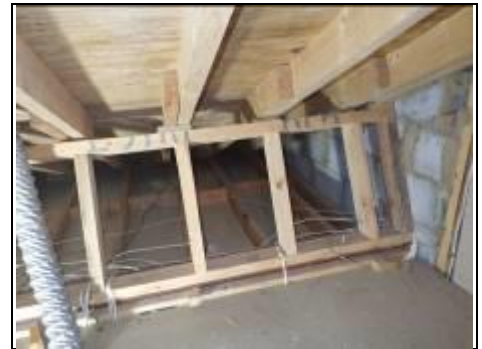
The rear left catslide roof is boarded with no protective underlayer.

Rear left catslide roof is boarded – no protective underlayer

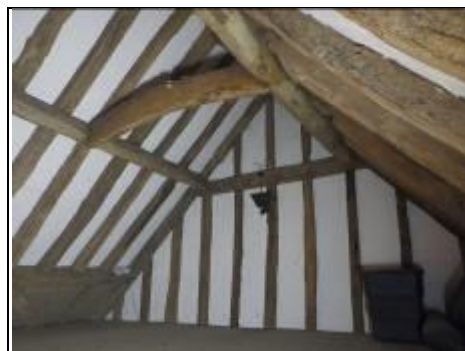
We believe the queen post truss would have originally been on the left side. Having said that, it looks to have been removed a long time ago or was not put back when it was rebuilt in the 1970's. However, as we discussed during the survey and we showed you there is movement to the left side of the building.

General view of left area where we believe queen post truss would have originally been

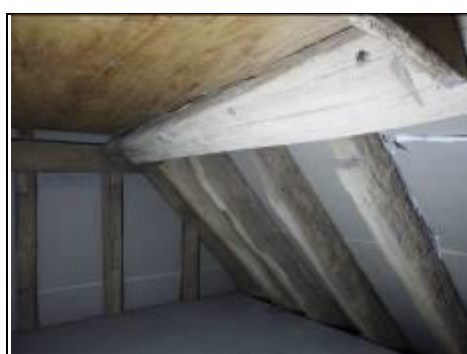
Limited access to right  
Timber plywood boarding above the collar area

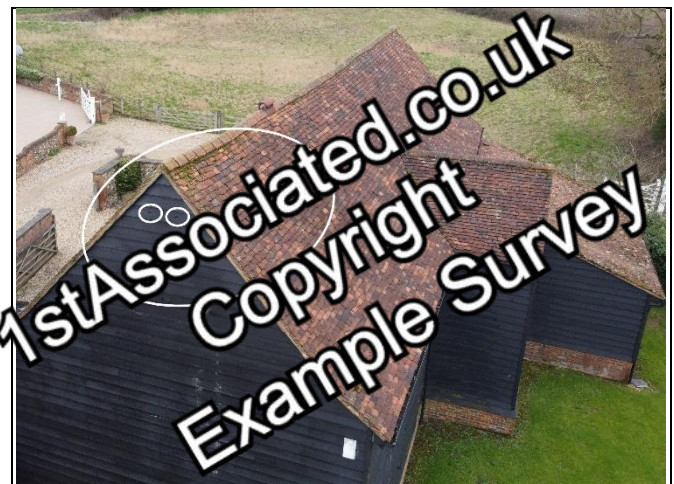
Vents in roof, area not accessed  
~ Aerial View - 360 Photo ~

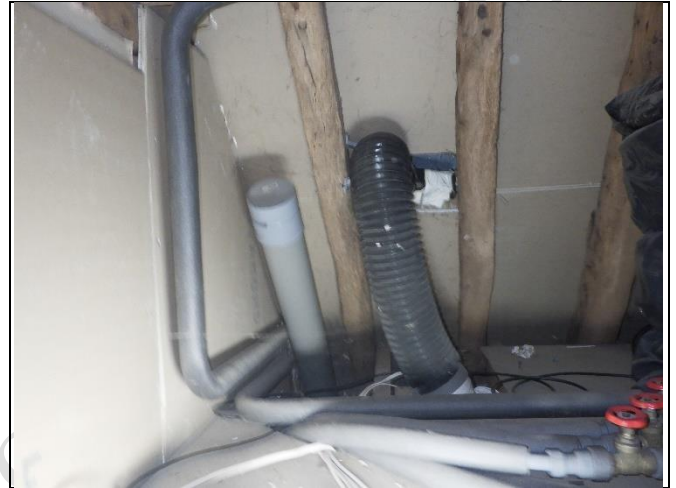
We assume the property has internal soil and vent pipes. Internal soil and vent pipes can work well, apart from if they leak, as they are hidden from view so a leak is not normally discovered.

Internal soil and vent pipe and Durgo valve  
~ Aerial View - 360 Photo ~

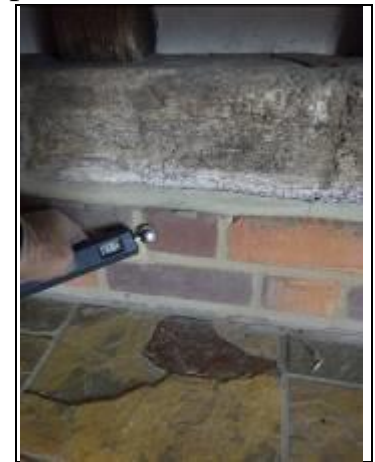
Often the most important part of these is the sole plate/base plate which is at the base of a wall which can be affected by dampness, causing wet rot and dry rot and general deterioration as this ground floor sole plate effectively forms the base of the timber frame. In most cases it is very difficult/impossible to see so we have to make assumptions. In this case it was visible and we could see that parts of it have been replaced and there was still some older timbers; whether they are original is very difficult to confirm. In this case we would comment that they are sitting on a damp wall. Please see our comments with regards to the brick to the base of the structure.

Checking for dampness  
beneath timber sole plate  
sill board

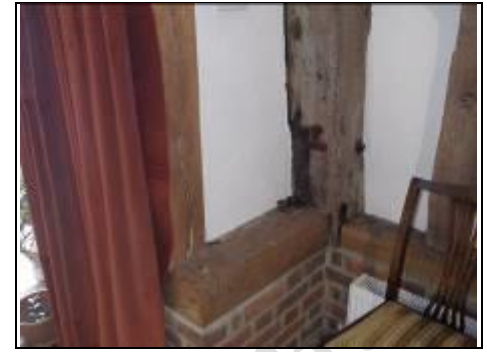
Replacement sole plate or sill boards

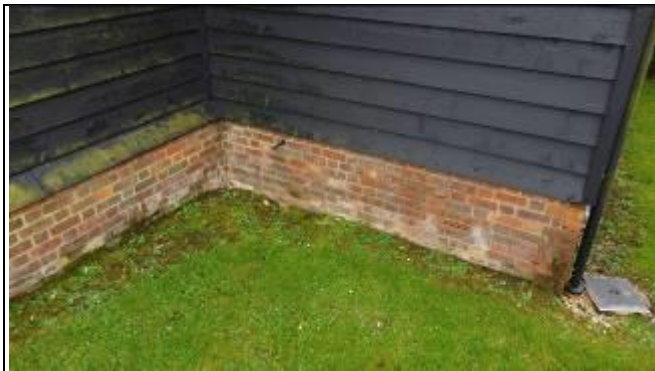
The property has brickwork to the base which is damp due to the sloping site. The bricks have been wrongly repointed in cement mortar.

Dampness to rear of property  
~ Aerial View - 360 Photo ~

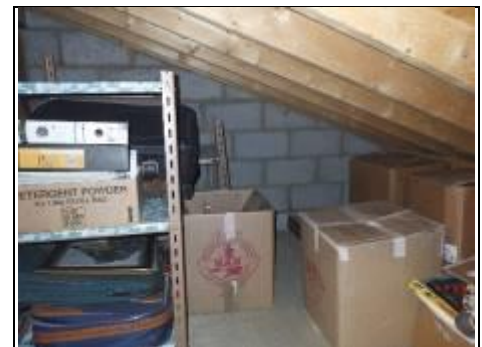
We could see some blockwork internally within the left gable of the roof.

Block work to left hand gable  
under the cat slide roof

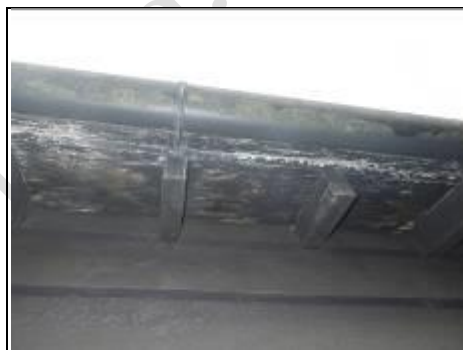
Exposed rafter feet deteriorating

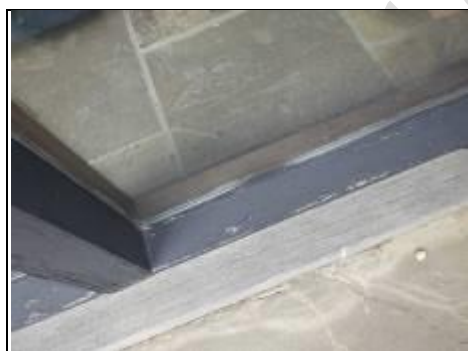
Weathering to timber at base of window within entrance to old barn

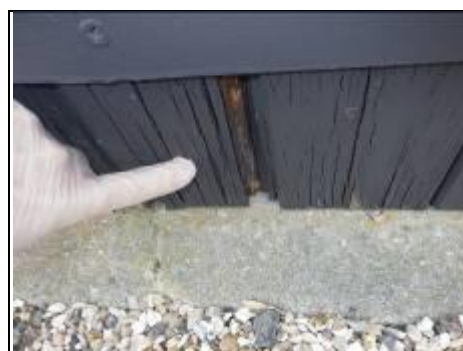
Deterioration to base of ledge and brace doors

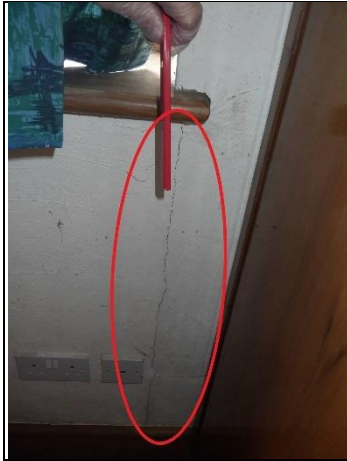
We noted vertical cracking in the ground floor left hand bedroom which is dry lined and false walled. We cannot be certain what this is hiding, it may relate to dampness or may relate to deterioration in the structure. Our concern is that we can see to the stairs area a fair amount of timber has been replaced and we do not know what quality of timber was used.

Vertical crack in ground floor left bedroom

**ACTION REQUIRED:** Please see our comments in the Executive Summary.

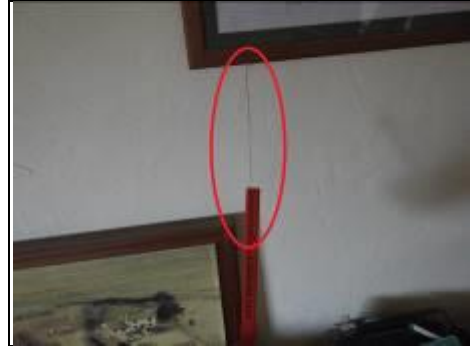
Second vertical crack found on rear wall of ground floor left bedroom

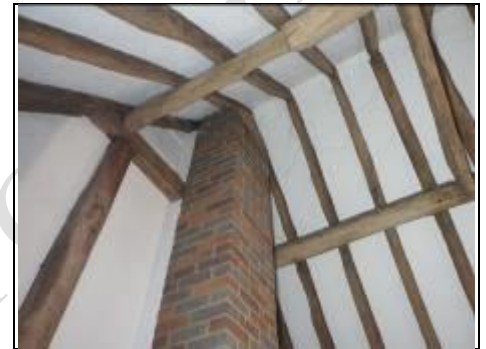
Chimney to right we assume this goes in to the ridge vent

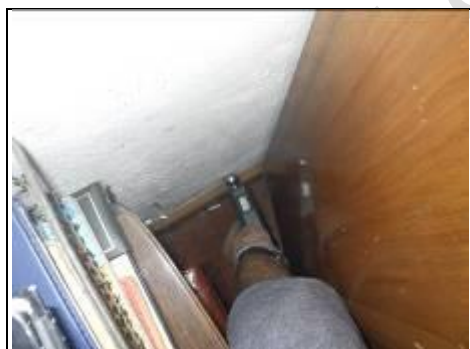
A random visual inspection and tests with a moisture meter have been taken to the perimeter walls. In this particular case we were unable to obtain readings due to the dry lining.

Dry lining in left hand ground floor bedroom

**ACTION REQUIRED:** Please see our comments in the Executive Summary.

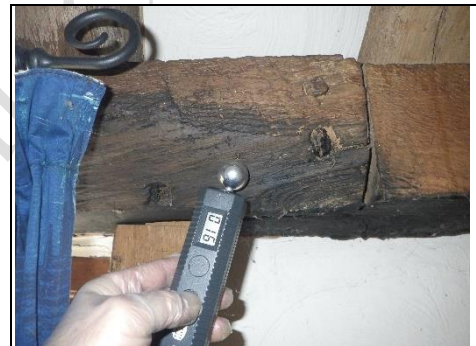
Testing timber for lateral dampness

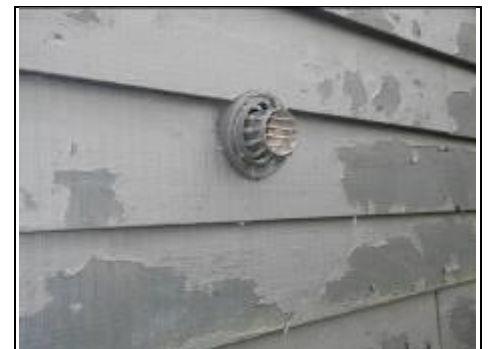
There is a vent to the rear of the property which we believe relates to the stair area although we cannot be certain and this needs double checking.

Vent to the rear of the property – why?

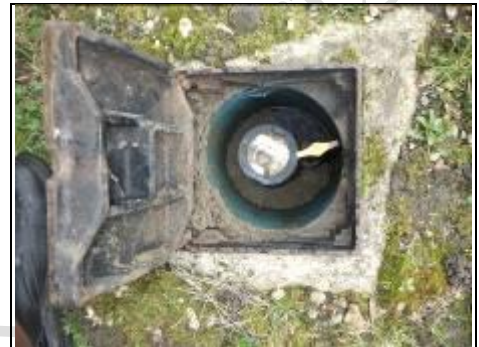
We noted an external stopcock in the right hand side garden; it needs to be checked to see what this does. The stopcock and other controlling valves have not been inspected or tested for operational effectiveness.

External stopcock on right hand side within garden

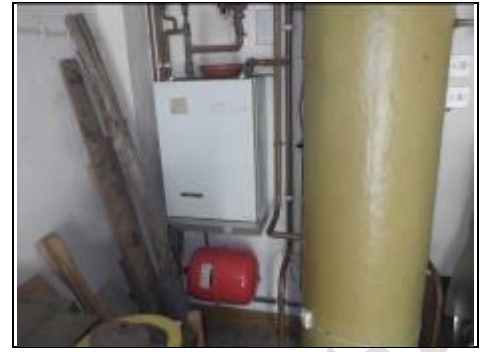
Hot water cylinder

There is a hot water cylinder located in the garage.

The hot water cylinder is factory insulated, which indicates that it is relatively new (they were first used around the 1980's). This cylinder will therefore have a good thermal efficiency, although not as good as the more modern hot water cylinders. You may wish to look at improving this.

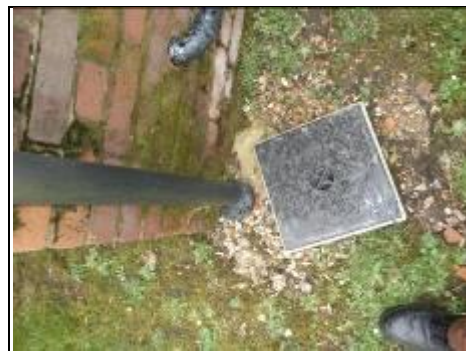
We were unable to lift this manhole to inspect.

Downpipe and rodding eye to cat slide roof right side

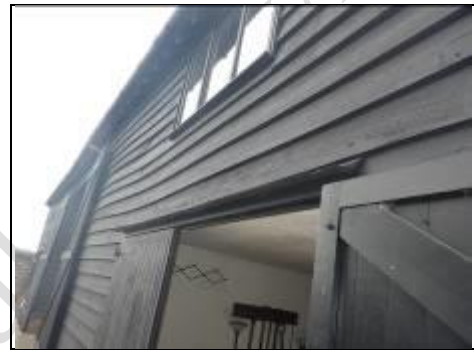
Drip detail to garage door far right
