Timber Frame Example Residential Building Survey

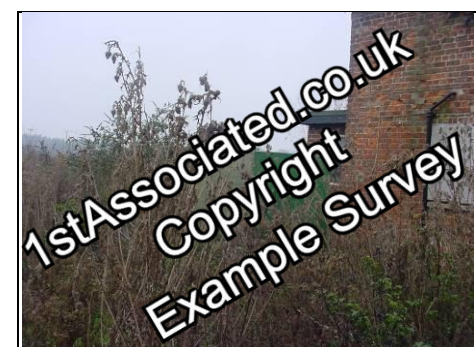
Overgrown rear garden

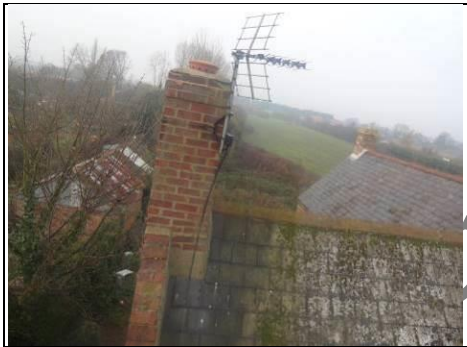
All four chimneys are weathered and require repair and repointing.

Front left chimney
Aerial view – 360 photo

ACTION REQUIRED: Repair and repoint as necessary, check flashings and also check flaunchings (the top of the chimney).

ANTICIPATED COST: £3,000 - £5,000 (three thousand pounds to five thousand pounds); please obtain quotations.

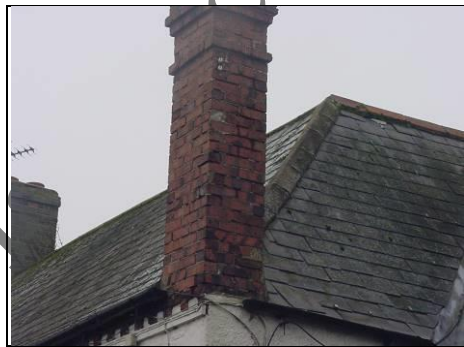
Front middle chimney

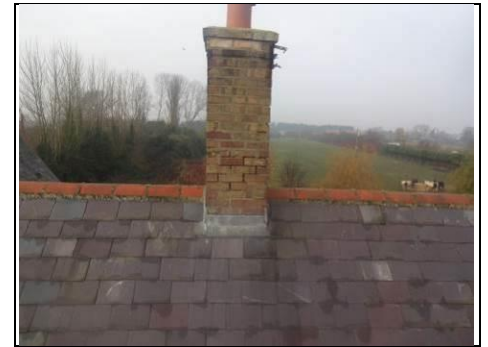
Front right chimney needs re-pointing at the base
Aerial view – 360 photo

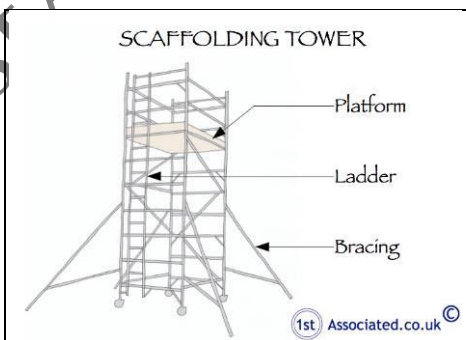
Tower scaffold

We assume the work can be carried out from a tower scaffolding as majority of cases. It may well be worth buying your own tower scaffold as they are several hundred pounds.

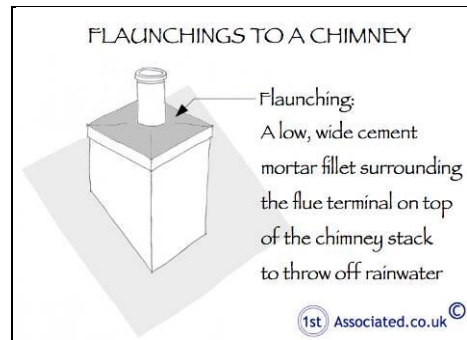
Flaunching to a chimney

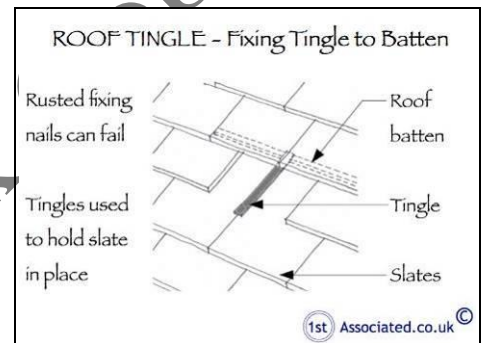
Tingles are a way of repairing a slate roof where the nails have deteriorated.

Roof tingles

ACTION REQUIRED: We believe several of the roofs will require repair and or re-slating within the next five to ten years.

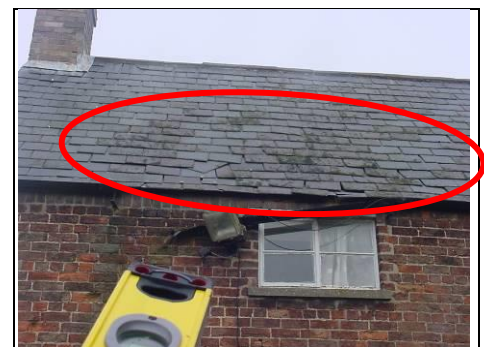
Slipped slates to the rear left

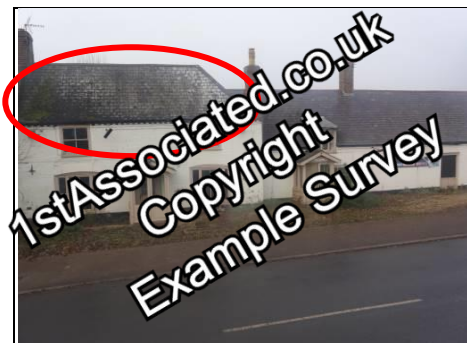
You have various different ages of cut timber roof. The cut timber roof to above the bar areas is the oldest roof in our option.

View of main old roof
Aerial view – 360 photo

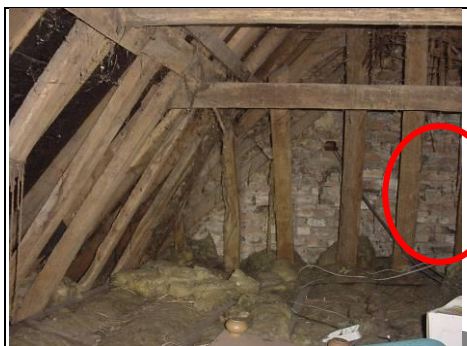
Old roof structure to the left
of the property

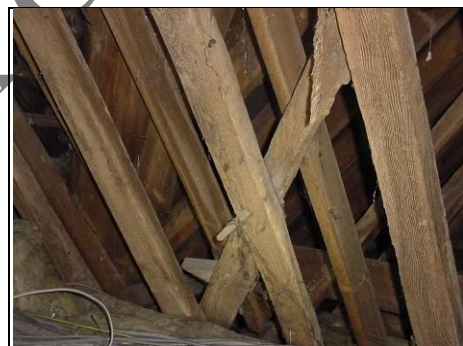
Within this roof we could see old timbers and some peg fixings and also deterioration and woodworm. Rather than replacing the timber it may be better to add additional timber in this way you keep any historic timber and improve the structure. This is the system that has been used over the years and we can see it being used in this roof.

Peg fixings in the roof

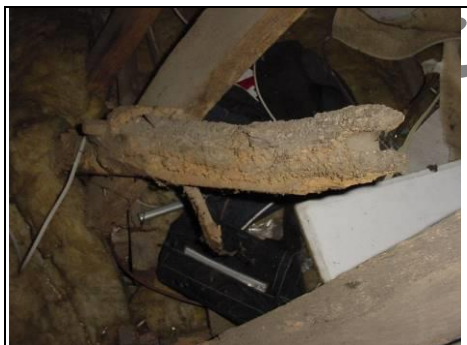
Old timbers

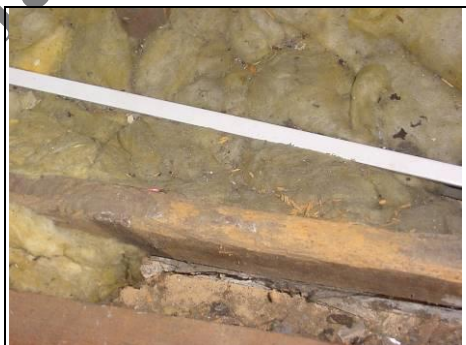
Woodworm in the roof

You will also notice there is some woodworm in the roof structure which we believe is active although there is a fair proportion of old woodworm.

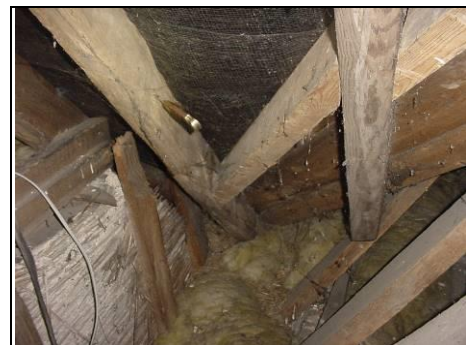
When you carry out the roof cover / slate roof repairs you must carry out repairs to the roof structure. There are various timbers that are split or are bending and need replacing particularly to the valley gutter to the rear and to the roof to the front right side.

Split timbers to the rear valley

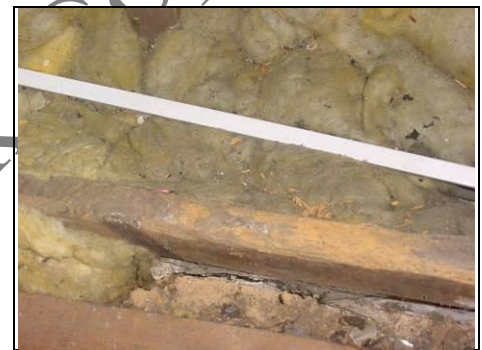
We think the woodworm activity will be reduced if not stopped all together once the roof is made water tight moving the dampness (woodworm like dampness) and also getting air ventilation in to the roof and heating to the building.

Woodworm in the roof

We would strongly advise against using chemicals or any other sprays to treat woodworm as we feel there are far better ways of dealing with woodworm in the long term.

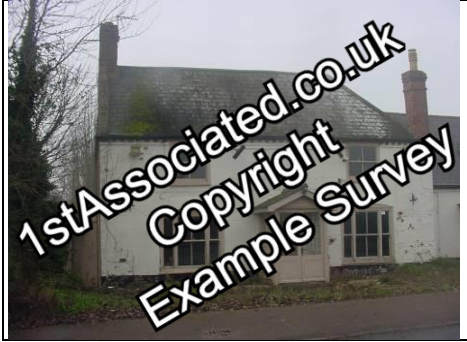
The rear entrance roof is asbestos and is deteriorating. We believe you have already agreed to remove this area. There also looks to be a manmade slate to the left side roof (in a blue oval) which may contain a small amount of asbestos as it was fairly common in older manmade slates (all directions given as you face the property).

Left manmade slate roof

ACTION REQUIRED: If you wish to confirm you are 100 percent free of asbestos, you need to have an asbestos survey carried out.

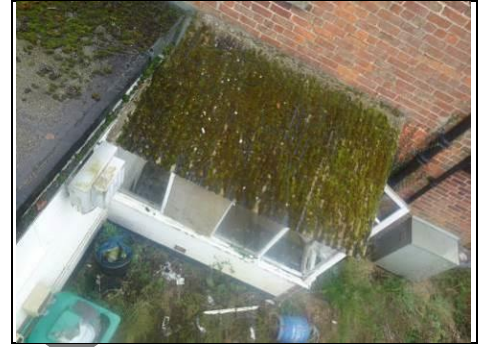
Asbestos roof to the rear entrance

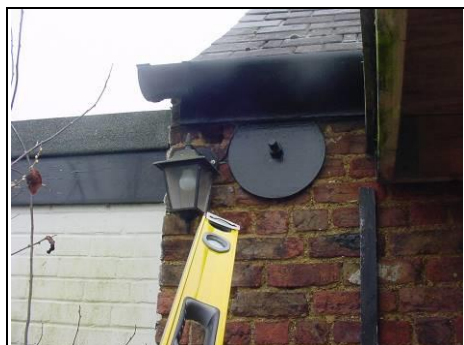
To the left side of the property we can see cracking. Unfortunately, they are very difficult to see in the photos. It does mean that movement is going on to the right side extension as tie bars are added to stabilise walls and offer cross bracing to them.

Tie bar to the function room

ACTION REQUIRED: We would recommend that you open up sections of the wall to see what the wall is constructed from and also to check if the tie bars are giving support to the structure.

The cracking needs monitoring. Before you legally commit to purchasing the property we would recommend the existing owners take out an insurance claim, advising that the cracking has been noted by a structural surveyor (this should cost them nothing other than time to write the letter).

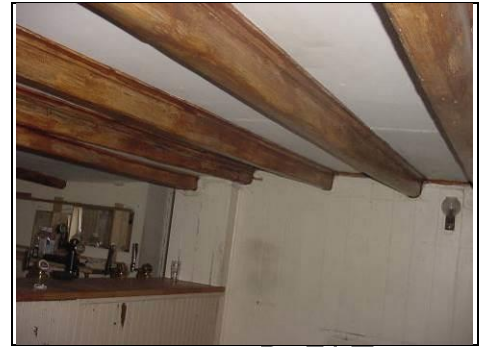
the modern timbers within the right side bar which have been painted with a smoke stain type colour which was popular in pubs years ago (particularly when smoking was allowed).

Timber beams to the right side of the main bar

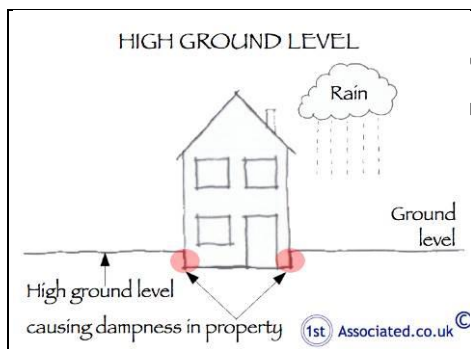
The ground level around the property is relatively high leading to dampness getting in particularly where the building is built from the soft red brick.

High level ground

ACTION REQUIRED: Lower the ground level around the property and we would also recommend you add a French drain.

ANTICIPATED COST: £2,000 - £4,000 (two thousand to four thousand pounds); please obtain quotations.

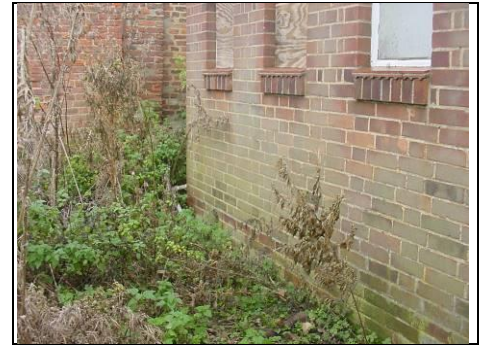
When we were looking down to this area from the flat roof it looked like the ground had been washed away. You advised that you were going to level the ground, you do need to make sure there is not a natural collection of water in this area or even a spring. If there is you need to get the water away from the building

Rear of the ladies' toilets

ACTION REQUIRED: We recommend soak aways are added to the entirety of the rainwater drainage, which will need to discharge as far away from the building as possible.

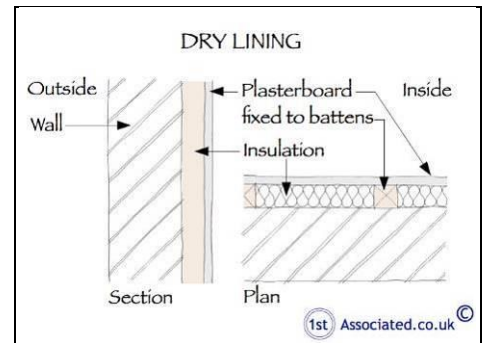
Perks of the dry lining / false wall is to hide the dampness coming through into the property which is considerable. Even with the repair work that we have mentioned you may get an element of dampness coming through. You have to consider part of the character of this building.

Dry lining

ACTION REQUIRED: You need to decide exactly what sort of finishes you want internally, but we think you will probably end up dry lining some of the property.

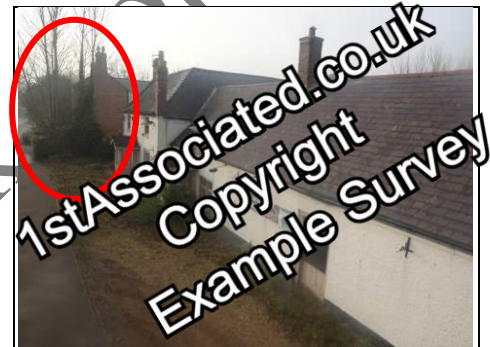
Trees to the left

ACTION REQUIRED: You need to regularly maintain the trees.

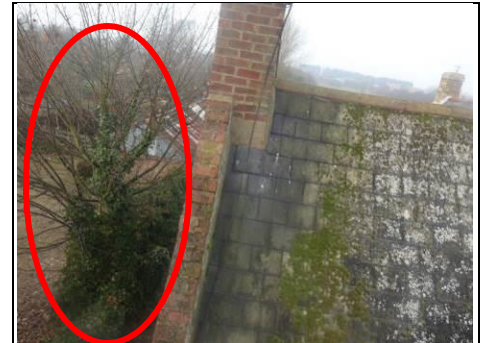
Trees to the left of the property

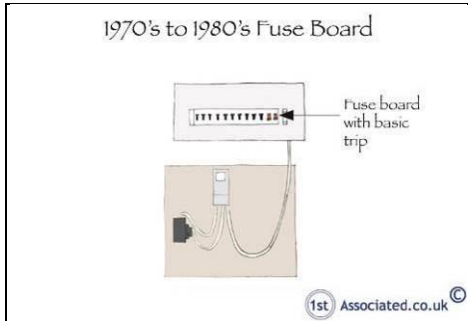
The electrics are dated and were not working at the time of our survey.

1970's Fuse board

ACTION REQUIRED: It may be worth having a new system installed. We recommend an Institution of Engineering and Technology (IET) test and report to be carried out by an NICEIC registered and approved electrical contractor or equivalent.

ANTICIPATED COST: £250 - £500 (two hundred and fifty pounds to five hundred pounds) for a test and report and would expect costs in the region of £2,000 - £5,000 (two thousand pounds to five thousand pounds) for a new system; please obtain quotations.

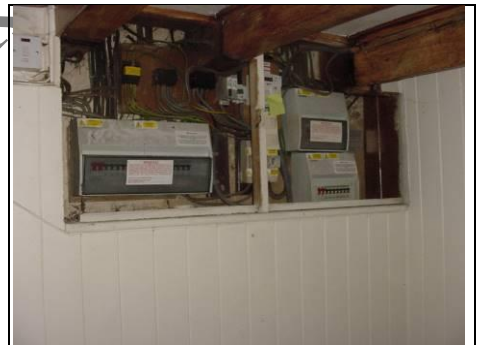
Electrics in the bar area

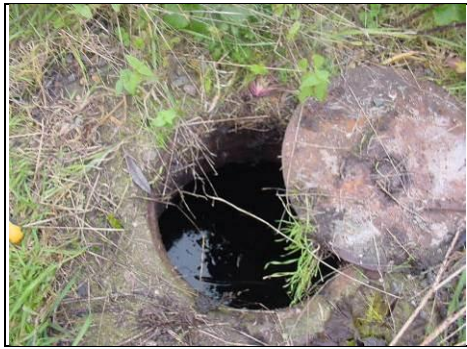
We believe there is a well in the garden, we would put a sump pump into this to see if it is a well, a septic tank or something similar. Place the sump pump into this and pump out what is in there to see if we can see the size and construction of the septic tank.

Well in the garden

ACTION REQUIRED: We recommend you pump out the well with a sump pump or get a company to drain it to see how it is constructed and put a new septic tank in depending upon the capacity etc.

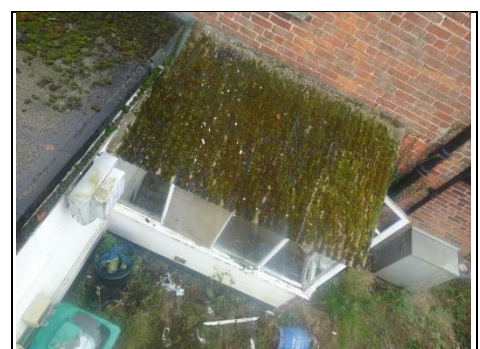
Asbestos roof to the rear
Aerial view -360 photo

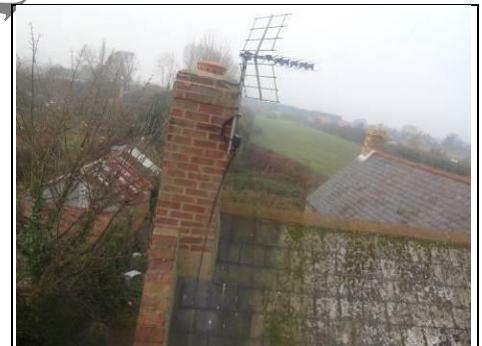
We noted an aerial attached to the chimney which we are not keen on as it cuts into the brickwork rather like a cheese wire cutting into cheese.

Unfortunately, we were unable to see the flashing properly, we therefore cannot comment upon them.

Front left chimney

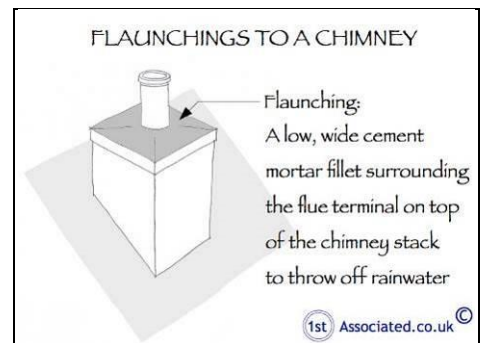
Flaunching

ACTION REQUIRED: All chimneys need repointing and repair work and flaunchings checking. We were generally surprised how long chimneys do last considering their exposed conditions, however in this particular case the sooner the work is carried out the better. You may need scaffolding.

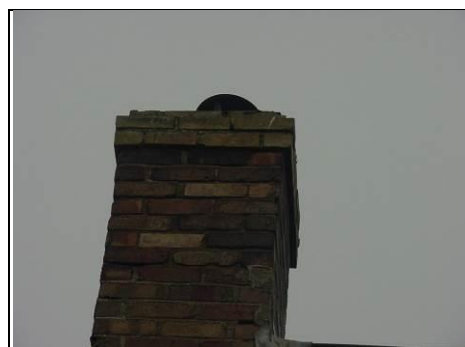
Close up

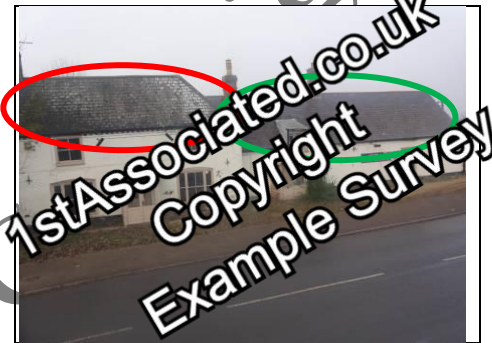
Main roof left (red oval)
and right (green oval)
Aerial view – 360 photo

The main roof is pitched and clad, partly in a manmade slate and partly in a natural slate and, from ground level, this looks in below average condition considering the roof's age type and style.

The natural slate shows an area that has slipped slates to the rear left side, tingles are holding the roof in place and some of the gutters are coming away.

ACTION REQUIRED: We recommend re-roofing. At the very least we would clear the moss.

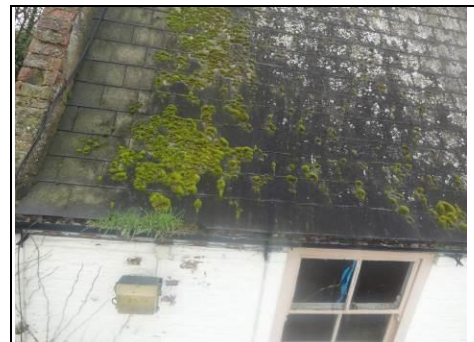
Moss on roof and grass growing
in gutter to main roof front left

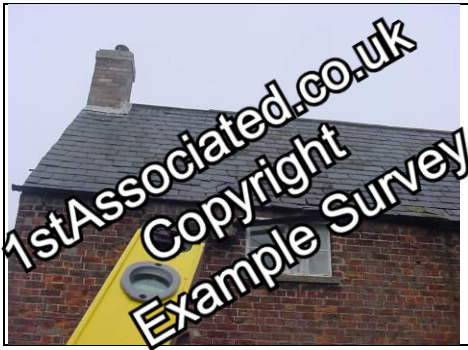
Slipped natural slates to main roof rear left

ANTICIPATED COST: If you can re-use the existing slates then we would expect costs to be in the region of £5,000 to £10,000 (five thousand pounds to ten thousand pounds). If not, and we think it is likely that these are already second-hand slates, then the bill would increase by about £5,000 to £10,000 (five thousand pounds to ten thousand pounds). Please obtain quotes.

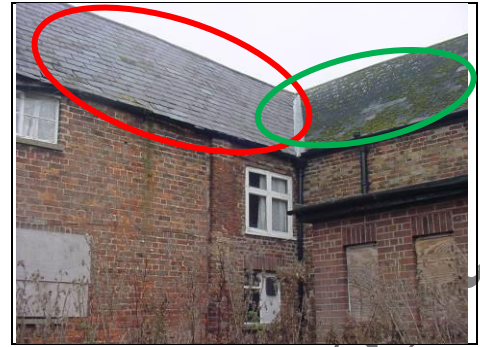
Main rear left roof to rear showing mix of natural slates (red oval) and manmade (with moss on it) (green oval)

There are over 50 tingles on the roof and we consider the roof needs re-roofing.

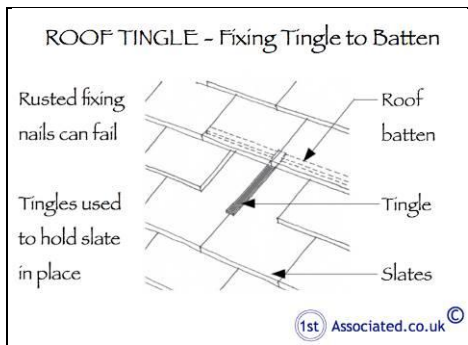
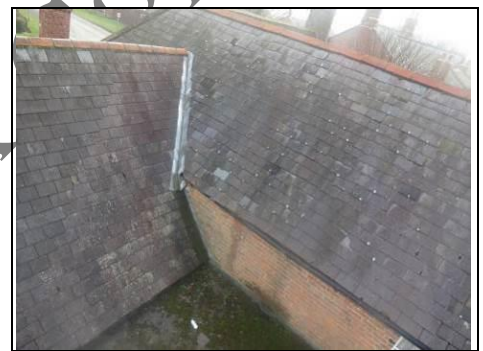
Lead tingles

Around 50 lead tingles on main roof

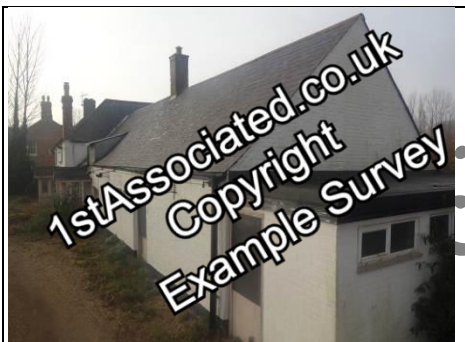
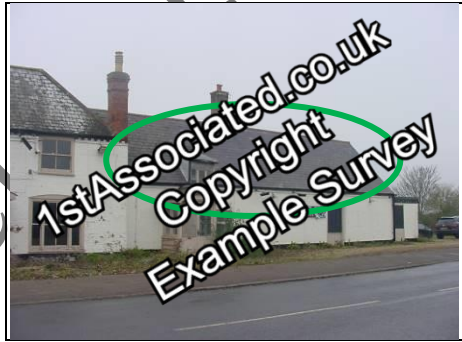
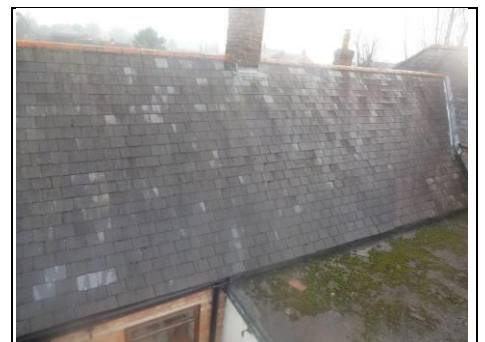
The main roof right side is pitched and clad with a manmade slate and, from ground level, this looks in a much better condition than the left main roof although we can still see some tingles to it. We believe this to be a relatively recent re-roofing (in surveying terms in this instance the last 30 years).

Main roof front right
Aerial view – 360 photo

ACTION REQUIRED: Ad hoc repairs to slates to make watertight for the oncoming winter.

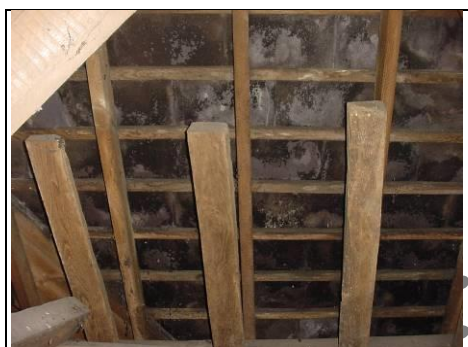
No protective underlayer to the left side of the roof

We generally found it to be in average condition with damage to some areas which is typical of what we find. Of course there are areas where there is no protective underlayer at all. Often in older roofs they had no protective underlayer.

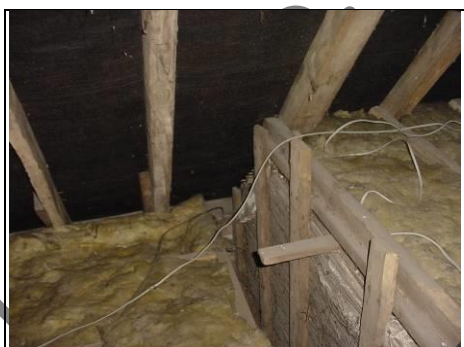
1960's Hessian base underlayer to left side of roof

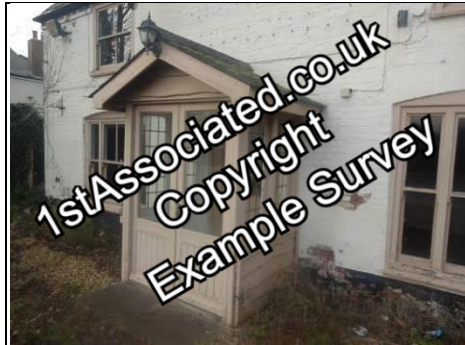
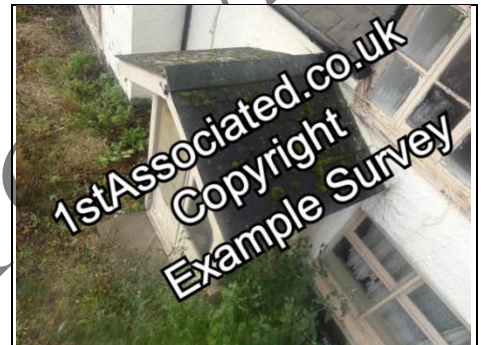
There are two small front entrance roofs to the property. Both of them are pitched with a manmade slate with a lot of moss of them. From ground level they look in below average condition considering the roofs age type and style.

Left entrance roof
Aerial view – 360 photo

Right entrance roof
Aerial view – 360 photo

ACTION REQUIRED: Ideally in both cases we would replace the manmade slates (remembering they may contain some asbestos) with a natural slate. We would also add gutters as well.

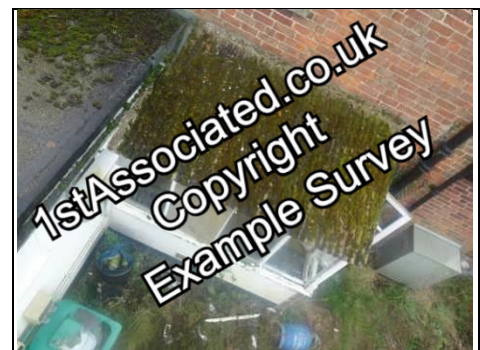
The rear entrance has an asbestos covered roof. From ground level, this looks in below average condition considering the roofs age type and style.

Rear entrance roof
Aerial view- 360 photo

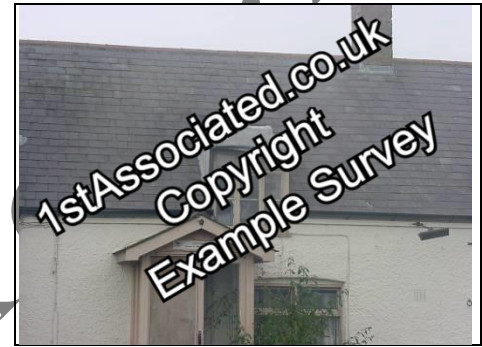
Dormer window

Generally, we could comment they are in below average condition for its age, type and style.

ACTION REQUIRED: Repair the roof, reposition the guttering and downpipes and repair and redecorate the window and side areas.

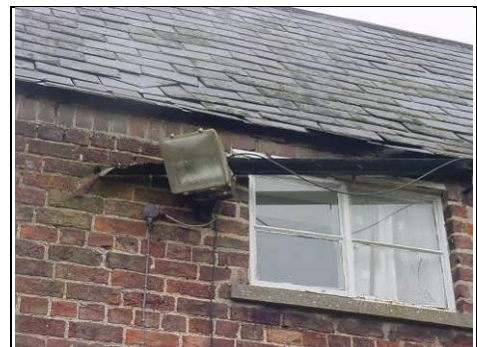
Generally, they are cast iron and are in poor condition.

Gutter falling off

ACTION REQUIRED: We recommend you repair the gutters and downpipes as soon as possible to stop water discharging down the building and damaging it. You will need to chat to the Conservation Officer.

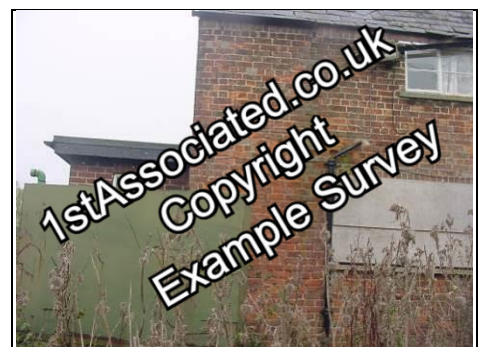
English bond brickwork to the rear

Wrongly repaired many times!

Unfortunately, the older brickwork has been wrongly repaired many times using cement to the joint and to cover whole bricks, which is such a shame. There are also areas where ivy has grown and causing deterioration.

In this case the brickwork is in poor to very poor condition with weathering to the brickwork. A lot of work is needed by a skilled bricklayer who is used to dealing with older historic properties and working in lime.

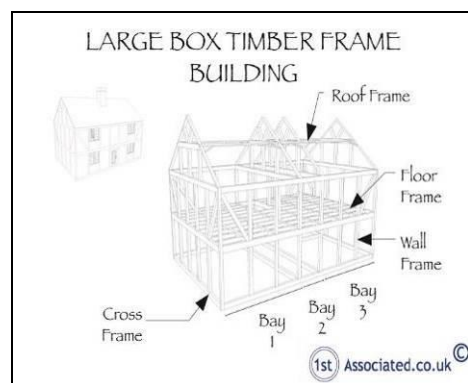
The question here is how much of this building was in a timber structure? From the Listing it would indicate it is probably just the left hand side of the property, but in our experience you may find more of the timber frame structure as work proceeds and if and when you open the property up.

Timber frame structure

ACTION REQUIRED: We recommend you open up several sample areas to see exactly what the construction is. We would specifically draw your attention to the front of the property to the left side (under Roof A in our roof plan), where the brickwork looks to have been re-created using a cement mortar or similar with the joints drawn into it.

We believe this section needs to be opened up very carefully with a builder/historic buildings expert who can then advise you on the best way to repair historic brickwork.

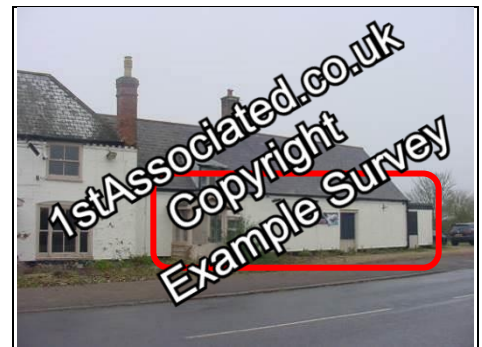
We have carried out a tap test (literally hitting the render with the back of a hammer). We found it to be in average condition for its age, type and style.

Roughcast render

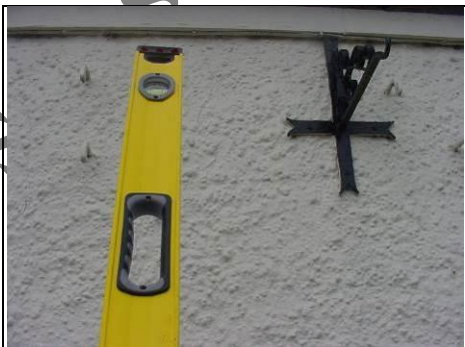
Vertical hair line cracking

ACTION REQUIRED: We would again recommend a section of the render is opened up, particularly bearing in mind the cracks that are in the building and we suggest the opening up is around these.

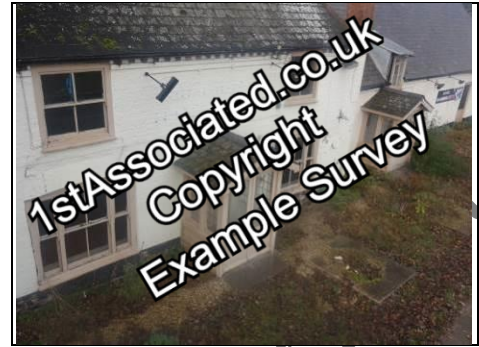
It looks like the brickwork has been painted and looks like the brickwork has also been formed in cement particularly to the front of the property. Ideally these areas need repairing with the cement that they are made of being removed from the building. It is particularly difficult as you will need to either saw or have made older style bricks. We do feel that working with the Conservation Officer in time, this could greatly be improved.

Painted brickwork to the front
Aerial view – 360 photo

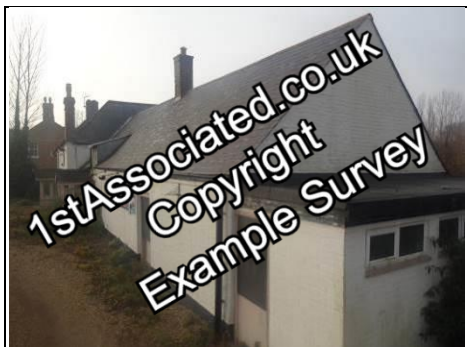
Painted Stretcher bond brickwork
to the right of the property
Aerial view – 360 photo

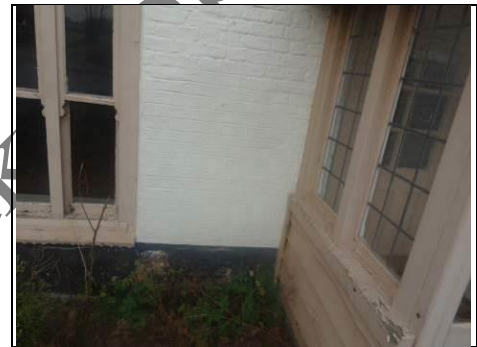
Painted brickwork
Aerial view – 360 photo

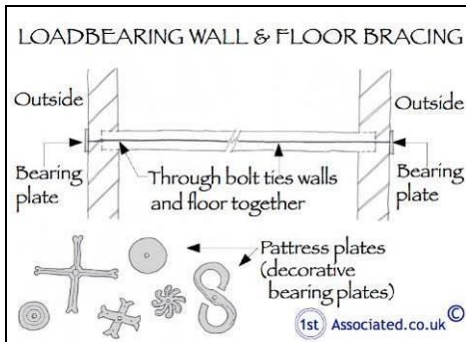
Also to the rear right side is a tie bar. There may be others in the walls that are well hidden, these were used for giving additional support to buildings. It is important that they are not just removed. This looks like a modern tie bar which may of replaced an older one that failed.

Tie bars

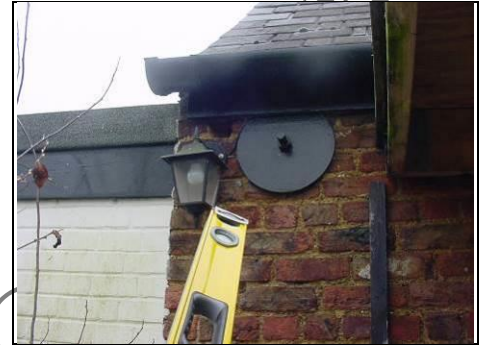
Tie bar to the right side

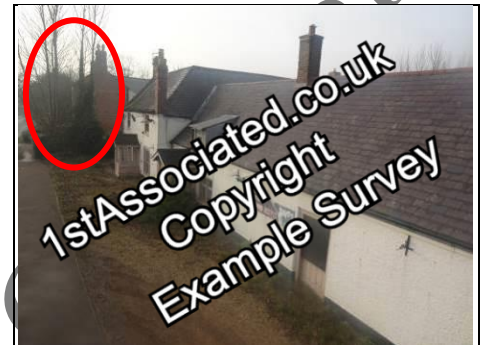
There are trees on the left hand side. We would consider these within what we would term as influencing distance, but the trees are so old the trees and buildings have normally got used to one another. We can see some trees have been cut down in this area.

Large trees located to the left

ACTION REQUIRED: Before you purchase the property we recommend you speak to an insurance company with regard to insuring the property and seeing if there are any outstanding or previous insurance claims that they are aware of. Ideally ensure with the existing owner's insurance company.

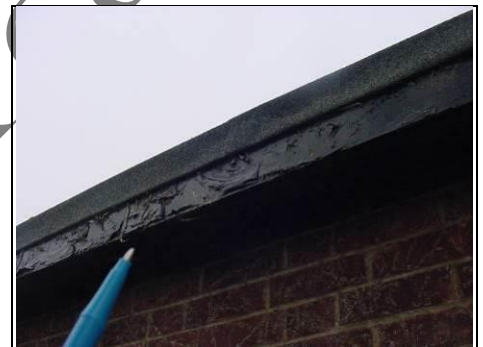
The fascias and soffits are timber. They are painted and we would comment they are in need of redecoration and repair once the works to the roofs and rainwater goods are completed.

Paintwork blistering to fascias and soffits

ACTION REQUIRED: Once the roof work has been carried out and the gutters and downpipes are water tight, then look at painting the fascias and soffits as they are relatively low in the priority list at the moment.

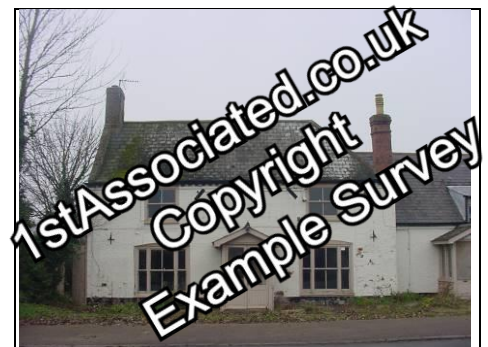
Sliding sash windows to the front

ACTION REQUIRED: Careful repairs need to be carried out to the windows. Once these have been carried out it is equally important to paint them in the right paint.

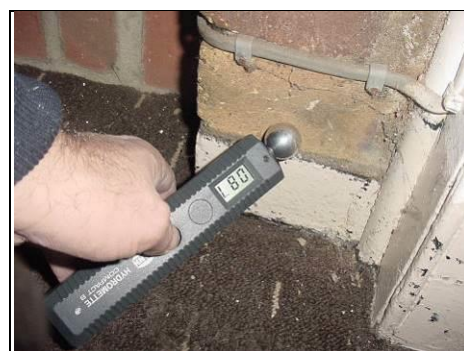
A visual inspection and tests were carried out with a moisture meter to the perimeter walls. In this particular case much of the dampness was hidden by the dry lining (please see our earlier comments), however where we could get back to the actual walls themselves there was damp. We believe this will be reduced considerably when the work is carried out to the exterior of the building that we have mentioned.

Testing for rising damp

Please do not deal with rising damp specialists, damp proof course insertion or anything like that on this age of building as these buildings need to breathe. This is what you need to do and is what has been explained in the External section of this report. Gradually and relatively slowly the building will start to dry out.

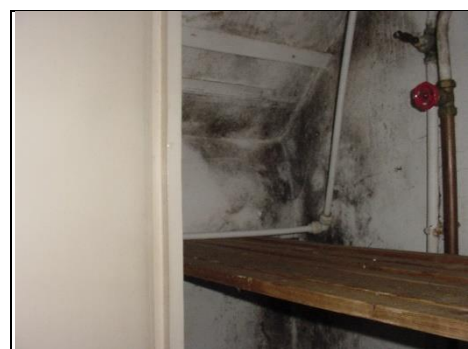
At the time of the inspection there were signs of condensation and black mould in the rear bathroom. We often find in older eras of property such as this where they have had modern facilities such as showers etc. added, there has been insufficient extraction and ventilation allowed which can lead to black mould.

Mould in the rear bathroom

Common sense is needed and a balance between heating, cooling and ventilation of properties and opening windows to air the property regularly.

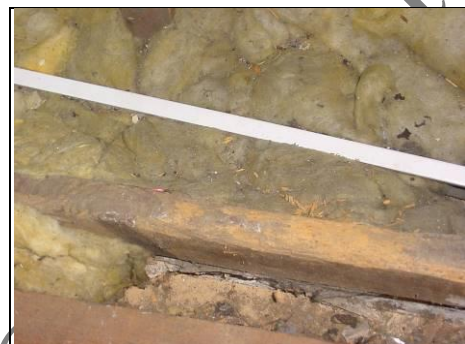
The roof is the main area that we look for woodworm. Within the roof we found visual signs of old and new woodworm activity and indeed signs of past woodworm and activity. However, none of this is what we would term ‘structurally significant’ damage.

Woodworm in the roof

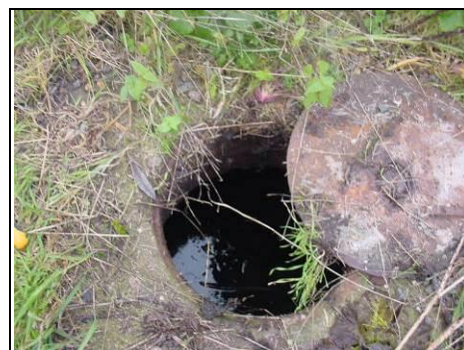
Most older properties would have had a well. In your back garden there is a circular manhole cover that is either covering over a septic tank or a well. We would normally be able to smell the difference but we assume that as the property has been unoccupied for such a long time that even a septic tank would just be full of water.

Well in the garden

ACTION REQUIRED: We would pump out all the water in the septic tank / well to check out how it is constructed and what is in there. If it is a septic tank as we suspect, then there may still be a well in the garden. We have in the past used divining rods which are a metal device for finding water to locate exactly where a well is.

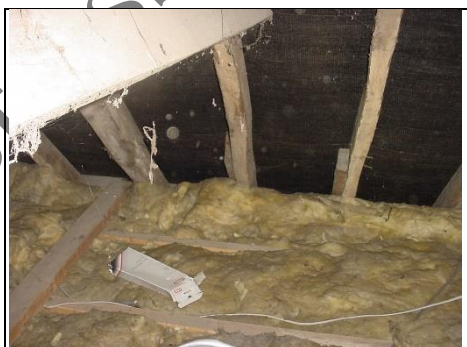
There were various levels of insulation within the roof ranging from 100mm to over 300mm. Current Building Regulations requirements of 300mm.

Insulation in the older roof

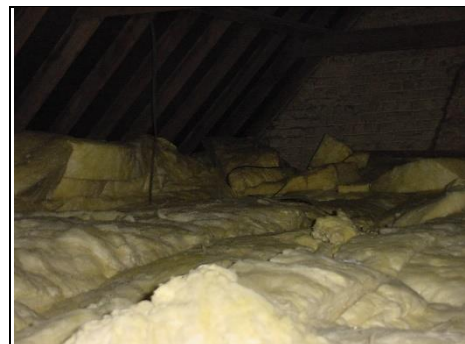
Mass of insulation in the modern roof over the function room

ACTION REQUIRED: We would take all the insulation out within the older roofs so you get a good look at the entire roof structure so you can best repair it.

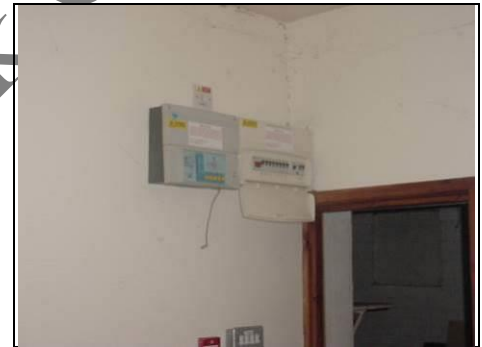
The electric fuses and consumer units were located in the function room and the bar and we would not be at all surprised if there are other fuse boards throughout the property. What tends to happen with pubs is the electric gets added to and added to over the years and unless there is a major extension carried out, the property rarely gets re-wired. For this reason, we recommend that you start again, all be it majority of the fuse boards are from the 1970's and 1980's and possibly even more recent than that.

Fuse Board in the function room

ACTION REQUIRED: As the property is in semi derelict condition and as it is changing occupancy, a suitable Institution of Engineering and Technology (IET) would normally recommend that a test and report is carried out by a NICEIC registered, or equivalent, approved electrical contractor or similarly approved.

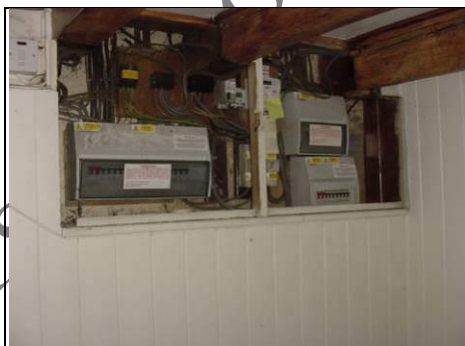
Fuse Board in the bar

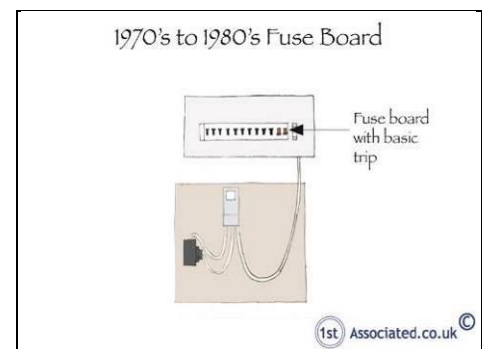
1970's to 1980's Fuse Board

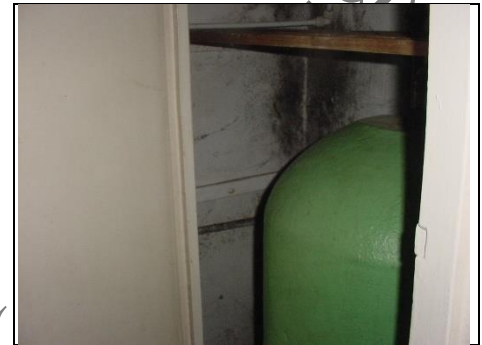
Hot water cylinder

There is a factory insulated hot water cylinder located within the shower room. This cylinder will therefore have a good thermal efficiency, although not as good as the more modern hot water cylinders.

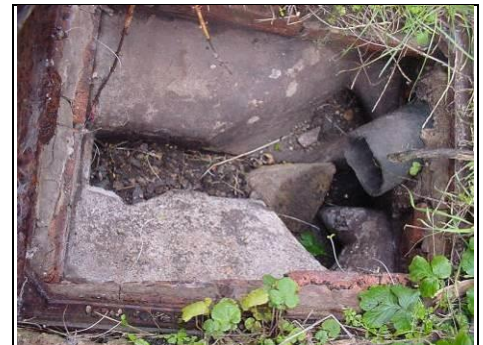
We duly lifted the cover and found it to be blocked and dry at the time of our inspection.

From what we could see it is concrete built.

Manhole to the rear

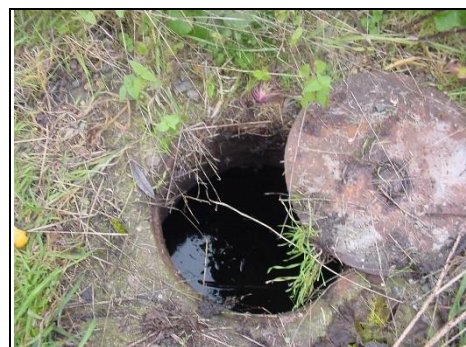
We found another manhole to the rear that maybe a well or maybe a septic tank. Please see our comments in the Well Section.

Septic tank / well

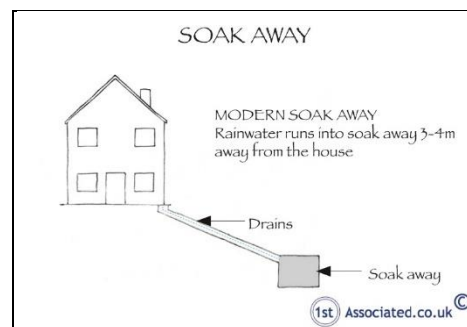
Soak-away

We have been unable to determine the ultimate means of rain/surface water disposal. The ones we could see where discharging directly onto the ground.

ACTION REQUIRED: We recommend soak-aways are added to get the water away from the building.

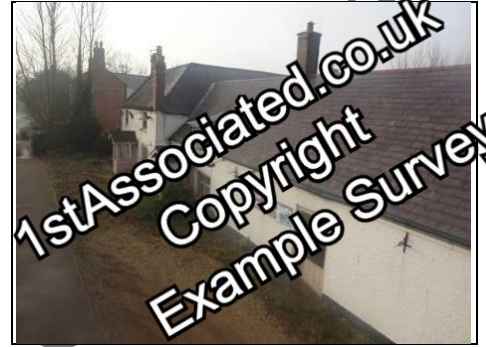
Front garden

There is more of a frontage than a garden to the property which is partly shingled and partly overgrown. The most noticeable thing to us is that it discharges water towards the property and has a relatively high ground level to the older part of the property, which is causing problems with dampness.

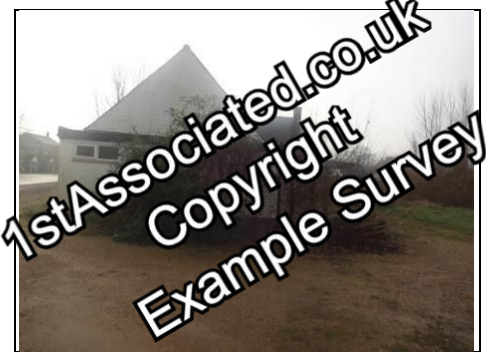
There is parking to the right side of the property.

Parking to the right

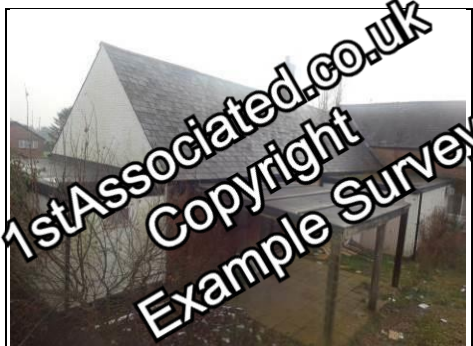
Rear garden

The rear garden is very overgrown and what we would term as quite swampy in some areas.

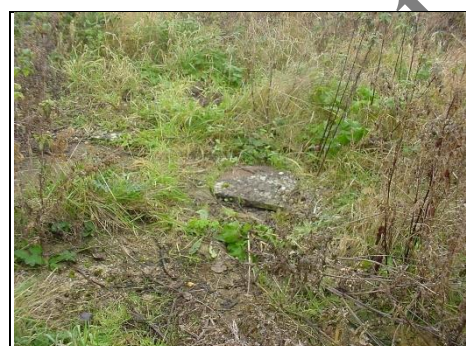
Swampy rear garden
