# RESIDENTIAL BUILDING SURVEY

XXXXXXXXXXXXXXXXXX,  
Marylebone,  
London ,  
W1U xxx

Prepared by:  
XXXXXXXXXXXXXXXXXXXX  
INDEPENDENT CHARTERED SURVEYORS

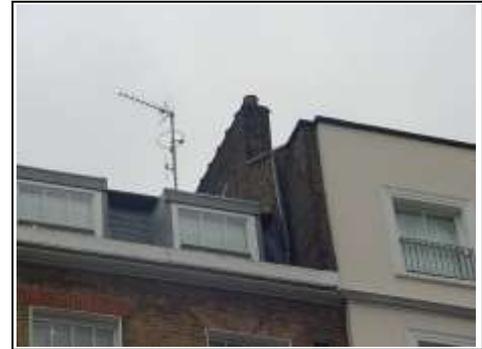
Roof, parapet wall and chimney - right

This property has substantial chimneys. The chimney to the left hand side is damaged and deteriorating. It looks to have a modern cement mortar detail that is prone to cracking.

**ANTICIPATED COST:** For a cement repair this will cost a few hundred pounds. A lead repair would approximately double this cost; please obtain quotations.

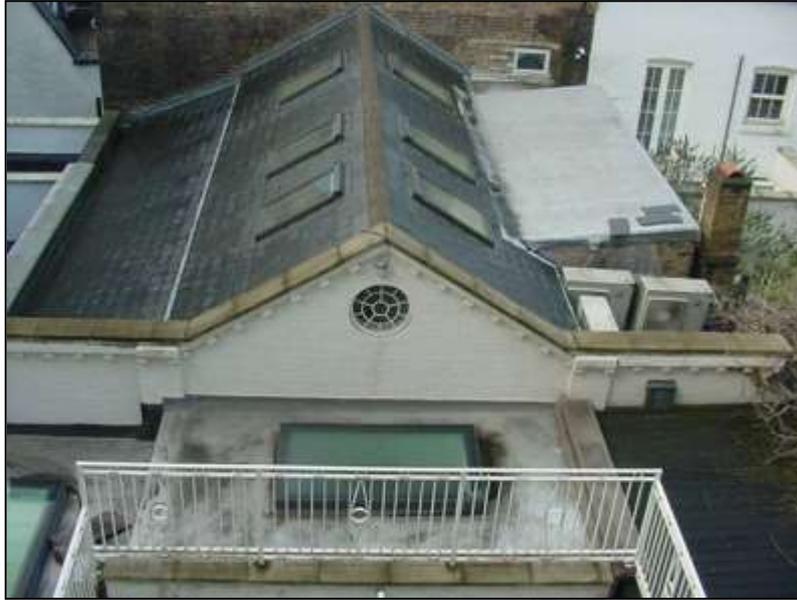
We can see that the courtyard to Apartment Two and the shared terrace to the rear of the property have a coping stone that looks to have leaked over the years. We can see that the joints of this have been tarred to the left hand side and the parapet wall has been completely tarred to the right hand side.

Rear of Apartment Two  
Awkward valley gutter (red)  
Straight lead flashings instead of stepped (green)  
Gutter leaking onto property (yellow)

**ACTION REQUIRED:** We would recommend that lead cappings are added to the parapet walls including the one on the main roof.

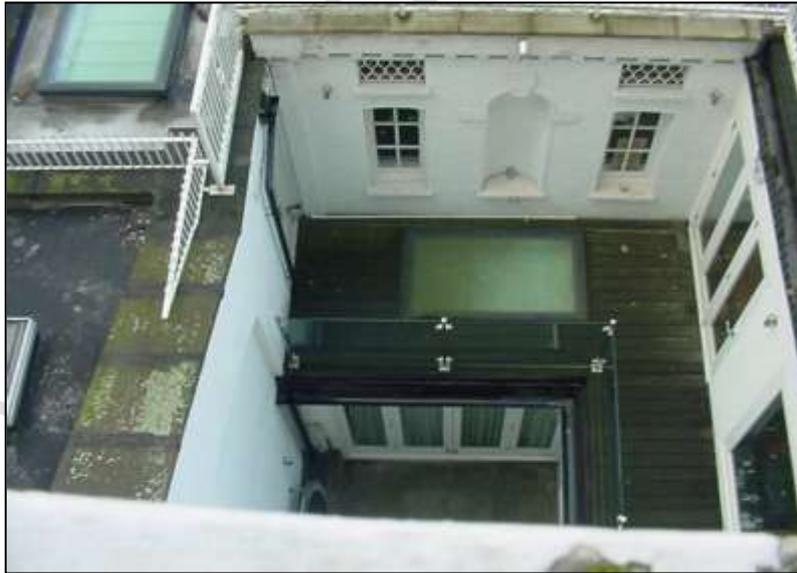
Courtyard of Apartment Two

Courtyard to apartment two – repairs visible

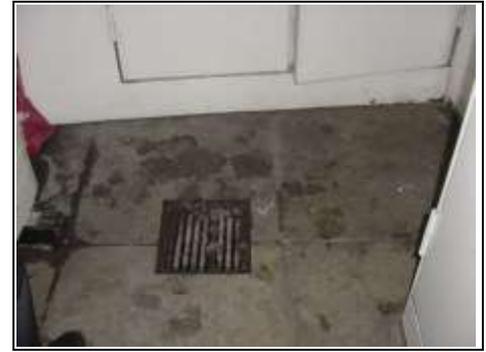
Only one drain for this apartment

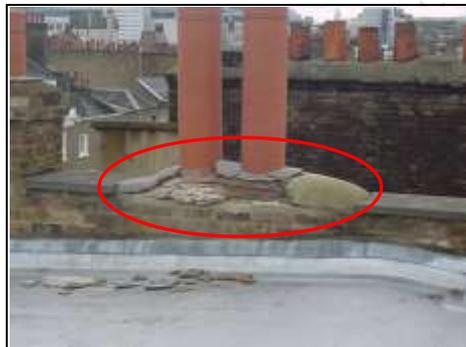
Left chimney requiring repairs

**ACTION REQUIRED:** It may well be that the best detail is a lead capping around the chimneys and also to the parapet walls, we will discuss this in the next section.

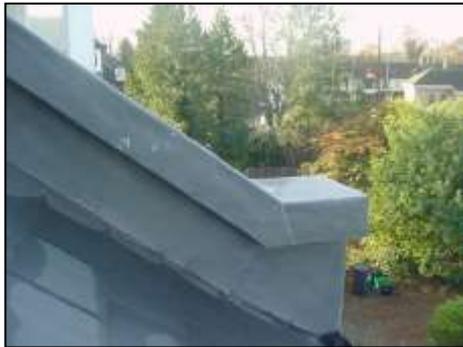
Example of lead capping to a parapet wall on another property.

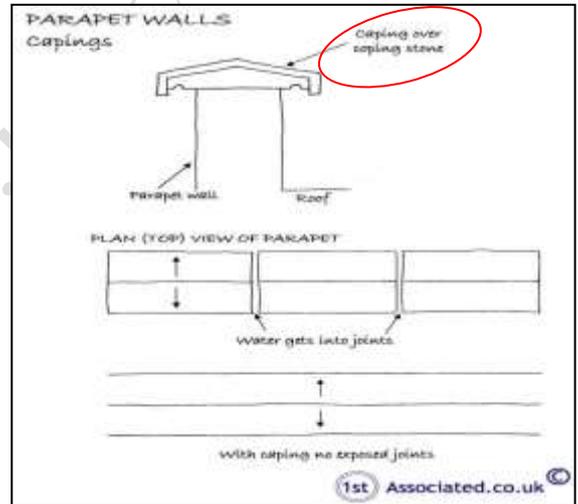
Parapet walls and cappings

**ANTICIPATED COST:** Lead work can be expensive but does offer the best watertight solution in our opinion. We would expect costs in the region of £10,000 to £20,000 for a complete solution. For temporary tar repairs, as

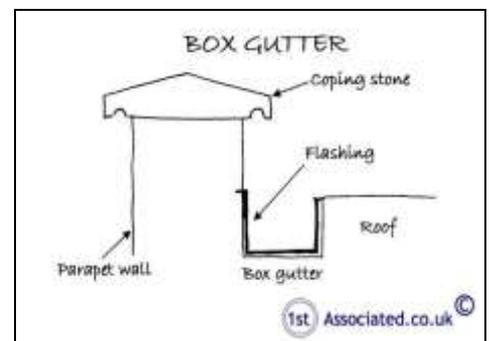
To the front of this Asphalt roof is a box gutter detail where we think rainwater is getting in. The problem may be caused by the poor detailing to the box gutter around the dormer windows, see further on in this section.

Box gutter

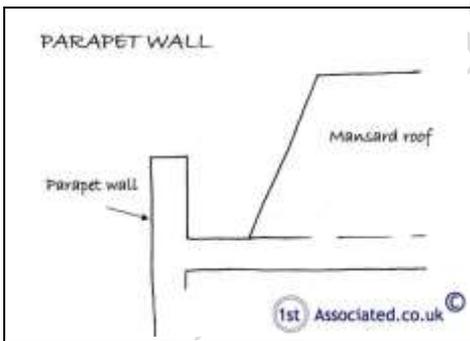
Parapet wall

**ACTION REQUIRED:** We would specifically ask if there has been any maintenance carried out on this area from basic clearing of the gutter to the renewing of the finish. We would always recommend that a

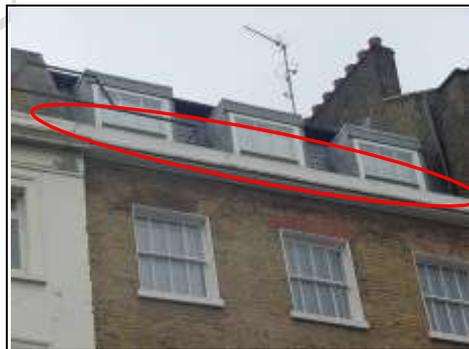
Box gutter

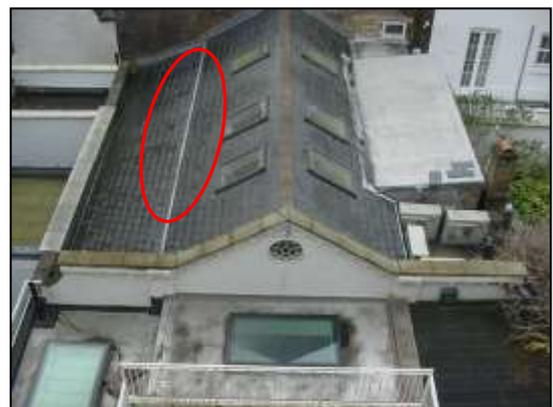
Rear pitched roof  
Awkward box gutter (red)

As mentioned there is a pitched roof to the rear of Apartment Two which forms the cathedral ceiling within the apartment. This has been re-roofed at some point with a manmade slate, this would typically have been during the 1990's. We noted that some slates have already been displaced to the rear right hand side.

To the left hand side there is an awkward gutter that we believe is leaking. Again as with the main roof, box gutters really can be problematic particularly in this case where any water that discharges from the gutter actually goes into the walls.

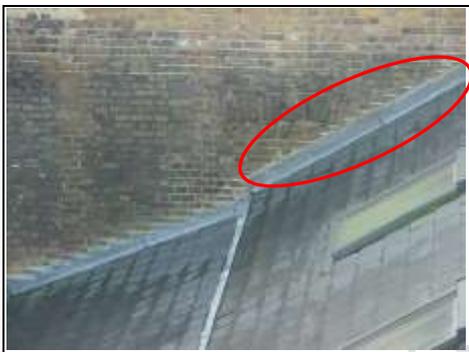
We can see that the lead flashing has been put onto the pitch roof using a straight cut rather than a stepped cut. We tend to find that straight cut lead does not work as well as a stepped lead flashing which is simply a better quality of workmanship and the steps follow the line of the brickwork. The step lead flashing is a subtle difference but we believe it does indicate that the quality of workmanship is not particularly good with regards to this roof.

Straight line flashing to left of rear roof instead of the correct stepped flashing.

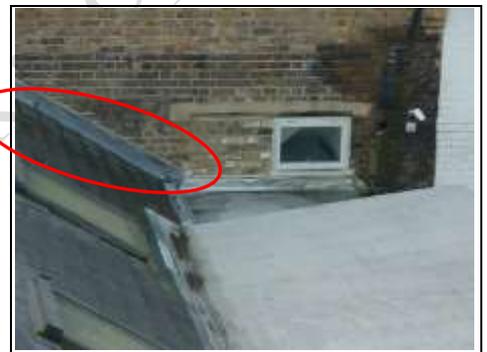
Straight line flashing to right of rear roof instead of the correct stepped flashing.

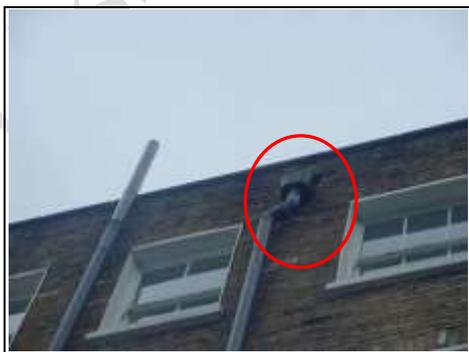
We could not see lead work behind the hopper head.

No lead behind hopper head

**ACTION REQUIRED:** We would recommend that lead is added to this area.

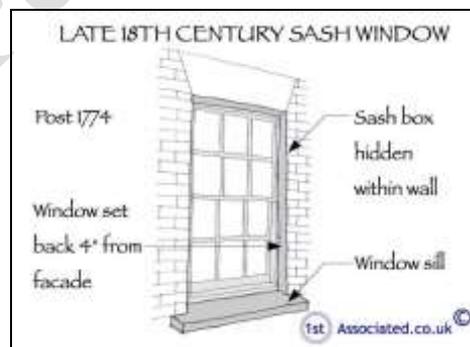
18<sup>th</sup> Century sash window

**ACTION REQUIRED:** Given the way that the windows sit in the wall, 100mm back from the fascia, indicates their date as being late 18<sup>th</sup> century, however they may have been replaced with a Victorian sliding sash window. Either way they need re-decorating in the summer of 2014 to stop damage and deterioration to the timber beneath.

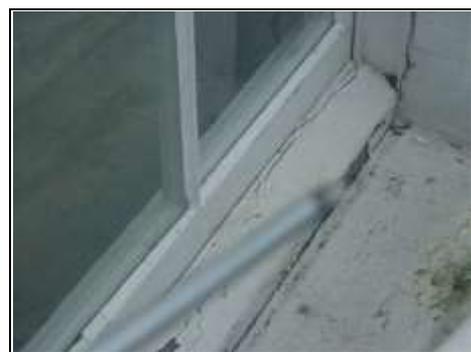
Windows in need of redecoration – rear right

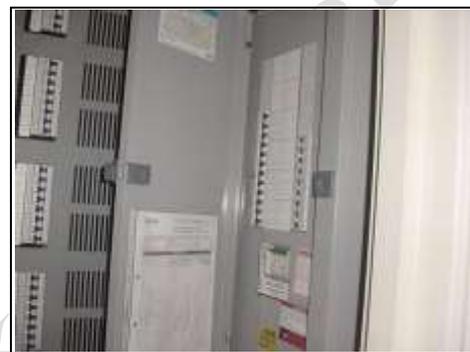
Fuse Board in Apartment Five

Our concern is that from speaking to the property agent/manager they are not aware of any electrical certificates having taken place. We believe these are essential to good property management.

**ACTION REQUIRED:** The Institute of Electrical Engineers standards (IEE) recommend a test and report whenever a property changes occupancy. This should be carried out by an NICEIC registered and approved electrical contractor or equivalent.

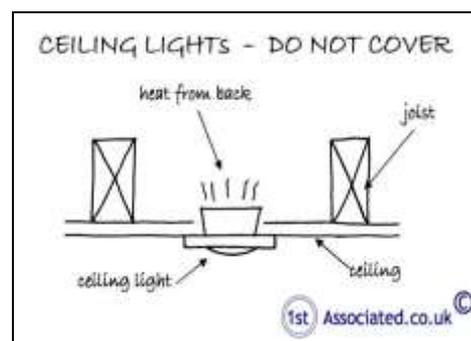
Ceiling lights

For example, we would draw your attention to one new piece of electrical legislation which is the requirement to have a fire resistant ceiling light where there are habitable rooms above.

There are lots of instances of this where this would apply within the property and we have personally come across situations where fires have been started due to ceiling lights like these.

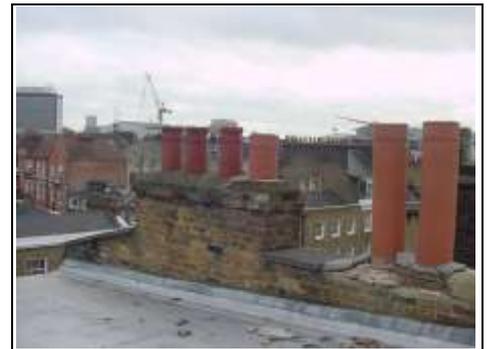
Chimney-left

This chimney is brick built finished with a lead flashing and several chimney pots. From what we could see from ground level it looked in below average condition considering its age, type and style due to the condition of the flashing

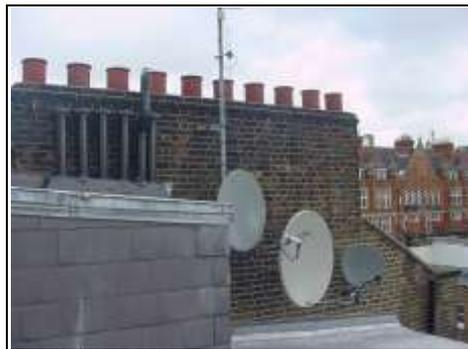
Chimney - right

This is a substantial chimney and again we have identified them as one chimney as this is how they originally would have been. The brickwork and the chimney pots look to be in average condition although we have not been able to see the flaunching properly.

**ACTION REQUIRED:** Carry out period inspections.

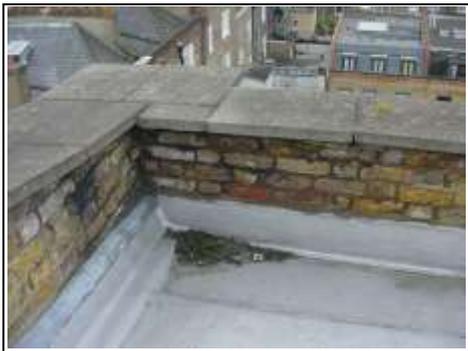
Rear parapet wall with paving slabs to the top

**ACTION REQUIRED:** We are recommending that any parapet walls with coping stones should be capped using lead as this stops any dampness getting in through the joints and through the brickwork.

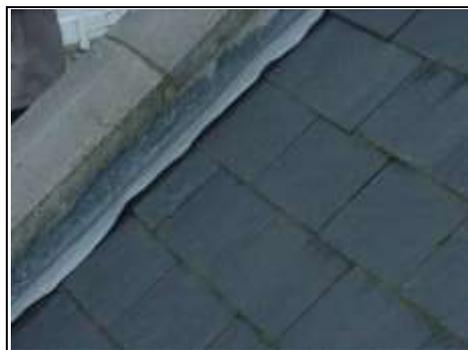
Lead flashing is lifting

**ANTICIPATED COST:** A few hundred pounds.

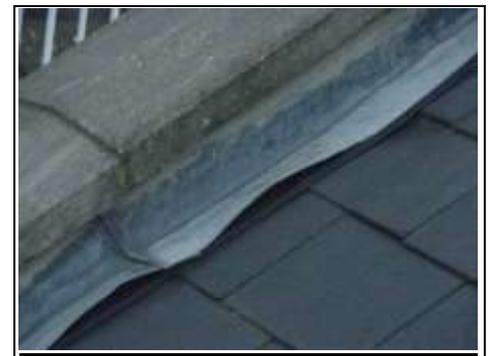
It almost looks as if someone has tried to remove/steal it

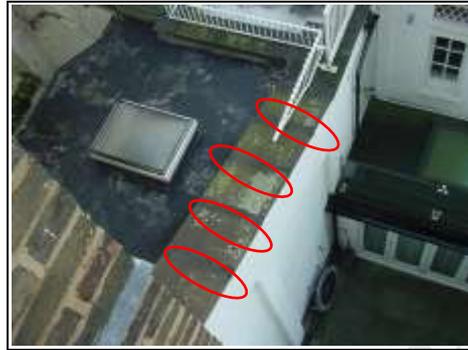
Parapet wall to courtyard has been tarred over the joints

**ACTION REQUIRED:** We are recommending that all walls have lead cappings added. Please see our comments within the Executive Summary.

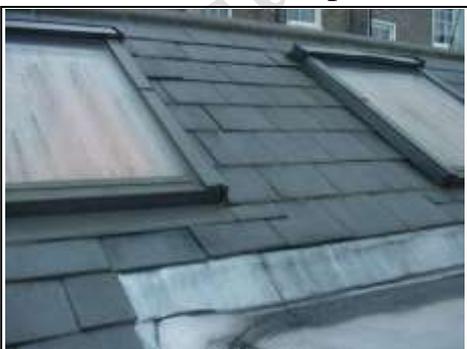
However we do tend to find that roof windows leak sooner or later and we can already see that some slates have been displaced around the rear pitched roof area.

Mould on roof window above Apartment two

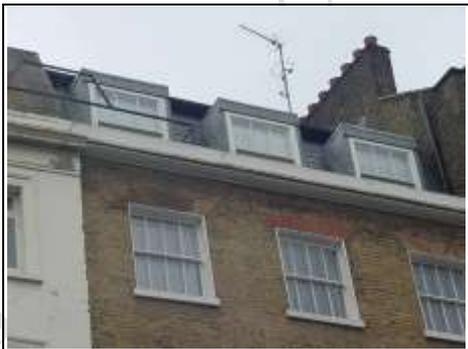
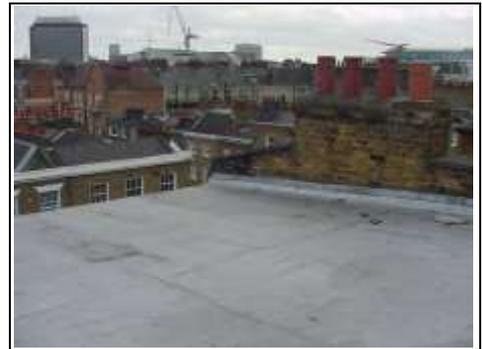
Main roof

The main roof is Asphalt and is in slightly below average condition considering the roofs age type and style. From the staining visible beneath, it looks as if water has come in and patch repairs have been carried out. We believe further repairs are likely to be required either here or to other areas as detailed within the Executive Summary.

**ACTION REQUIRED:** Please see our comments within the Executive Summary and carry out periodic inspections and maintenance of the roof, as required.

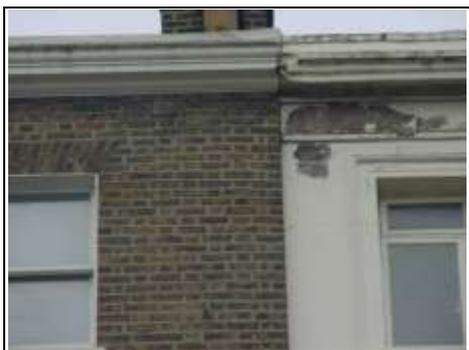
Problems with roof detail please see our comments in the Executive Summary with regards to the box gutter

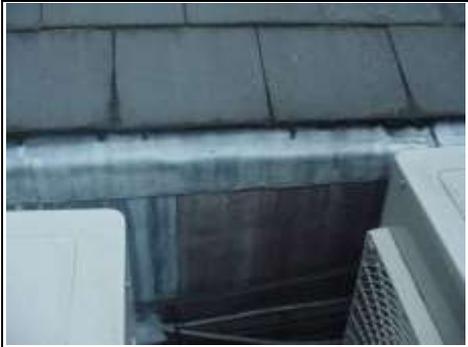
Vertical lead

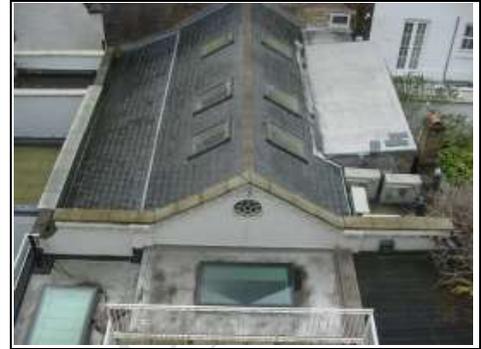
The rear roof is clad in manmade slates and is in average condition with some displaced slates.

Rear pitched roof over  
Apartment Two

**ACTION REQUIRED:** Please see our comments within the executive Summary.

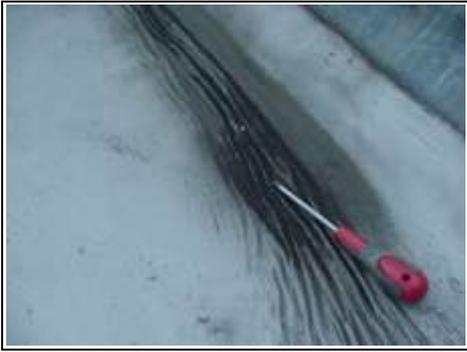
Rucking to the flat roof over  
Apartment Two

We have suggested within the Executive Summary that the main roof is tested to pin point the leak. This is an electric testing system where the roof is covered in a liquid and a charge passed over it via a metal detector type device to see if there is any water getting in. We feel that this will be beneficial here as although there are no obvious signs of water getting in, it is best to be on the safe side.

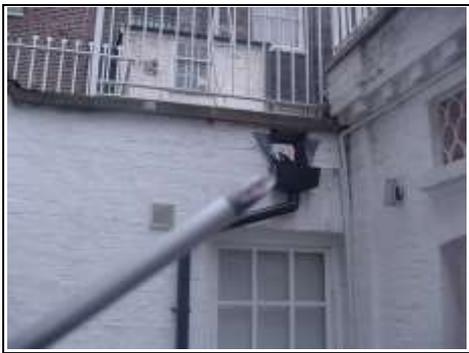
Hopper head left hand side wall of Apartment Two

**ACTION REQUIRED:** Please see our comments within the Executive Summary referencing the hopper heads and the hopper head detailing.

We have recommending that lead is added around the hopper heads but also we would recommend these are checked next time it rains heavily to see if they are overflowing as it may simply be that they need to be a larger size. The original cast iron hopper heads

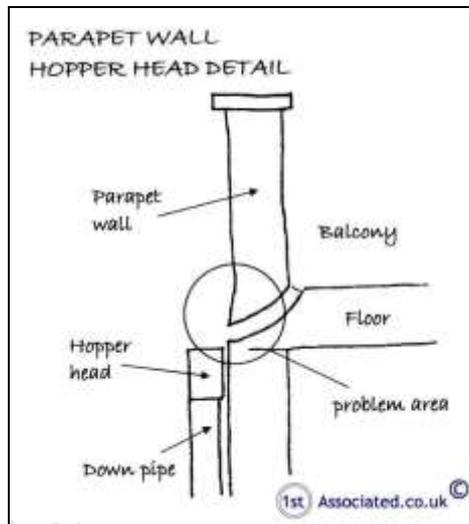
Hopper head

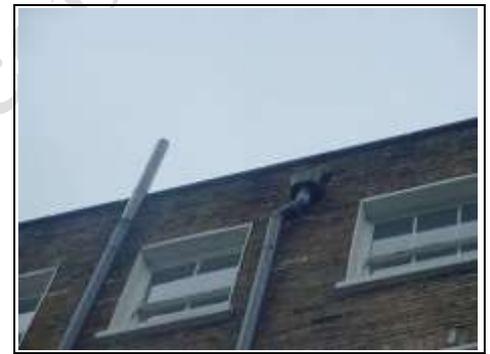
Hopper head taking water off the roof

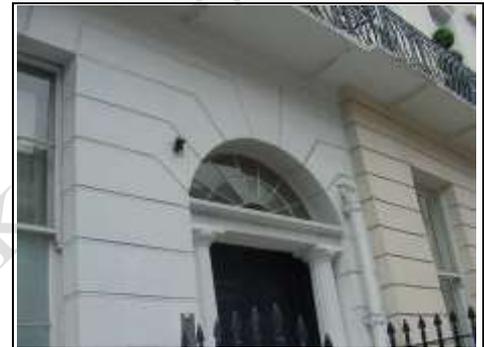
The external walls at lower level are finished in a Stucco render. This looks to be a replacement cement based render which is harder and can suffer from what we term as a hardboiled egg situation where the outer skin does not move in the same way that the inner skin does.

Stucco render

This generally seemed to be in average condition but would benefit from redecoration. We would recommend that this is carried out with the redecoration of the windows (please see further on in the report) in the summer of 2014.

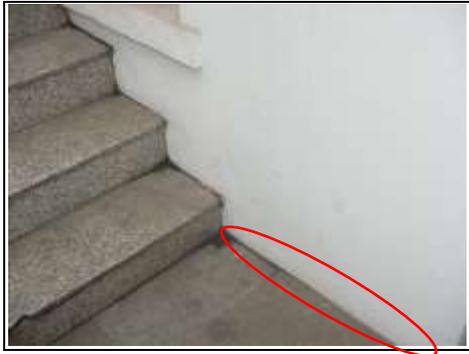
Poor render detail- this is why there is dampness in the property

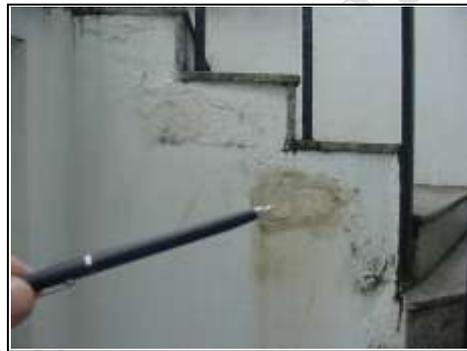
Damp coming from the stairs into the wall. Asphalt tends to be the only way to resolve this

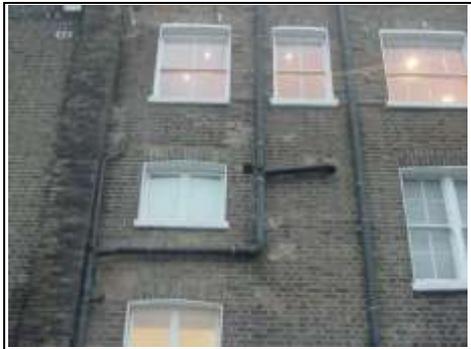
Sash windows to the rear of the property look in reasonable condition

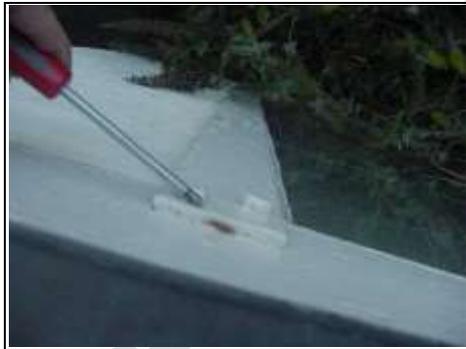
Rusting to the metal work on the timber windows to the right hand side of Apartment Two

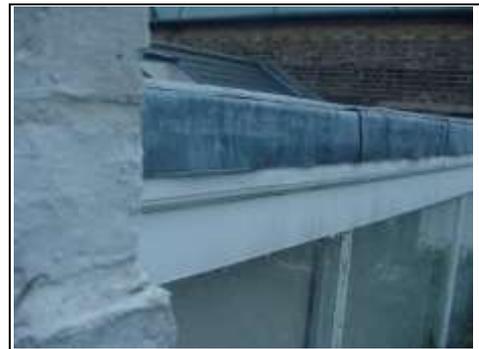
Poor detailing

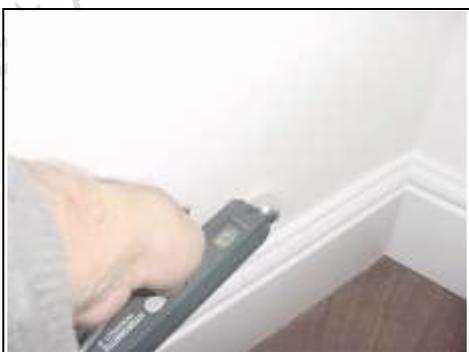
A random visual inspection and tests with a moisture meter have been taken to the perimeter walls. In this particular case we have found minor dampness to the lower ground floor. Looking at the detail externally we think that levels are higher but they are effectively hidden by the dry lining

Testing for dampness in Apartment Three - slightly higher readings

**ACTION REQUIRED:** Please see the Executive Summary regarding changing the detailing to the front of the property.

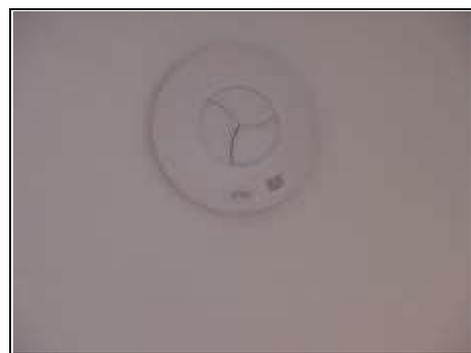
Extract fan in apartment Five

**ACTION REQUIRED:** We would

recommend humidity controlled extract fans be added to kitchens, bathrooms and drying areas.

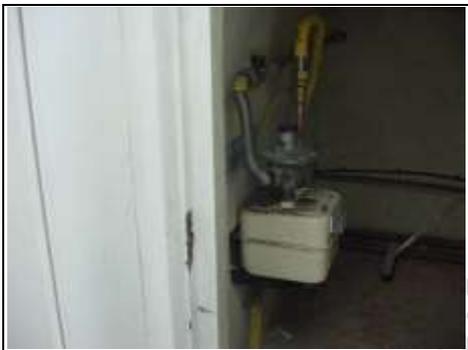
There are vaults to the property that go under the road. These are damp and have been used for various items of service equipment.

Various services in the vaults under the pathways

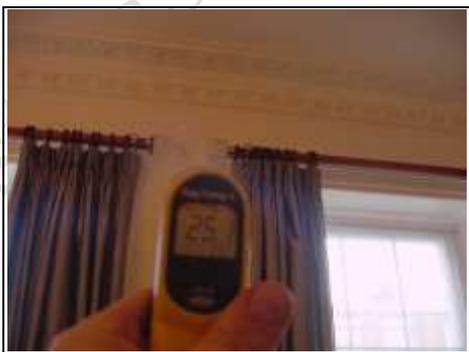
There is a significant difference in the lower level and high level temperatures in some of the apartments. We believe that whilst these walls were originally solid they have now been dry lined with insulation etc. Also the upper flats are effectively insulated by the flats above them and warmed by the flats below them.

Taking surface temperature in Apartment Four

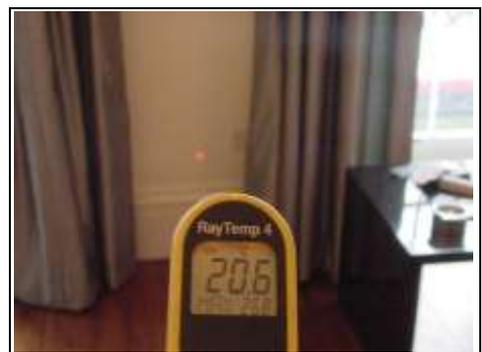
Five degrees warmer at the top of the room than the bottom of the room

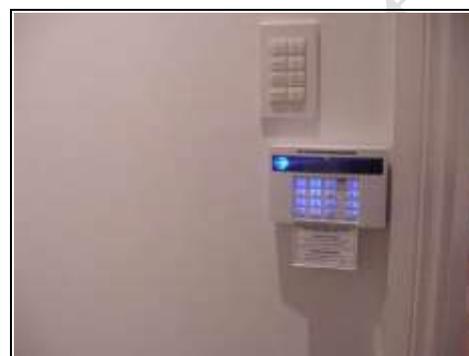
A security system has been installed. A good alarm system should not only help reduce break-ins but also your insurance. We are not experts in this field and therefore cannot comment further.

Security alarm in  
Apartment two

**ACTION REQUIRED:** Further information should be obtained from the vendor and the installer.

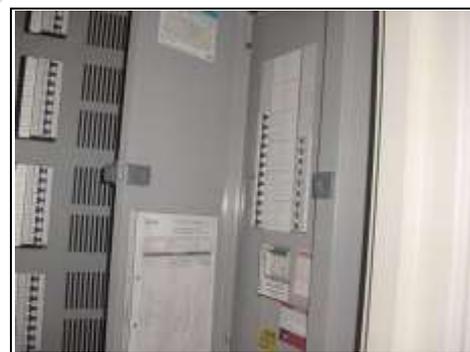
From what we could see each apartment has separate fuse boards which looked reasonably new (past thirty years) although regulations are changing all the time.

The fuse boards also feed the comfort cooling systems.

Fuse Board in Apartment Five

**ACTION REQUIRED:** Please see our comments in the Executive Summary with regards to the electrics and ceiling lights.

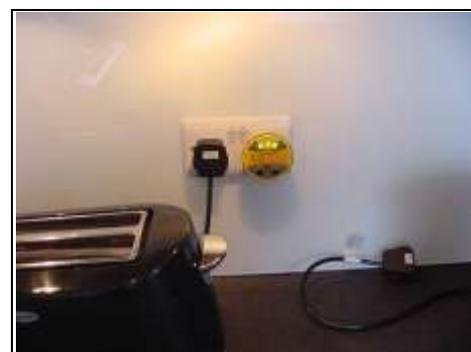
We carried out an earth test in the kitchen area of apartments, one, three and four, to the socket point that is normally used for the kettle, in each case this proved satisfactory.

We would reiterate our concerns with regards to not having a current up to date IEE

Earth test

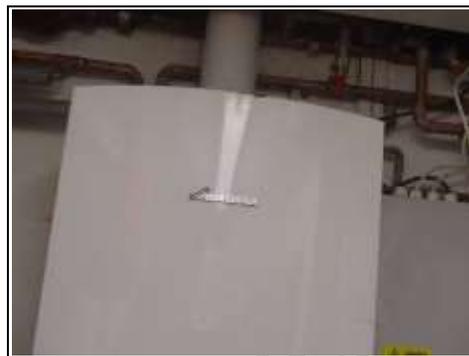
Worcester boiler in Apartment two

Our limited inspection of the hot water and central heating system revealed no evidence to suggest any serious defects but we would nevertheless recommend that the system be tested and overhauled before exchange of contracts and that a regular maintenance contract be placed with an approved heating engineer.

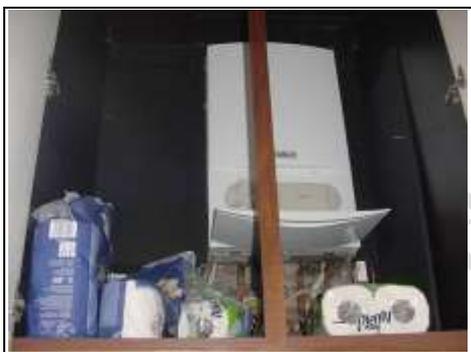
Vaillant boiler in Apartment Four

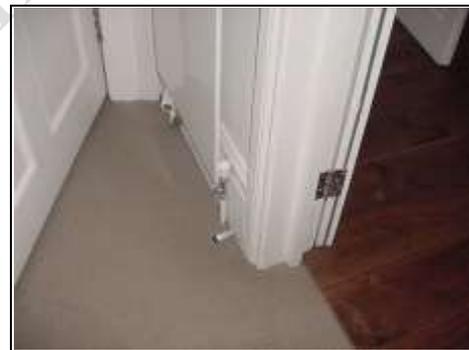
Thin radiator in Apartment Four, very efficient

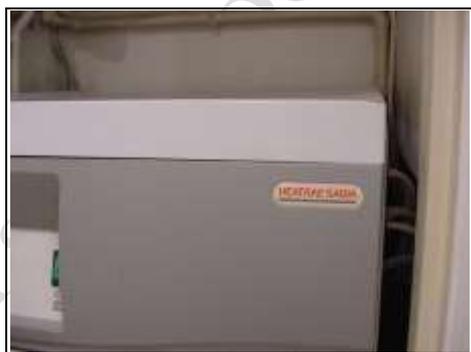
Floor mounted boiler next to bathroom in Flat Three

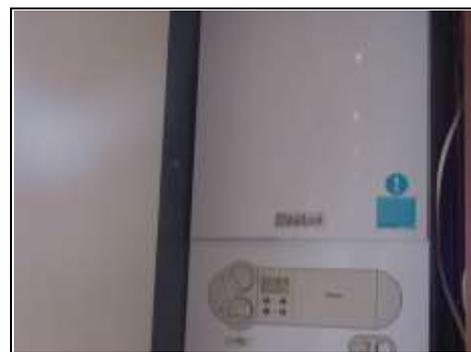
Vaillant boiler in Apartment Five

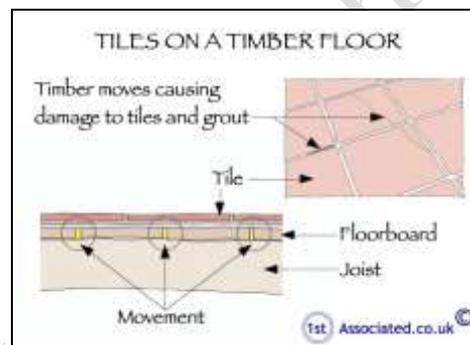
We do come across instance where bathrooms have been upgraded where there is a tiled floor onto timber where the tiles or the joints of the tiles crack.

Tiles on a timber floor

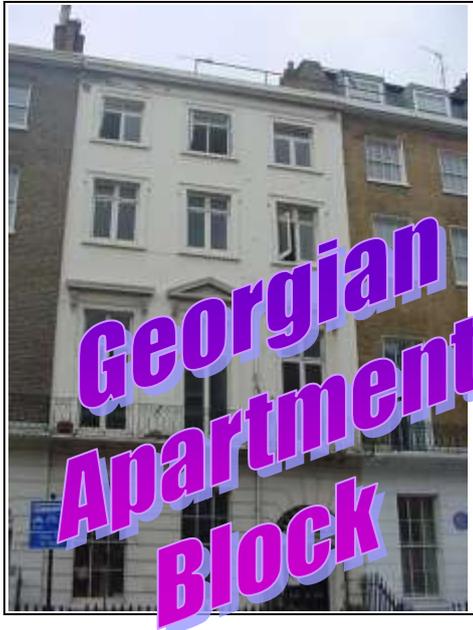
Rendered building - left

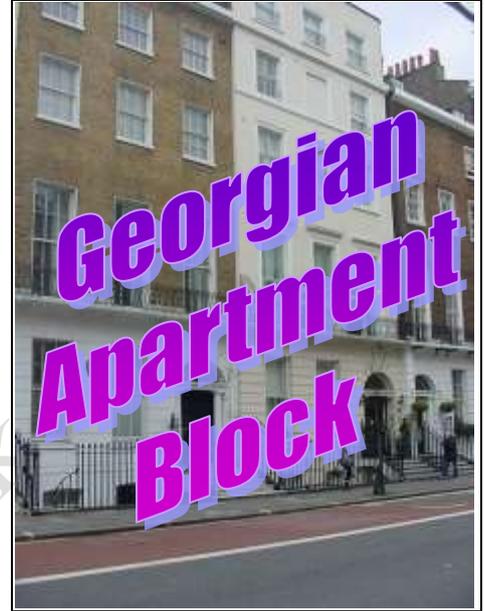
Rendered building - right
