# RESIDENTIAL BUILDING SURVEY

West Sussex, RH11

**Detached  
Tudor  
Property**

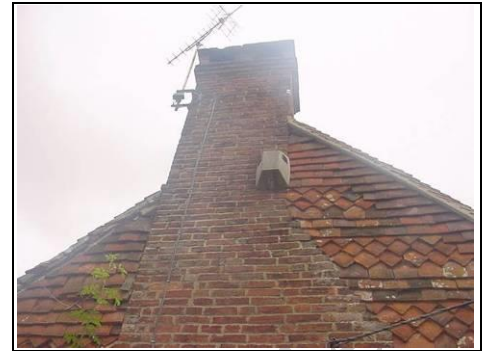
The chimney needs some work generally from repointing. You also need to check to see if it has been repointed in a cement mortar or lime mortar. It looks from ground level to be cement mortar.

We would also recommend a lime coat or similar for the external of the building and you may also wish to look at how to treat the timbers rather than the black and white look which has become traditional (which was introduced by the Victorians). You may wish to lime wash the timbers as well for protection.

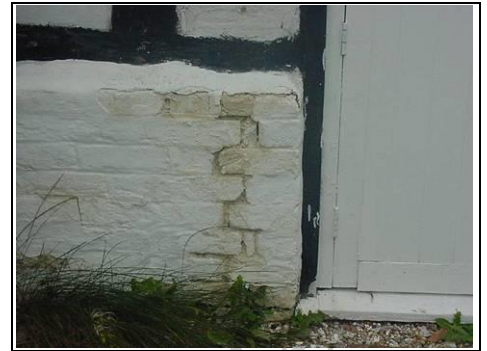
Brick plinth underneath the timber frame

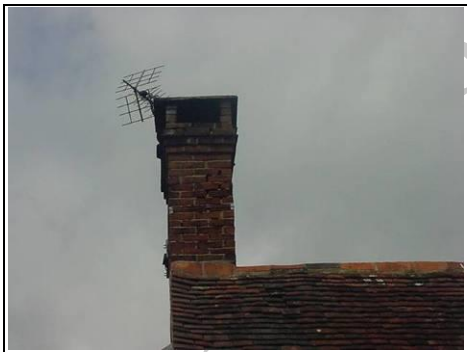
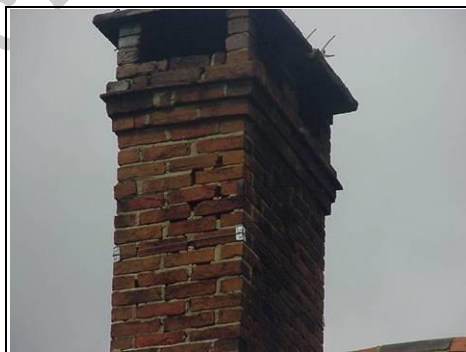
Chimney one

This chimney is brick finished with a tile on edge flashing. It would benefit from repointing and possibly re-building. The original structure is likely to be have been built without a chimney which is why the Listed building details identify the blackened timbers as the smoke would have risen into the roof. It may well therefore act as a separate structure to the main building, depending upon how it was built and how it was tied into the main structure.

**ACTION REQUIRED:** We feel the best way forward is to have a close look at the chimney from the top (using the tower scaffold that we have recommended you buy).

**ANTICIPATED COST:** We would set aside the sum of £750 to £1,500 to carry out repairs/rebuilding work. Please obtain quotations. Ultimately you will need to repoint the chimney in a lime mortar.

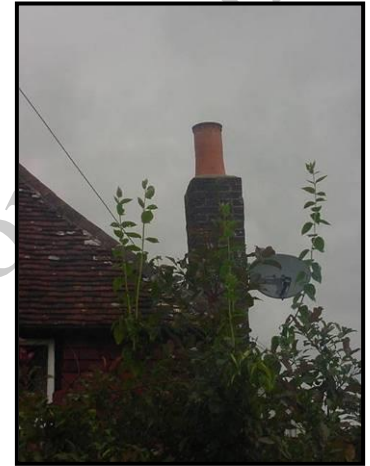
Chimney two

This chimney is brick finished with a lead flashing and one chimney pot. From what we could see from ground level, although our view was limited, it is in average condition for its age, type and style.

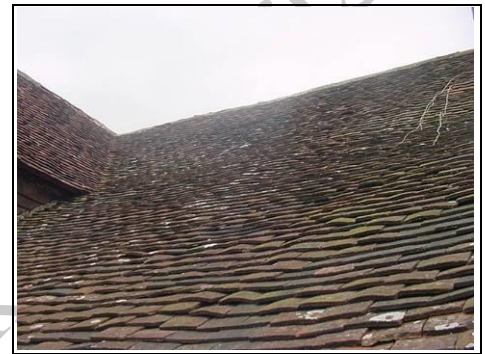
The main roof is pitched and has hand made and machine cut tiles. There is some dampness visible, as we would expect with this age of roof. Often it is created by wind driven rain or more recently we have seen it caused by condensation due to high insulation levels.

Mixture of hand made tiles  
and machine cut tiles

**ACTION REQUIRED:** Please see our comments in the Executive Summary.

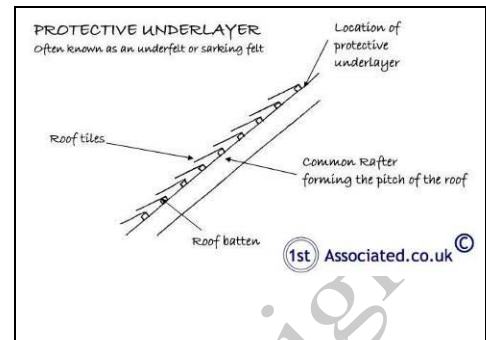
When we inspected the loft space we found there was no underfelt. It is therefore possible that during periods of heavy and prolonged driving rain some water penetration could take place through the roof coverings. At the time of our inspection this was not occurring.

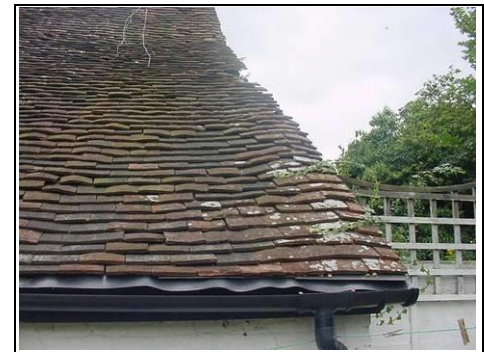
We would add that if you look at the adjacent photo you will see that a protective underlayer, often known as a sarking felt has been added indicating that this roof is likely to have been re-roofed in part since the 1940's/1950's. We much prefer a modern breathable protective underlayer.

Protective underlayer poking out  
from underneath the tiles.

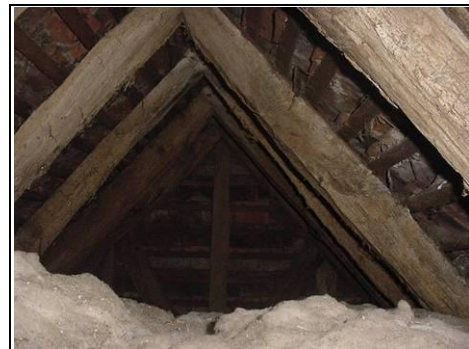
General view of roof

Our examination was limited by the general configuration of the roof, the insulation and a lot of stored items. We generally found that the property has woodworm, whether it is active or redundant we are not absolutely sure. Given what we have seen in the rest of the building we expect some of it to be active, although we did not physically see any in the roof.

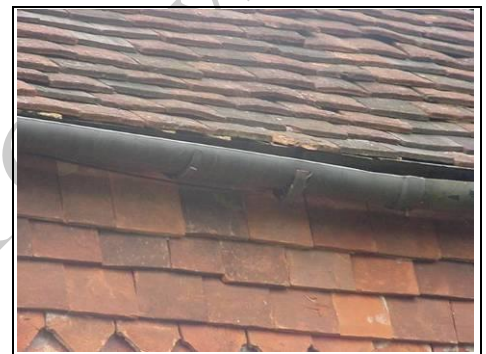
The gutters and downpipes are predominantly plastic, although we believe there is some cast iron remaining. As we showed you the plastic does not have the same strength and integrity as you find with a metal gutter. We suggest these gutters and downpipes are ultimately replaced with metal ones, again subject to the Conservation Officer's approval. However, your first task is to ensure that these gutters are working well and making sure water is being discharged from the property without it being discharged down the property.

Plastic guttering

You need to make this a priority before the winter of 2011, making sure that the gutters and downpipes are working properly and most importantly, discharging away from the building. We are a great fan of water butts as they obviously allow you to use the water on your garden but also they are a good way of ensuring that water gets away from the building. We have even seen a system of several water butts that works very well.

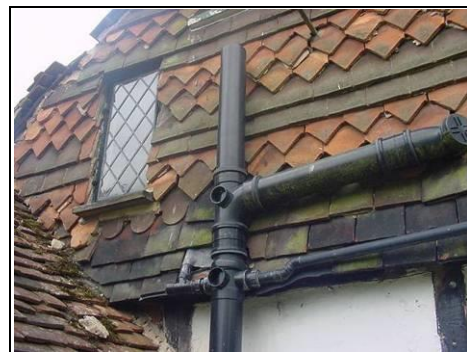
The property has plastic soil and vent pipes. There are some ugly soil and vent pipes to the rear of the property. Interestingly enough the soil and vent pipe is normally meant to discharge approximately one metre above the top of the roof. In this case it does not do, due to its position it would go over a window and this really is poor planning.

Plastic soil and vent pipe to the rear

You may be able to think of an appropriate way of hiding the soil and vent pipes if you so wish, such as boxing around them, again subject to the Conservation Officer's agreement.

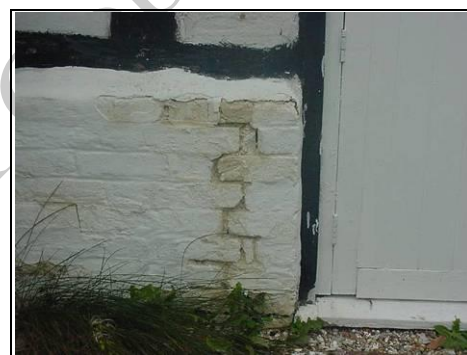
The base of the property has brick walls. These are painted and form a plinth for the timber frame to sit upon. We have seen many various ways of detailing this plinth. The main problem with it is that water sits on it and rolls back to the timber sole plate that is at the base of the timber frame, which sits on this brick plinth. This is what you need to stop from happening. We have seen a very good lead detail, which is no doubt expensive and time consuming to fit.

Close up of base of wall

Initially before the winter of 2011 you need to make sure there is as little water as possible sitting on, or able to sit on, the plinth.

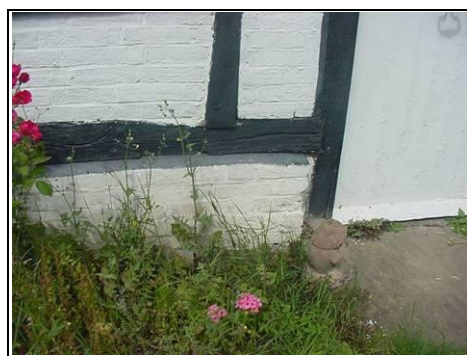
External timber frame with brick  
infill panel

**ACTION REQUIRED:** You need to methodically work around the property repairing any damaged timbers. We suggest that you work elevation by elevation.

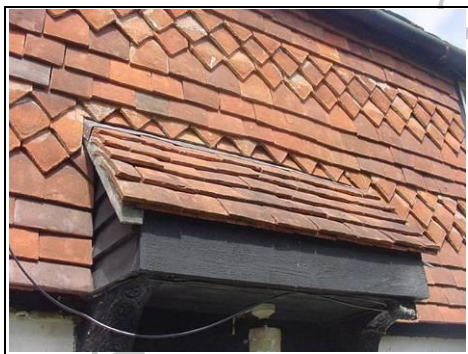
The property has decorative vertical tiling. In some areas this is in good condition, in other areas it needs rebuilding, for example on the left hand gable. Vertical tiles may be fixed directly to a wall or battens, or indeed counter battens. It is necessary to nail all tiles and it is also good practice to use an underfelt and lap the tiles to approximately two inches (30 mm).

We noted vertical tiles coming off to left hand side of building.

Vertical tiling

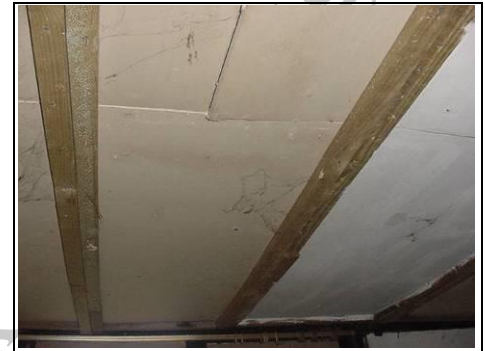
From our visual inspection the ceilings are likely to have originally been lath and plaster. We can see that they have been infilled with many materials including plaster, with some of it finished and some unfinished.

Infill to the ceiling

Whilst we have mentioned you initially need to make the property wind and watertight, ultimately you will need to carry our repairs to the various panels throughout the property. Some of the ceiling panels may also be a reed that is used in older properties.

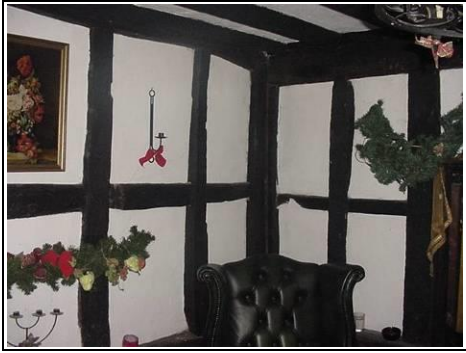
Internal panels

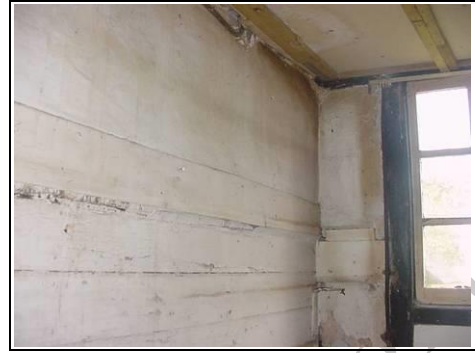
Boarded partitions

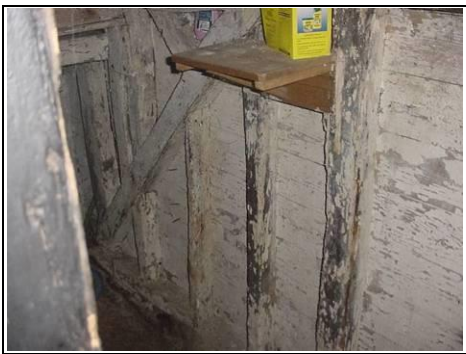
Lime washed timbers – this is how the timbers would have originally been

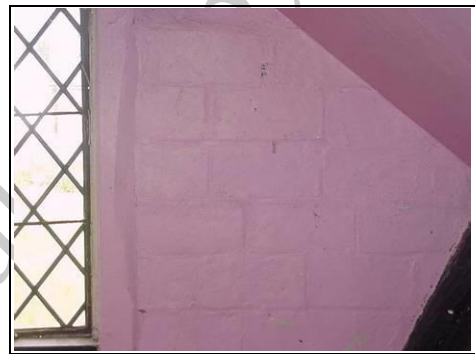
Within the corner of the rear right hand bedroom we can see brick on edge sometimes known as rat trap bond

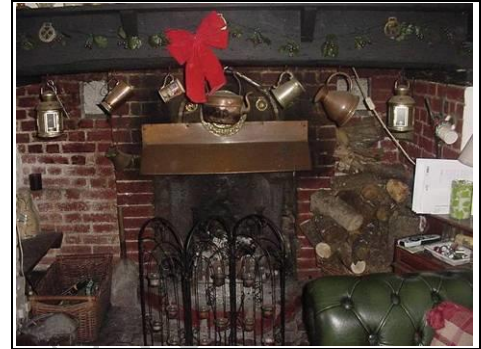
Inglenook fireplace

At the time of the survey no chimneys were in use. Any chimneys that you do not propose to use should be capped and ventilated to prevent dampness.

Finally, it is strongly recommended that flues be cleaned and checked for obstruction prior to use to minimise the risk of hazardous fumes entering the building.

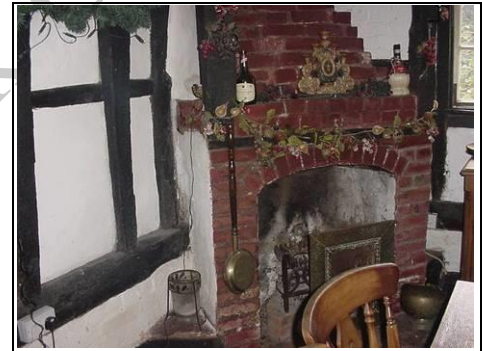
Chimney in dining room

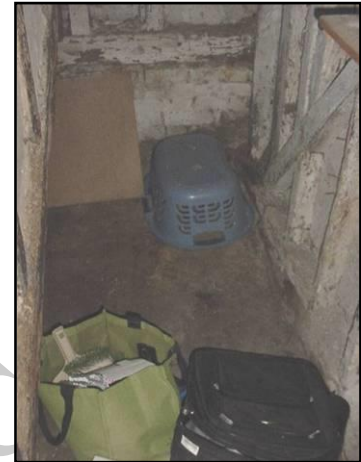
Beaten earth under the stair area

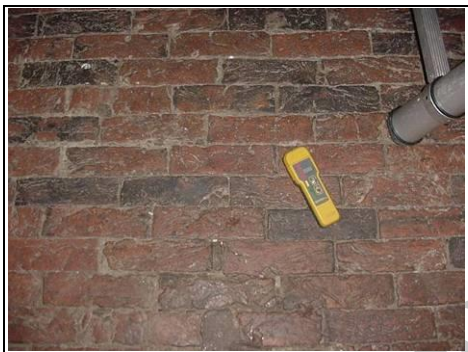
Brick tiles

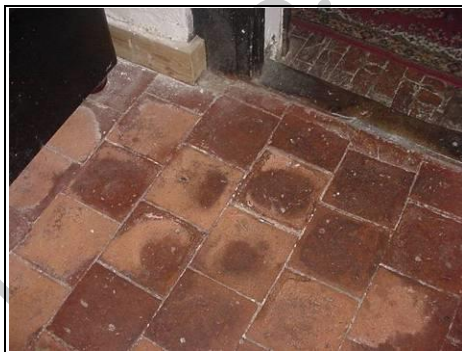
Quarry tiles

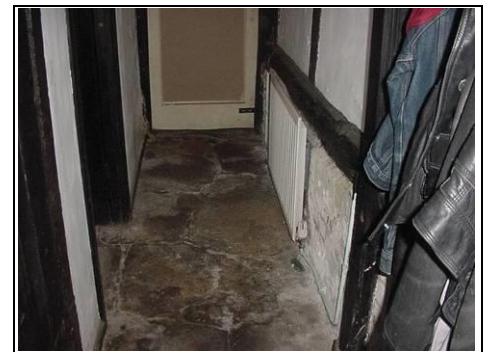
Rustic stone

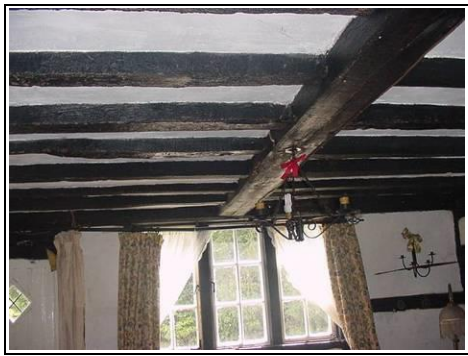
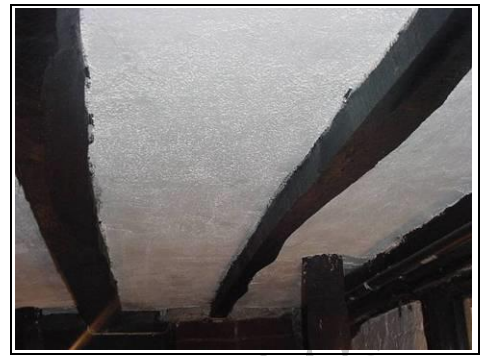
Timbers supporting first floor

The timbers therefore given an element of deflection (springiness) when you walk upon them. This springiness is added to by the woodworm deterioration that we noted within this timber frame. This is another important reason why you need to reduce or get rid of completely the woodworm.

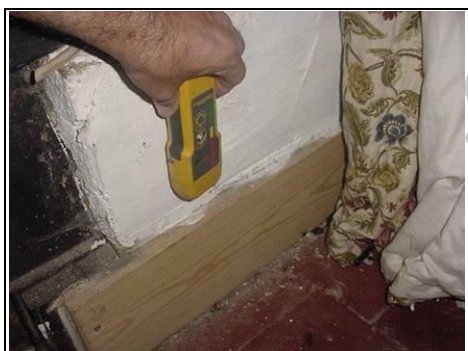
As we would expect in a property of this age it has dampness.

Checking for rising damp

**ACTION REQUIRED:** Please see our comments in the Executive Summary with regard to how we recommend reducing dampness. You will not get rid of the dampness.

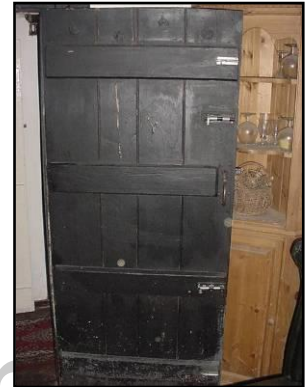
Plank door

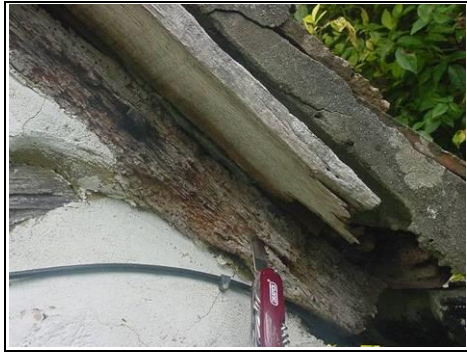
Woodworm was found both old and new, which we believe is active.

Woodworm

**ACTION REQUIRED:** Please see our comments in the Executive Summary.

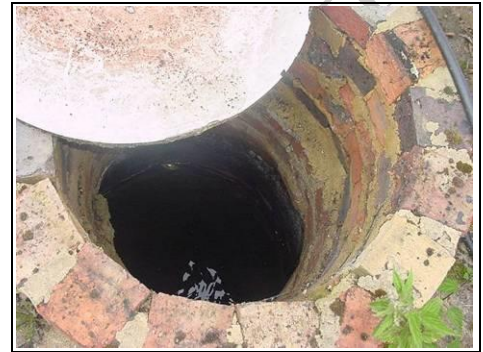
As with any good old property there is a well close to the rear of the property. We have in the past had experience of these causing structural problems with the property but the majority of cases that we see the well and the house live happily next to each other.

Well to the rear of the property

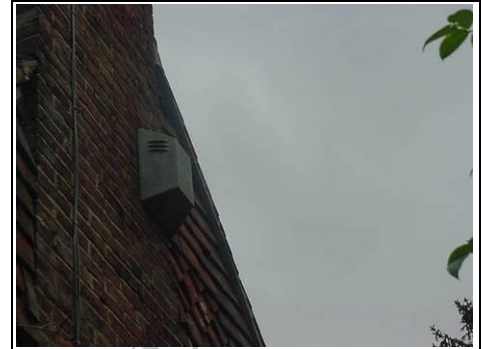
We did note a security alarm box on the outside. We are not certain whether this still works. A good alarm system should not only help reduce break-ins but also your insurance. We are not experts in this field and therefore cannot comment further. Further information should be obtained from the vendor and the installer at a later date.

Alarm box

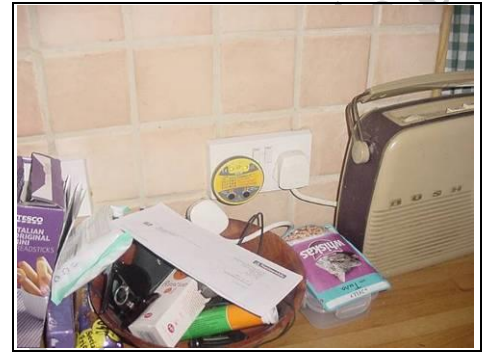
We carried out an earth test in the kitchen area to the socket point that is normally used for the kettle, this proved satisfactory.

Earth test

**ACTION REQUIRED:** As the property is changing occupancy an IEE report should be carried out by a NICEIC registered and approved electrical contractor.

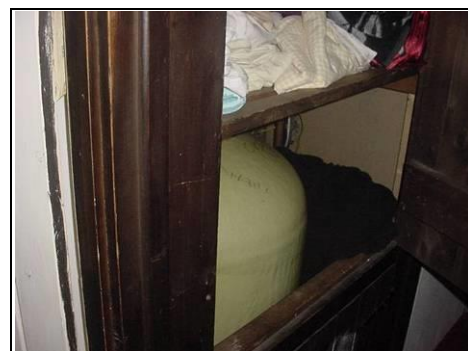
Hot water cylinder which is factory lagged

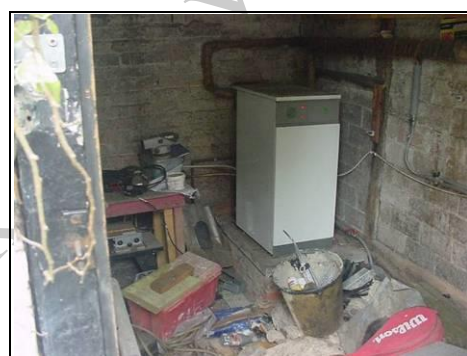
Our limited inspection of the hot water and central heating system revealed no evidence to suggest any serious defects but we would nevertheless recommend that the system be tested and overhauled before exchange of contracts and that a regular maintenance contract be placed with an approved heating engineer.

Boiler

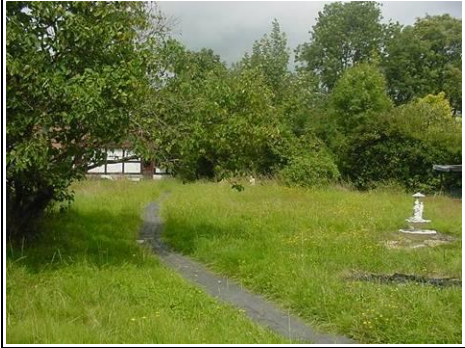
The rear garden again is laid mainly to lawn which was overgrown. There are bushes surrounding the property.

Rear garden

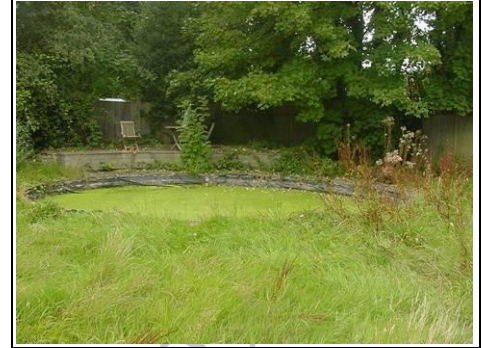
Pond at end of garden
