RESIDENTIAL BUILDING SURVEY

XXXXXXXXXXXXXXXXXX,
XXXXXXX, Coventry,
West Midlands,
CV7 xxx

**Two bedroom
Semi-detached
Listed property**

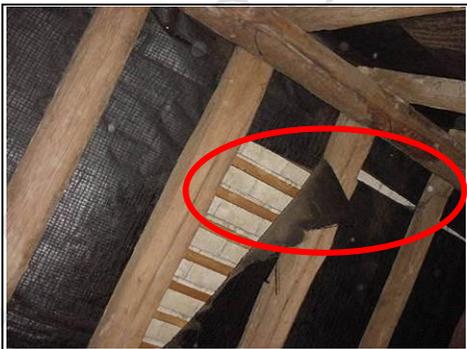
From within the roof we can see to the left hand side of the roof construction that there has been some tearing to the hessian based protective underlayer (sometimes known as sarking felt or under felt). This we assume was fitted in the 1970's refurbishment.

Hessian protective underlayer

ACTION REQUIRED: Seal the roof by repairing the protective underlayer/sarking felt.

ANTICIPATED COST: In the region of £500 - £1000 (five hundred to one thousand pounds) to carry out an internal repair which although is not ideal would improve matters. At the same time we would recommend ventilation tiles are added to reduce dampness and woodworm in the roof; please obtain quotations.

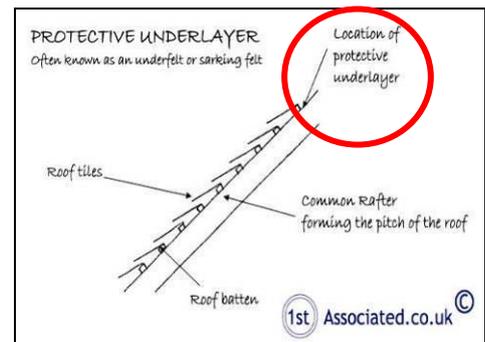
Protective underlayer

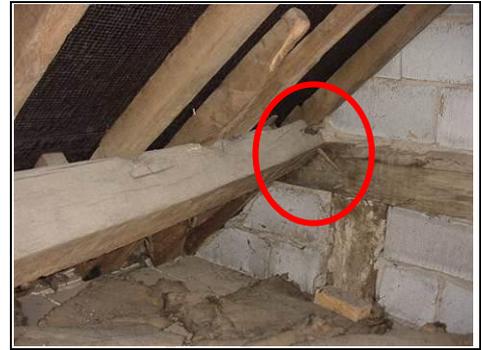
Front purlin

From what we can see the front purlin is no longer tied in fully on the front left hand side of the roof, however, this looks to be an historic problem as the purlin has been doubled up (these are substantial purlins, at least double or triple of what we would typically expect in a newer property).

Over the years there has been some movement to the left hand purlin

ACTION REQUIRED: As a belt and braces measure we would look at putting some form of tie or prop to the purlin taking support from the central wall.

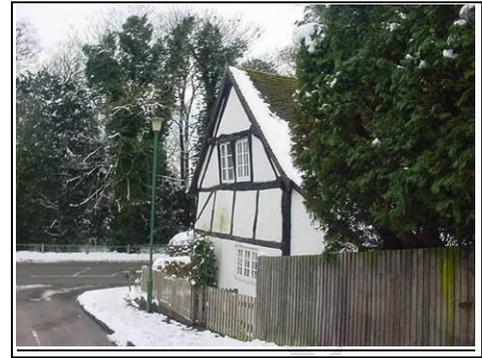
2.2 Gable end

The gable end is out of true (vertically) by many centimetres. In our experience this is not a problem unless movement is progressive as many older properties have moved and settled over the years and it will have been out of true for decades if not hundreds of years.

Gable wall is not straight

ACTION REQUIRED: We would suggest again as a belt and braces measure that a cross braced timber (sometimes known as wind brace timber) is added within the right hand roof space. The support must allow for movement within the structure as there is seasonal movement within this property.

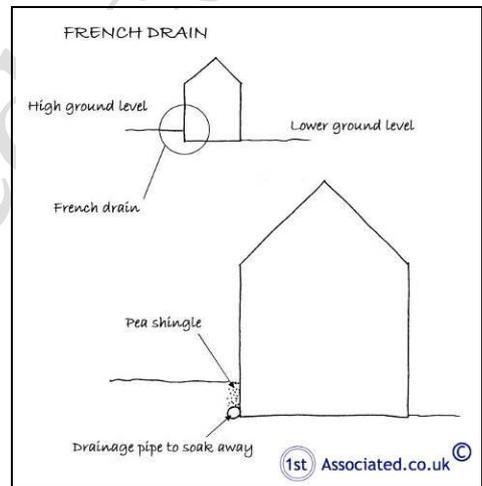
French Drain

ACTION REQUIRED: Add weep holes to retaining walls and add French drain around the property.

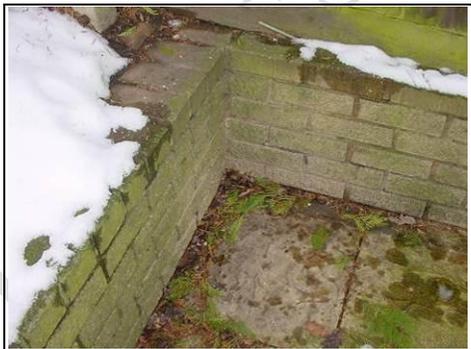
Small retaining walls need weep holes

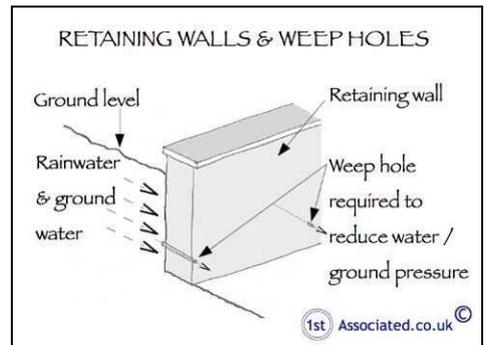
Retaining walls

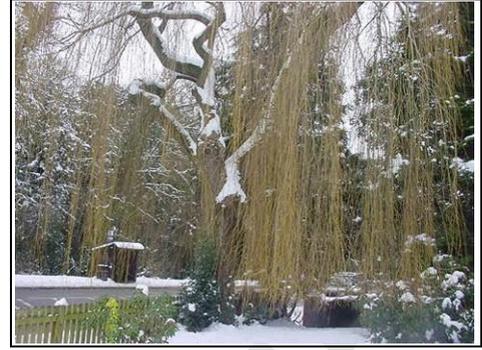
Willow trees are renowned for having a large root system that can affect properties. Although the Willow tree is some distance away the roots will be underneath your property and as such can affect it. The tree does need to be kept well maintained. The neighbour advised that they did maintain it from time to time.

Nearby willow tree

ACTION REQUIRED: We would have a cup of tea meeting and a chat with the next door neighbours both about the drains and the tree. From speaking to them they have been in the property for a long time so we are sure they will have thoughts about both. They advised us that the Willow tree is relatively new being planted in the 1940's.

ANTICIPATED COST: As mentioned above your neighbours have had their drains fibre glassed to prevent tree root problems. This may be necessary within your drains. You would need to have the drains flushed clean and then the closed circuit TV camera report carried out; please obtain quotations.

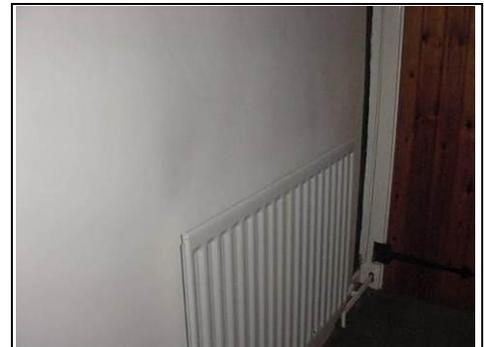
You have the benefit of a relatively new wall mounted energy efficient boiler which is then feeding some internal single panel radiators which are not ideal for air circulation.

Single panel radiator.

ACTION REQUIRED: We would live in the property to see if it is warm enough if not upgrade the single panel radiators to double panel convection radiators as this would heat the property quicker and more effectively.

ANTICIPATED COST: A few hundred pounds per radiator; please obtain quotations.

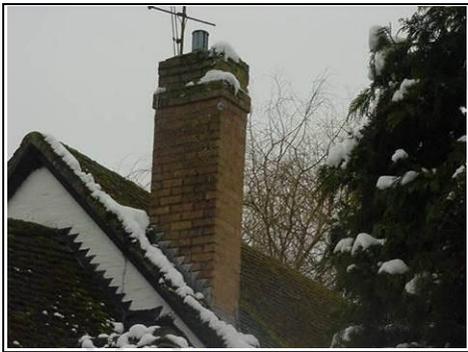
Chimney One - rear

This chimney is brick finished with a lead flashing and one flue. From what we could see from ground level it looked in average condition considering its age, type and style although we can see a lot of moss and growth around it indicating dampness is sitting behind it.

Chimney

ACTION REQUIRED: Clear the moss and vegetation around the chimney and also check the flashings.

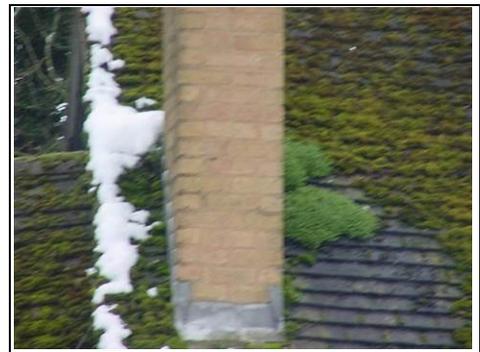
Lead flashing

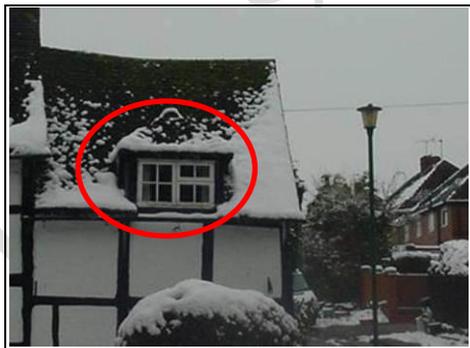
There are two dormer windows, one to the front and one to the rear right hand side of the property. The dormer window roofs are tiled and the cheeks of the dormers appear to be lead (this was slightly difficult to tell as they were snow covered at the time). Generally we could comment for their age, type and style that they are in average condition.

Dormer window- front

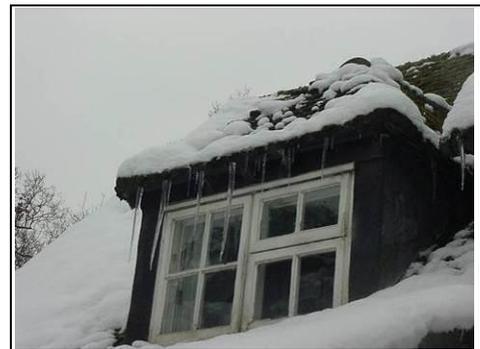
Dormer window - rear

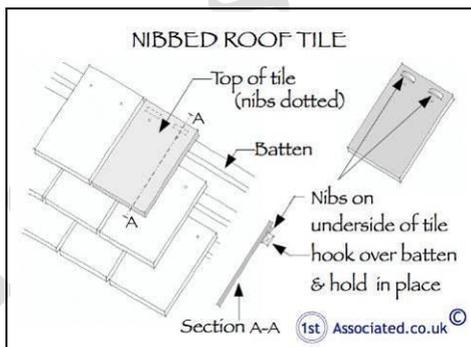
The roof is pitched and clad with a small nibbed machine made tile. This is possibly concrete as it has a large moss covering which is common for this type of roof. This is likely to have been replaced in the 1970's and from ground level, this looks in average condition considering the roofs age type and style.

Nibbed tiles

ACTION REQUIRED: We would recommend clearing the moss. Please see our comments with regards to the sarking felt in the Executive Summary.

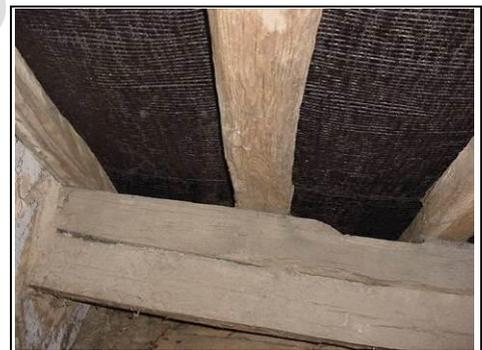
When we inspected the loft space we found a Hessian base Bitumen membrane. This type of membrane has been used since the 1960s. No doubt this has been replaced in the 1970's when the new roof was put on.

This photo shows the common rafters in the left hand side (the ones that form the pitch of the roof) and the dark area between is the underlayer

There are some splits and gaps in the underlay that need repairing.

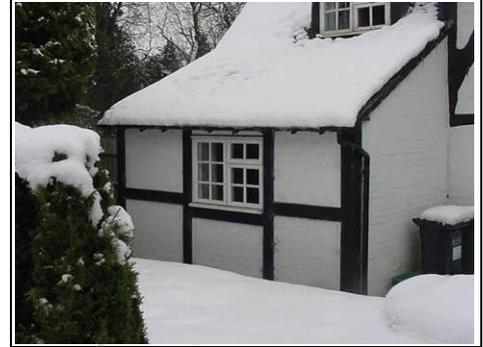
The roof was completely covered in snow at the time of the survey. There were no obvious visual signs internally of dampness getting in on the day of the survey.

Low level rear roof

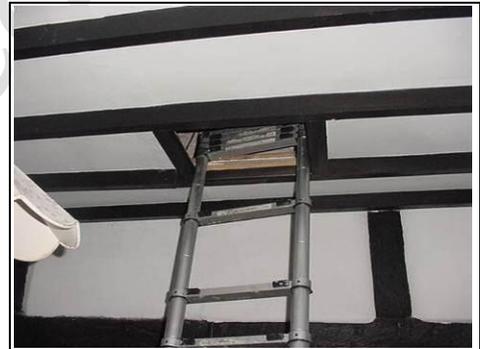
Loft hatch for right hand roof
Not the easiest of hatches to use.

The right hand side is accessed via the loft hatch located in the bedroom. The left hand side is accessed via the loft hatch located on the landing. There are no loft ladders, electric lights or secured floorboards. We recommend that these be added, as it will make the loft space safer and easier to use.

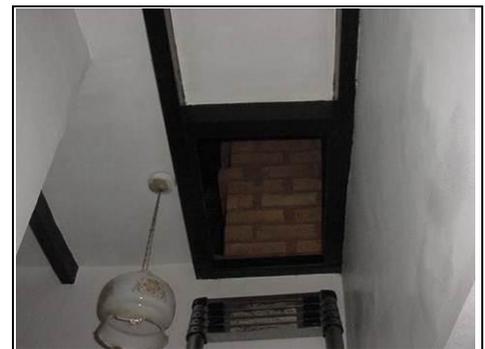
Loft hatch to the left hand side of
the roof on the landing

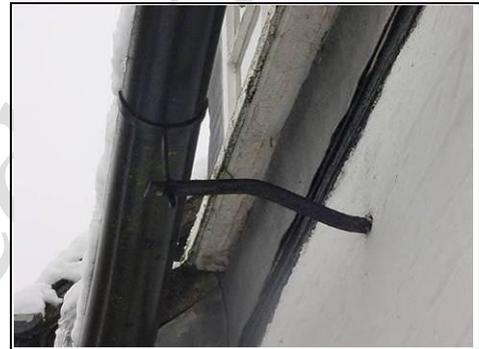
The guttering to the rear looks to be out of alignment but we really could not tell if there were any problems due to the snow. We noted that the gutters were full.

Metal bracket for gutter

ACTION REQUIRED: Realign the gutters. We would recommend you stand outside the property next time it rains heavily and see how well the drains cope with the rainwater particularly looking at the guttering and the joints.

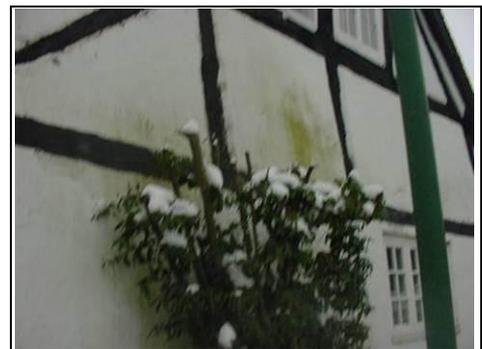
The brick and render infill panels are in need of re-decoration. Please see our comments within the Executive Summary regarding External Decoration.

Panels with moss - right hand side

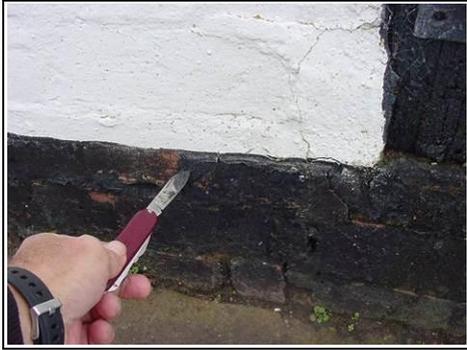
To the base of the walls we noticed there is a bedrock stone visible in some areas and brickwork in others. This plinth is built to help protect the timber sole plate that is at floor level. As you are on a sloping site there may have been deterioration as water passes from the top of the sloping site to the bottom. We would recommend that during the summer months investigations are carried out to the sole plate to check its condition.

Brickwork to the base of the property

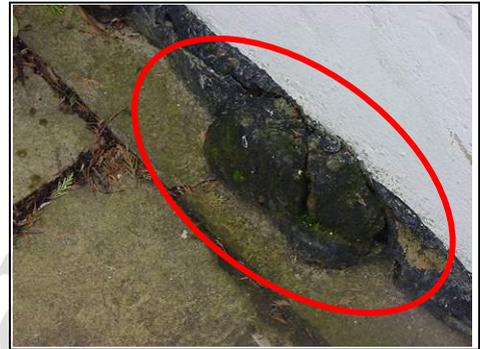
Bedrock visible to the base of the property

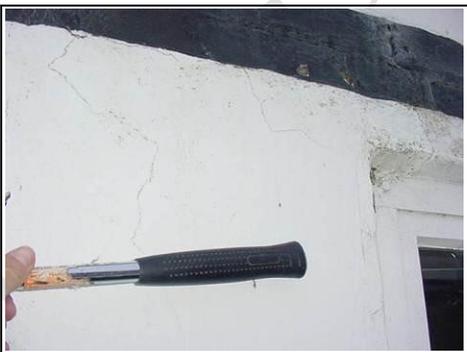
We always take a second look at the render as it may be hiding wattle and daub. We have carried out a tap test (literally hitting the render with the back of a hammer). We found some hollow areas where the cracking is visible.

Hammer test

ACTION REQUIRED: During the warmer months sections will need to be removed to check what is underneath and repair as appropriate. We would always recommend lime every time.

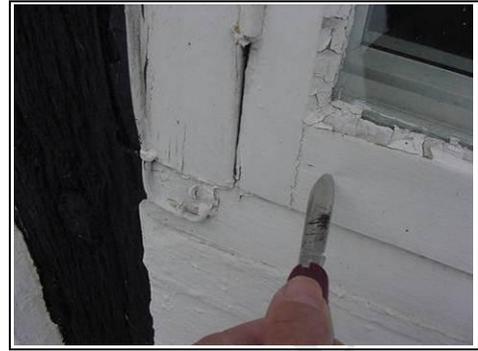
We have tested the windows by pushing a knife into a random selection. We generally tend to do the lower windows as access is easier. As stated above the windows were solid in these areas. However there is moss on the rear windows. Also the windows to the gable end, for example, do not fit and we were unable to open them as they appeared to be painted shut.

Knife test to window

ACTION REQUIRED: You may want to get the windows eased and adjusted

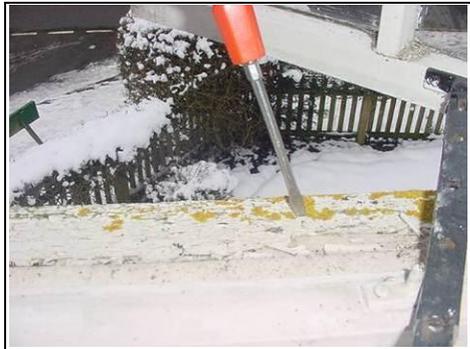
Moss on window sill

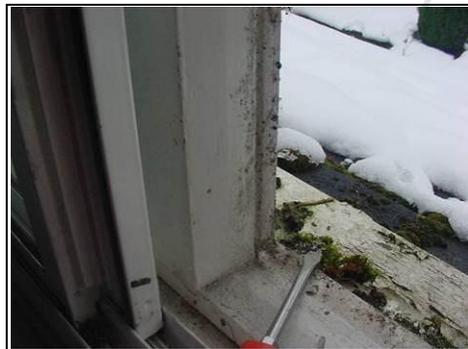
First floor window with moss growing on it

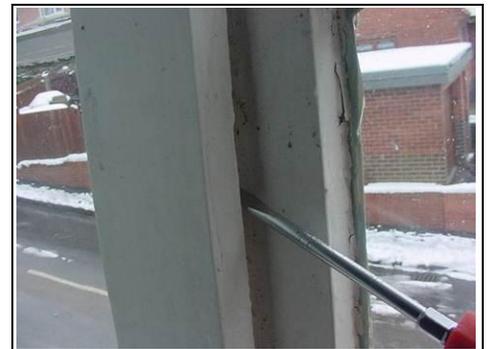
Window does not close properly

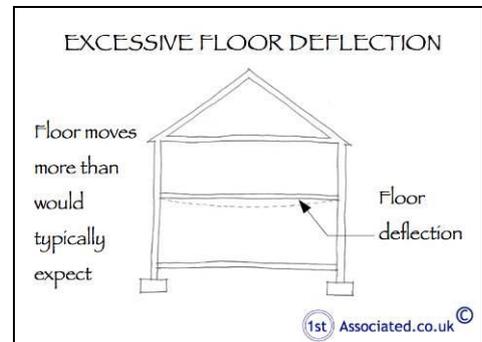
There is an above average level of deflection to the right hand bedroom. It is not unusual for this age and era of property but you do need to be aware of it.

Deflection to the first floor

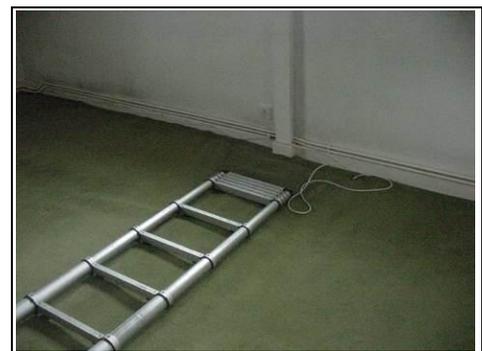
In the right hand bedroom there was more deflection than we would normally expect. We feel can feel within the floor a central spine beam which is where we have placed the ladder in this photo. As with older properties the floors are uneven and you may need to pack underneath the furniture. This is caused by general settlement and movement within the property over the year which is nothing unusual.

Ridge in right hand bedroom
Ladder indicates the position of the ridge

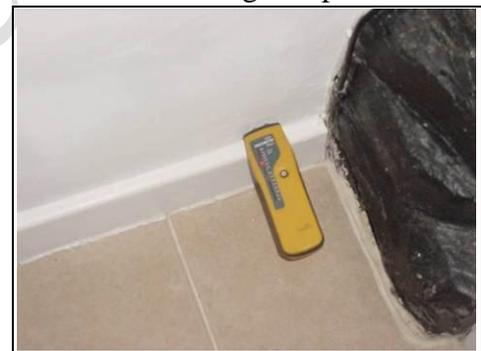
A visual inspection and tests with a moisture meter have been taken to the perimeter walls. In this particular case we have found minor dampness particularly to the central wall. We do feel that some of this can be attributed to the building being empty and unoccupied and the lack of air circulation but we do believe there is some dampness to the central wall.

Testing for rising damp

ACTION REQUIRED: Please see the Executive Summary

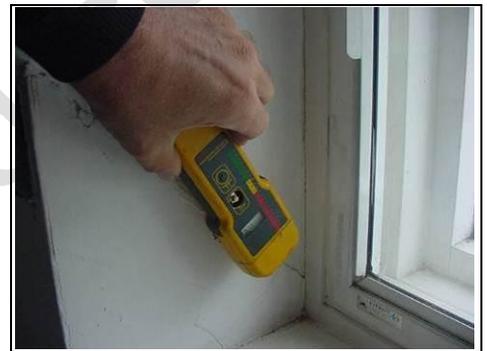
We have found minor dampness; again we would attribute it to being empty. We would say it is in line with what we typically see for this age, type and style of property.

Testing for lateral dampness on the window reveals

ACTION REQUIRED: Please see our comments in the Executive Summary.

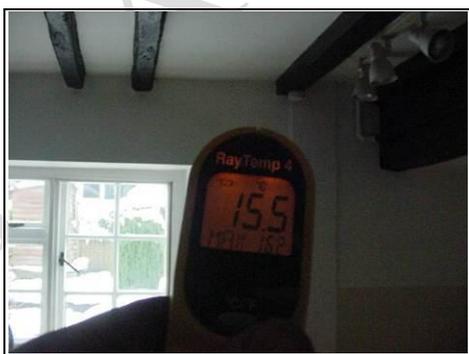
We tested the temperature readings internally. There was less than a degree difference between the high and low temperature at present. Nevertheless we feel when occupied the property may suffer from condensation. Please see the next section.

High level of 15.5

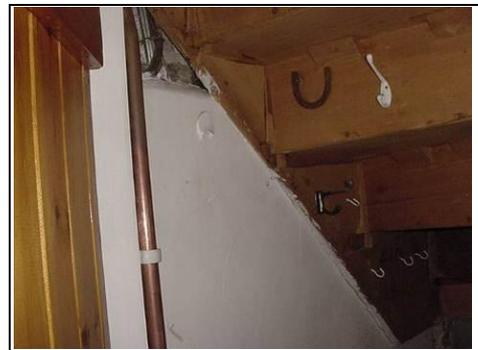
We noted that the underside of the staircase was exposed. It is more normal today to have a half hour fire barrier to stop fire spreading from the ground floor to the first floor in a worst case scenario. You may wish to take a view on whether you add this.

Staircase is not lined

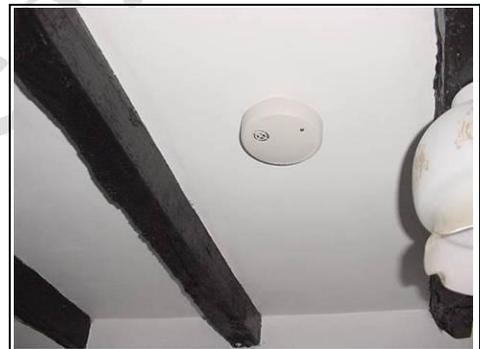
Smoke alarm

Some smoke detectors were noted. The current Building Regulations require that they be wired into the main power supply. Obviously in a property of this age this is difficult, as it would mean having surface mounted wires or cutting wiring into the plaster.

ACTION REQUIRED: We would always recommend a hard wired fire alarm system and are also aware that some now work from a wireless signal which may be worth investigating. Whilst fire is relatively rare it is in a worst case scenario obviously devastating.

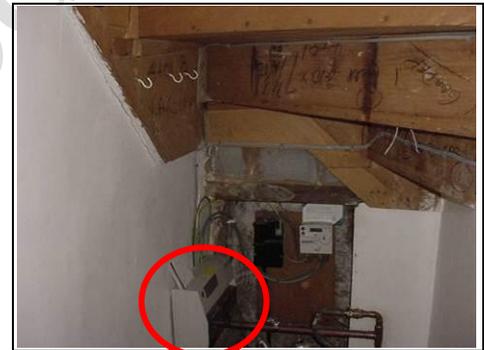
Fuse Board

The electric fuses and consumer units were located in the cupboard under the stairs. The fuse board looked relatively new. In an older property a defective fuse board can be particularly dangerous.

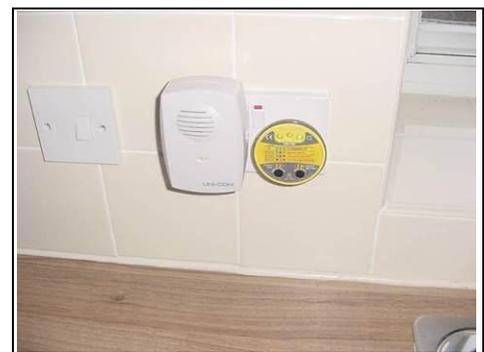
Earth Test

We carried out an earth test in the kitchen area to the socket point that is normally used for the kettle, this proved satisfactory.

ACTION REQUIRED: The Institute of Electrical Engineers (IEE) recommend that when a property is changing occupancy a test and report is carried out by an NICEIC registered and approved electrical contractor or equivalent. We are advised that there is an IEE certificate which can be viewed.

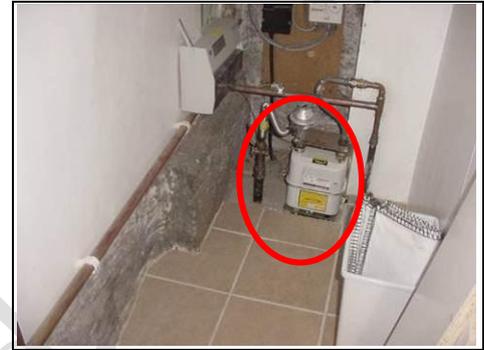
All gas appliances, pipework and flues should be the subject of an annual service by a competent engineer, i.e., a member of Gas Safe; works to gas appliances etc., by unqualified personnel is illegal. Unless evidence can be provided to confirm that there has been annual servicing we would recommend that you commission such a service prior to use to ensure safe and efficient operation.

ACTION REQUIRED: As a matter of course it is recommended that the entire gas installation is inspected and made good, as necessary, by a Gas Safe registered contractor. Thereafter the installation should be serviced annually.

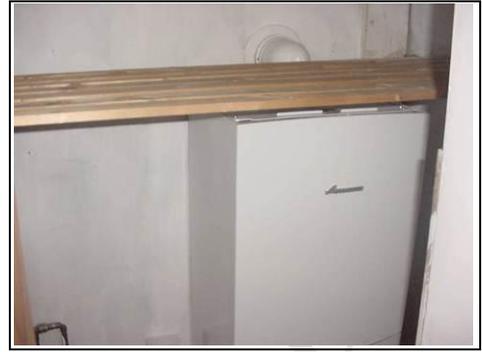
The wall mounted boiler was located in the airing cupboard/boiler room. It is manufactured by Worcester and we are advised is about four years old.

Our limited inspection of the hot water and central heating system revealed no evidence to suggest any serious defects but we would nevertheless recommend that the system be tested and overhauled before exchange of contracts and that a regular maintenance contract be placed with an approved heating engineer.

Worcester boiler

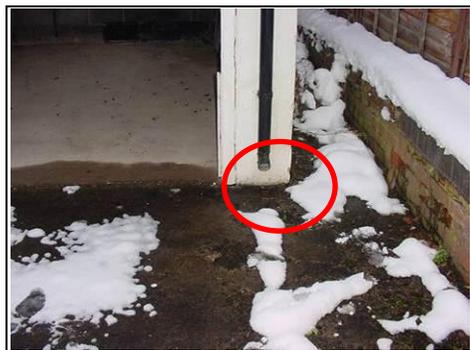
Gutters discharging onto the ground

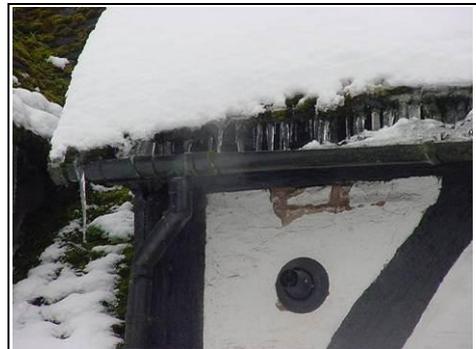
Unfortunately in this instance our inspection has been limited by the snow. We have not been able to open up the ground floor or the first floor. Also we were not able to access the roof space as we were not sure if it would take human weight.

Heavy snow
