RESIDENTIAL BUILDING SURVEY

Shooters Hill, London,
SE18 xxxx

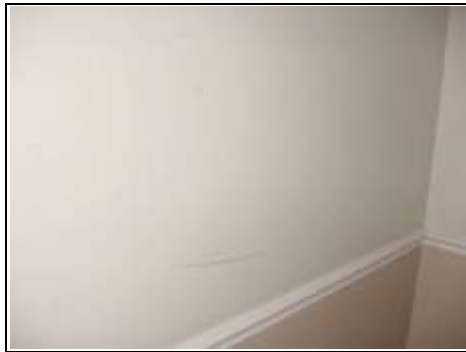
Communal stairwell
These would benefit from
re-decoration

We noted that the communal areas would benefit from a re-decoration. Whilst this does not affect you much, as you do not have to walk up the stairs etc., it does give an indication of the quality of the management company.

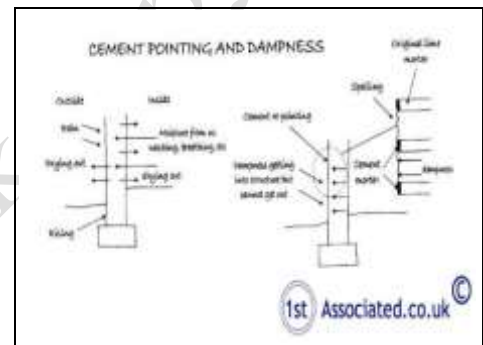
Unfortunately the cement re-pointing, whilst well meaning, is not appropriate for this type of construction. A cement mortar has been used rather than a lime based mortar. We recommend you use lime mortar in any future repairs regardless of what the builders say! Using lime mortar will limit further damage to the brickwork, which is almost impossible to repair successfully. However, we would add that many, if not most, of the properties that are re-pointed are re-pointed wrongly; it is only in recent years that we have discovered the problems that can occur from it.

Cement- re-pointing and dampness

ACTION REQUIRED: The using of cement mortar would seem to be due to a lack of knowledge and next time the building is re-pointed it should be carried out in a lime mortar. This will not be that long as this is a very thin/poor re-pointing and is starting to come away.

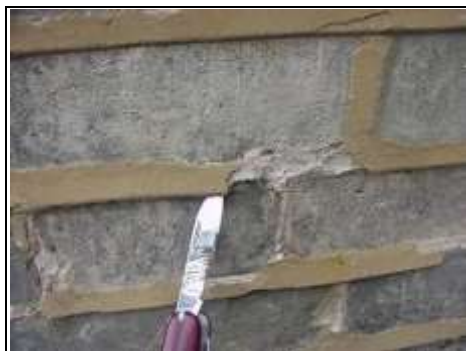
Poor re-pointing.
Just a skim coat we are amazed it has stayed on.

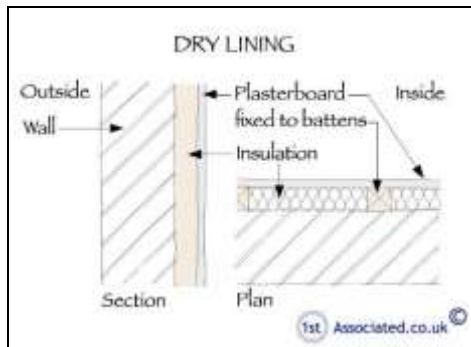
We often find that alterations and conversions such as this one often suffer from the over-use of stud work partitions. This means that you do get some noise transfer between the properties. As mentioned we did speak to one person on the ground floor and we also spoke to a neighbour on the top floor who advised that in their particular location noise transfer was minimal.

Dry lining

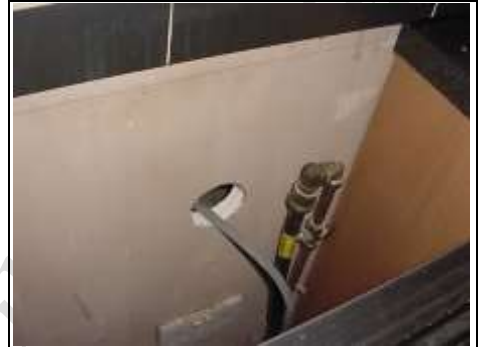
False wall / dry lining in the kitchen

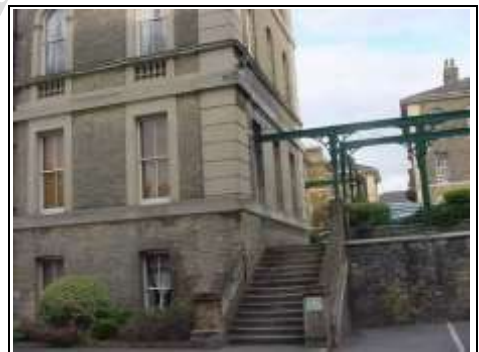
It was noted when we carried out the survey that other occupiers literally walk right past your window to the side of the property and to the rear. The entrance to the block of properties is at the rear. You need to revisit the property and make sure you are happy with this.

This is the main staircase used by a number of people. This passes by the side of your lounge

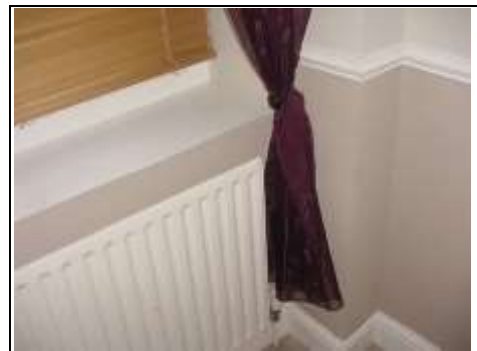
The large rooms are heated by single panel radiators which we feel may be undersized especially for rapid heating of the rooms with their large single glazed windows.

Single panel radiator

ACTION REQUIRED: We would change these to double panel convection radiators.

ANTICIPATED COST: In our experience this is a few hundred pounds per radiator if you are having a few done at once. It can be more expensive to just have a single radiator replaced. However you do need to live in the property for some time before making a decision on this; please obtain quotations.

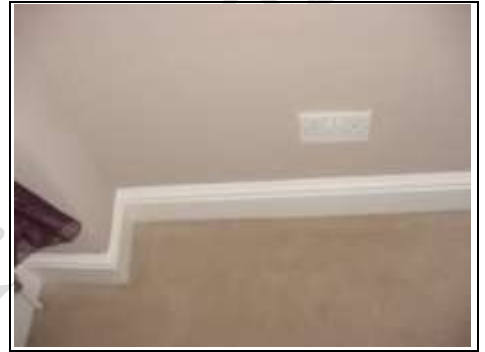
The number of electric sockets in the property is minimal.

Electric socket point

ACTION REQUIRED: You may wish to increase the number of electric sockets before you re-decorate.

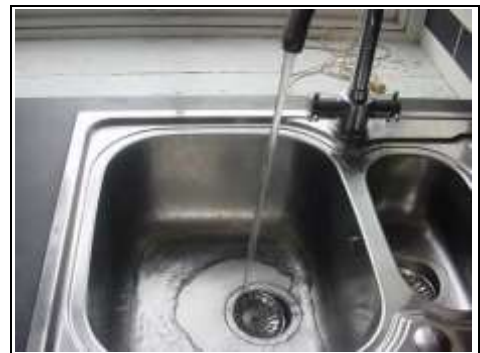
We ran the tap for 15 minutes and found that water leaked onto the floor. This may be due to the disconnection of a washing machine or similar or it may be a leak. Please see our comments in the earlier part of the report.

There was no build up or back up but the only true way to find out the condition of the drains is to have a closed circuit TV camera

Taps run for 15 minutes to check for blockages

ACTION REQUIRED: Your Legal Advisor to check and confirm if there are any drainage repairs due and if there is a closed circuit TV camera report of the drains.

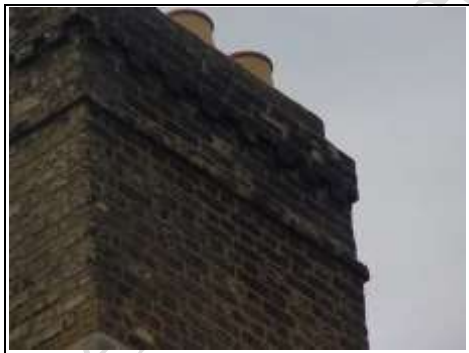
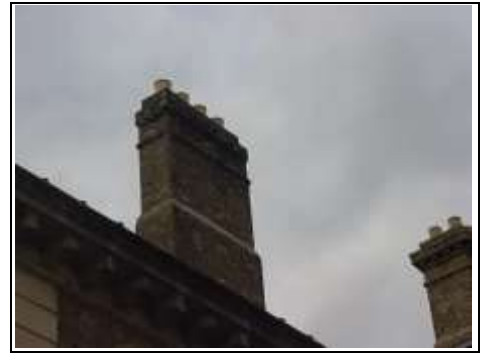
Chimney One – rear right

This is the chimney that should in theory lead into your property but we cannot see it so we assume it has been removed. The chimney is brick built with four or more chimney pots. We cannot see the flashing properly. From what we could see from ground level it looks to have weathered over the years

Close up of rear chimney

Chimney one - rear

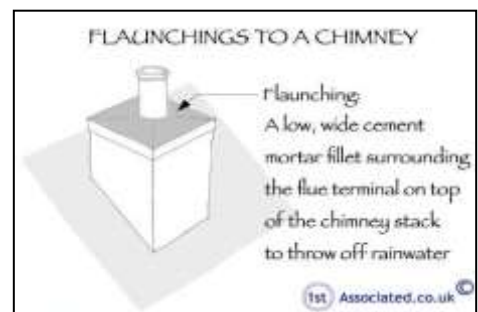
Flaunching

Unfortunately we were unable to see the flaunching, we therefore cannot comment upon them.

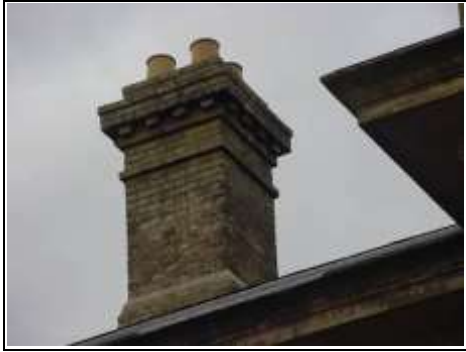
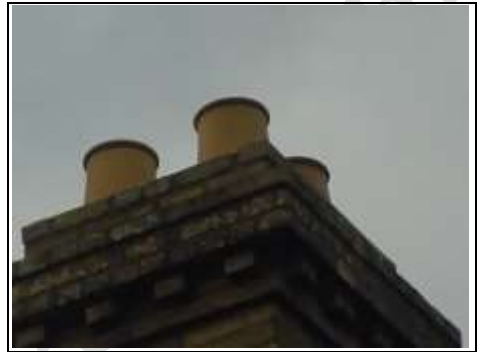
Chimney Two – Rear left

This chimney is also brick built and has four or more chimney pots and again we cannot see the flashing. From what we could see from ground level it looked in average condition considering its age, type and style.

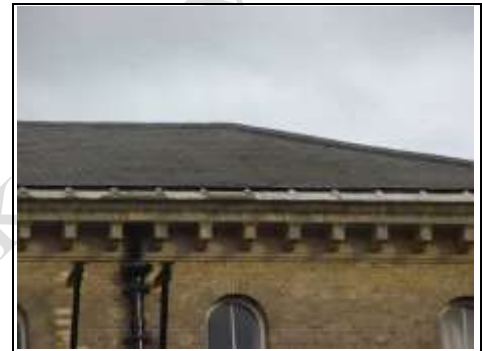
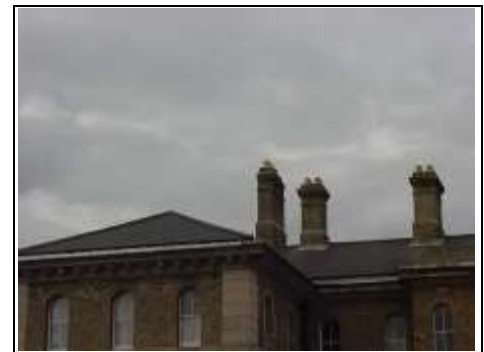
Roof

The main roof is pitched and clad with a quarried slate tile and, from ground level, this looks in average condition considering the roofs age type and style. We assume it was re-roofed in the mid 1990's when the property was refurbished. Unfortunately we have not been able to access the roof.

ACTION REQUIRED: Both you and your Management Company should carry out periodic inspections of the roof with the Management Company carrying out any maintenance that would usually be re-charged to you.

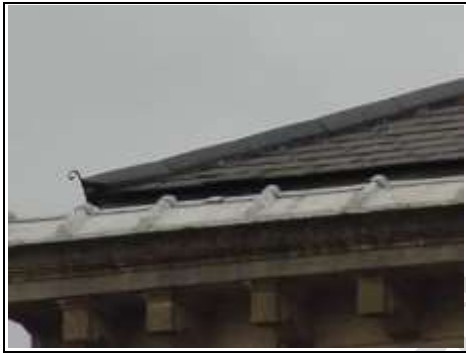
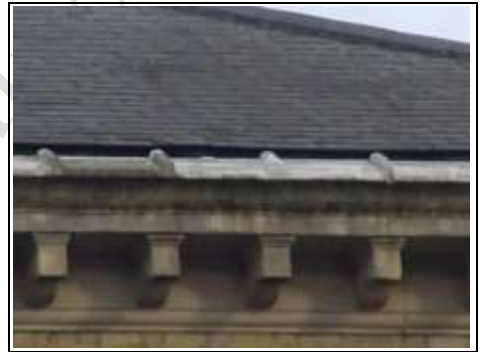
Box gutter

The box gutters are probably lead lined but we cannot be certain as we have not seen them clearly.

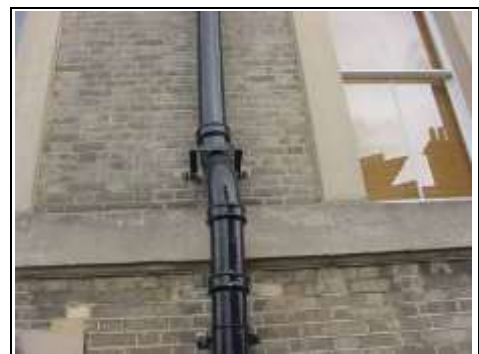
The rainwater is transferred down the downpipes which may be cast iron/ plastic and or painted asbestos. We have made comments on this within the Executive Summary.

Possibly asbestos

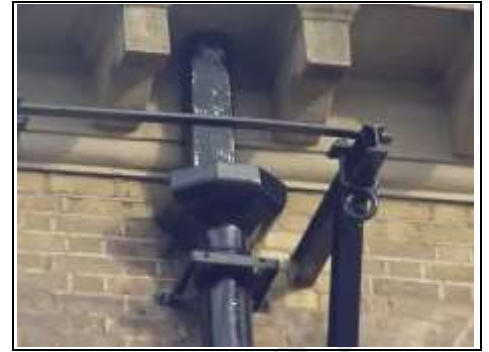
Hopper head

This appears, from its size, to be metal.

We could not see any leaks but it is not unusual to have some minor leaks but most people would be happy to live with this in this age of property.

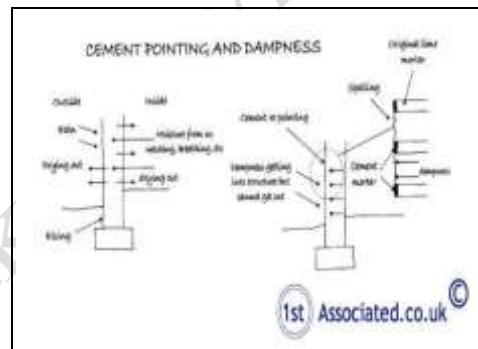
The re-pointing is poor; please see our comments within the Executive Summary as we expect it to come away quite quickly. The colour of it also indicates it is cement rather than a lime mortar. We would personally have recommended that re-pointing was carried out. The clearing out of the joints, which would allow the mortar to bed properly, would have been advisable.

Cement pointing and dampness

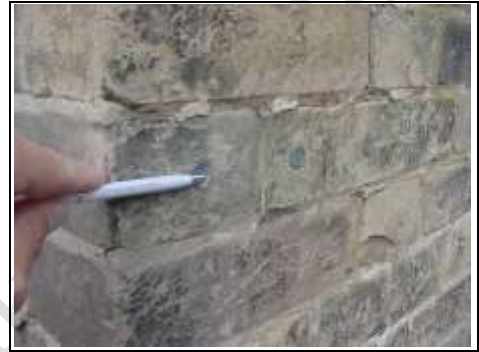
All modern properties should incorporate a damp proof course (DPC) and good building practice dictates that a differential of 150mm (6 inches) should be maintained between the damp proof course and ground levels. In this case, we can see a DPC in places. This building would not originally have had a damp proof course given it was built in 1865 but we can see it has had a damp proof course inserted after. Again this is something we would never recommend on an old Listed building such as this. It really is about allowing the brick work to breathe. Please see the sketch in the brickwork.

ACTION REQUIRED: Please see our comments within the Executive Summary.

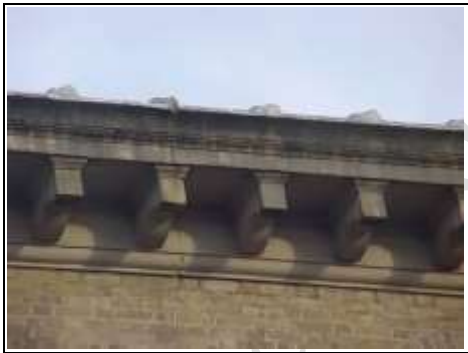
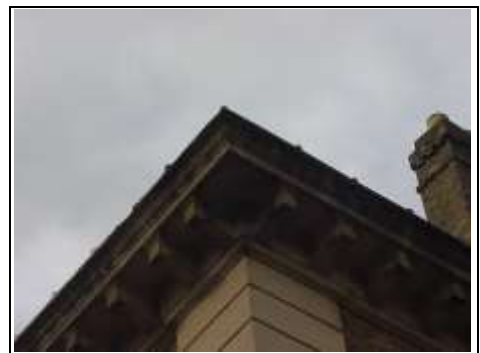
Fascias, soffits and pediments

The fascias, soffits and pediments look to be stone from ground level. We have not had a close up inspection of them.

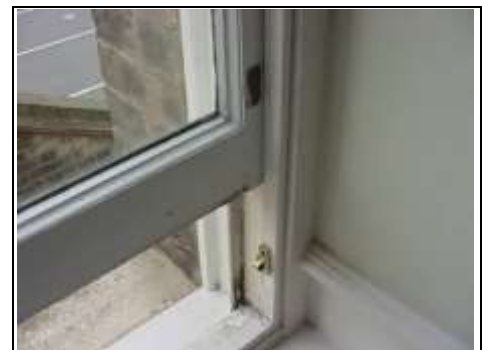
The property has single glazed timber sliding sash windows. We would specifically comment that we opened some of the windows and they opened without problems.

We opened the sash windows

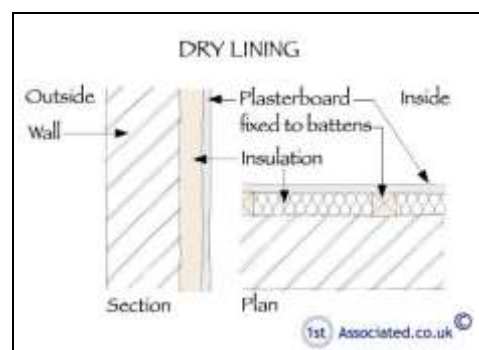
Dry lining

Again we believe dry lining may have been used. This may have been to meet building regulation requirements.

This comment has been based on the visual look of the wall which is relatively “smooth” and normally means a modern finish.

ACTION REQUIRED: Please see our comments within the Executive Summary with regard to the cracking and dry lining.

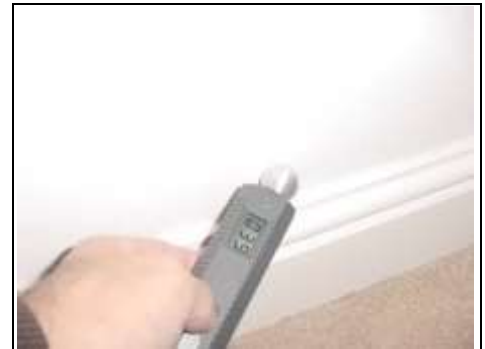
A random visual inspection and tests with a moisture meter have been taken to the perimeter walls. In this particular case we have found slightly higher readings than usual but this is acceptable for an unoccupied property at this time of year.

Testing for rising damp

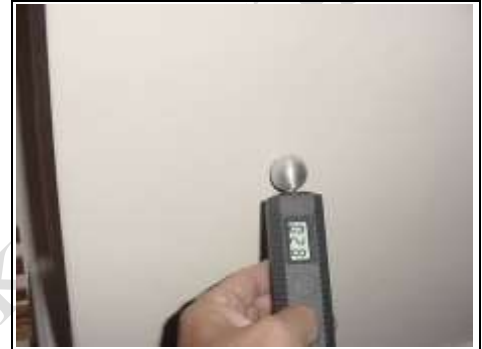
We used a damp meter on the external walls. We have not found dampness. We found it to be in line with what we would expect for this age, type and style of property.

Testing for lateral dampness

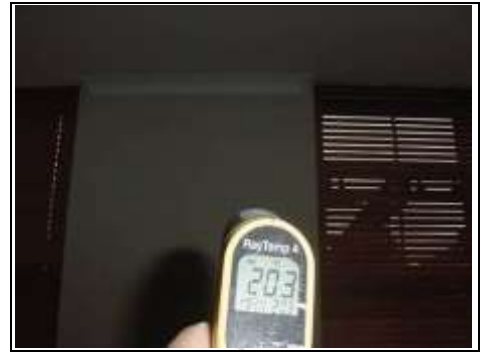
At the time of the inspection there were obvious signs of condensation including the mould in the bathroom and there also looks to be condensation on the window sills throughout the property.

Checking for condensation

ACTION REQUIRED: We would recommend humidity controlled extract fans be added to kitchens and bathrooms. You will need to agree this with your landlord/ the local authority conservation officer as we think an extract fan in the kitchen may be seen from the outside.

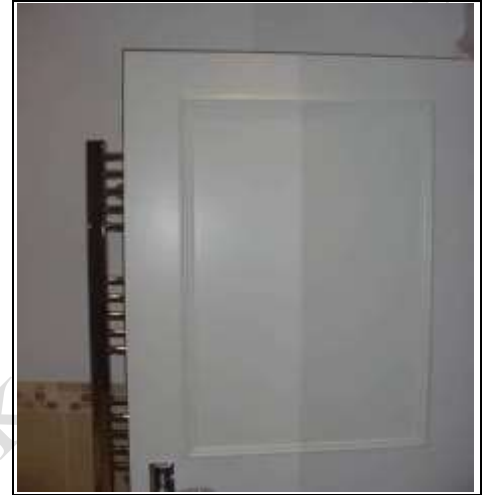
Door

The doors are painted panel doors and are in average condition.

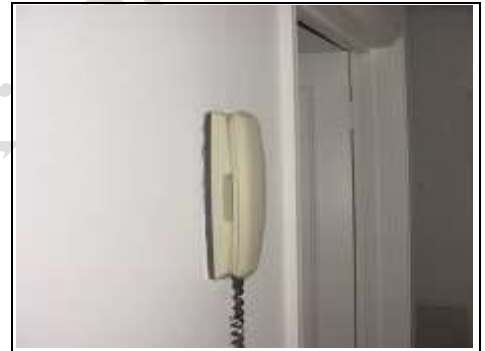
Entry phone system

We would prefer to see a video phone entry system these days and this is the sort of thing that could be budgeted for via the sinking fund.

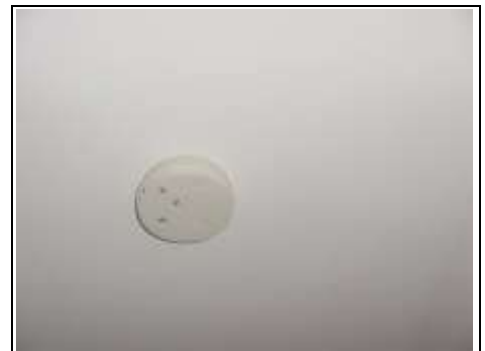
Smoke alarm

We are a strong believer that where properties are multi occupied, i.e. there are more than one resident or tenancy, that the fire alarm system should be interconnected alerting any of the properties if there is a fire anywhere within the building.

In addition to this there should be regular fire alarm drills.

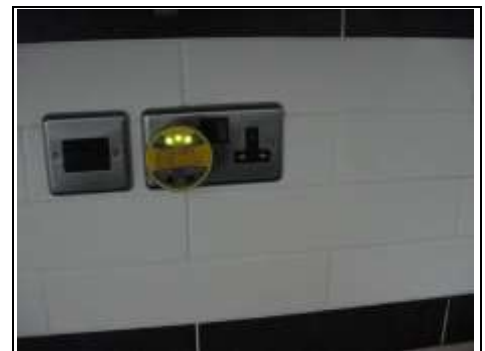
Earth Test

We carried out an earth test in the kitchen area to the socket point that is normally used for the kettle, this proved satisfactory.

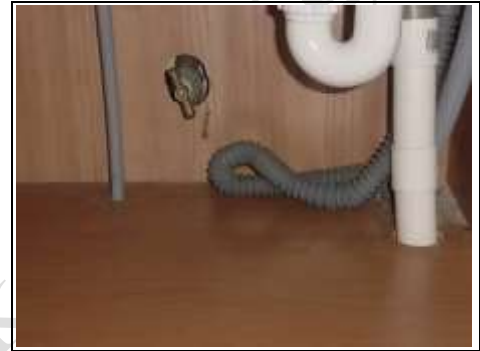
We found what we believe to be the controlling stopcock is located under the sink.

Stopcock under the sink

ACTION REQUIRED: Ask the owners to show you where it is.

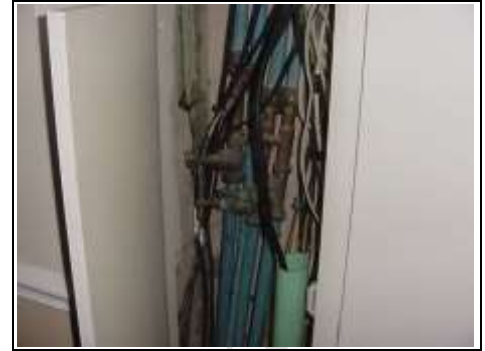
The plumbing, where visible, comprises plastic and copper piping. we are not keen on mixing plastic with copper as we tend to find that the joints suffer but we are aware that this is the way the plumbing industry is heading.

Plastic and copper pipe in communal area

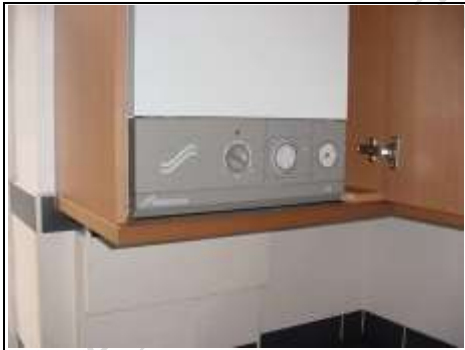
Our limited inspection of the hot water and central heating system revealed no evidence to suggest any serious defects but we would nevertheless recommend that the system be tested and overhauled before exchange of contracts and that a regular maintenance contract be placed with an approved heating engineer.

Wall mounted
Worcester Boiler

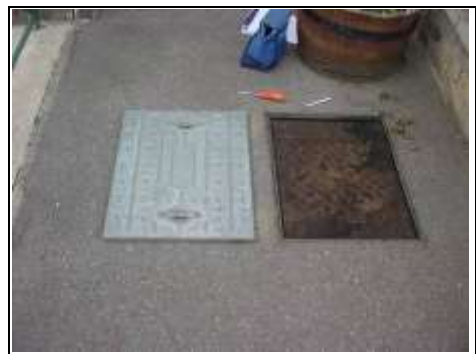
Manhole - right

When we lifted the cover we found another manhole underneath it which is most unusual. We could not lift the second manhole.

The Management Company for the property as a whole should have details of this.

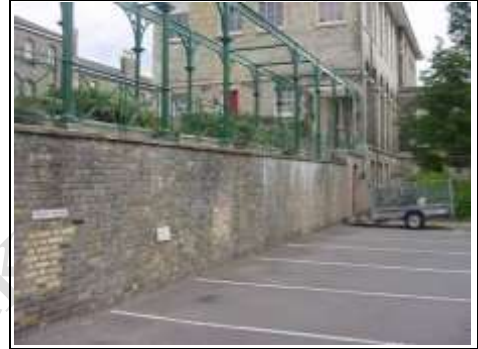
Parking area

It is likely that the property has allocated parking although we did not know where this was. We are also aware from talking to the security guard on the entrance gate that there are visitor spaces as well (one of which we used).

ACTION REQUIRED: Your Legal Advisor to check and confirm.

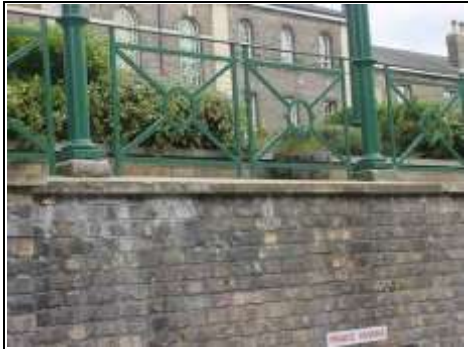
Retaining wall without weep holes

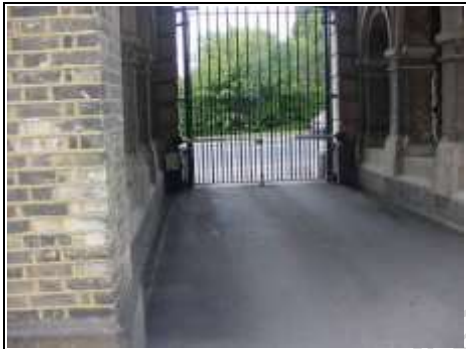
Other gated entrance for cars that we did not see used during the course of our survey. We do not know the arrangements for this.

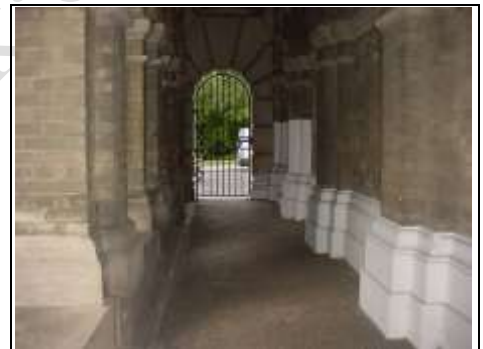
Pedestrian access that we did not see used during the course of our survey.

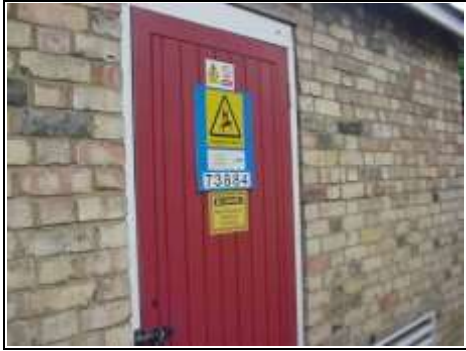
Rubbish store seems to have a generator

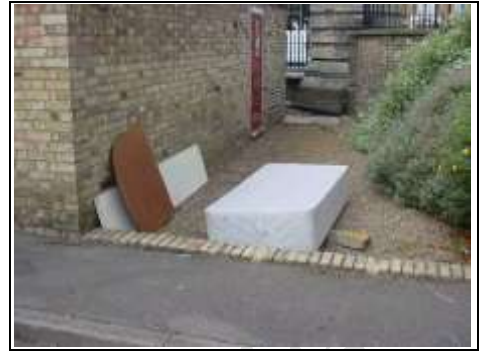
Dumped rubbish
