RESIDENTIAL BUILDING SURVEY

Worcestershire
WR10

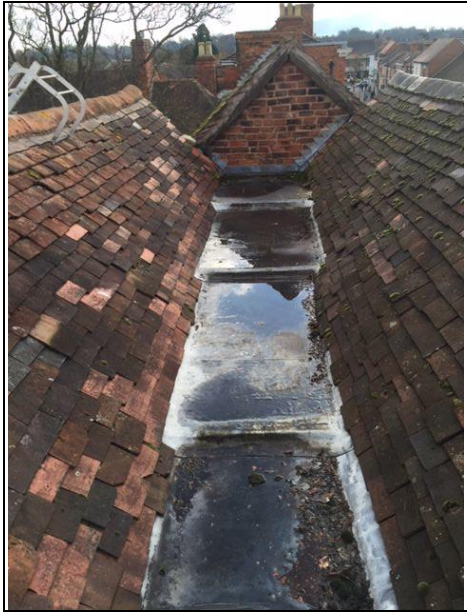
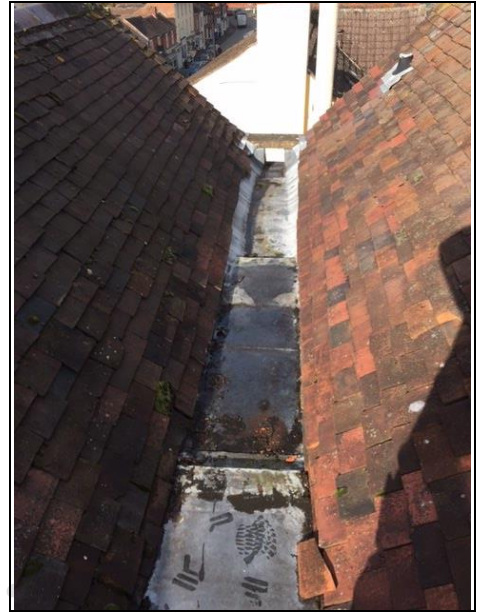
The vendor informed us that there have been some roof leaks in the past and that these have been repaired. When viewed inside the roof space the lower part of the roof slope has been re-boarded. The valley gutter has been re-lined. However there is some sludge and pooling of water in the gutter together with some slipped tiles.

Valley gutter

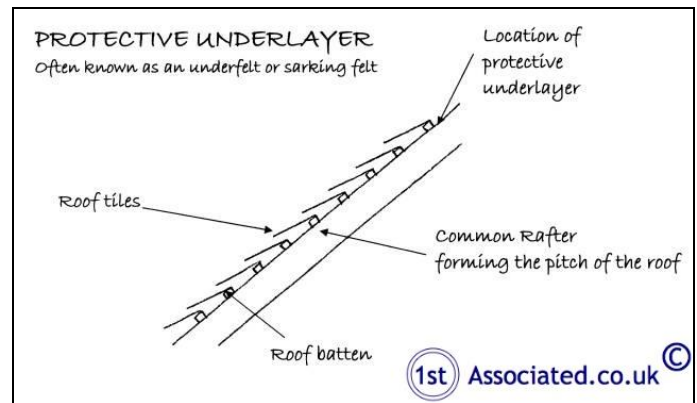
Protective underlayer

When we inspected the loft space we found a Hessian based Bitumen membrane. This type of membrane has been used since the 1960s and indicates that the roof has received attention in recent times.

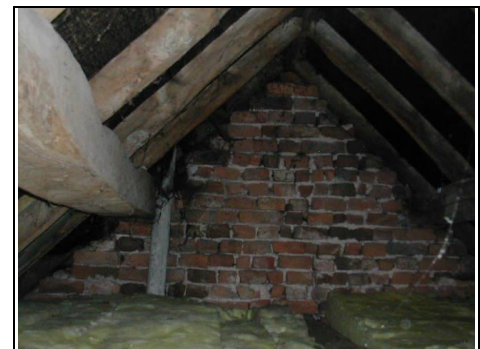
- Evidence of wood boring beetle in many areas.
- A split and bowed purlin.
- Incomplete areas of brickwork forming the end walls.
- Inadequate roofing insulation in places.
- Poor pointing of brickwork.
- Deflection in the gable wall.

End wall in front roof pitch

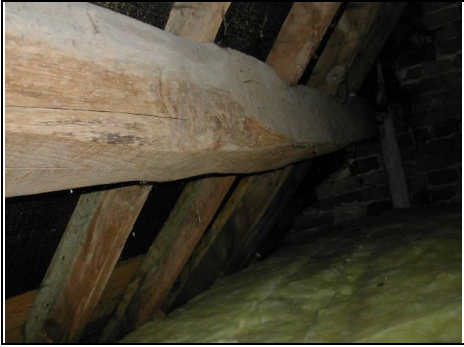
We noted one split purlin and a purlin that has a bowed shape.

Purlin

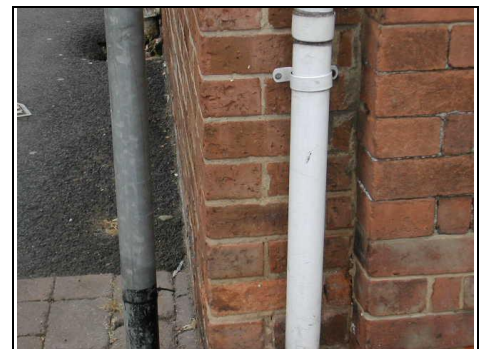
Plastic downpipe

ACTION REQUIRED: We would always recommend you stand outside the property next time it rains heavily and see how well the drains cope with the rainwater particularly looking at the guttering and the joints.

We would also recommend that the gutters and downpipes are cleaned out, the joints are checked and the alignment checked to ensure that the gutters fall towards the downpipes.

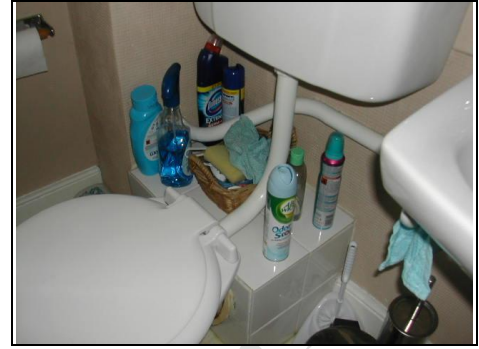
We were unable to locate the soil and vent pipe; we came to the conclusion that the pipe is internal and runs from the bathroom to rear porch, where other w.c.'s are located.

Internal soil and vent pipe
(assumed)

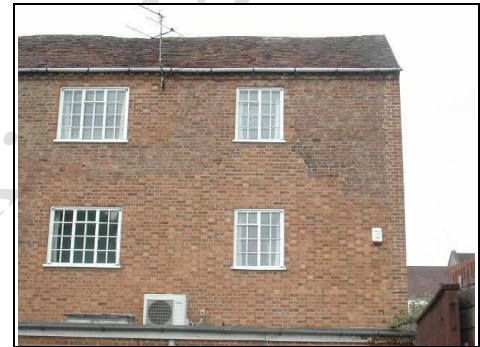
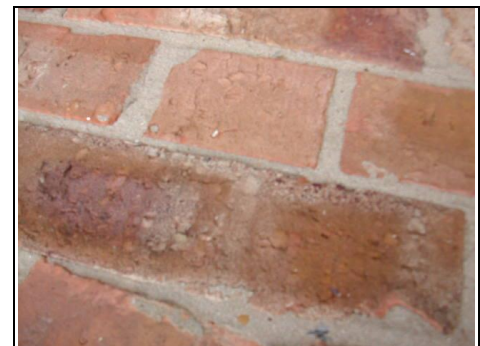
Areas of brickwork require re-pointing.

The rear elevation wall bows out which is an area of concern. Without opening up the structure we are unable to say whether this movement is continuing.

Flemish bond

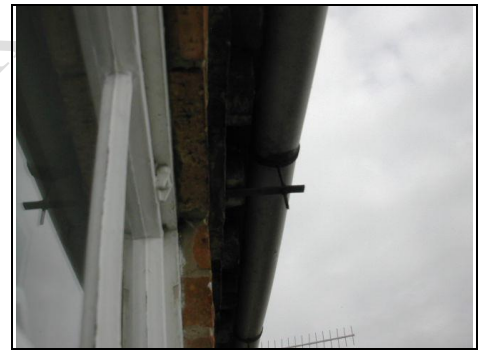
There are no fascias and soffits to this property. At the top of the external walls there are brick corbel details where alternative bricks in the top course are laid at a right angle to the wall.

Brick corbels

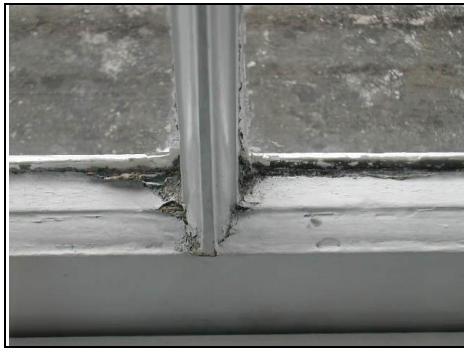
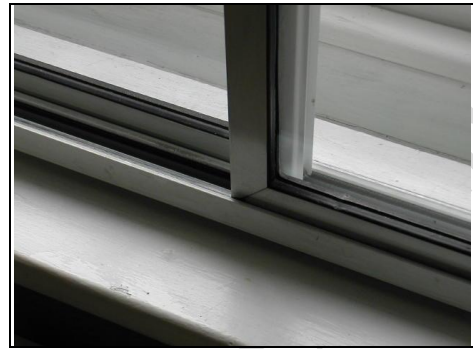
All windows are in fair condition and will require internal and external decoration in the next 3 years.

Sash window

Sliding aluminium window

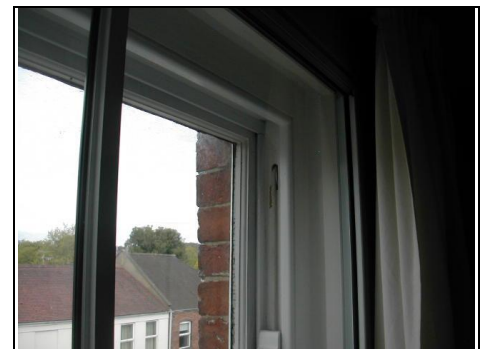
Window cill

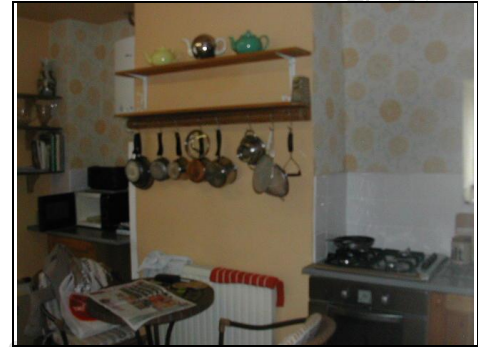
The fireplace to the chimney breast has been blocked up.

Chimney breast in kitchen

We could see that the chimney has been removed. Any chimneys that you do not propose to use should be capped and ventilated to prevent dampness.

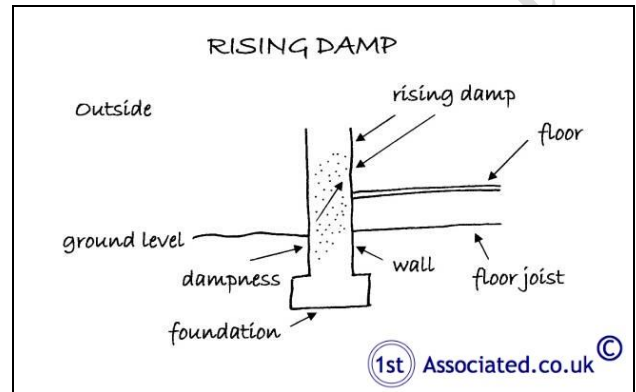
Rising damp

A visual inspection and tests with a moisture meter have been taken to the perimeter walls. In this particular case we have found significant rising damp in the ground floor porch walls.

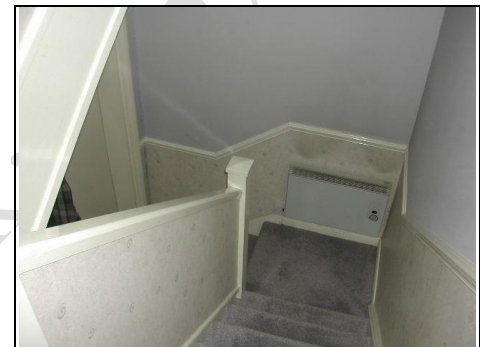
We noted that the underside of the staircase is enclosed. It is normal today to have a half hour fire barrier to stop fire spreading from the ground floor to the first floor in a worse case scenario.

We believe the staircase is not original and has been re-constructed at a later date.

Staircase

The staircase is the only way out of the property in the event of a fire. It needs to offer a level of fire protection in the event of fire and we do not consider the inner porch door is half hour fire rated, nor the door leading from the shop to the outer porch.

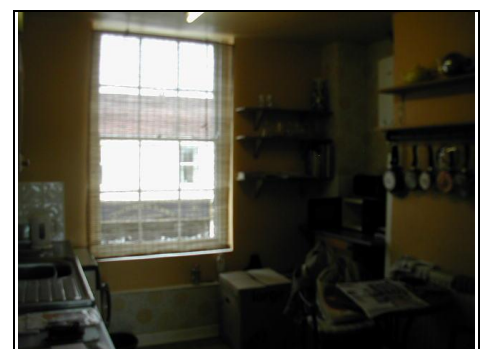
We found the kitchen in average condition, subject to some wear and tear as one would expect.

Kitchen

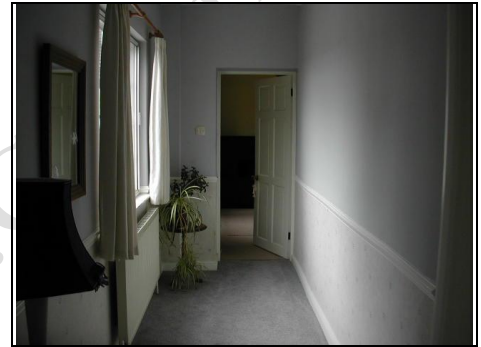
Internal decorations are in average condition.

General decorative condition

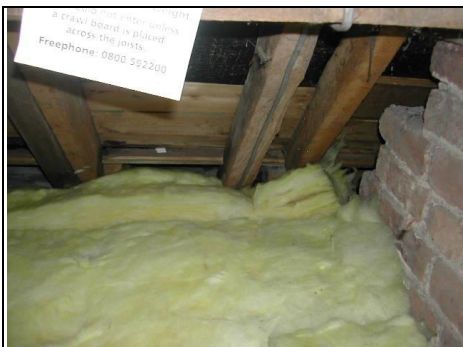
Some roof insulation was present in varying degrees of thickness.

Mass of insulation

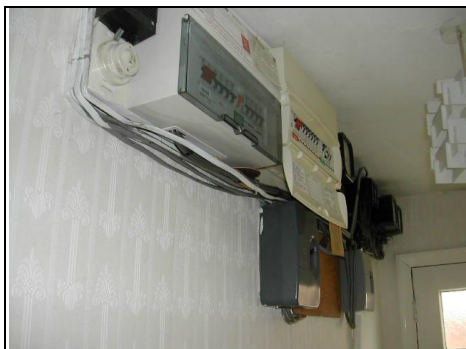
The electric fuses and consumer units were located in the porch. The fuse board looked newish but we noted older style sockets and fuse boards.

Fuse board

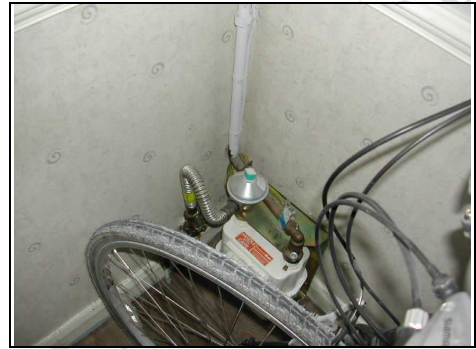
We are advised that the property has mains gas. The consumer unit is located in the inner porch.

Gas consumer unit

ACTION REQUIRED: As a matter of course it is recommended that the entire gas installation is inspected and made good, as necessary, by a Gas Safe registered contractor. Thereafter the installation should be serviced annually.

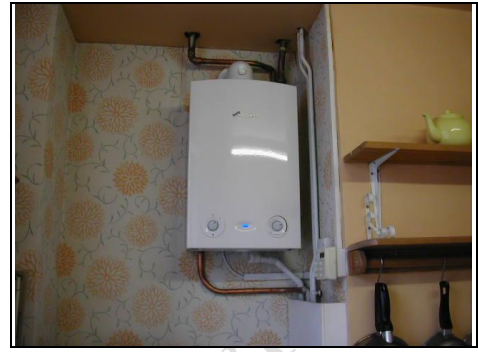
The boiler was located in the kitchen; it is manufactured by Worcester Greenstar.

Our limited inspection of the hot water and central heating system revealed no evidence to suggest any serious defects but we would nevertheless recommend that the system be tested and overhauled before exchange of contracts and that a regular maintenance contract be placed with an approved heating engineer.

Boiler

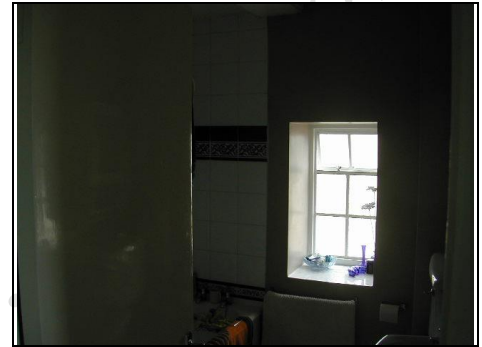
The property has a three piece bathroom suite, consisting of a bath, wash hand basin and WC, which look in average condition, subject to some day-to-day wear and tear, as one would expect.

Bathroom

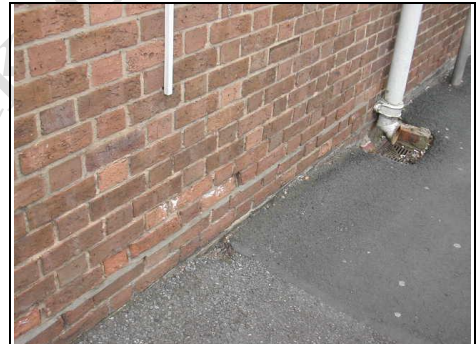
We believe the destination of rain/surface water run-off from the valley gutter is the gulley at the side of the property.

Gulley
