Georgian/Regency Example Residential Building Survey

The property is Grade II Listed, as found in BritishListedBuildings.co.uk

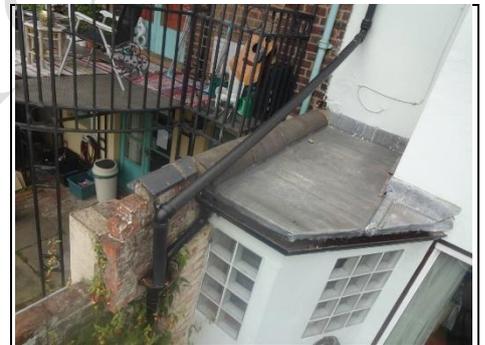
- 1) Lower ground floor front room changed to a utility/bathroom area
- 2) Rear room changed to kitchen area
- 3) Associated rear right area changed from toilet to boiler room
- 4) We can also see some fairly modern alterations such as the glass to the front of the property.

Toilet area changed to boiler room

ACTION REQUIRED: We would recommend legal advisors obtain a full list from the present owners as to what they have and have not done and what they consider previous owners have not done. Then arrange an informal ‘cup of tea’ meeting with the Listed Building Officer and show them the list and ask if they have a photographic record of the property as many local authorities do have.

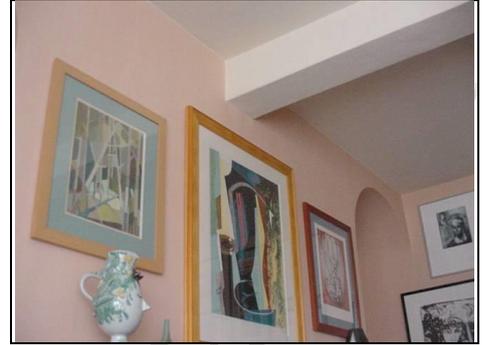
As with many properties of this age walls have been removed and the stairs have been altered for example today on the ground floor where the beam is you would be required to have a 450mm for it to be supported however the property has obviously stood the test of time.

No return to removed wall

The owner advised the extension and reposition of the staircase was carried out in 1928.

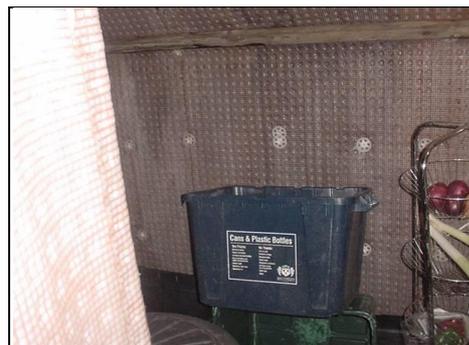
We found some dampness to the lower ground floor as we would expect. Basements were never meant to be dry or as what we would term as habitable rooms. The use of it as a bathroom to the front and a kitchen to the rear is probably ideal. There tends to be problems where these rooms are used for sleeping in.

Dampness in basement area

ACTION REQUIRED: You could add a French drain to the property to try and keep the lower ground floor/basement slightly drier however at the end of the day it is a basement.

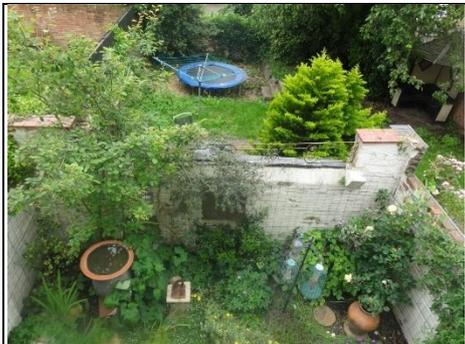
The rear garden wall is slightly unsafe and worse for wear. We could see it is built in a red brick which is starting to deteriorate and also some of the capping is not ideal, possibly because of the conifers and trees nearby. We tend to find that garden walls are built without proper foundations.

Rear garden wall and surrounding garden

ANTICIPATED COST: We recommend you set aside the sum of £500 to £1,000 assuming that the adjoining owners will also pay some money.

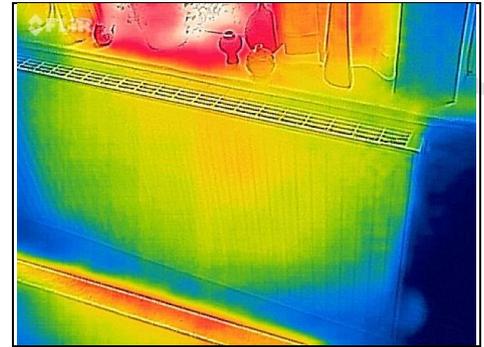
We gave the owners the opportunity to turn the heating on and warm the house up for a ten minute test however unfortunately we could not get any of the radiators warm.

Heating not working

There is a Baxi boiler located in the kitchen. We are advised the boiler was installed in 2009. We would recommend that the system be tested and overhauled before exchange of contracts and that a regular maintenance contract be placed with an approved heating engineer.

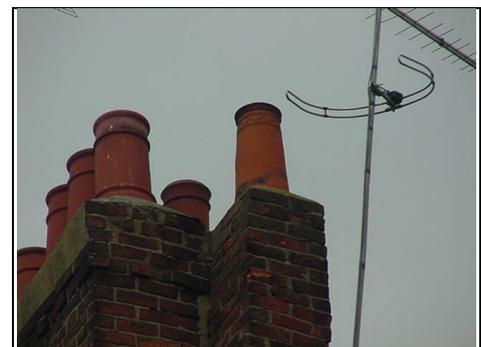
This is a large brick chimney with a lead flashing and numerous chimney pots. From what we could see from ground level we noted some deterioration to the soft red brick.

We noted aerials attached to the chimney which we are not keen on as it cuts into the brickwork rather like a cheese wire cutting into cheese.

Closer view of chimney

ACTION REQUIRED: Check the chimney when carrying out the high level roof work as it is built in soft red brick.

ANTICIPATED COST: Set aside a few hundred pounds; quotations required.

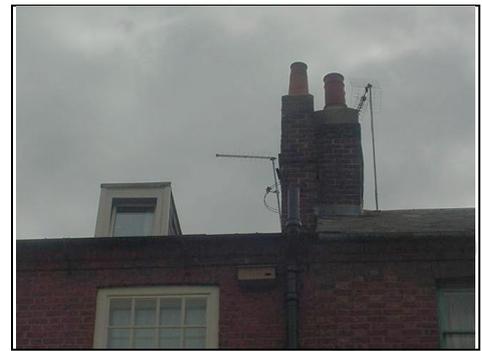
The property has a dormer window to the front and rear which were very difficult to view. The dormer window roof and cheeks are made from lead, we could not see any leaks internally. They have metal double glazed windows.

Front dormer window

ACTION REQUIRED: The dormers need to be checked when high level work is being carried out.

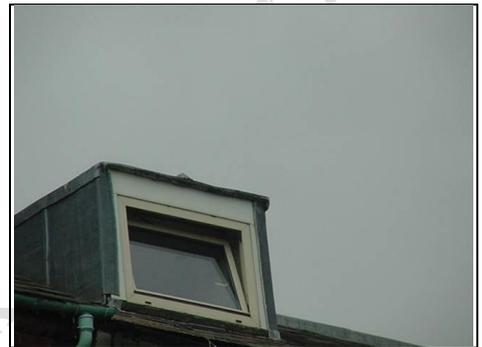
Rear dormer window

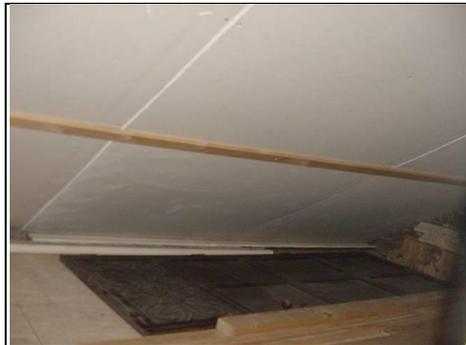
In this case the roof has been lined therefore we were unable to see a protective underlayer/sarking felt.

Room in roof lined

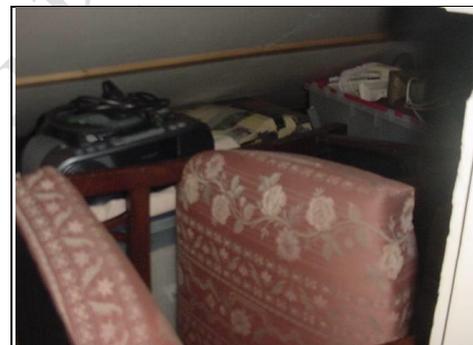
Area to front lined and full of stored items

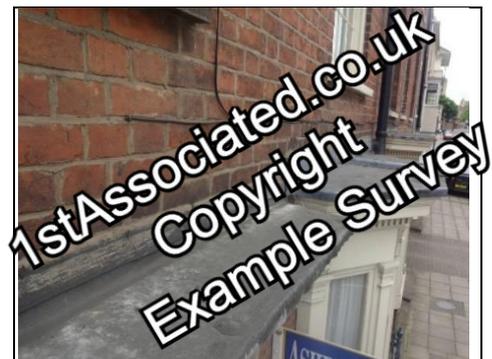
The roof is flat and covered with lead which looked in average condition.

Flat lead roof over front door

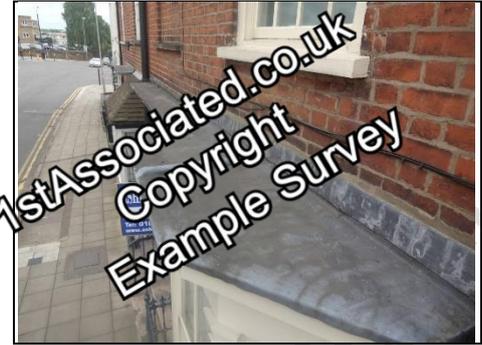
The roof is flat and covered with lead which looked in average condition.

Front lead over canted bay

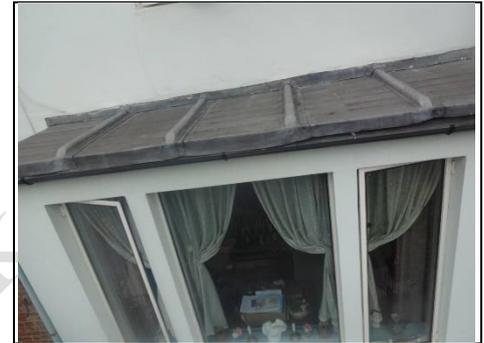
The roof is flat and covered with lead which looked in average condition.

Flat roof to rear box bay

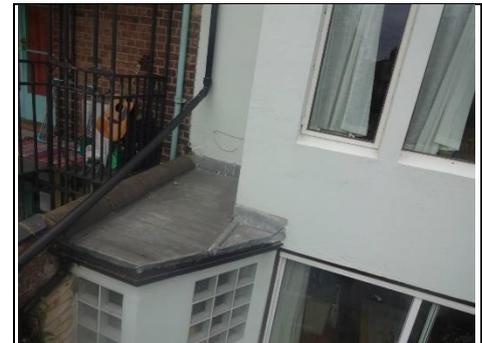
Again, the roof is flat and covered with lead which looked in average condition.

Rear right flat roof

We were advised the flat roofs were re-leaded in 2006 and 2008.

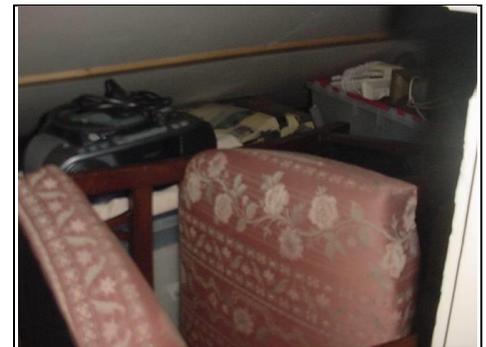
Area to front lined and full of stored items

In this case we were unable to inspect due to the room formed within the roof. The access areas were lined and full of stored items.

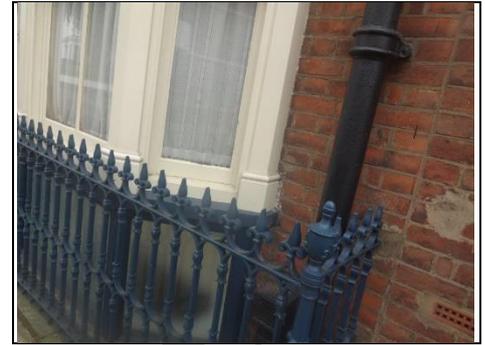
The property has cast iron soil and vent pipes. Cast iron of this age will need maintenance. If regularly maintained it lasts longer than plastic, in our experience.

Cast iron soil and vent pipe

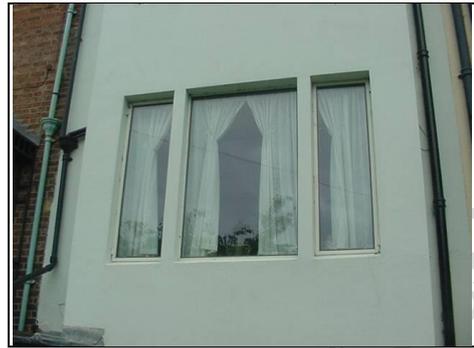
No drip detail

ACTION REQUIRED: Interestingly, if you look to add drip details on this we would discuss it with the Listed Building Officer before you do it. Although it is a defect it may be considered part of the style of this property.

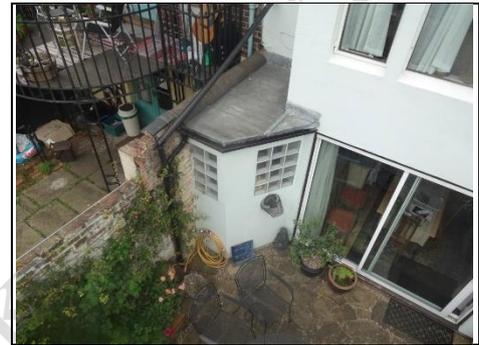
In properties of this age it is unlikely that a damp proof course would have been built in originally however, often they have had damp proof courses added at a later date. In this case we could not see a damp proof course.

Unable to see damp proof course

Your attention is drawn to the section of the report specifically dealing with dampness.

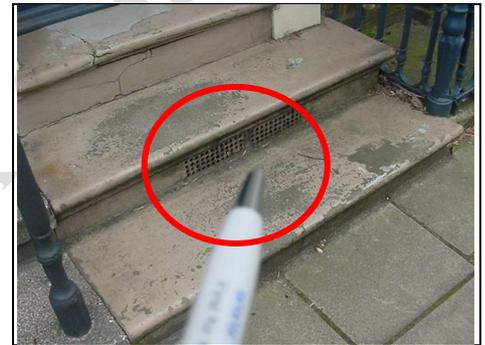
Air bricks are essential to have a through flow of air as this helps to reduce the chances of wet rot, dry rot and woodworm. In this case we noted an airbrick to the front step giving an airflow to the lower ground floor/basement.

Air brick to front

ACTION REQUIRED: Ensure the airbricks are clear.

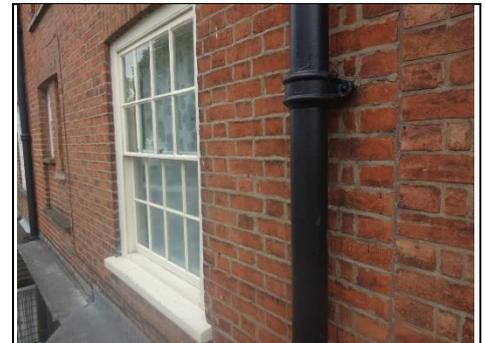
The property has sliding sash Georgian style windows to the front of the property with more modern double glazed metal framed windows to the rear - we are advised these replaced crittal style windows to the rear bay; we would be very interested to see if there was any listed building consent on this. We were advised the windows were replaced in 2008.

Georgian window

ACTION REQUIRED: Your legal Advisor needs to check and confirm if there has been any listed building consent for alterations to windows.

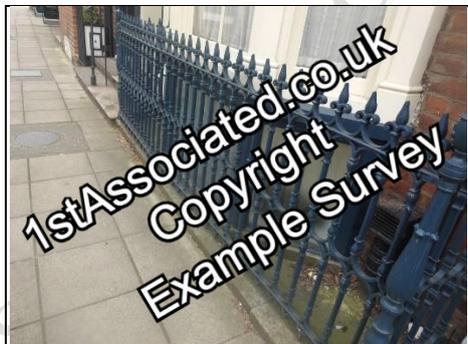
We think the area that is glazed gives natural light into the downstairs bathroom/utility room. This will be susceptible to dampness and water getting into this area.

Glazed area below railings area

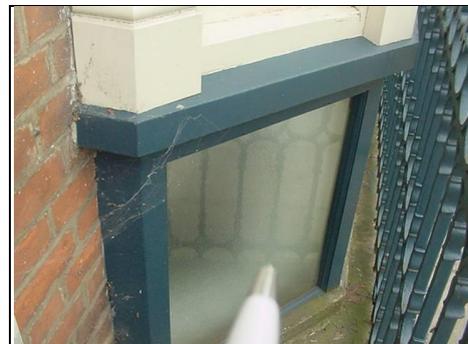
Glazed area

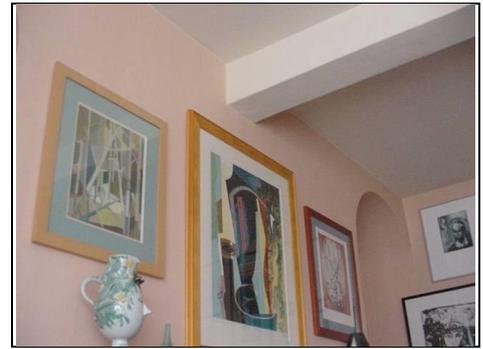
These are, we believe a mixture of solid and studwork construction. It is impossible to determine the construction without opening up the walls and we have therefore taken an educated guess. Some walls look to have been removed to accommodate the altering of the staircase.

No return to removed wall

ACTION REQUIRED: Please see our comments in the Executive Summary.

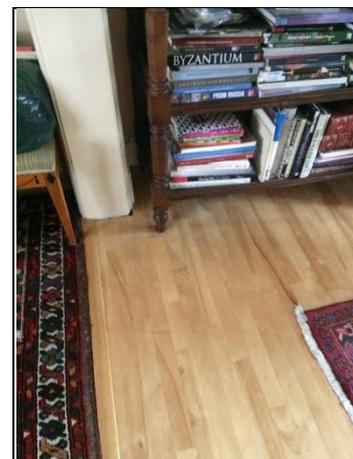
We normally find these floors have undulations and are not level and true however in this case as laminate floor is used in some areas this hid the true condition of the floors.

Laminate floor to upper ground floor

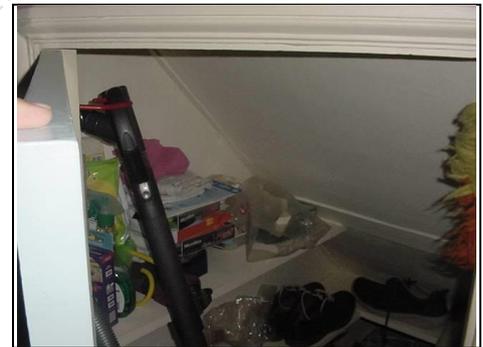
We were unable to examine the underside of the stair timbers due to it being lined where we could see it, which precluded our inspection, so we cannot comment further upon the stair structure. We can, however, say that the lining gives a resistance to the spread of fire if such circumstances were to occur.

Stairs lined

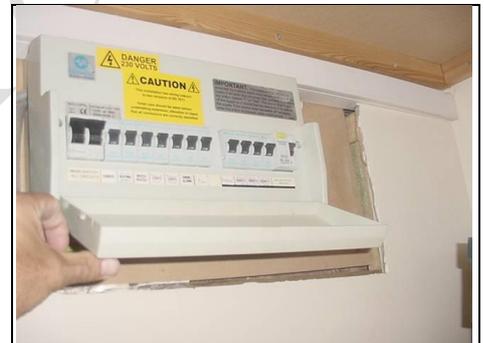
The electric fuses and consumer units were located in the utility room/shower room on the lower ground floor. The fuse board looked 1980's/1990's and better are now available.

Fuse Board

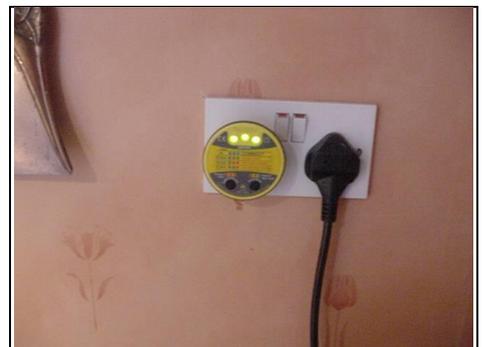
We carried out an earth test in the kitchen area to the socket point that is normally used for the kettle, this proved satisfactory.

Earth test

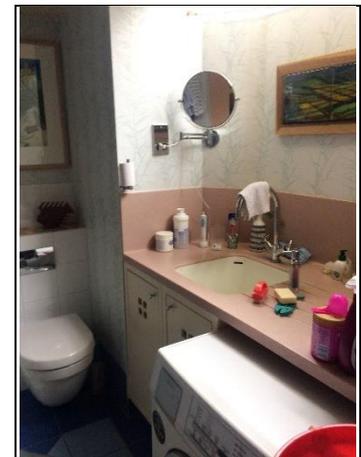
The lower ground floor/basement has a utility room/shower room comprising a shower, wash hand basin and WC which looks in average condition with some dampness as we would expect in a basement location.

Utility room/shower

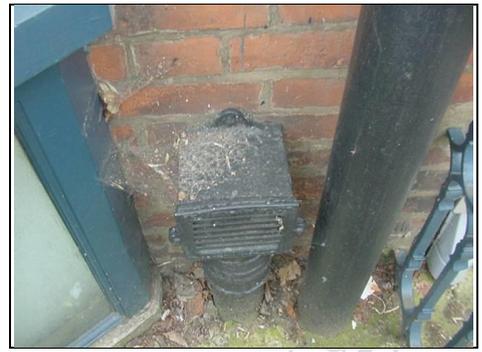
To the front of the property there is a deep vent we assume to the drains.

Deep vent to drain

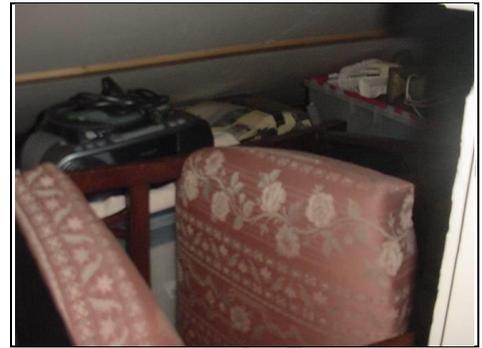
- 1) We did not have a full view of the roof due to the room formed within the roof and the lining.
- 2) We did not open up the walls as we could not see a way of doing this without causing damage.
- 3) We did not open up the floor as we could not see a way to do it without causing damage.
- 4) We were unable to see the heating working.

Area to front lined and full of stored items
