# Timber Frame Example Residential Building Survey

# INTRODUCTION

Firstly, may we thank you for your instructions of xxx; we have now undertaken an independent Building Survey (formerly known as a Structural Survey) of the aforementioned property. This Survey was carried out on xxx.

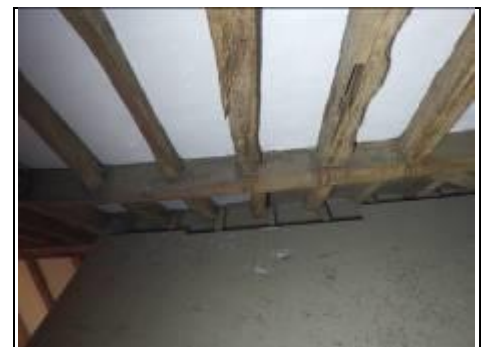
Common rafters into purlin out of true/ movement occurring

**ACTION REQUIRED:** Initially we would recommend monitoring however we feel it is likely that work will be required to the area above the left side bedroom. Often strengthening can take place with timber or metal. Further investigation is required.

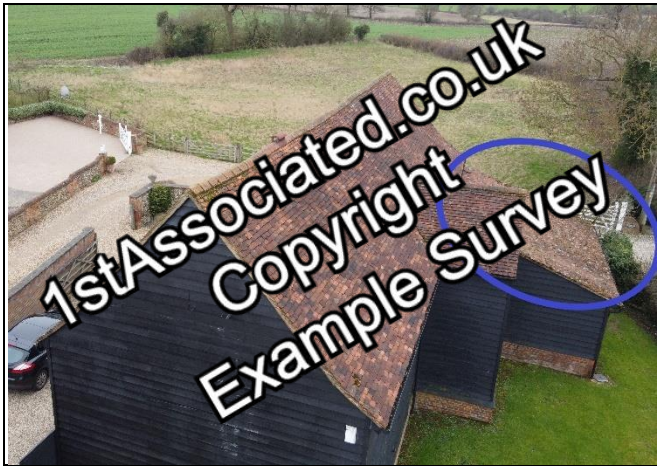
Catslide/shallow pitched roof to rear left  
~ Aerial View - 360 Photo ~

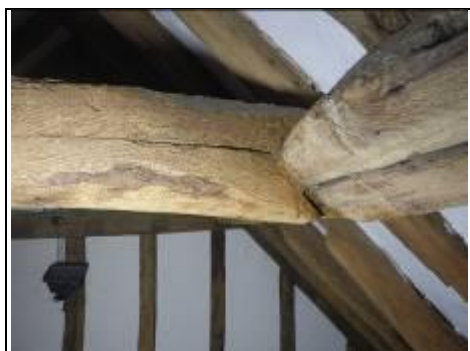
Woodworm

**ACTION REQUIRED:** We would use the woodworm breeding season of spring to identify the extent of the woodworm using sticky backed paper or similar to catch any. We would be more than happy to discuss this further. Generally warming up the property and making it watertight will make the environment not appropriate for woodworm and it will move on/die off.

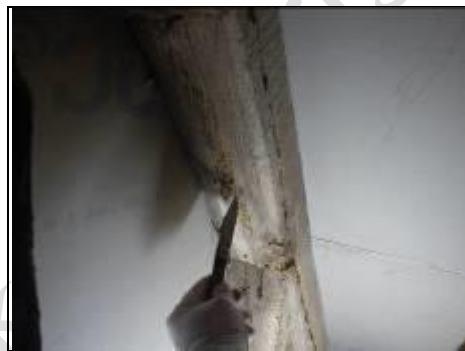
Signs of active woodworm

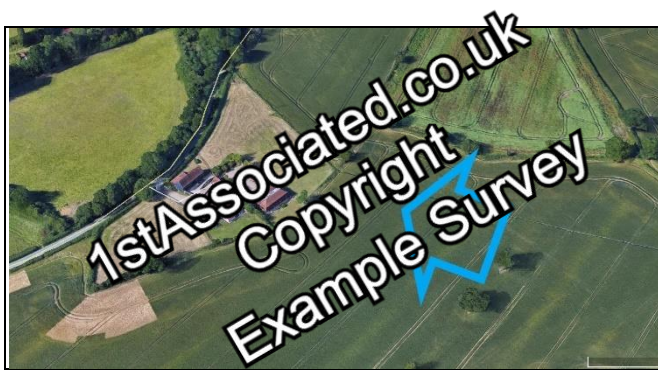
Site slopes towards road  
~ Aerial View - 360 Photo ~

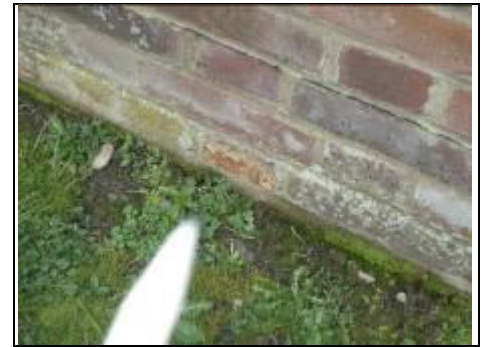
This has resulted in dampness to the brickwork. There looks to have been a bitumen damp proof course put in which was very popular in the 1950's-1970's. the bricks are spalling and generally deteriorating due to water damage.

Bitumen damp proof course

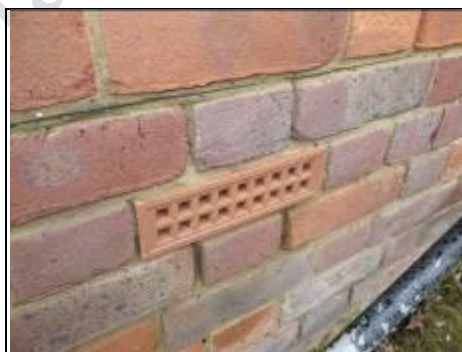
Weathered pointing

- 1) Establish if it is lime and if it is lime you need to remember lime every time and lime takes time – see sketch below
- 2) If it is originally bedded in cement mortar then you need to accept this is an inherent defect and a characteristic of the building.

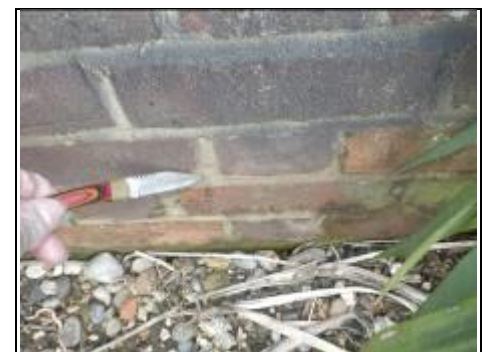
Cement mortar

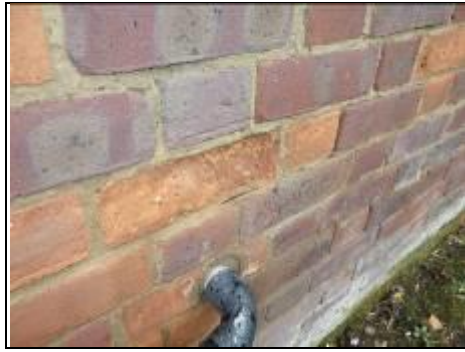
Spalling/deteriorating brickwork

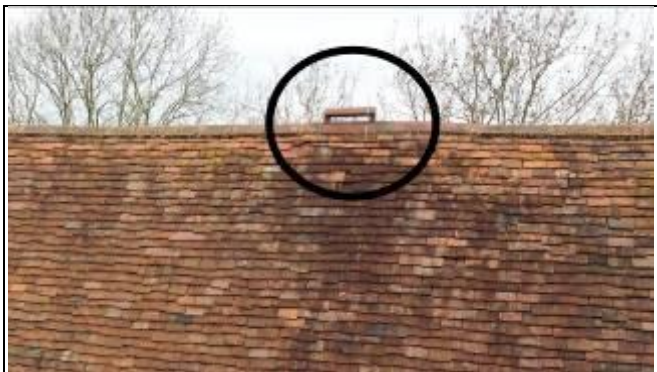
We noted a chimney/ridge vent to the roof which we assume is to vent the fire.

Ridge vent  
~ Aerial View - 360 Photo ~

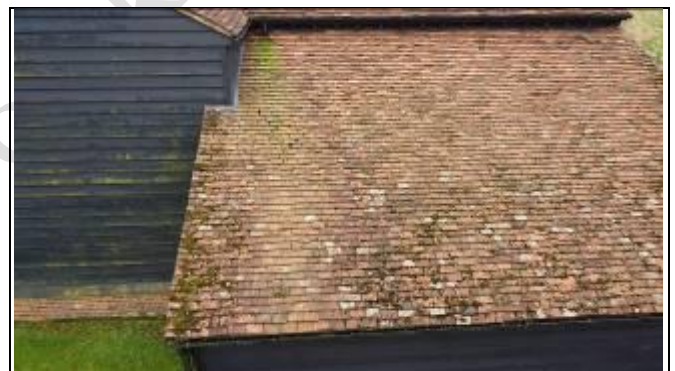
Rear gable end where repairs taken place  
~ Aerial View - 360 Photo ~

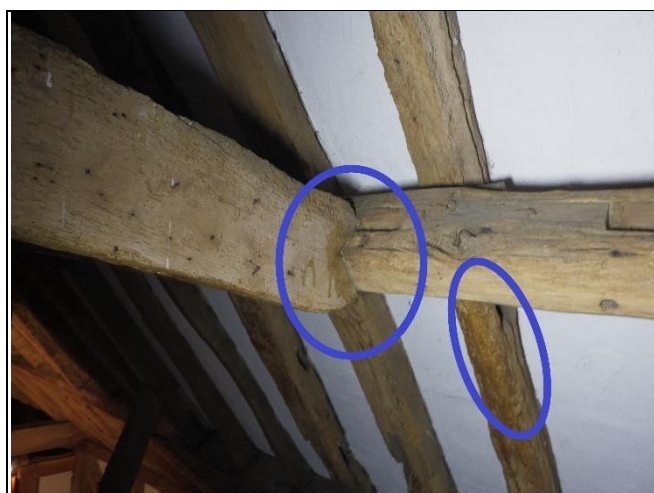
We noted some type of bonding agent to the timber frame such as resin. Your legal advisor should specifically ask the present owners for details of any repairs carried out.

Resin bonded  
~ Aerial View - 360 Photo ~

**ACTION REQUIRED:**  
Please see our comments in the Executive Summary.

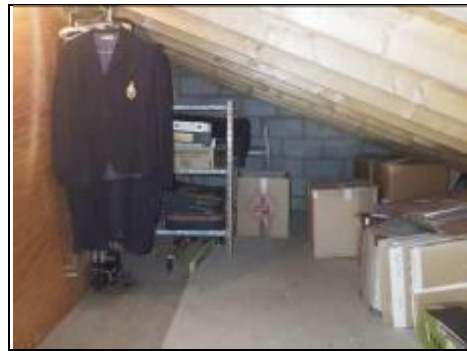
Stored items limited view

**ACTION REQUIRED:** Please  
comments in the Executive Summary.

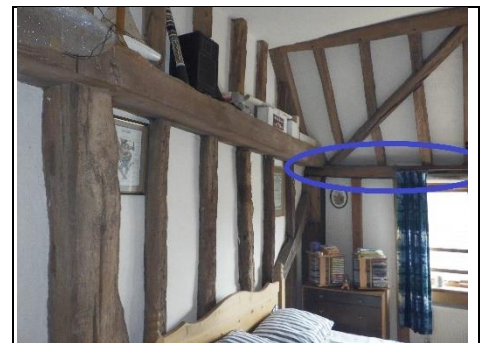
At the very top of the wall is a wall plate which effectively forms the end of the timber wall construction and is where the common rafter ceilings joists sit onto. In this instance we can see that areas have been replaced and amended over the years. It generally looked in average condition. We can see there have been amendments around the staircase area as mentioned elsewhere within this report and to some extent the wall plates purpose has been changed in the stair area to a structural element to allow the opening of the stairs where it once would not have been.

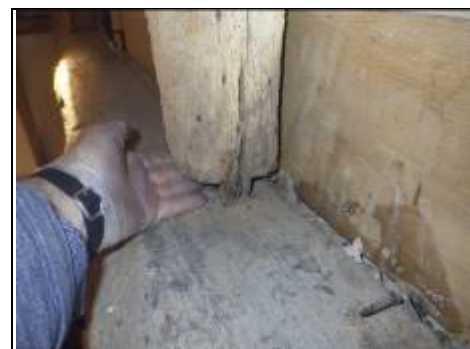
Vertical timbers mortise and tenon joint not working

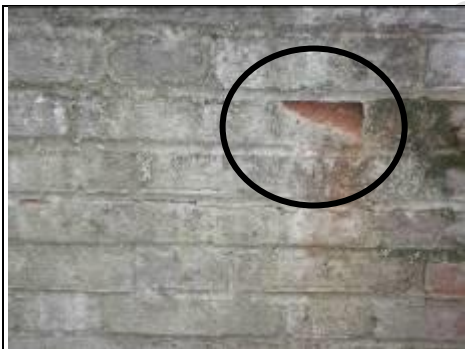
Spalling brickwork

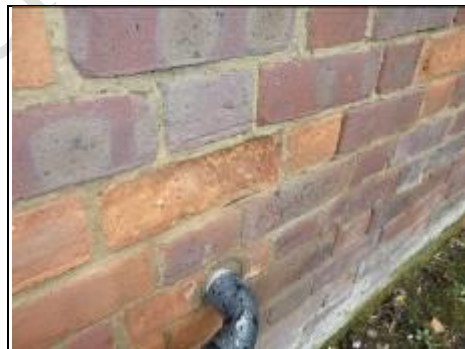
Spalling/deteriorating brickwork

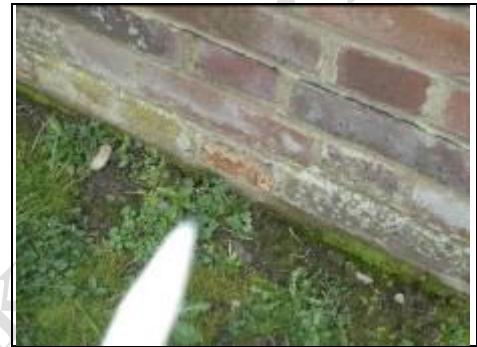
In properties of this age it is unlikely that a damp proof course (DPC) would have been built in originally however often they have had damp proof courses added at a later date. In this case, we can see a bitumen damp proof course in some areas.

Bitumen damp proof course

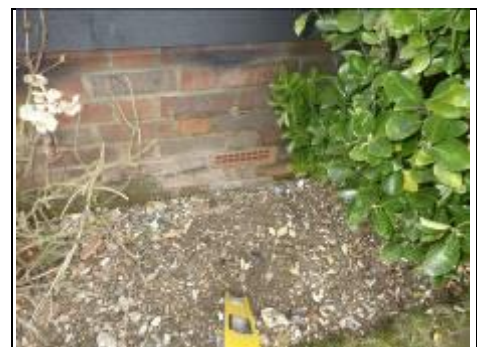
Air brick

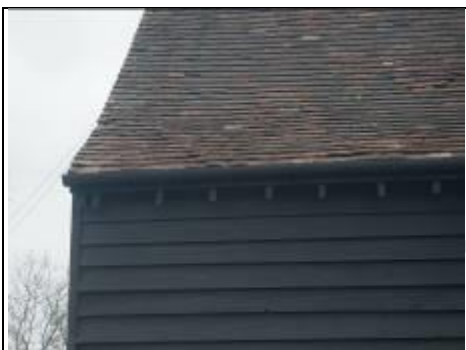
Rafter feet

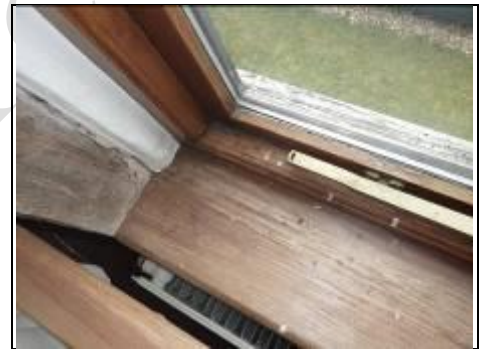
The property has timber windows with thin double glazing. We would specifically comment that they are generally in below average condition.

Double glazed timber windows

**ACTION REQUIRED:** Repair/replace subject to agreement from the Conservation Officer. Please see our comments in the Executive Summary.

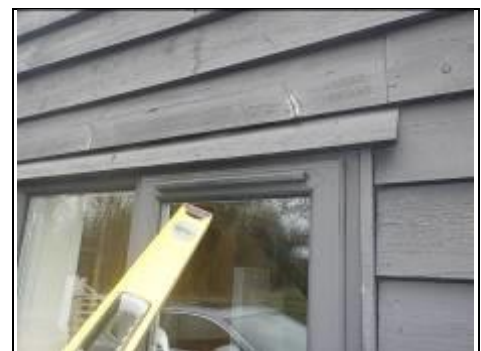
Trickle vent

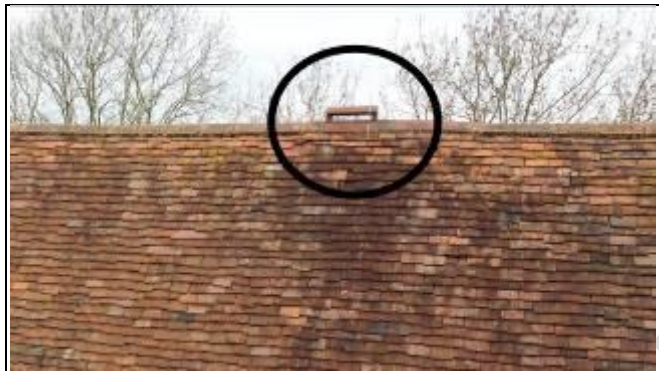
We noted a chimney/ridge vent to the roof which we assume is for the chimney. The fire was not working at the time of our survey. The owner advised that they did not know when the chimneys were last cleaned therefore we would recommend clearing. We would assume that they do not work unless evidence can be provided otherwise.

Ridge vent  
~ Aerial View - 360 Photo ~

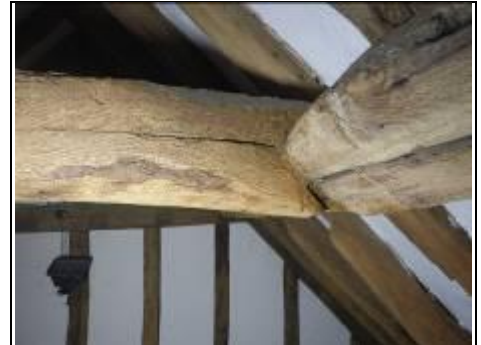
The roof is the main area that we look for woodworm as well as the actual traditional timber structural frame. Within the roof we found no obvious visual signs of significant woodworm activity however there was some minor woodworm.

Woodworm

**ACTION REQUIRED:** If you wish to be one hundred percent certain that there is no woodworm the only way would be to check the property when is emptied of fixtures and fittings etc and monitor it during the breeding season in the spring.

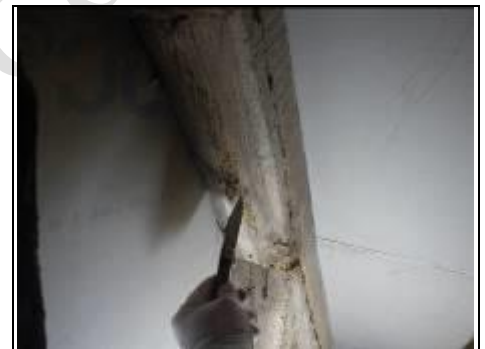
Signs of active woodworm

We would add that we would not recommend any chemical treatments, there are natural ways of removing woodworm that are far better in this type of property.

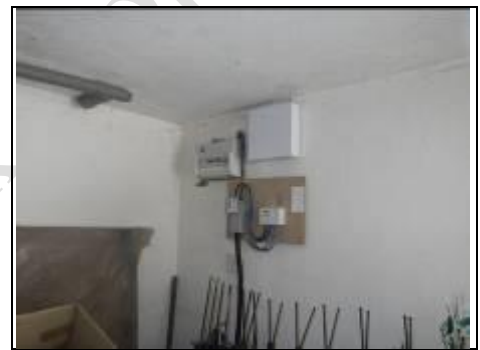
The electric fuses and consumer units were located in the integral garage. The fuse board looked 1970's to 2000 and better are now available. In an older property a defective fuse board can be particularly dangerous.

Fuse Board

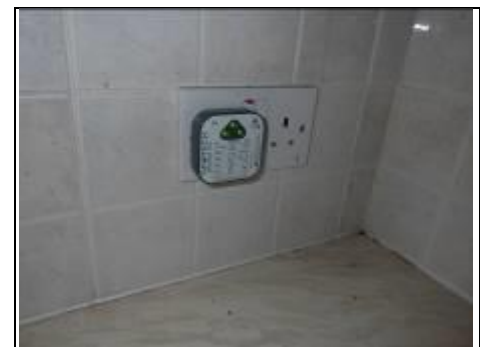
Earth test

We carried out an earth test in the kitchen area to the socket point that is normally used for the kettle, this proved satisfactory.

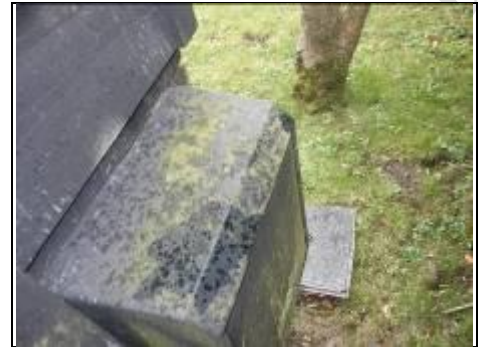
Gas unit to left side

We are advised that the property has mains gas.  
The consumer unit is located to the left.

**ACTION REQUIRED:** As a matter of course it is recommended that the entire gas installation is inspected and made good, as necessary, by a Gas Safe registered contractor. Thereafter the installation should be serviced annually.

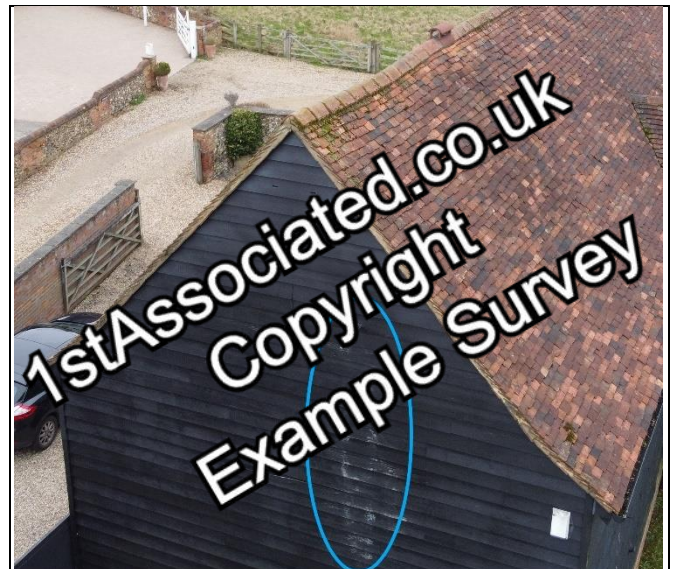
Please see our comments in the Roof Section. The overflows look to be discharging down the right side wall.

Overflow has overflowed from tank and discharged down building  
~ Aerial View - 360 Photo ~

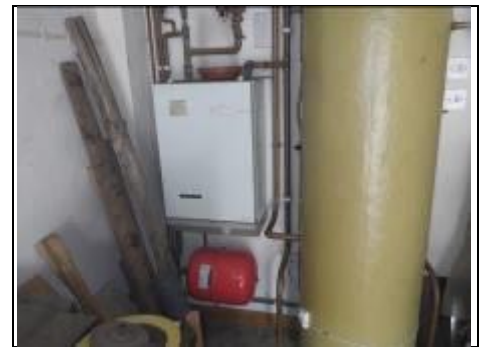
Boiler

There is a Potterton boiler located in the integral garage.

Our limited inspection of the hot water and central heating system revealed no evidence to suggest any serious defects but we would nevertheless recommend that the system be tested and overhauled before exchange of contracts and that a regular maintenance contract be placed with an approved heating engineer.

**ACTION REQUIRED:** We recommend you return to the property with the estate agent to turn the heating on to ensure it is working.

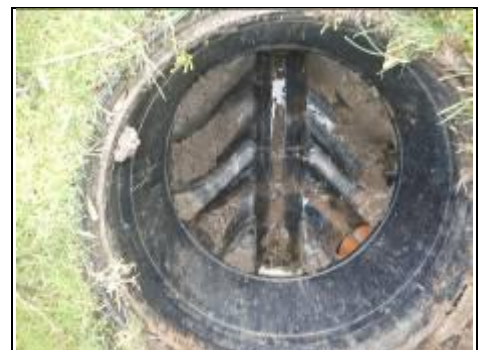
We duly lifted the cover and found it to be clear at the time of our inspection.

From what we could see it is plastic built.

Modern plastic manhole

**ACTION REQUIRED:** We would recommend a closed circuit TV camera report of the drains.

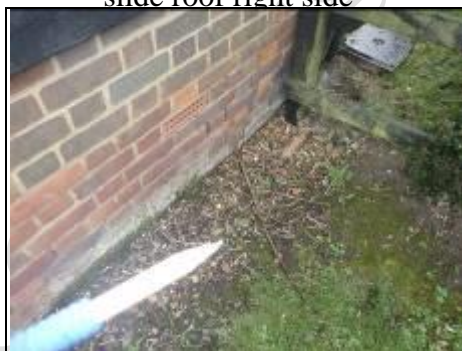
We were unable to lift this manhole to inspect.

Rear left of cat slide area rodding eye

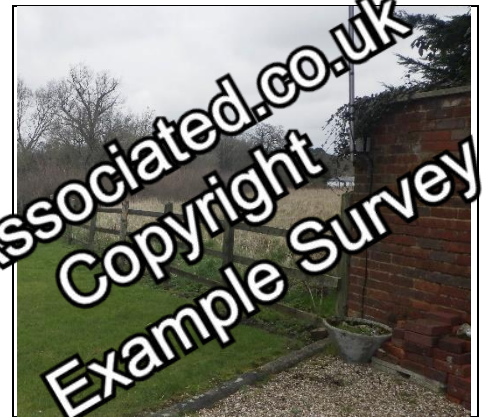
Brick wall tor right

The brick wall to the right is weathered and in need of repointing.

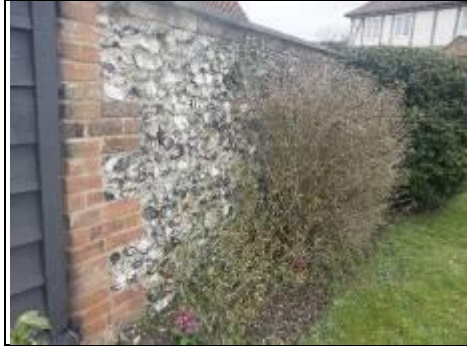
There is a flint garden wall, some areas of which have come loose.

Flint/brick wall to left side

**ACTION REQUIRED:** We would recommend that you visit the neighbours.
